LESSONS LEARNED FROM THE 2008 SICHUAN EARTHQUAKE AND APPLICATION TO THE RETROFIT PROGRAM IN ISTANBUL, TURKEY

H. K. Miyamoto¹, A. S. J. Gilani², and P. Yanev³

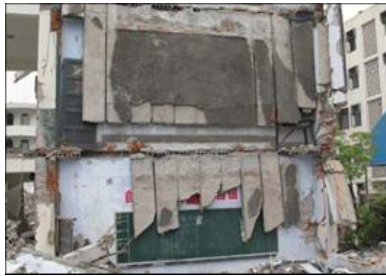
The three-story Juyuan Middle School is in Juyuan, a town with a population greater than 50,000 and approximately 20 kilometers from the fault rupture. The school, constructed in 1986, housed 1,000 students; more than 700 died when the building collapsed. Building construction consisted of non-ductile, cast-in-place reinforced concrete (CIP-RC) beams supported by unreinforced masonry (URM) walls with precast concrete floor planks. Figure 1 shows the collapsed floor precast planks. Note that the inadequately connected and under-reinforced planks pulled away from the walls and were left hanging and attached to the opposite walls. Figure 2 shows the collapse of non-ductile bond (perimeter) beams.

Figure 1. Collapsed ceiling/floor planks

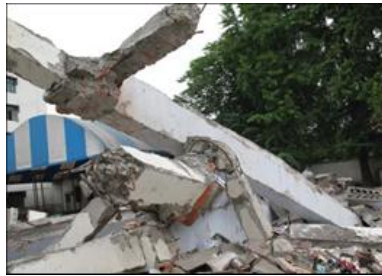
Figure 2. Collapsed concrete beam

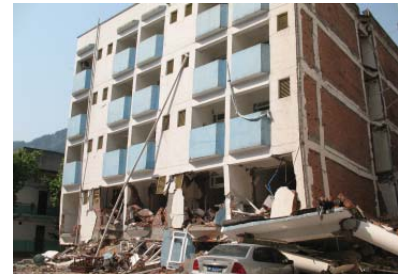
The five-story Hanwang hospital was constructed in 1999. Building construction consisted of non-ductile CIP-RC framing and URM walls. The ground floor was designed as a parking garage; hence, the URM bearing walls were terminated at the first floor, creating a bottom story with a significant reduction in lateral stiffness. This soft-story (ground floor) collapsed during the earthquake (Figure 3) and the upper floors dropped down one floor.

Figure 3. Soft story collapse

Soft story at ground floor	Lack of lateral stiffness and capacity at a floor	Add single-story ductile RC shear walls on the exterior of the building.
		Add single story steel braces on the exterior of the.
		Add viscous or viscoelastic dampers to the ground floor.

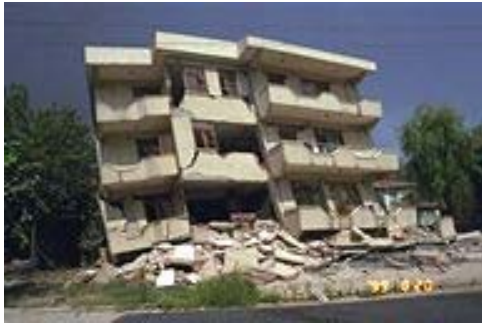
The 1999 magnitude 7.6 Izmit (Kocaeli) and magnitude 7.2 Duzce earthquakes caused extensive damage to its local region. Fatalities exceeded 18,000 while casualties exceeded 50,000, with a direct financial loss of over US \$6 billion. High ground accelerations were recorded. During these earthquakes and during the other strong Turkish earthquakes, many vulnerable structures have either collapsed or have been severely damaged. A review of post-earthquake surveys in Turkey (Sezen et al. 2000) reveals that many of the types of structures that were damaged in the Sichuan earthquake also performed poorly during the 1999 earthquakes in Turkey. For example, as shown in Figure 5, soft story collapses occurred when the lateral stiffness of the bottom floor was lower than that of upper floors and URM buildings or infill walls collapsed (NISEE 2009), as shown in Figure 6.

Figure 5. Soft story collapse (Sezen 2000)

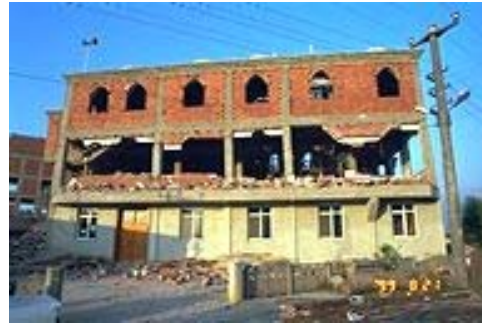
Figure 6. URM infill collapse (NISEE 2009)

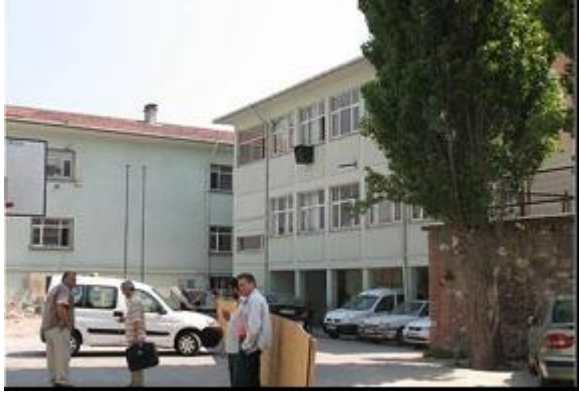
Figure 7 depicts a vulnerable building in Istanbul taken during a recent site visit and its condition-assessment survey. For this building, the walls terminate above the first floor to allow parking beneath. This introduces a soft-story mechanism and can lead to collapse in a future earthquake. This structural configuration is not much different from those observed in China (see Figure 1). Once such dangerous buildings are identified, it is important that steps be taken to address their vulnerabilities.

Figure 7. A vulnerable structure

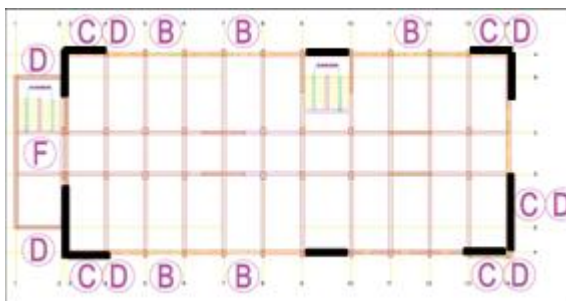
Figure 10. Retrofit with new concrete walls

The addition of shear walls (Figure 10 and Figure 11) is the most widespread retrofitting method for the Istanbul strengthening work. This technique is attractive because of its effectiveness, relative simplicity of construction, and cost effectiveness. The key reason for effectiveness is that the additional shear walls are designed to resist a large portion of the lateral seismic loads, which significantly reduces the demand on the existing frame members.

- The walls must be designed and detailed to have adequate ductility.
- Connections between new and existing structural members should be properly designed.
- The existing members should be analyzed to ensure they could resist the imposed loads.
- Diaphragms, collectors, and diaphragm anchorage to the new walls should be evaluated.
- Connections between existing and new concrete components shall be checked.

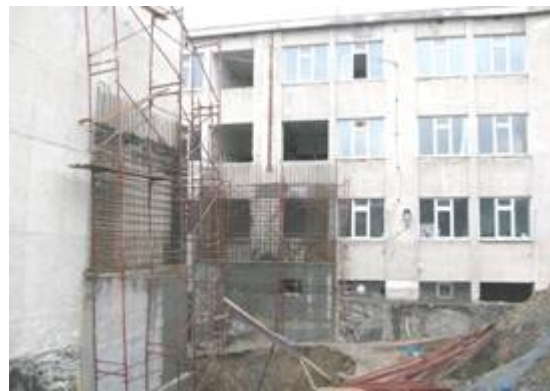
Figure 11. Construction of exterior concrete walls for school retrofit
