A TALE OF THREE CITIES

B. Bayhan¹ and P.Gülkan²

ABSTRACT

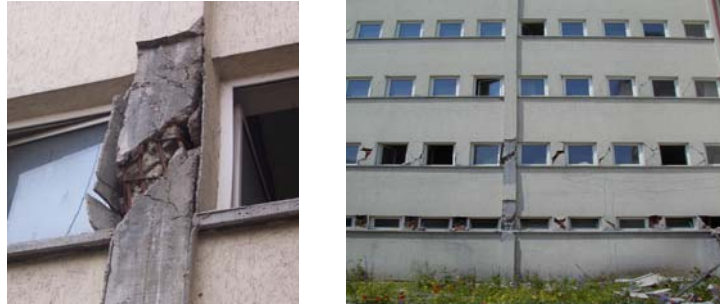
Figure 6. Captive column effect and buckling of longitudinal steel

After the Düzce earthquake, a careful recording of the damage distribution was performed for the building in Bolu. The structural damage was concentrated in the lowest three stories. Damage consisted essentially of diagonal shear cracks in the columns, shear failure in the captive columns (Fig. 6) and infill wall failures. Flexural cracks were observed in almost all beams of the first three floors. Crushing of concrete, buckling of longitudinal steel and disengagement of ties was noticed after a careful investigation (Cagnan 2001).

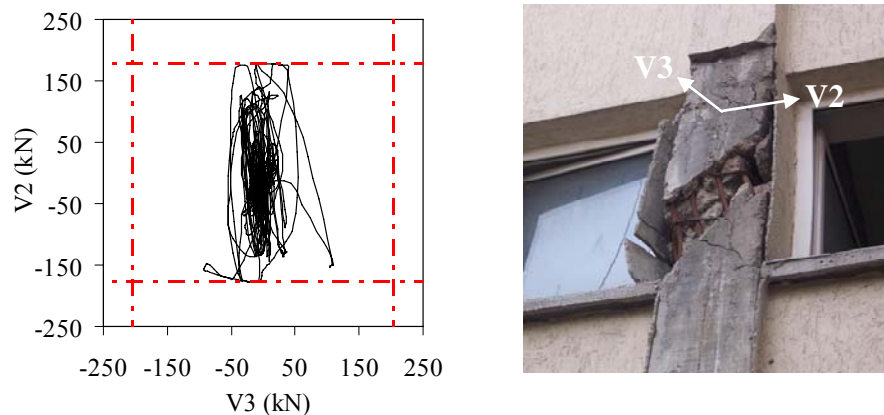
Figure 7. The bi-axial shear behavior (captive column effect) of the column C3 at the first floor

The assessment which is made according to ASCE/SEI 41-06 at member level shows that the Eq. 1 which is used to calculate the shear strength of the columns, underestimates the shear capacity of the columns subjected to bi-axial dynamic loading. In the mathematical model, the columns reach their shear strength even where only minor diagonal cracks occur. The columns are in immediate occupancy performance level (IO) for flexure which is consistent with observations. The analytical results match the observed data with 86%, 93% and 70% success ratio for the infill walls at the ground, first and second floors, respectively.
