BRIDGE SEISMIC DESIGN LESSONS LEARNED FROM WENCHUAN EARTHQUAKE OF CHINA

Kehai Wang¹, Qian Li², Han Wei², and Jiangpeng Yang³

ABSTRACT

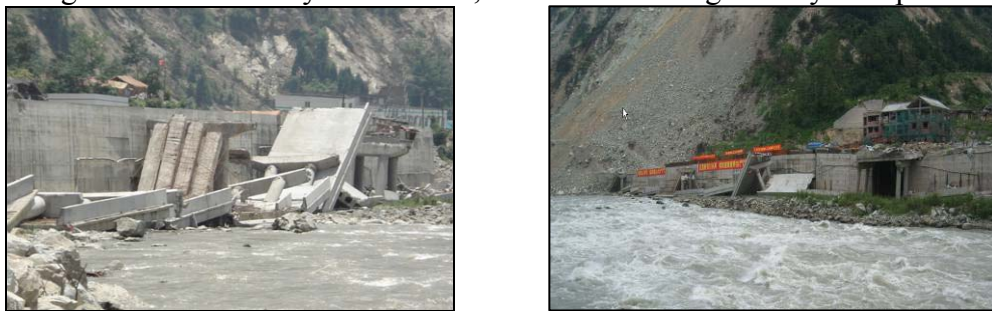
Figure 1. Shunhe Bridge

Shunhe Bridge in Yingxiu town(See Figure 1), whose main part was already completed when the earthquake occurred, is along the Minjiang River. Most of the main girders dropped off, piers experienced damages of collapse, leaning, shear failure on the top part. There was a frame structure nearby (not more than 50m), whose long axis direction is also along the Minjiang River, the second floor of which is totally crushed; and there is a longitudinal displacement of about 1m between the first floor and the rest (Shown in Figure 2). There was a bridge cross the Minjiang River and about 100m away from the Shunhe Bridge, suffered less damage in the earthquake, the main girder of which displayed a little transverse offset(See Figure 3). From that, we can draw a conclusion that main part of the seismic wave near the Shunhe Bridge was along the Minjiang River, and the performance of the bridge was closely related to the direction of the bridge and the seismic wave.

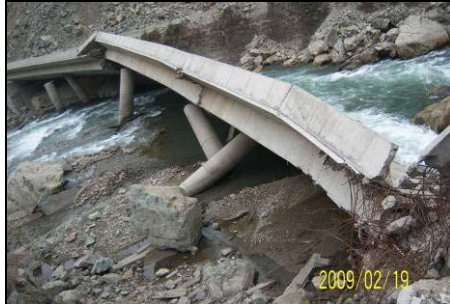
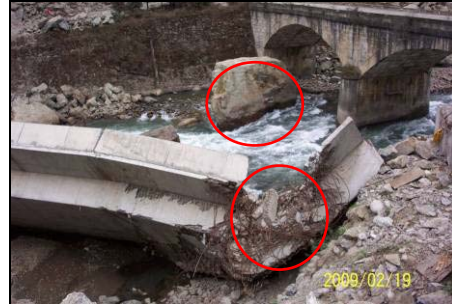
Figure 4. Yuzixi No.2 bridge

And most of the totally collapsed girder bridges was shattered by the secondary disaster , such as landslide, rockfall, and debris flow. Yuzixi Bridge No.2(See Figure 4) at S303, crosses the Yuzixi River, the superstructure of which is consists of 4 continuous spans of 25m each, the piers of which are consist of one-column bents and two-columns bents, 113m total. The first span near Gengda was shocked by the rockfall, and then the bridge totally collapsed.

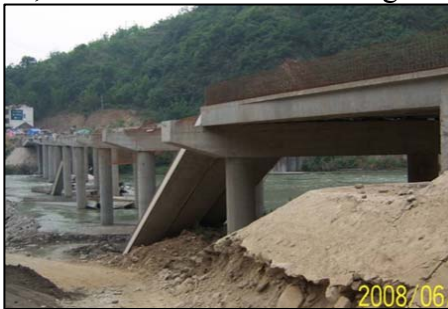
Figure 7. Nanba bridge

There are several failures types of girder bridge superstructure, including pull-off-and-drop collapse of bridge decks, offset in longitudinal or transverse direction, collision between the girders, and shear keys failure. The girder falling failure was quite prevalent, such as the bridge under construction in Nanba town (See Figure 7), and the Miaoziping bridge (See Figure 8). The failure of offset in longitudinal or transverse direction appeared in most of the girder bridges in the worst-hit areas, such as Baihua bridge, Yuzixi No.1 bridge. There was a severe transverse offset on the top of pier 10 of Baihua bridge, the shear keys of which experienced shear failure(See Figure 9). Yuzixi No.1 bridge under construction also displayed severe transverse offset, that caused the shear keys failed(See Figure 10). The failure of shear keys was quite

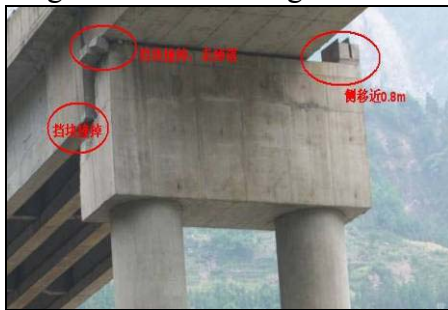
Figure 9. Transverse offset of Baihua bridge

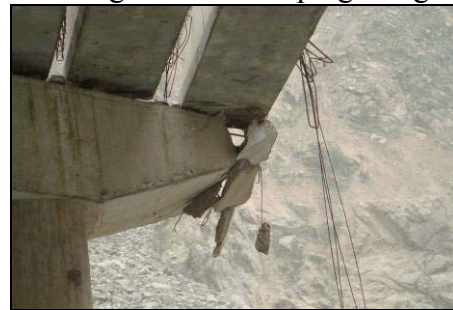
prevalent in Wenchuan earthquake. Based on our observation, the lack of reinforcements and anchor length, insufficient thickness of the shear keys and construction measures exist in some bridges. Collision between the girders may induce the loss of bearing capacity of the bridge.

Figure 10. Transverse offset of Yuzixi No.1

(4) Shear keys are required to prevent spans falling transversely

The most prevalent failure type for girder bridges was the shear keys failure. Although bridges with shear keys failure were damaged, but few bridge decks fall, and the offsets in the transverse direction were not that big that may not affect the normal usage. According to our

observation, the transverse offsets of bridges without shear keys were greater. In one word, the shear keys play an important role for the girder bridges once earthquake occur, shear keys should not be abandoned in the construction; on the other hand, shear keys failure was too prevalent in Wenchuan Earthquake, the design philosophy and technology of shear keys should be deeply researched in the future.

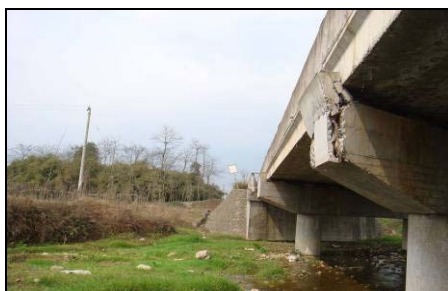
Figure 11. Maweihe Bridge in Mianzhu City

According to our observation, the damage of the skewed bridges was damaged more serious than the orthogonal bridges. The behaviors expressed as collision between the girders or girder and the abutments, shear keys failure, offset in the longitudinal and transverse direction. In most cases, the superstructures of the skewed bridges may rotate by a small angle along the vertical axis, such as the Maweihe Bridge in Mianzhu City(See Figure 11).

(1) Skewed bridge and curved bridge should be avoided in high intensity zone

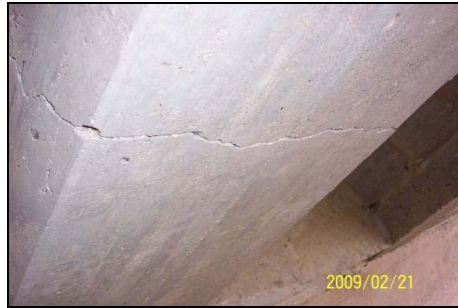
There are several failures types of arch bridge superstructure, including crack in the arch ring, crack in the spandrel arch, spalling of the pave seam, dislocation of the arch ring, railing offset, expansion joint deformation. Quhe Bridge in Qingchuan appeared the failure of crack in arch ring as shown in Figure 12, It is a double convex arch bridge with a span of 75m. The crack in arch ring isn't the essential to the bridge. The crack in spandrel arch is more severe, as shown in Figure 13.

Figure 12. Crack in Arch Ring

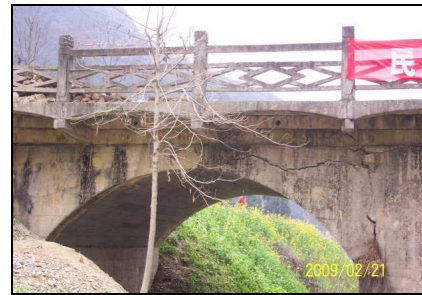
Figure 13. Crack in Spandrel Arch

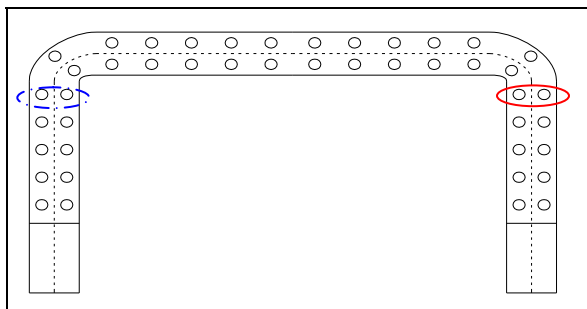
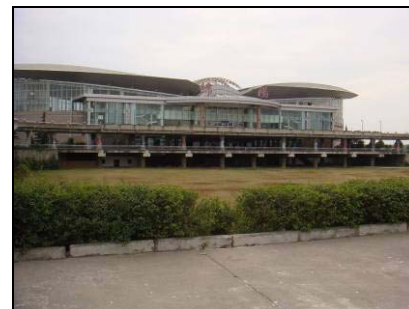
Figure 14. Mianyang Airport Bridge

Mianyang Airport Bridge was a viaduct with two floor at Mianyang Airport(See Figure 14). The shear failure appeared in the tow piers circled by the red line in Figure 14, as shown in Figure 15(a) and 15(b). There are may be two reasons that why these two piers suffered such severe damage: a)the top of the pier was fixed the bridge deck, the corresponding piers at the other side(circled by the blue line in Figure14) performed well in the earthquake; b) short-column effects, the effect length of these two piers are shorter than other piers at the approach bridge because of rigidly connected to the first floor.

(3) Shear failures must be avoided in piers

The shear failure can induce the loss of bearing capacity, such as the Mianyang Airport Bridge that the upper bridge was blocked. And the shear failure was fragile without little ductility. Piers with reluctant ductility may cause less casualties and economic loss.

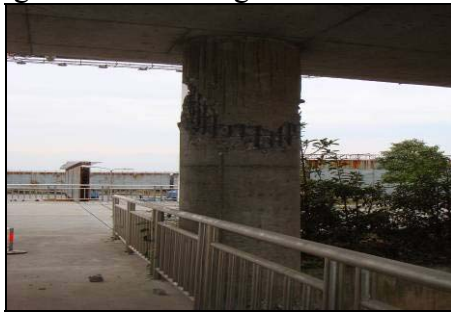
(a) pier inside

Figure 15. Shear failure in piers of Mianyang Airport Bridge

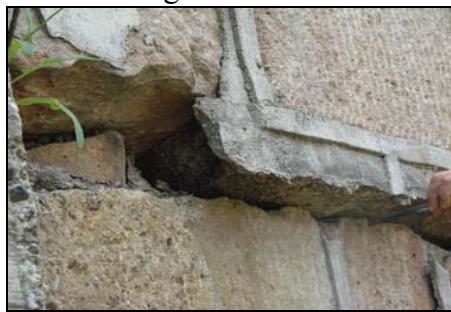
Figure 16. Baimayan bridge No.2

superstructure decks and abutment in Wenchuan Earthquake. Due to the transverse offset of girders, the shear keys also fails in most cases. And some cases, there were cracks in the wing wall(See Figure 16 and Figure 17). The prevalent failure types of arch bridges abutment included sinkage, crack in the wing wall. As compared to the girder bridge, the abutment of the arch bridge suffered more severe damage. Ganxihe Bridge in Guangyuan suffered severe abutment failure, as shown in Figure 18. The cracks in the wing wall was perforative. According to our observation, the failure in the abutment was very prevalent in the earthquake for both girder bridges and arch bridges.

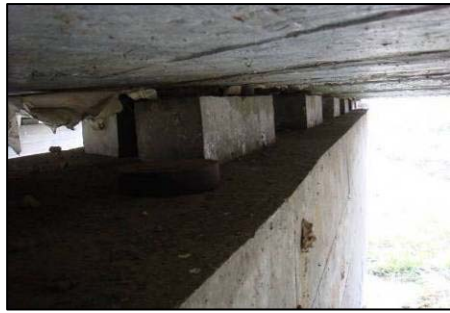
According to our field investigation, most of girder bridges' bearing were rubber pad bearing and basin rubber bearing. For the rubber pad bearing, the failure expressed as fall off, offset and shear failure (See Figure 19). For basin rubber bearing, the failure expressed as offset in longitudinal or transverse direction in most cases (See Figure 20).

(a) fall off

There are a lot of bearing failure in Wenchuan earthquake because of the installation method, in which the plate rubber bearings are directly place between the piers and the decks. If there are some kind of displacement-limit measures, the effect may be better.

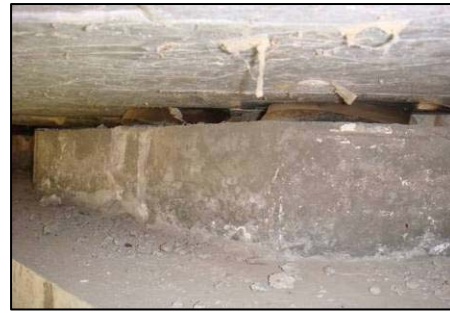
(b) shear failure

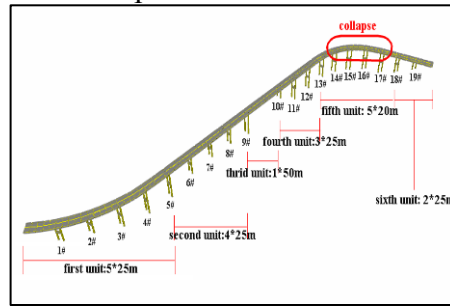
Figure 21. Baihua bridge

Baihua bridge was constructed in 2004, consisted of 18 spans, and the total length was 450 m. It contained six units (See Figure 21). The bridge is just about 9 kilometers away from the epicenter of the earthquake, and in the fault belt zone. The fifth unit, the curve part, totally collapsed in the earthquake, and the rest parts of the bridge also deserved severe damage. To protect the rescue troops who went through right under the bridge and citizens around the area, the bridge was demolished in May 28, 2008.

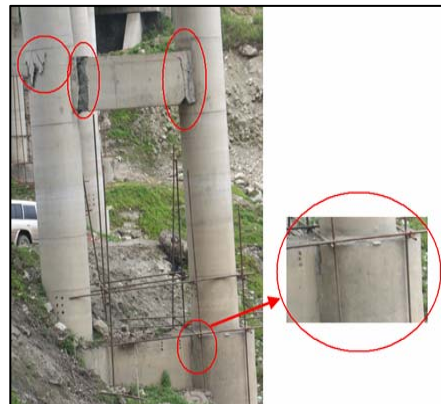
Figure 22. Pier 3# of Baihua Bridge

Pier Number	Description of Failure
1	bearing failure, tie beam failure
2	tie beam failure, the bottom of the pier crack
3	tie beam failure, pier at the beam-column joint crushed (See Figure 22)
4	tie beam failure, the bottom of the pier crack
5	bearing failure, tie beam failure, the bottom of the pier crack
6	bearing failure, pier at the beam-column joint crushed
7	tie beam failure, the bottom of the pier crack
8	tie beam failure
9	shear keys failure
10	shear keys failure
11	bearing failure, tie beam failure
12	tie beam failure, pier at the beam-column joint crack (See Figure 23)
13	Shear keys failure, tie beam failure
14-17	totally collapsed (See Figure 24)
18	bearing failure, tie beam failure
19	bearing failure(offset in the longitudinal direction), the bottom of the pier crushed

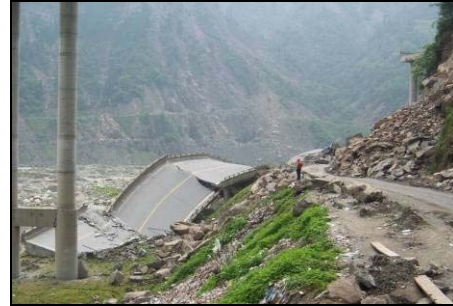
Figure 24. collapsed unit 5

The irregular stiffness of the bridge may be another reason, especially the stiffness between unit 5 and unit 6. The piers in unit 5 are 13#-18#, the heights of which are 30.3m, 21.9m, 23.4m, 21.6m, 21.8m, 16.8m. As compared to this, the pier height of unit 6 is just 7.1m. So under the seismic load, the two units may not appear in the same direction, result in the great relative displacement, when that displacement exceeded the supporting length, unit 5 will have to experience internal force redistribution.

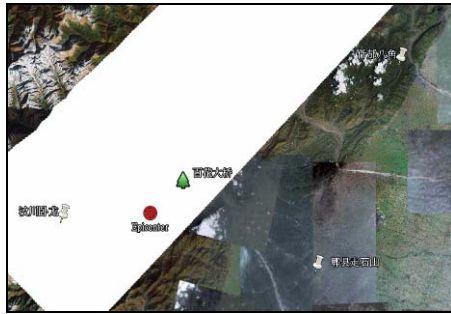
Figure 25 Site of Baihua bridge

There are three strong ground motions monitor station around the bridge, included: Wenchuanwolong station, Pixianzoushishan station and Shifangbajiao station(See Figure 25), the distance of which between the bridge are 28 km, 35km and 56km respectively, the peak accelerations of which are 0.958g, 0.142g and 0.58g, respectively. The distance of Baihua bridge between the microscopic epicenter is about 9km, the distance of Baihua bridge between causative fault is about 2-3km. The distance of Wenchuanwolong station between the microscopic epicenter is about 20km, the distance of Pixianzoushishan station between the microscopic epicenter is about 40km, the distance of Shifangbajiao station between the microscopic epicenter is about 57km. The resistance level of the bridge is equal to 0.1g, so the practical seismic load is much greater than the fortification level.

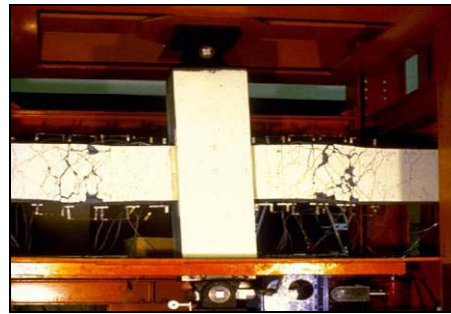
The damage of joints between the tie beam and pier is very fragile as shown in Figure 26, we can draw a conclusion that the quality of joints may be in low-level.

For two-column piers, the design philosophy should be “Strong column weak beam”, that will result in the damage of tie beam not the pier in a strong earthquake. The ideal damage mode is indicated in Figure 26, in which the joint part and the pier are in great condition, the beam suffered flexural damage.

Figure 26 Ideal damage mode

(7) "Strong column weak beam" should be attached importance to

For two-column or multi-column piers, the design philosophy should be "Strong column weak beam", that will resulted in the damage of tie beam not the pier in a strong earthquake.
