## SEISMIC EVALUATION OF SCHOOL BUILDINGS IN VENEZUELA

A. Marinilli<sup>1</sup>, N. Fernández<sup>1</sup>, O. A. López<sup>1</sup>, and G. Coronel<sup>1</sup>

### ABSTRACT

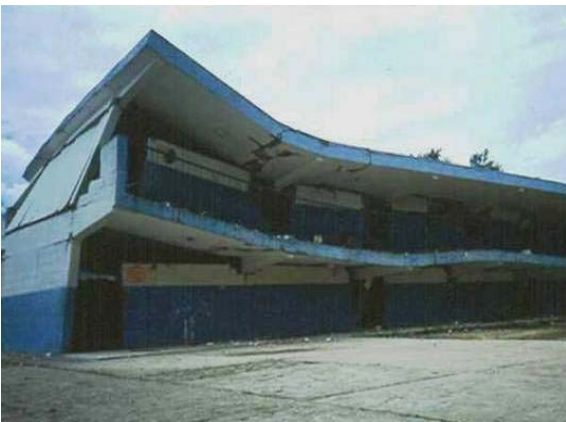
Figure 2. School buildings collapsed during 07/09/1997 Cariaco Earthquake (Mw=6.9): (a) Valentin Valiente School and (b) Raimundo Martinez Centeno High School.

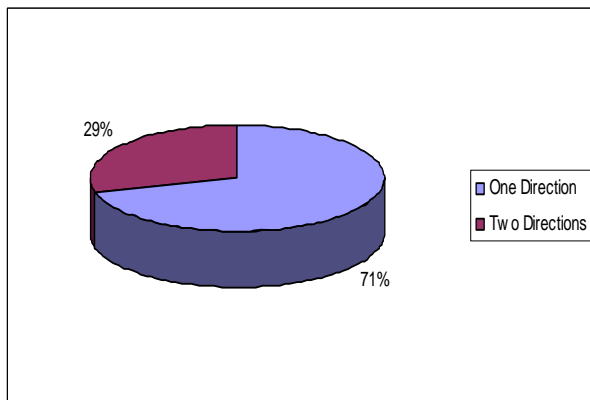
Figure 6 shows if the inspected school buildings have lines of resistance in one direction or two orthogonal directions. 71% of the inspected buildings have lines of resistance in just one direction. Figure 7 shows the percentage of short columns of the total amount of columns in a given story. 68% of the inspected school buildings showed 50% or more short columns in at least one of their stories, usually at the ground level.

Figure 6. Presence of lines of resistance for the inspected buildings.

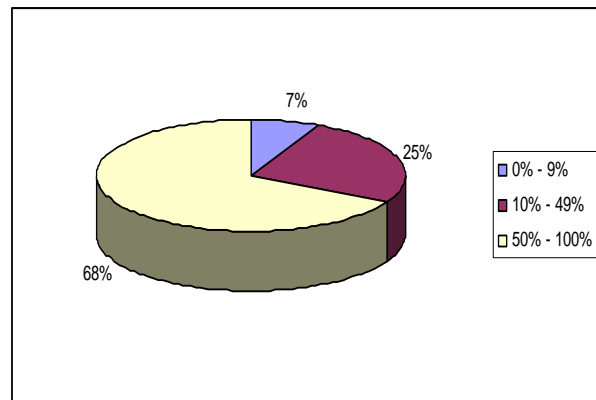
Figure 7. Amount of short columns for the inspected buildings.
