## **SPATIAL DISTRIBUTION OF DAMAGES TO BURIED PIPES FOLLOWING THE 2007 NIIGATA-KEN CHUETSU-OKI, JAPAN, EARTHQUAKE**

K. Kimishima<sup>1</sup>, Y. Maruyama<sup>2</sup> and F. Yamazaki<sup>3</sup>

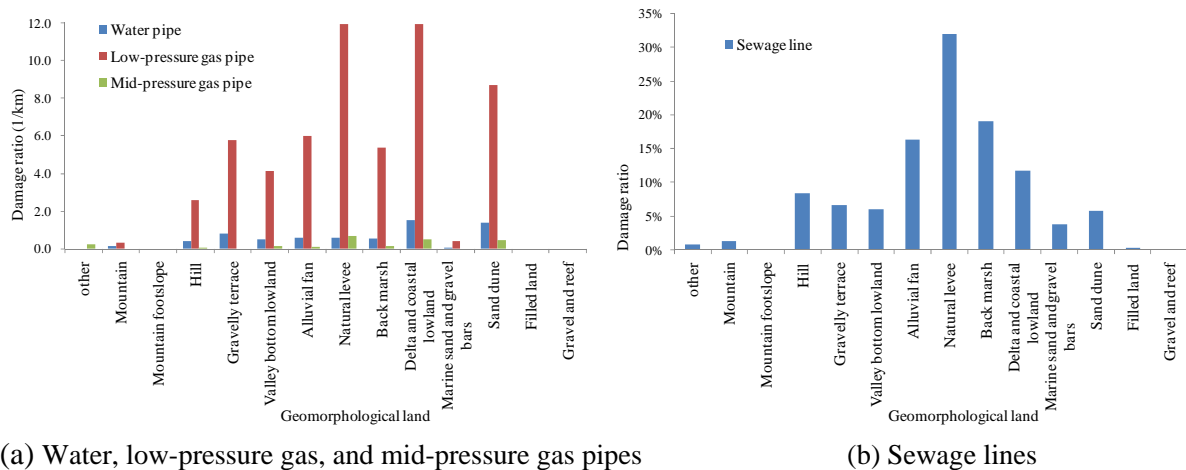
The damage ratio of water distribution pipes is the highest in *delta and coastal lowland* areas (1.48), followed by *sand dune* (1.35). Similarly, the damage ratio of low-pressure gas pipes

Figure 3. Damage ratios of lifelines with respect to geographical land classifications.

is the highest in *delta and coastal lowland* (11.93), followed by *natural levee* (11.92). As for the water and low-pressure gas pipes, the damage ratios are high for the geographical classes, which mainly consist of soft soil. The damage ratio of mid-pressure gas pipes is the highest in *natural levee* (0.65) and the second highest in *delta and coastal lowland* (0.47). The damage ratio of sewage lines is the highest in *natural levee* (32%) while it is 19% in *delta and coastal lowland*. As for the mid-pressure gas pipes and sewage lines, the damage ratios are high in *natural levee* and *delta and coastal lowland*.

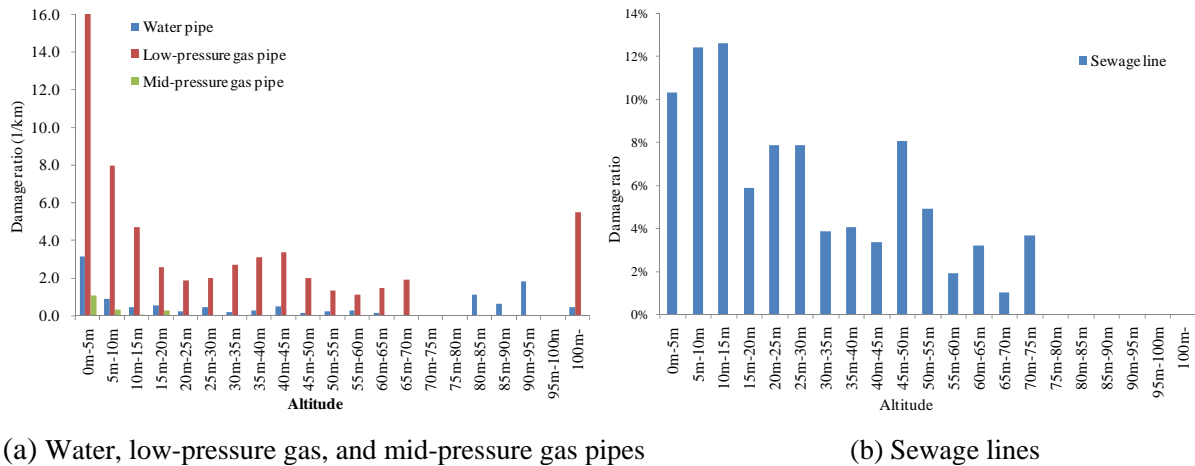
Figure 5. Damage ratios of lifelines with respect to the altitude class

pressure gas pipes with respect to the altitude are shown in Fig. 5(a) and that of sewage lines is shown in Fig. 5(b).

The damage ratios of water, low-pressure gas and mid-pressure gas pipes are the highest for altitude class 0-5 m. The damage ratio of sewage lines is the highest when the altitude is 10-15 m. The damage ratio is still in high values for the altitude 0-10 m. As for water, low-pressure gas, and mid-pressure gas pipes, no notable difference is seen in the trend of the damage ratios of the three buried pipes.
