IN-SITU PUSHOVER TEST AND NUMERICAL SIMULATION OF A REAL REINFORCED CONCRETE FRAME STRUCTURE

Xilin Lu¹, Jiang Qian¹, Tuo Lei², Liang Lu³ and Guangye Zhao²

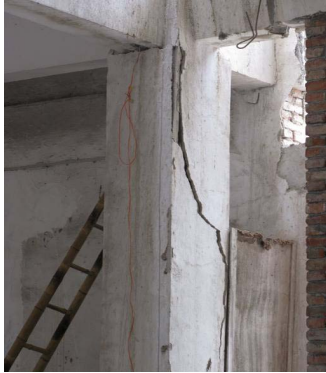
In the first 5 load steps, no visible cracks were observed on the surface of major structural members. At the load step 14, an inclined crack appeared on the East side of upper end of column ③-④ in the first floor and the total base shear reached its maximum value of 861KN. At the load step 15, cracks expanded suddenly with a blare and the shear failure occurred as shown in Fig.4. After that, loading at points *P2*, *P4* and *P6* maintained increasing proportionally while oil pressure of jacks at points *P1*, *P3*, *P5* kept unchanged. As shown in Fig.5, at the load step 23, shear failure again suddenly occurred on upper end of column ②-④ in the first floor. The testing frame became unstable. For safety, the test was terminated. Comparing Fig.4 and Fig.5, it can be seen that the crack pattern in two columns are similar. Fig.6 shows the final crack development in column ③-④ in the first floor. Crash of concrete cover on the northern upper end of the column ②-④ in the first floor is shown in Fig.7. Fig.8 and Fig.9 show the failure characteristic of the wall ① in the first floor, there are inclined shear cracks as well as horizontal cracks between windows.

Figure 4. Shear failure of column ③-⑧ at the load step 15

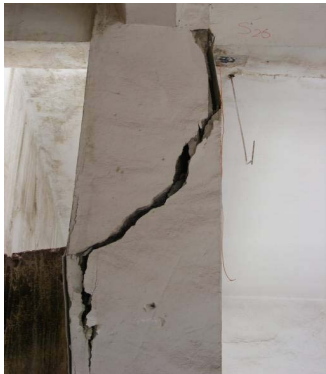
Figure 6. Shear failure of column ③-⑧ at the load step 23

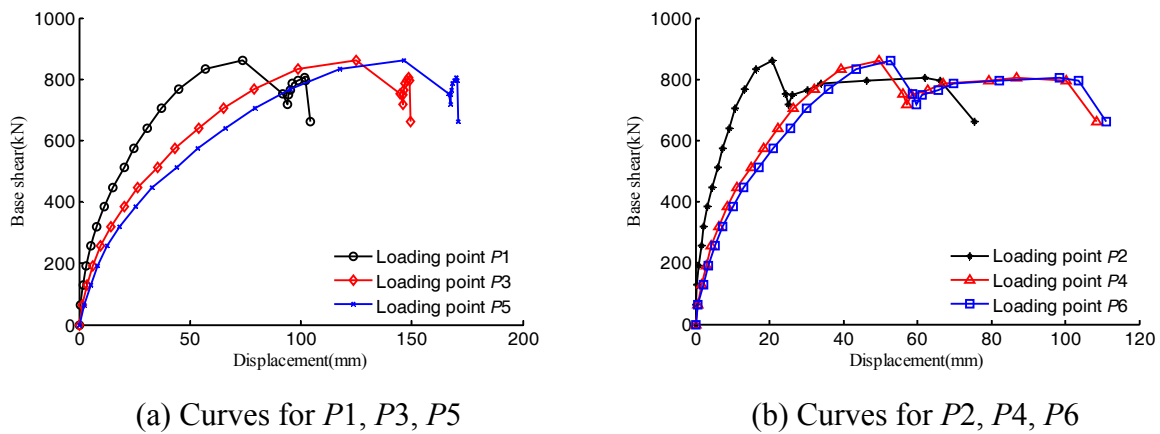
Fig.10 shows the measured base shear force versus the Story lateral displacements at each loading point. Due to a successive shear failures of column ③-Ⓑ and column ②-Ⓑ, the response curves in soften stage for the testing frame behave sudden and unstable. The maximum displacement of the roof at point P5 is 171.14mm and, in contrast, that at point P6 is 111.14mm. Comparing the two figures, it might be concluded that, frame ② was stiffer than frame ③ because of the presence of perimeter walls while the latter had more displacement ductility than the former.

Figure 10. Base shear - displacement curves

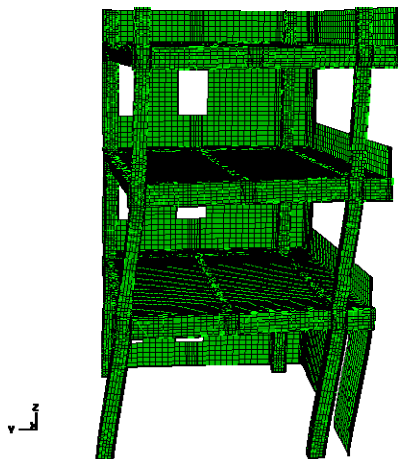
Figure 13. Deformed shape of the structure

It can be seen in Fig.13 that the structure is undertaken an obvious torsional deformation due to the participation of the perimeter walls. Figs.14 shows the Mises stress distribution in concrete at the last load step. Fig. 15 indicates that some longitudinal reinforcement yield at this load step, they occur at the end of columns on axis ③. Fig.16 shows the stress level in walls with a maximum value about 3.0MPa, which is far beyond the possible strength stress of the equivalent material property.

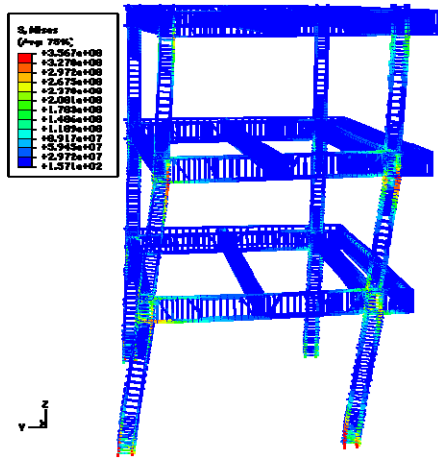
Figure 15. Stress distribution in rebar

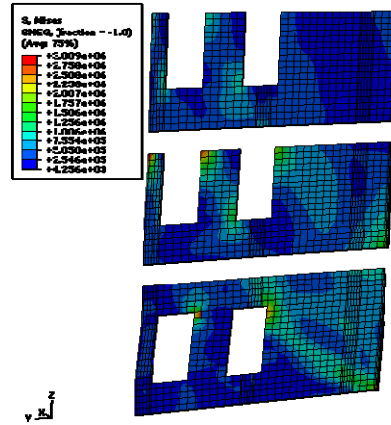
Figure 16. Stress distribution in brick wall
