NON-STRUCTURAL COMPONENT PERFORMANCE IN FULL-SCALE 4-STORY BUILDING

ABSTRACT

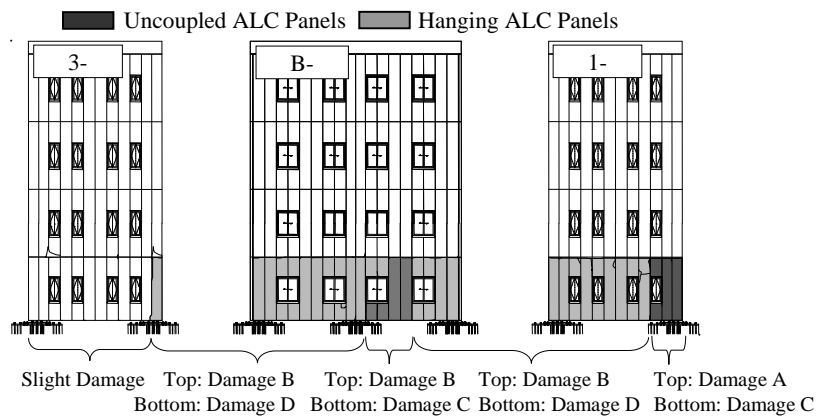
Under 0.2 times the Takatori records (maximum story drift at the 2nd story: X direction 0.0055 rad, Y direction 0.0053 rad), damage to the external wall was not observed on all façade. Under 0.6 times the Takatori records (maximum story drift at the 1st story: X direction 0.012 rad, Y direction 0.019 rad), some cracks of approximately 100mm length were observed in the corner of the ALC panels. However, the functional performance of external walls such as water-resistance, heat-insulation and sound-insulation did not spoil. Under 1.0 times the Takatori records (maximum story drift at the 1st story: X direction 0.08 rad, Y direction 0.19 rad), severe damage was observed at the 1st story. The ALC panels hatching as shown Figure 2 fell off or

Figure 2. Damage to the ALC panels after test by 1.0 Takatori records

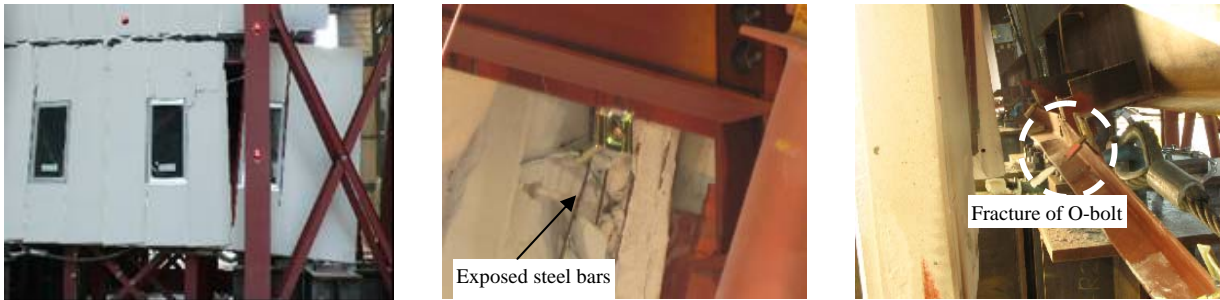
(a) Damage to the ALC panels (b) Damage B (c) Damage C
Figure 3. ALC panels after test by 1.0 Takatori records

Top	Damage A	Fracture of the welding between the supporting steel angle and the attachment plate
	Damage B	Crash of the ALC panel and exposure of the reinforcing bars
Bottom	Damage C	Fracture of the O-bolt fastening the ALC panel
	Damage D	Fracture of the welding between the supporting steel angle and the main frame

hanged. Figure 3a shows the damage to the ALC panels at Line 1 of the 1st story after 1.0 times the Takatori records. In the top and bottom of these ALC panels, two kind of damage to the fastener was observed as shown Table 1. Figure 3b shows Damage B, and Figure 3c shows Damage C. On the ALC panels falling off, the top of the panel has Damage A and the bottom of the panel has Damage D. On the hanging ALC panels, the top of the panel has Damage B and the bottom of the panel has Damage C or D.

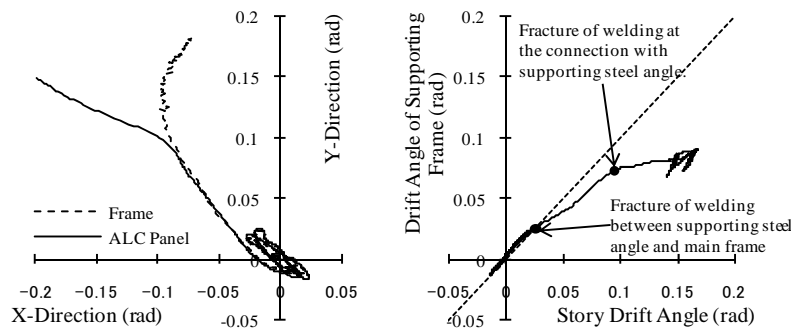
Figure 5a shows the orbit of the story drift and the rotation of the ALC panel at the 1st story. After the story drift reached to 0.080 rad for the X direction and 0.083 rad for the Y direction, the behavior of the ALC panel was not accommodated to the story drift. It is understood that Damage D was occurred at this point and the ALC panel hanged. Figure 5b shows the relationship between the drift angle of the supporting frame of the sash and the inter-story

Figure 5. Deformation of the external wall at 1st story by 1.0 Takatori records

drift angle. Since the drift angle of the supporting frame of the sash was not increase after the instance, it is expected that Damage D occurred at this point. In addition, it is confirmed by the video that Damage A and C occurred simultaneously.

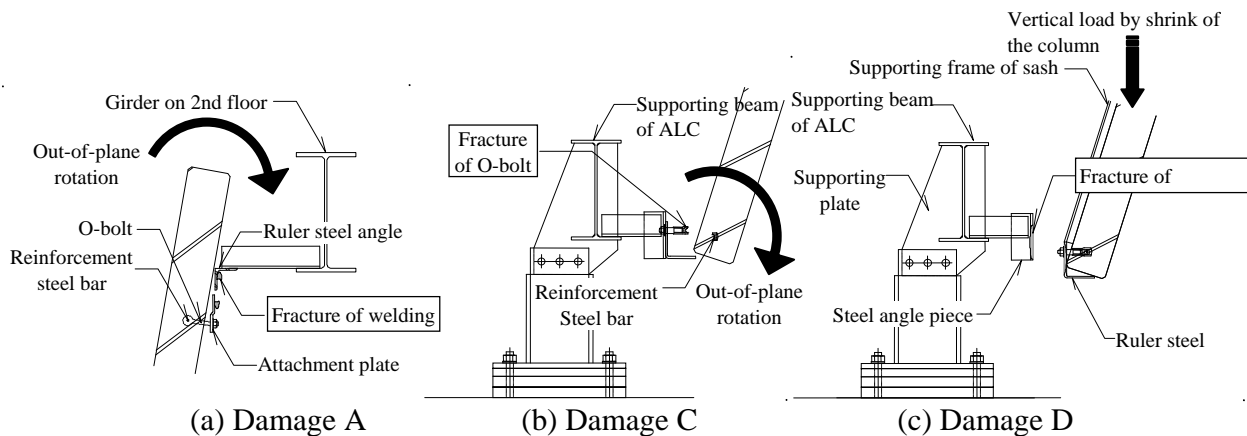
In the component test to investigate the simple behavior of the ALC panel (Matsuoka, et. Al. 2007), the ALC panels did not fall when the in-plane rotation angle reached to 0.15 rad. However, in the present shake test, the some ALC panels fell off or hanged until 0.12 rad rotation in bi-axial direction during 1.0 times the Takatori records. Figure 6 shows the observed damage mechanism of the fastener of the ALC panel. On Damage A and C, the welding or the O-bolt fractured because of the shear or tensile force induced by the out-of plane rotation of the ALC panels. On Damage D, the welding fractured because of the vertical force induced by the shrinkage of the 1st story column with the local buckling. Thus, the out-of plane rotation or the vertical load which were not observed in the component test might contribute to the damage to the fastener in the present shake test.

Figure 6. Damage mechanism of the ALC panels

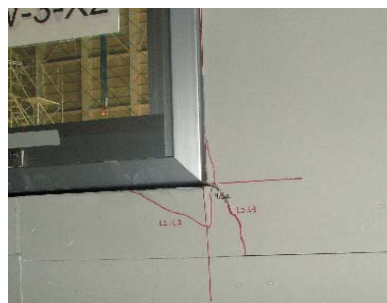
(a) Non-seismic type

On the non-seismic type of the internal finishing drywalls attached on the inside of the ALC external wall, the gypsum board met the window frame under the small story drift and some local crushing and cracks were observed as shown in Figure 7a. On the seismic type of the internal finishing drywalls, the window frame did not meet the gypsum board until 0.05 rad of the story drift because of 10.5mm gap, so no damage was observed as shown in Figure 7b. However, when the deformation exceeded the gap, the gypsum board was damaged, and the larger gap remained.

Figure 7. Internal walls around window frame after test by 0.6 Takatori records
