# EARTHQUAKE OF MARCH 4, 1977 IN ROMANIA — DAMAGE AND STRENGTHENING OF STRUCTURES

Mihail Ifrim

## SYNOPSIS

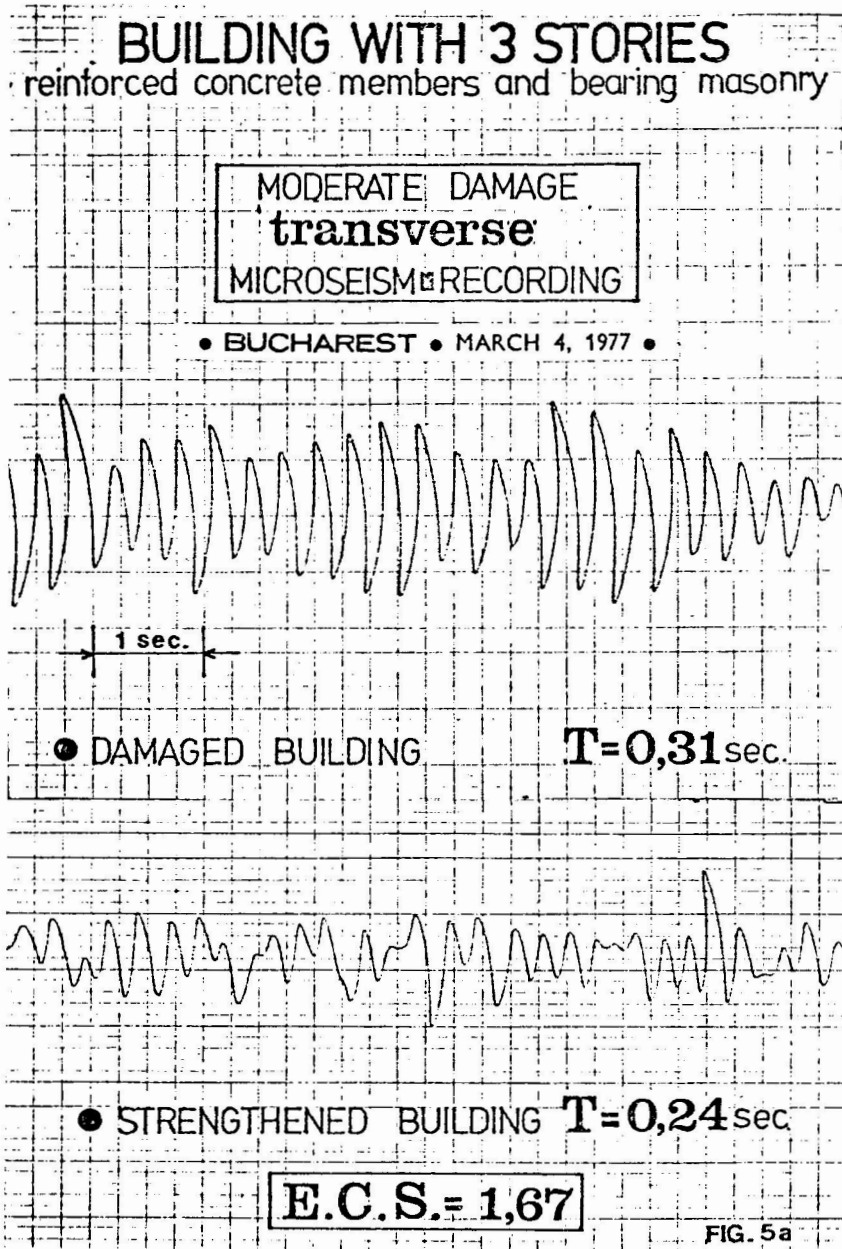
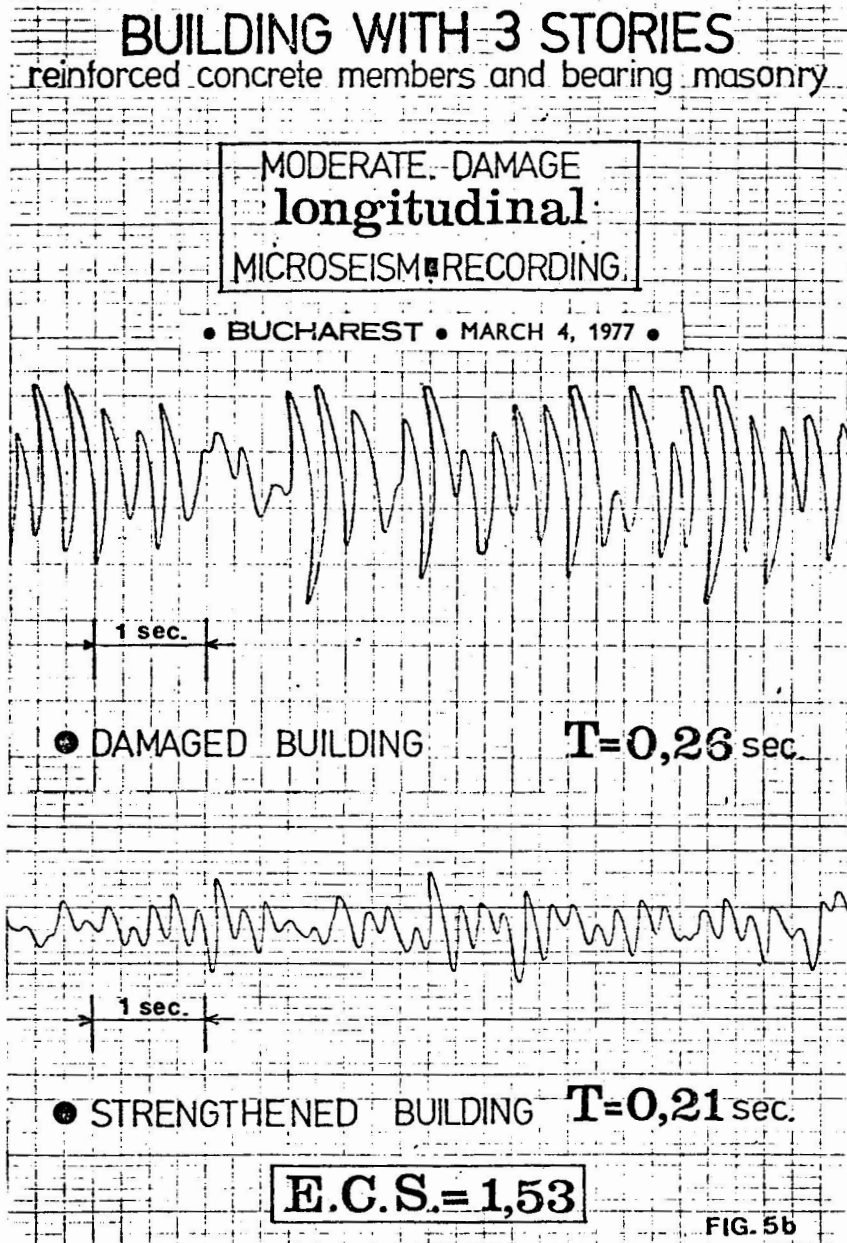
Fig. 5a,b Microseismic recordings obtained before and after the strengthening of a three-storey building with a mixed structural system (load-bearing masonry, widely spaced columns, beams and slabs of reinforced concrete). Efficiency coefficient of strengthening (E.C.S.) demonstrated the moderate damage to the building, as well as the effective strengthening on both directions

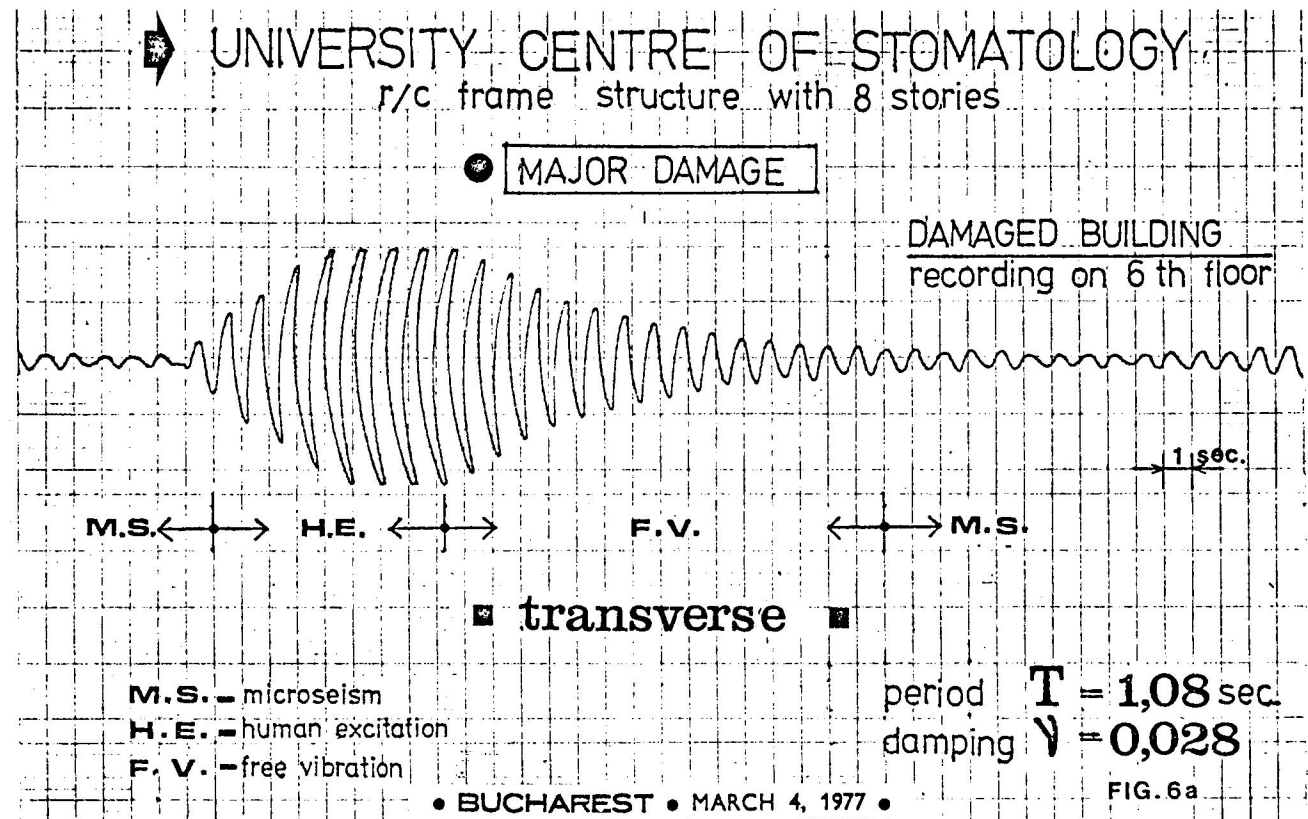
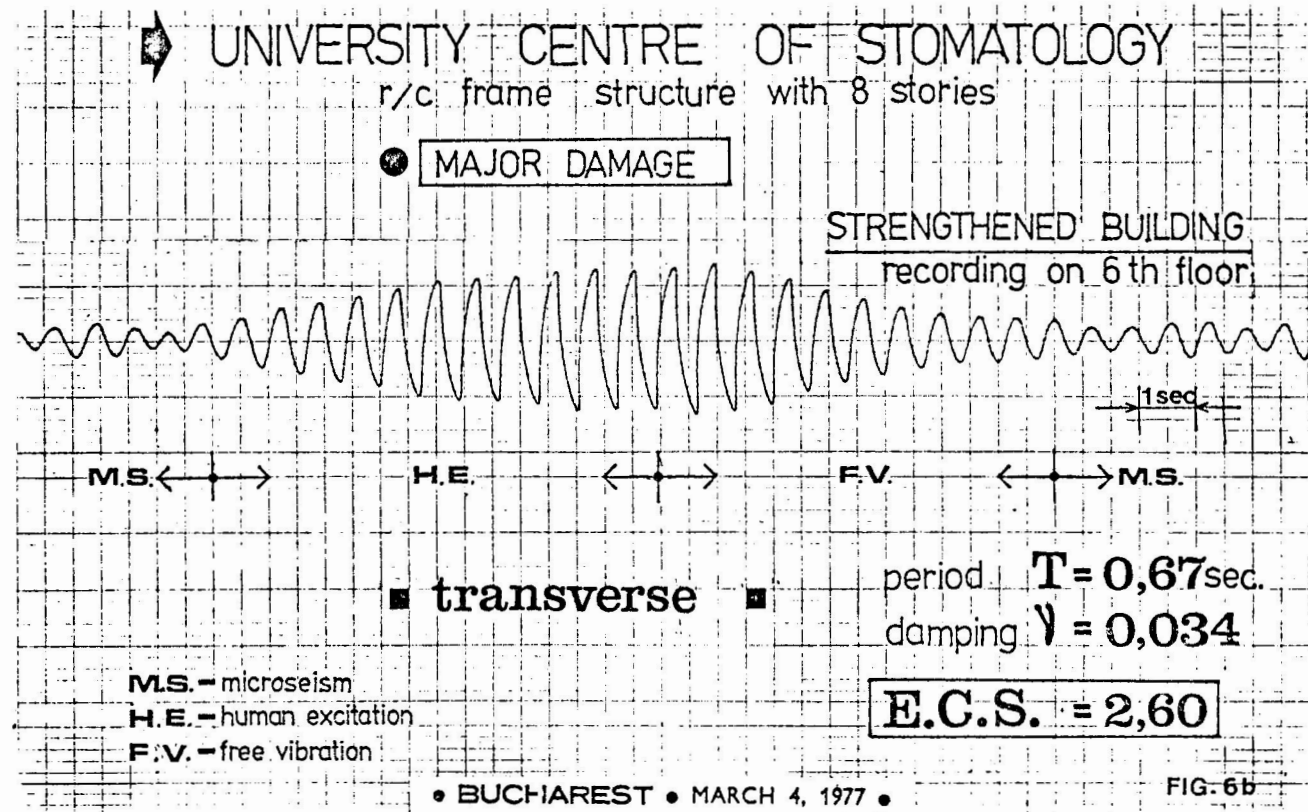
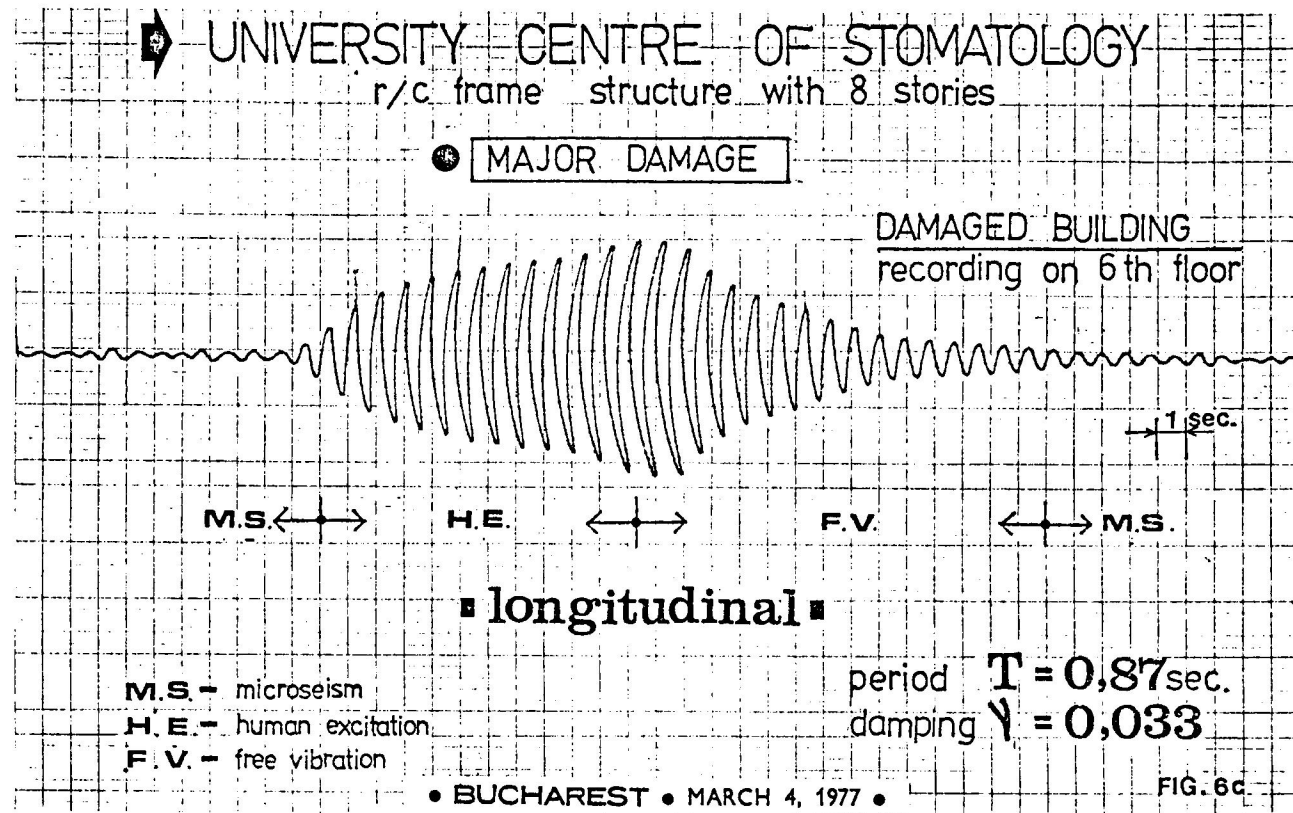
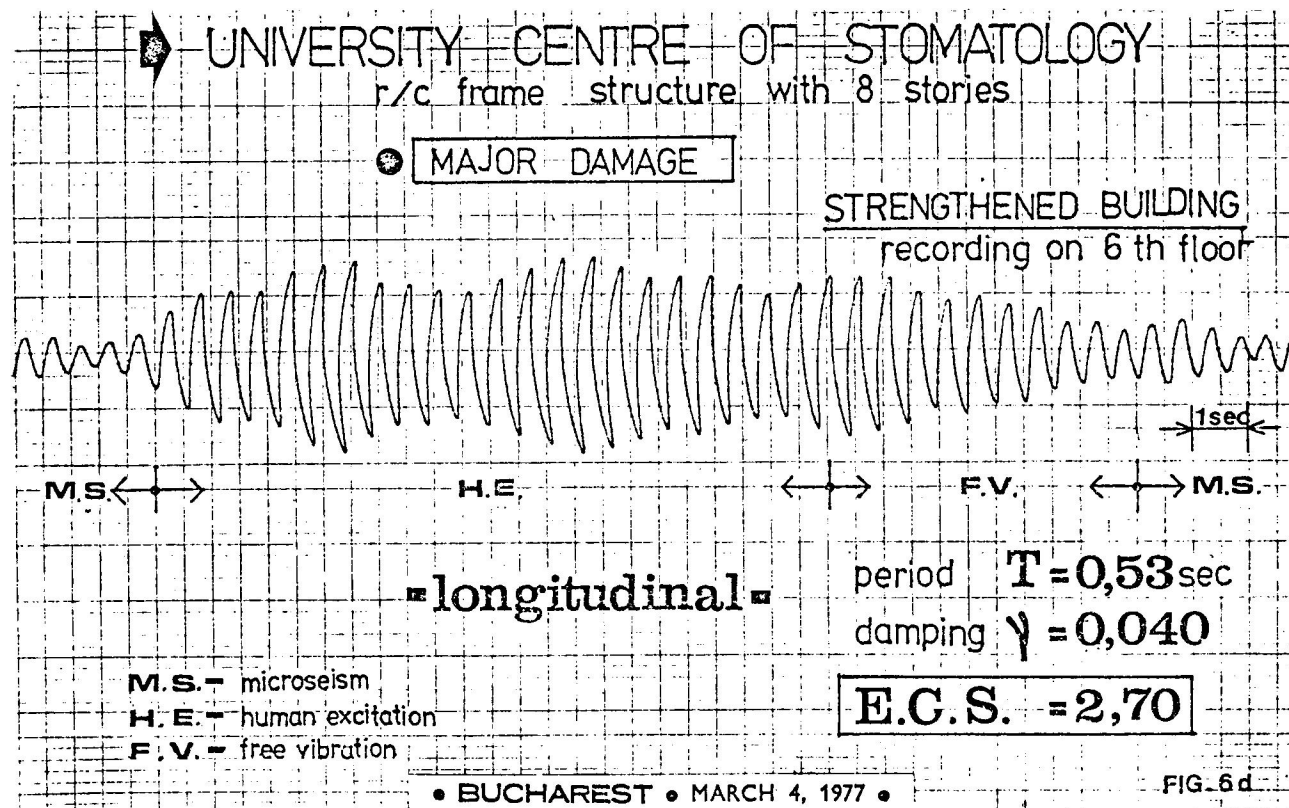
Fig. 6a,b,c,d

Recordings obtained on the 6th floor of a reinforced concrete frame building. The values of E.C.S. show the major damage level of the structure, as well as the strengthening in both directions

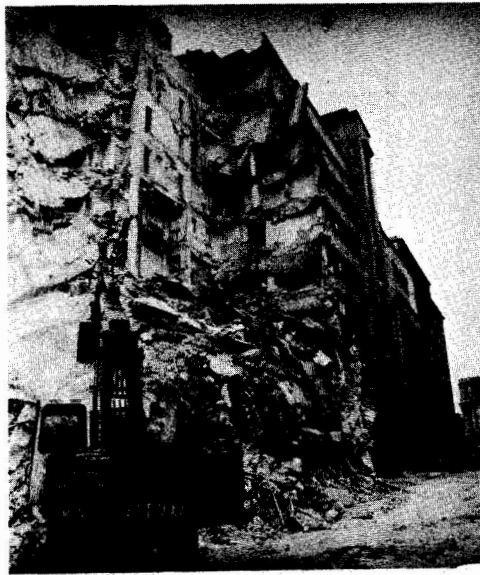
1 • BUCHAREST • MARCH 4, 1977 •

Partial collapse of a 10 storey apartment building of reinforced concrete frames (erected before 1940)

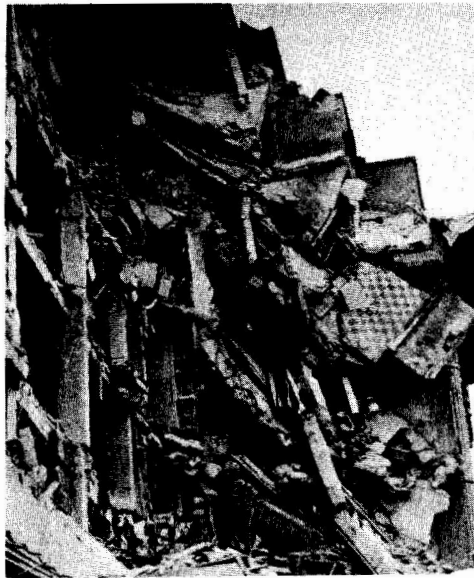
2 • BUCHAREST • MARCH 4, 1977 •

Detail of a partial collapse of an 8 storey building with reinforced concrete frames (erected before 1940)

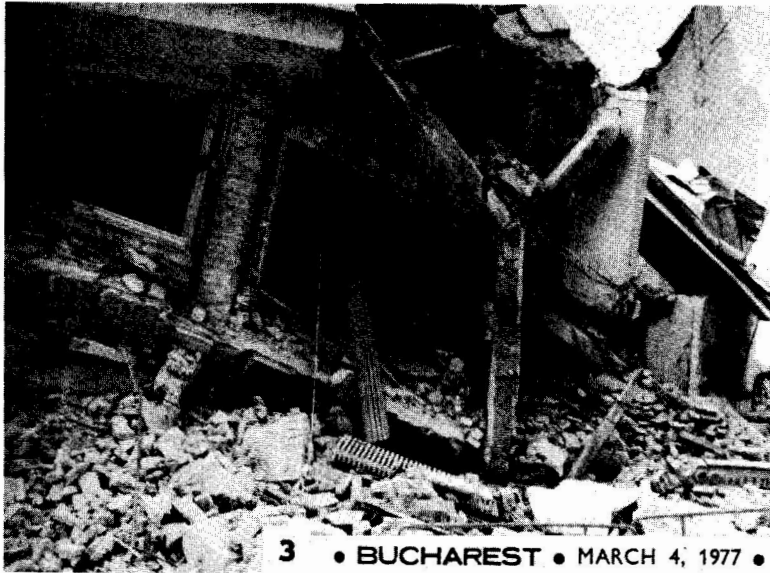
Collapsed block of flats with soft ground floor (erected before 1940)

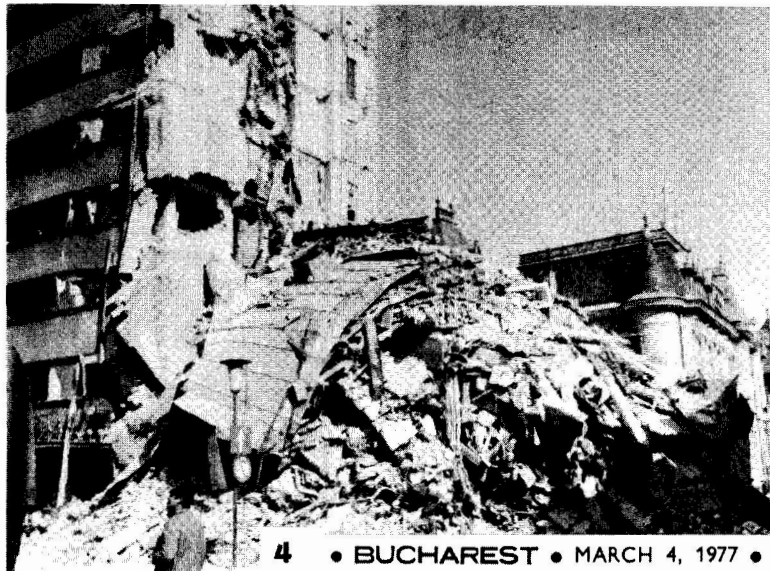
Complete collapse and wreckage of the multi-storey apartment building with reinforced concrete frames (erected before 1940)

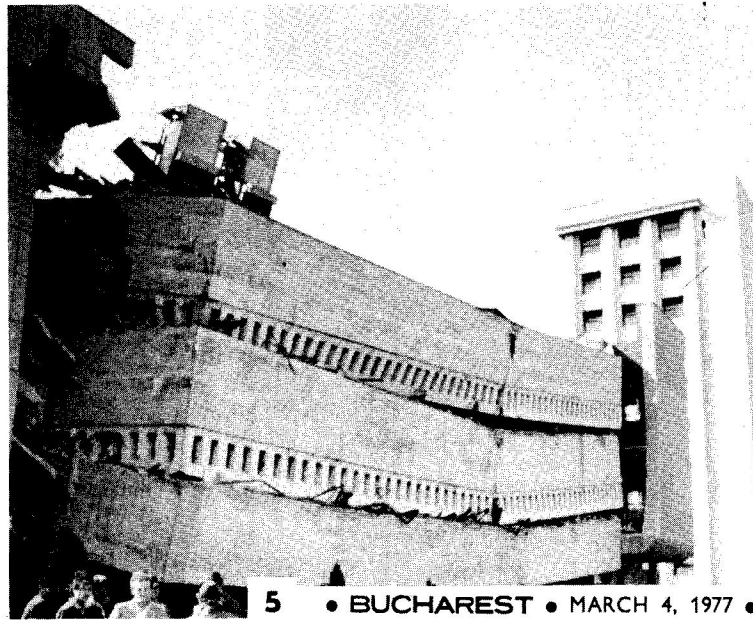
5 • BUCHAREST • MARCH 4, 1977 •

Collapsed Computer Centre designed according to code requirements

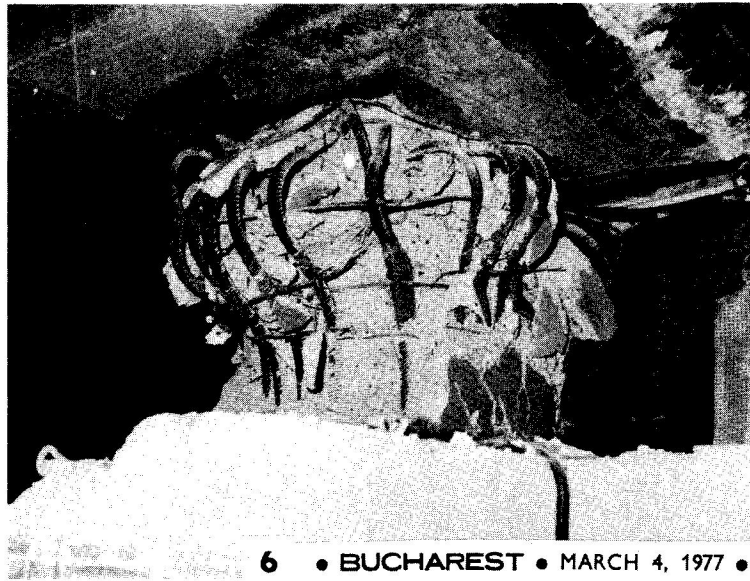
6 • BUCHAREST • MARCH 4, 1977 •

Failure at the top of the first storey (Computer Centre)

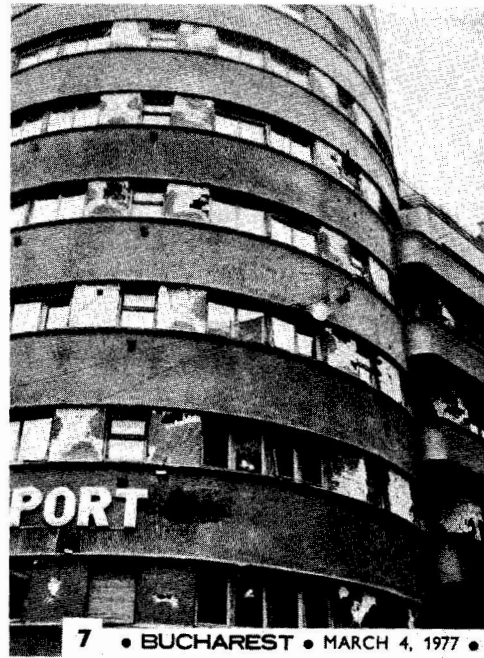
Cracking in exterior infill masonry walls of a reinforced concrete structure, erected before 1940

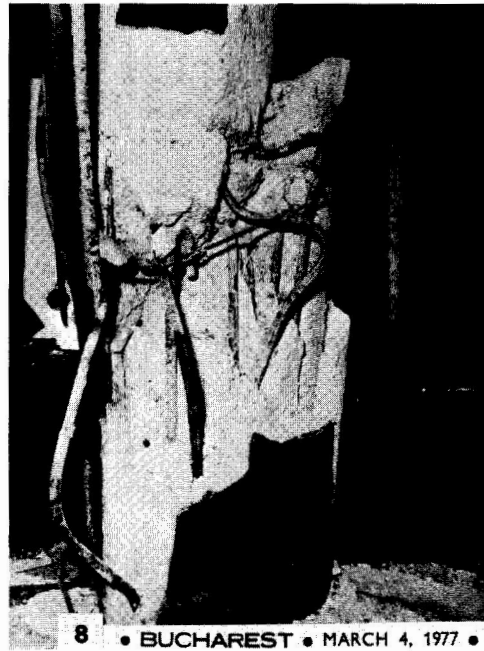
Fracture of interior first storey column

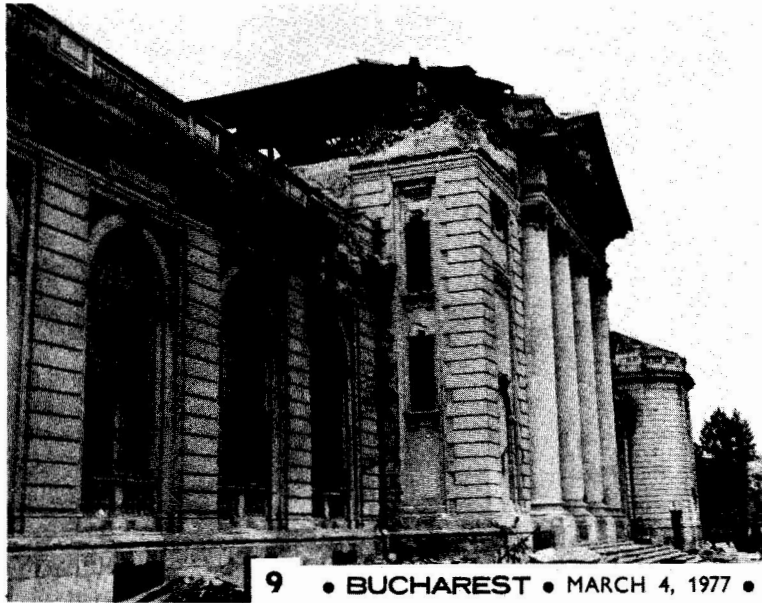
9 • BUCHAREST • MARCH 4, 1977 •

Partial collapse of old brick wall building which was not designed to resist earthquake

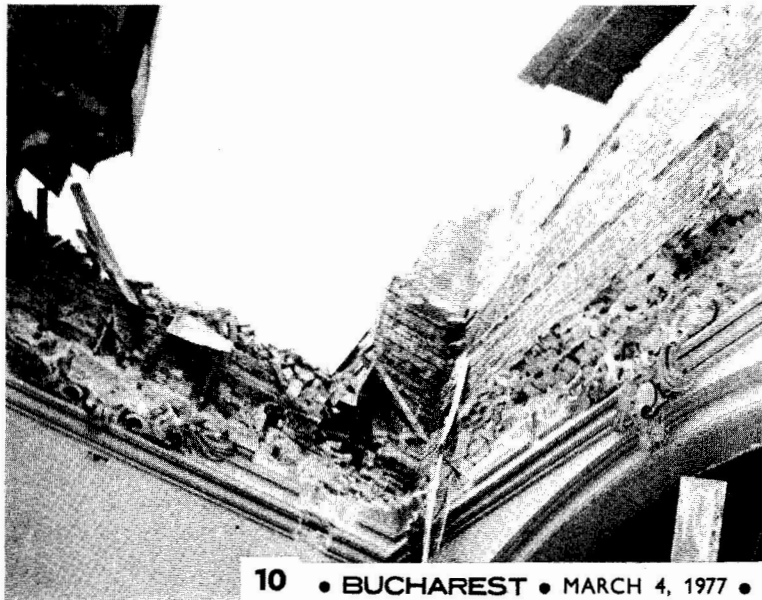
10 • BUCHAREST • MARCH 4, 1977 •

Interior close-up view of the building in photo 9 with partial damage

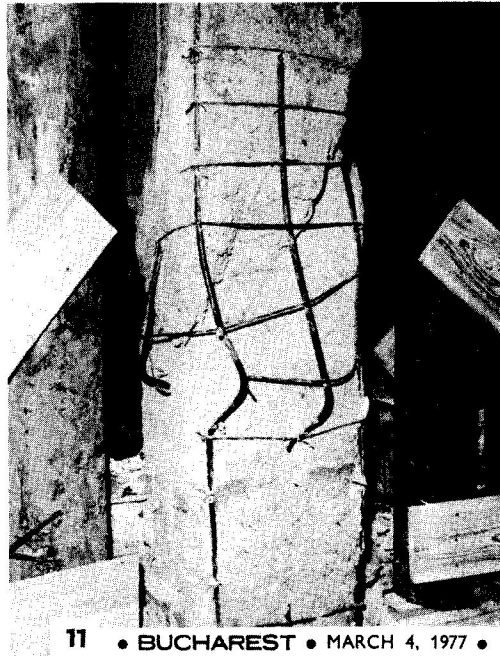
11 • BUCHAREST • MARCH 4, 1977 •

Shear failure in ground floor column

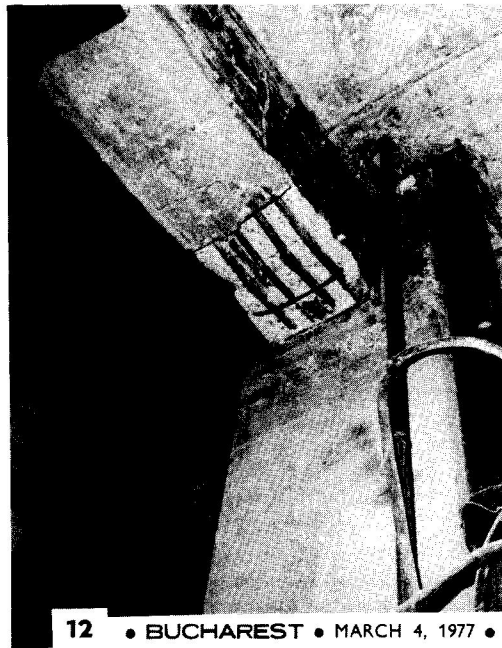
12 • BUCHAREST • MARCH 4, 1977 •

Deterioration of transverse beam at the support

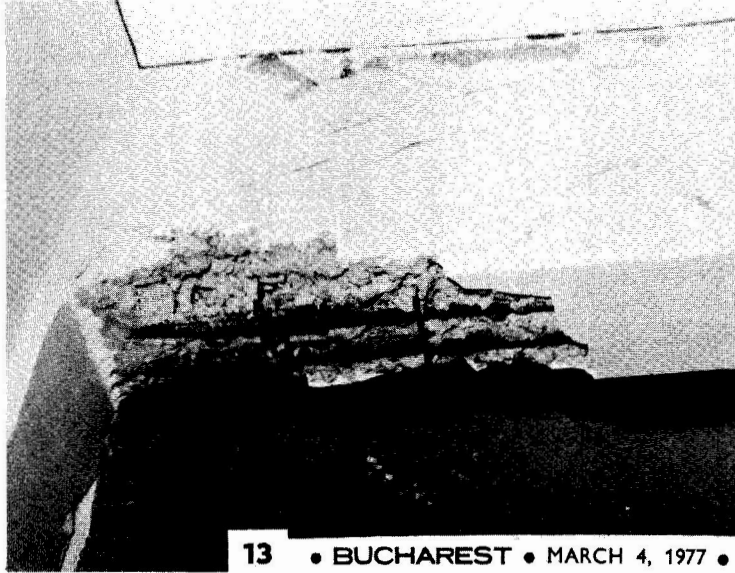
**13** • BUCHAREST • MARCH 4, 1977 •

Fractured lintel of reinforced concrete shear wall building

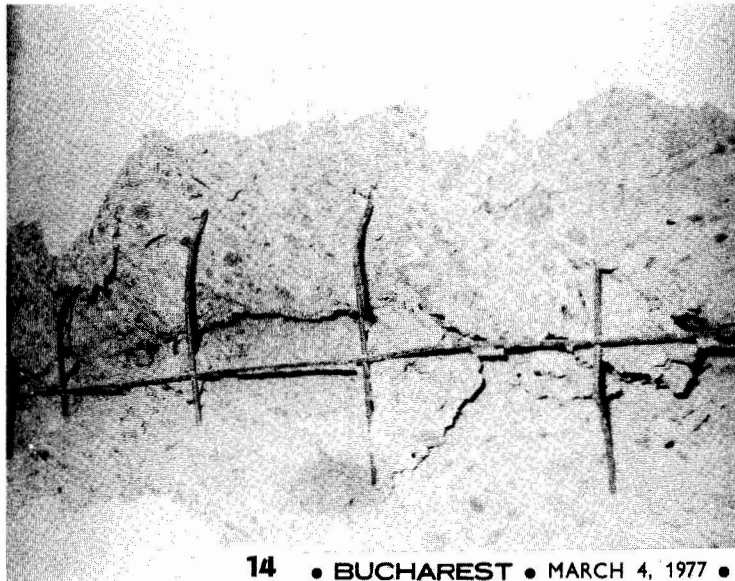
**14** • BUCHAREST • MARCH 4, 1977 •

Cracked reinforced concrete shear walls
