BLOCK 15 HERITAGE REDEVELOPMENT

SEISMIC UPGRADING

Roger Woodhead, Ph.D., P.Eng.
McKenzie, Snowball, Skalbania & Associates Ltd.

D.R. Morgan, Ph.D., P.Eng.
Hardy Associates (1978) Ltd.

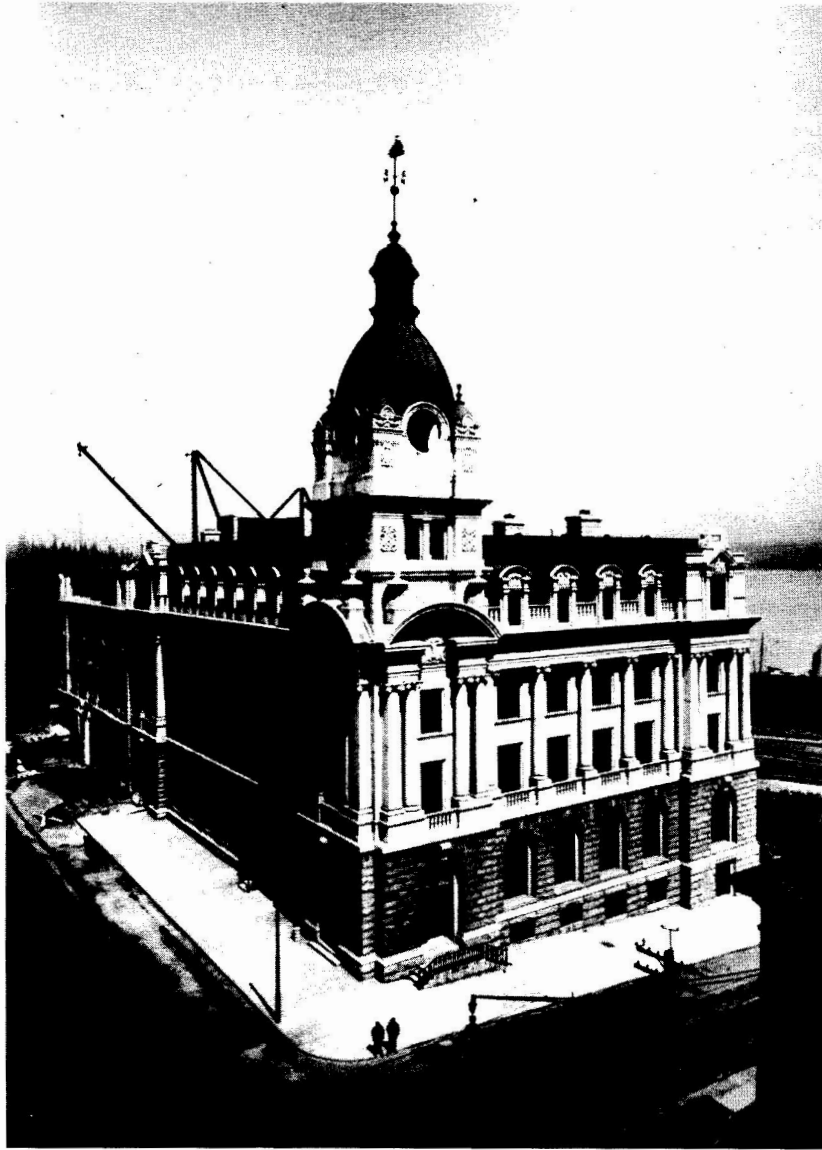
FIGURE I. POST OFFICE AND WINCH BUILDING
UNDER CONSTRUCTION (CIRCA 1909)

7. The copper-clad ornate clock tower can be seen in Figure 1. The lower portion of the clock tower was comprised of a composite granite masonry exterior wall and clay brick interior wall, reinforced with vertical metal tie-rods connected to reinforced concrete diaphragm floors at two levels. The dome portion of the tower was of wood construction. Deterioration over the years of the wooden window frames and joints in the copper cladding had permitted the ingress of wind driven rain, to the extent that there was some deterioration in structural wood components and interior clay brick units and mortar. The shear capacity of the masonry mortar was determined by pull-out tests on clay brick units. The compressive strength of the mortar

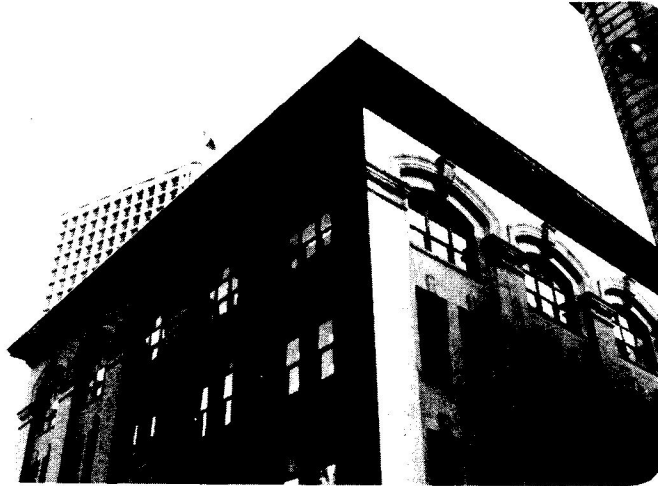
FIGURE 2. CORNICE ON ROOF OF CUSTOMS EXAMINING WAREHOUSE

6. The Customs Examining Warehouse contained a complex copper clad ornate box frieze at the roof level as illustrated in Figure 2. This frieze was 7 feet wide at the top and projected approximately 4.5 feet beyond the face of the building. In order to establish the details of construction of the frieze and the method of connection to the building, an inspection port was first excavated in the 28 inch thick masonry wall, through which a camera was inserted to photograph internal construction details. Selected sheets of copper were then removed from the top of the frieze for detailed examination of connection details.

This structure could only resist about 15% of the lateral force in each direction. The exterior masonry walls were unreinforced and the roof had a large cornice projection which needed to be adequately braced (Figure 2).
