Permanent ground displacement induced by soil liquefaction during 1983 Nihonkai-Chubu and the 1964 Niigata earthquakes

ABSTRACT: Permanent ground displacements caused by liquefaction during the 1983 Nihonkai-Chubu and the 1964 Niigata earthquakes were measured by pre- and post-earthquake aerial survey, and the causes of the ground displacements based on the geological and the topographical conditions, are discussed.

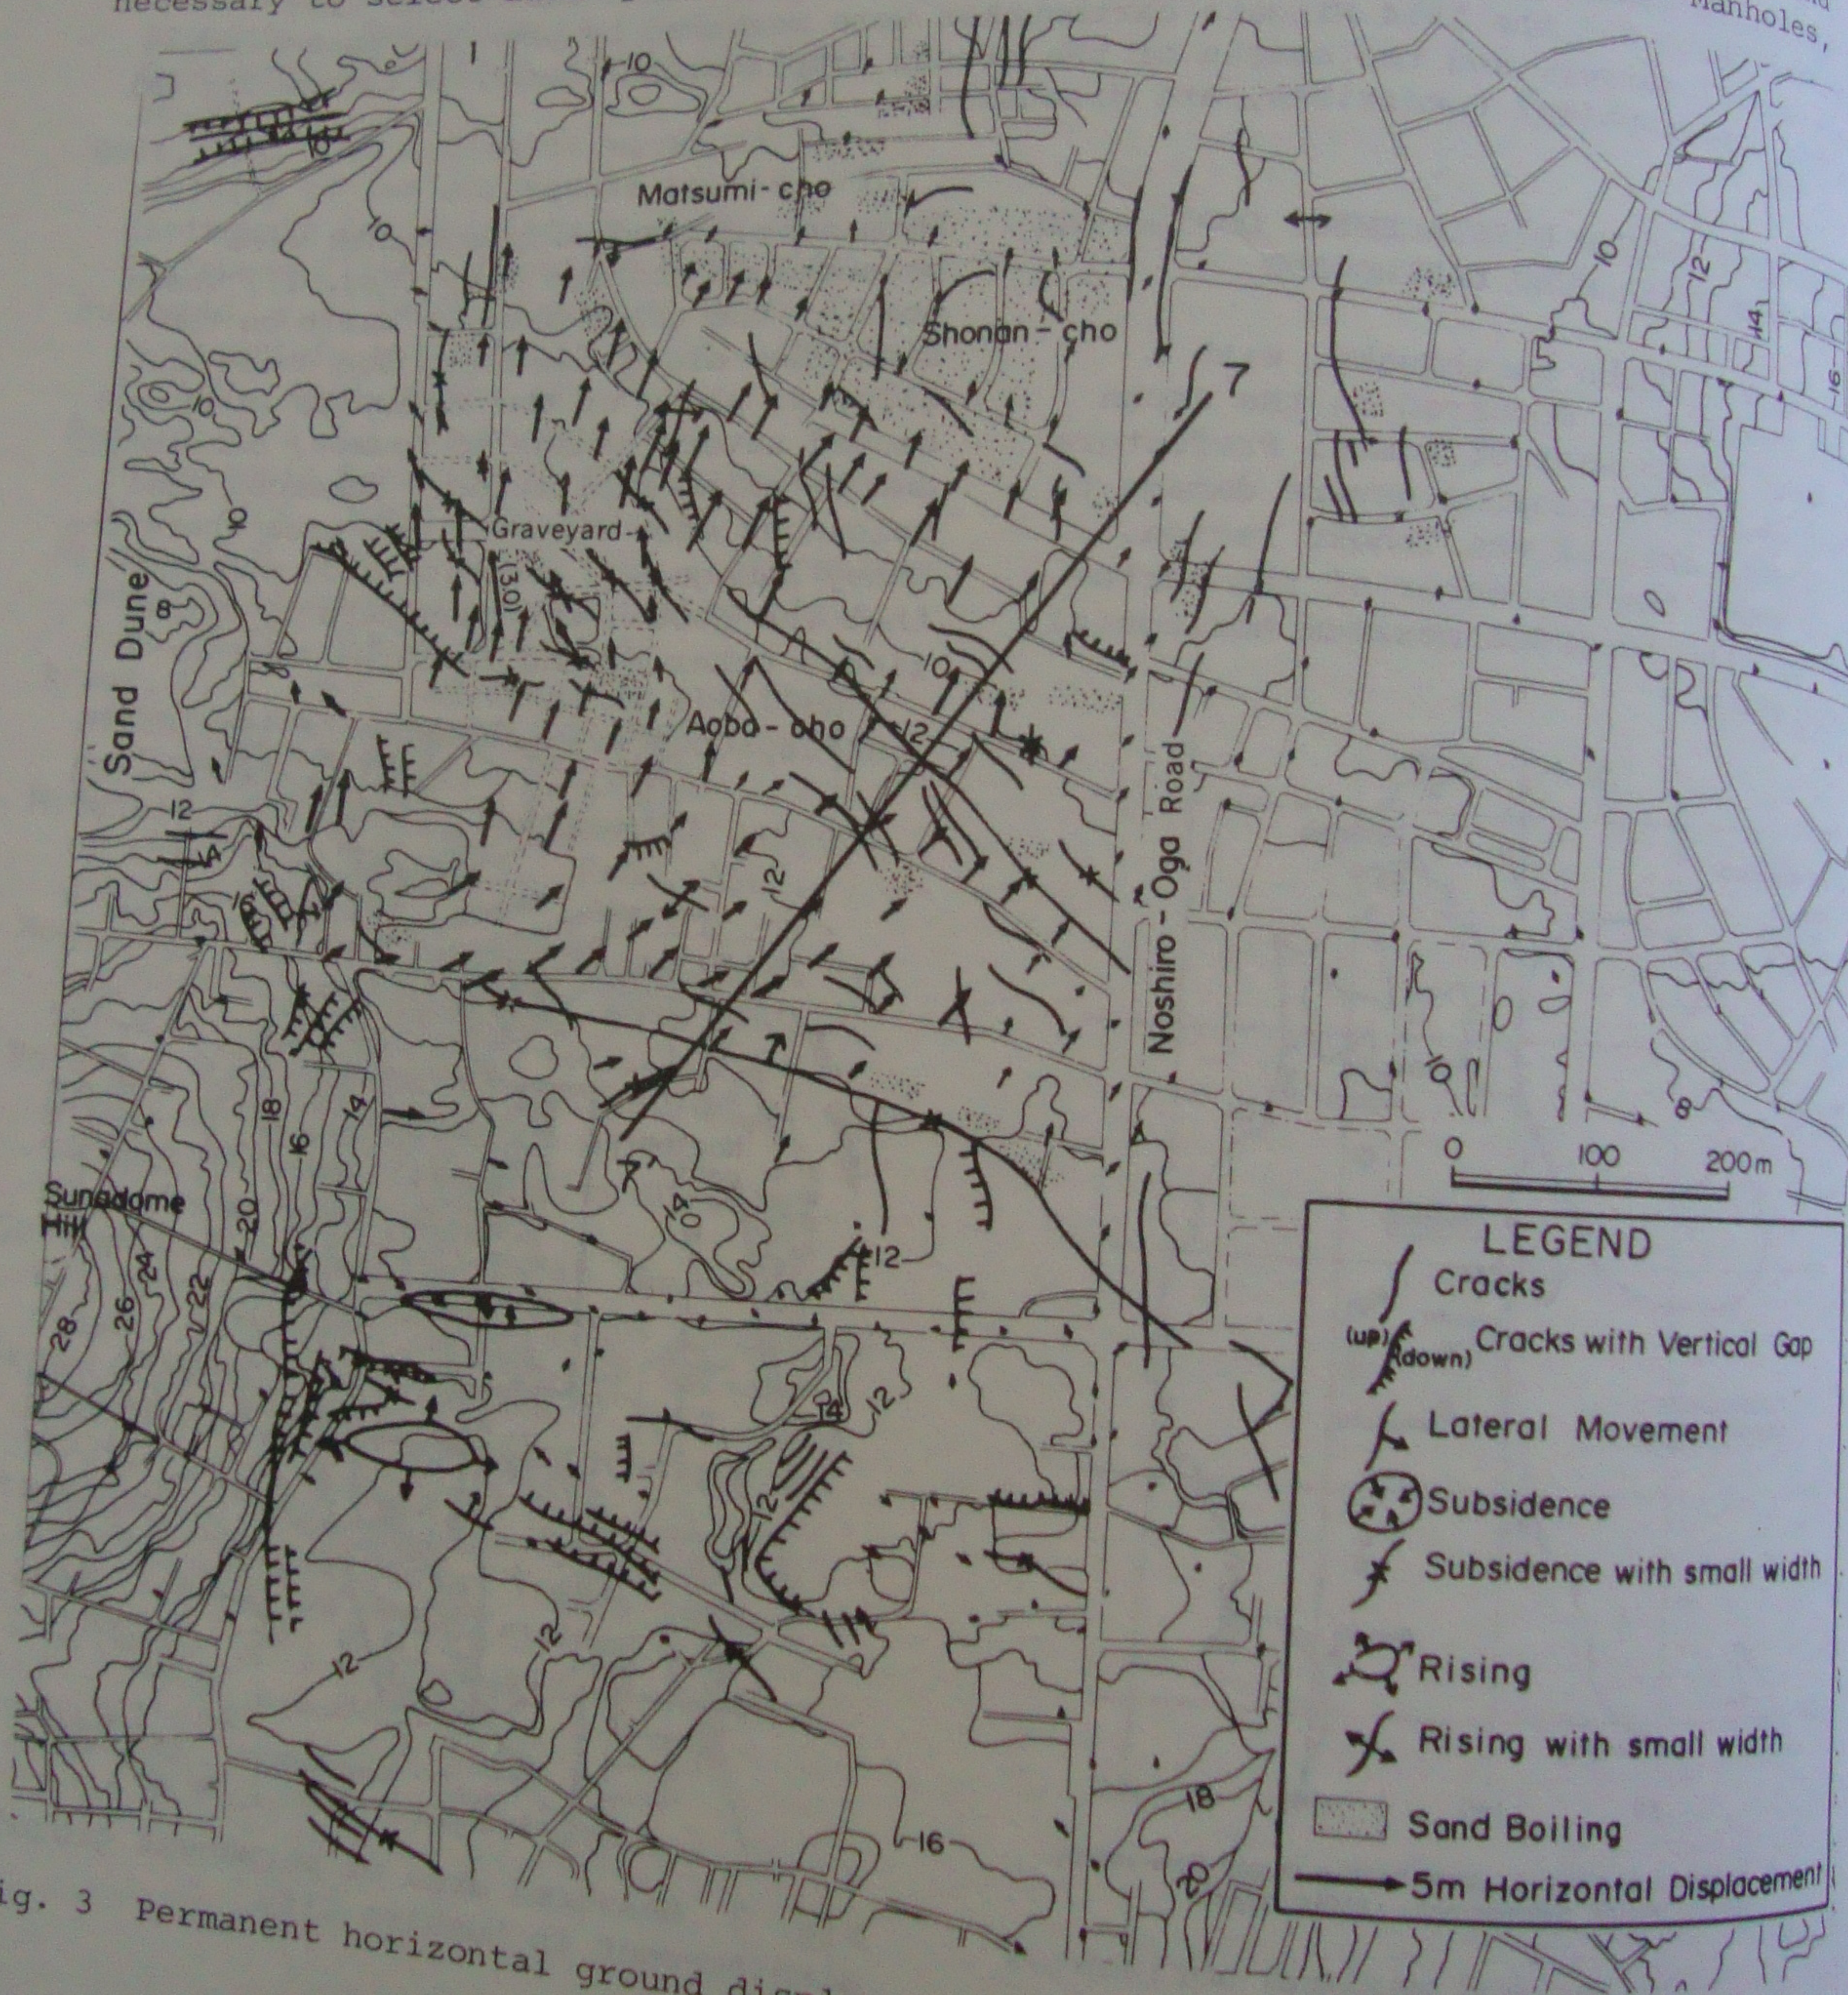
Fig. 3 Permanent horizontal ground displacements in the northern part of Noshiro City

In the northern area, as shown in Fig. 3, permanent ground displacements were dominant in the western half on the west side of the Noshiro-Oga Road, which is gently sloped, and forms the transition area between the sand dunes and the alluvial plane. The displacements started from halfway down the sand dune, Sunadome Hill, and extended for about 800 m in a northerly or northeasterly direction. The maximum horizontal displacement in the northern area reached about 3 m, in the graveyard of Aoba-cho.

On the other hand, the permanent ground displacements in the eastern half on the east side of the Noshiro-Oga Road, which is located mostly on the alluvial plane, were very small, at less than 1.0 m.

Figs. 3 and 4 also show ground failures such as sand volcanoes, cracks, subsidences and, bulgings, as investigated by the University of Akita. In the northern area, as shown in Fig. 3, the ground failures were concentrated in the western part (Aoba-cho, Matsumi-cho, etc.), where the permanent ground displacements were large. Photo 2 shows one example of cracks in the road leading to the graveyard in Aoba-cho, where the maximum horizontal displacement was 3.0 m.

On the eastern side of the Noshiro-Oga Road, where the permanent ground displacements were very small, very few ground failures were found.

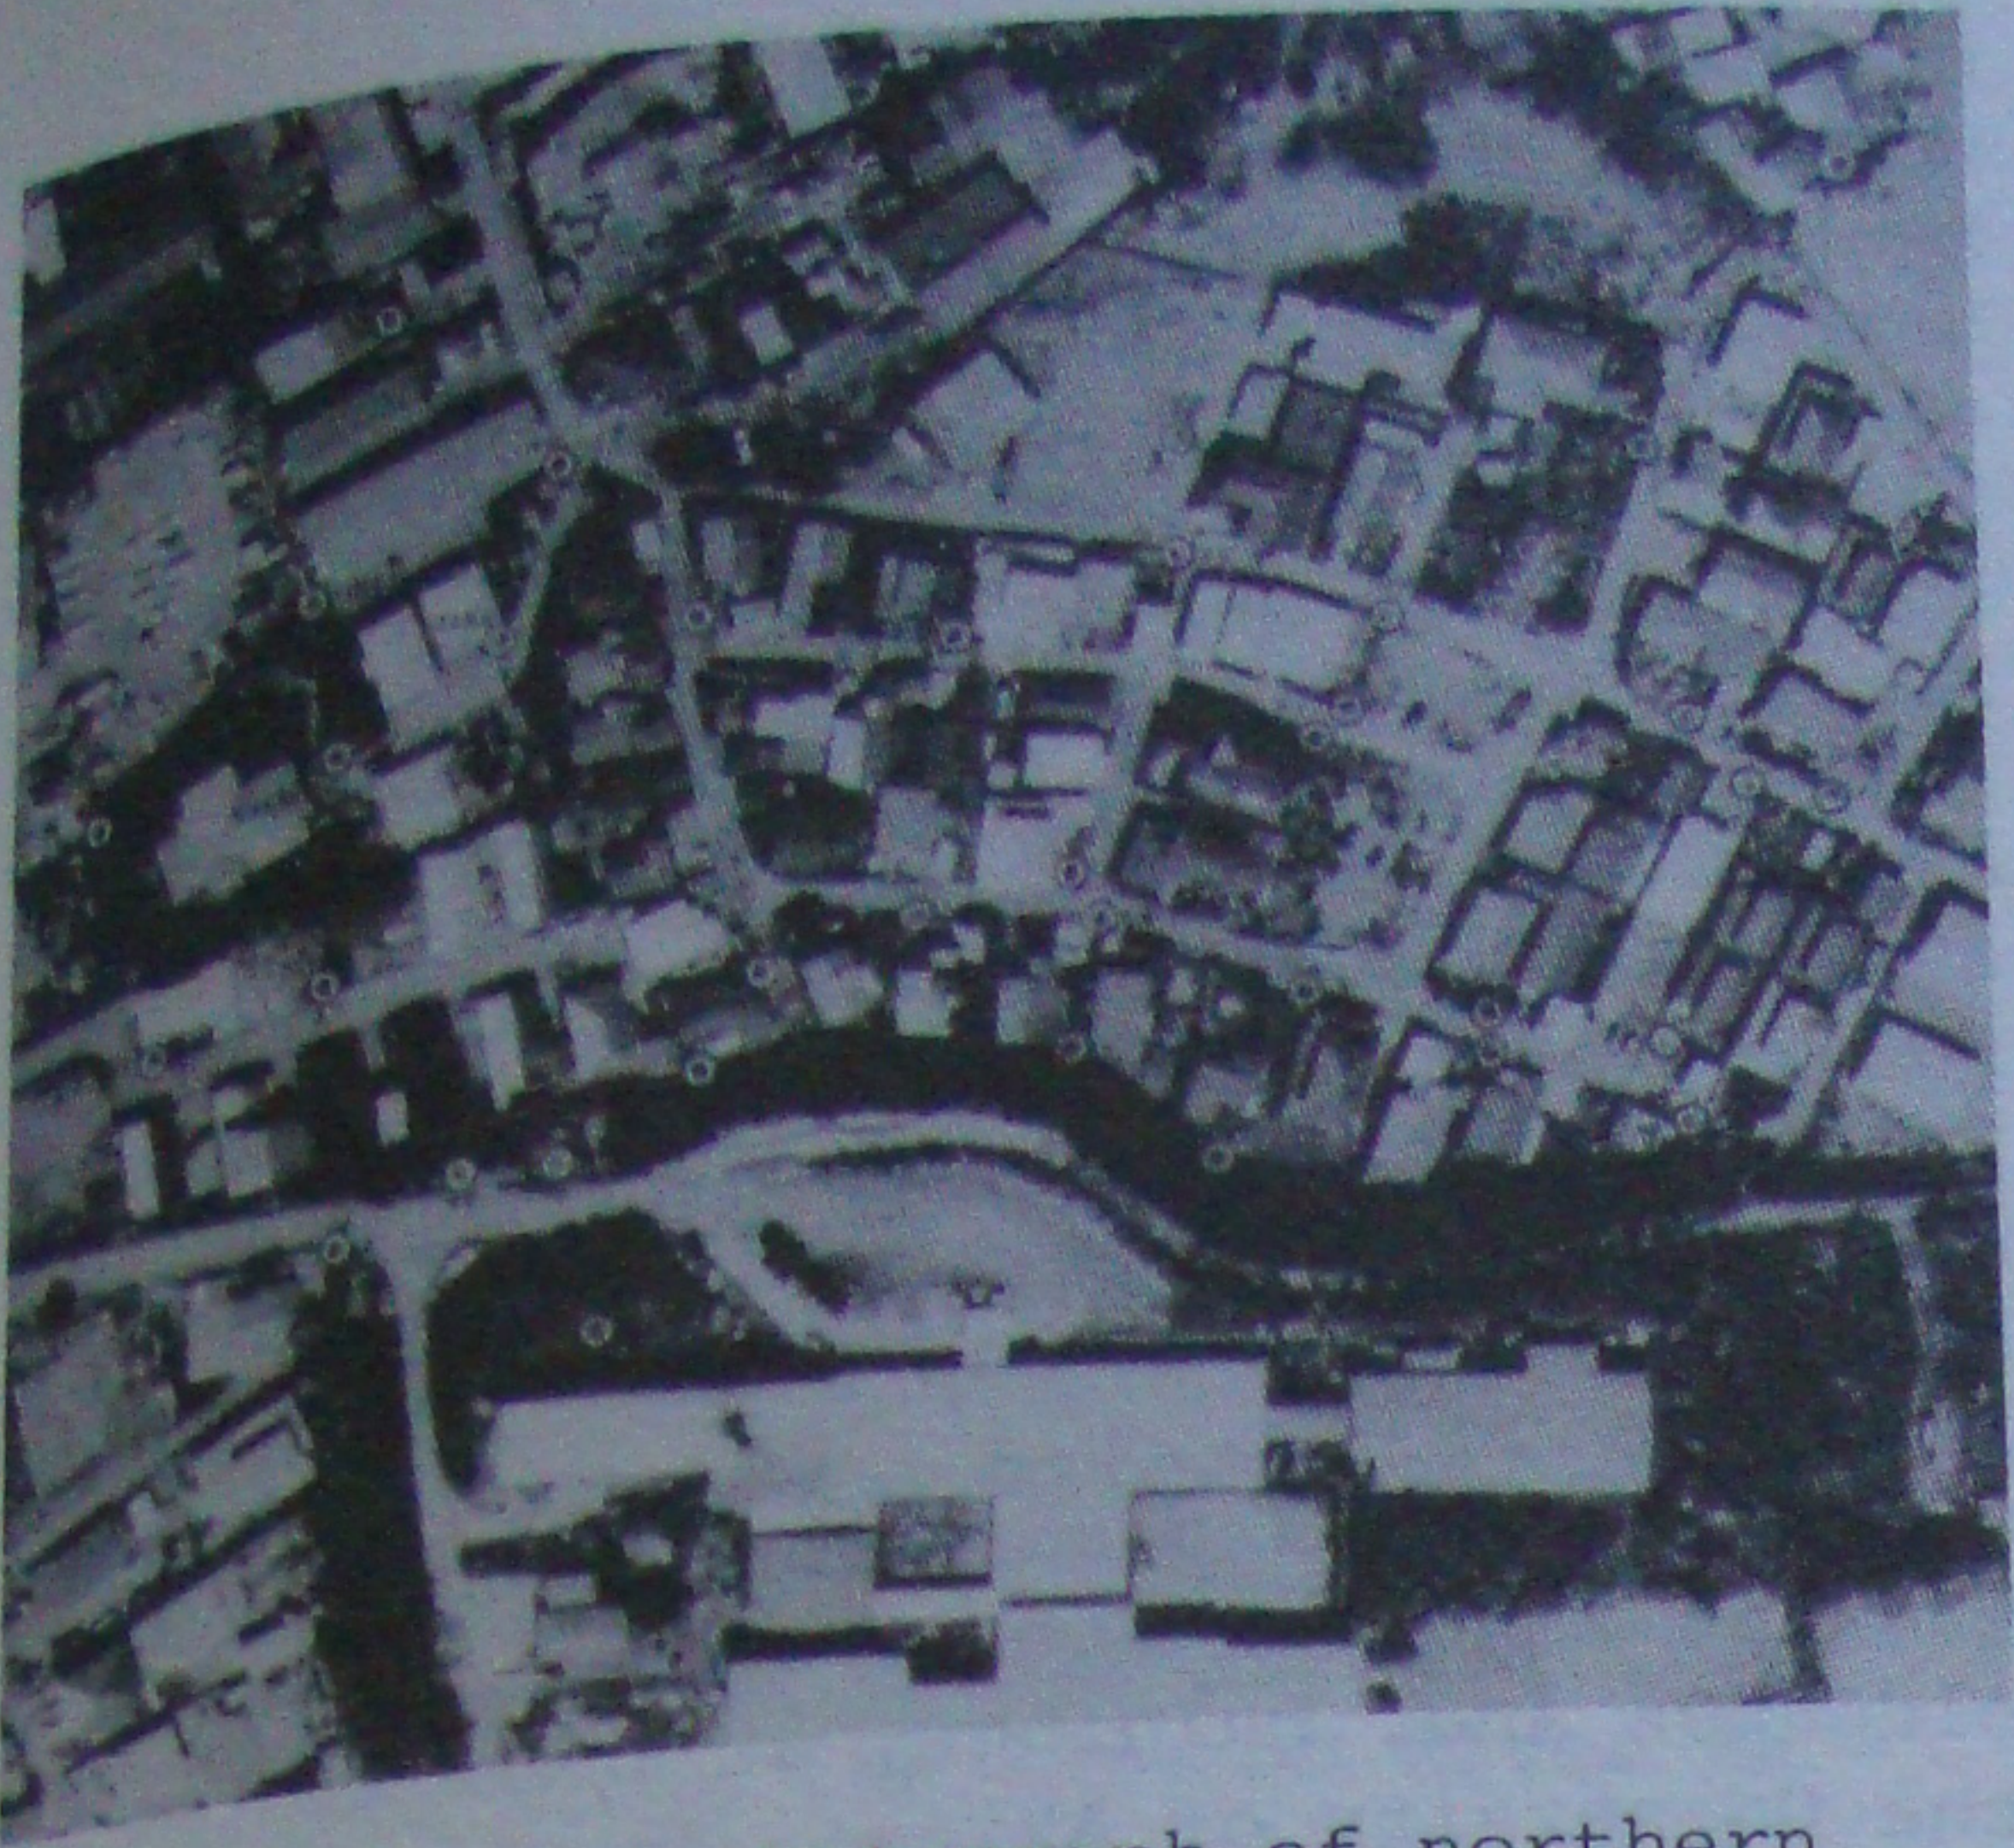
Photo 1 Aerial photograph of northern slope of the Mae Hill

higher than the surrounding area. On the northern slope of the hill, the displacements started from near the top and extended horizontally for more than 400 m in a northerly direction. The maximum horizontal displacement exceeded 5.0 m and the direction of the displacement was almost parallel to that of the slope.

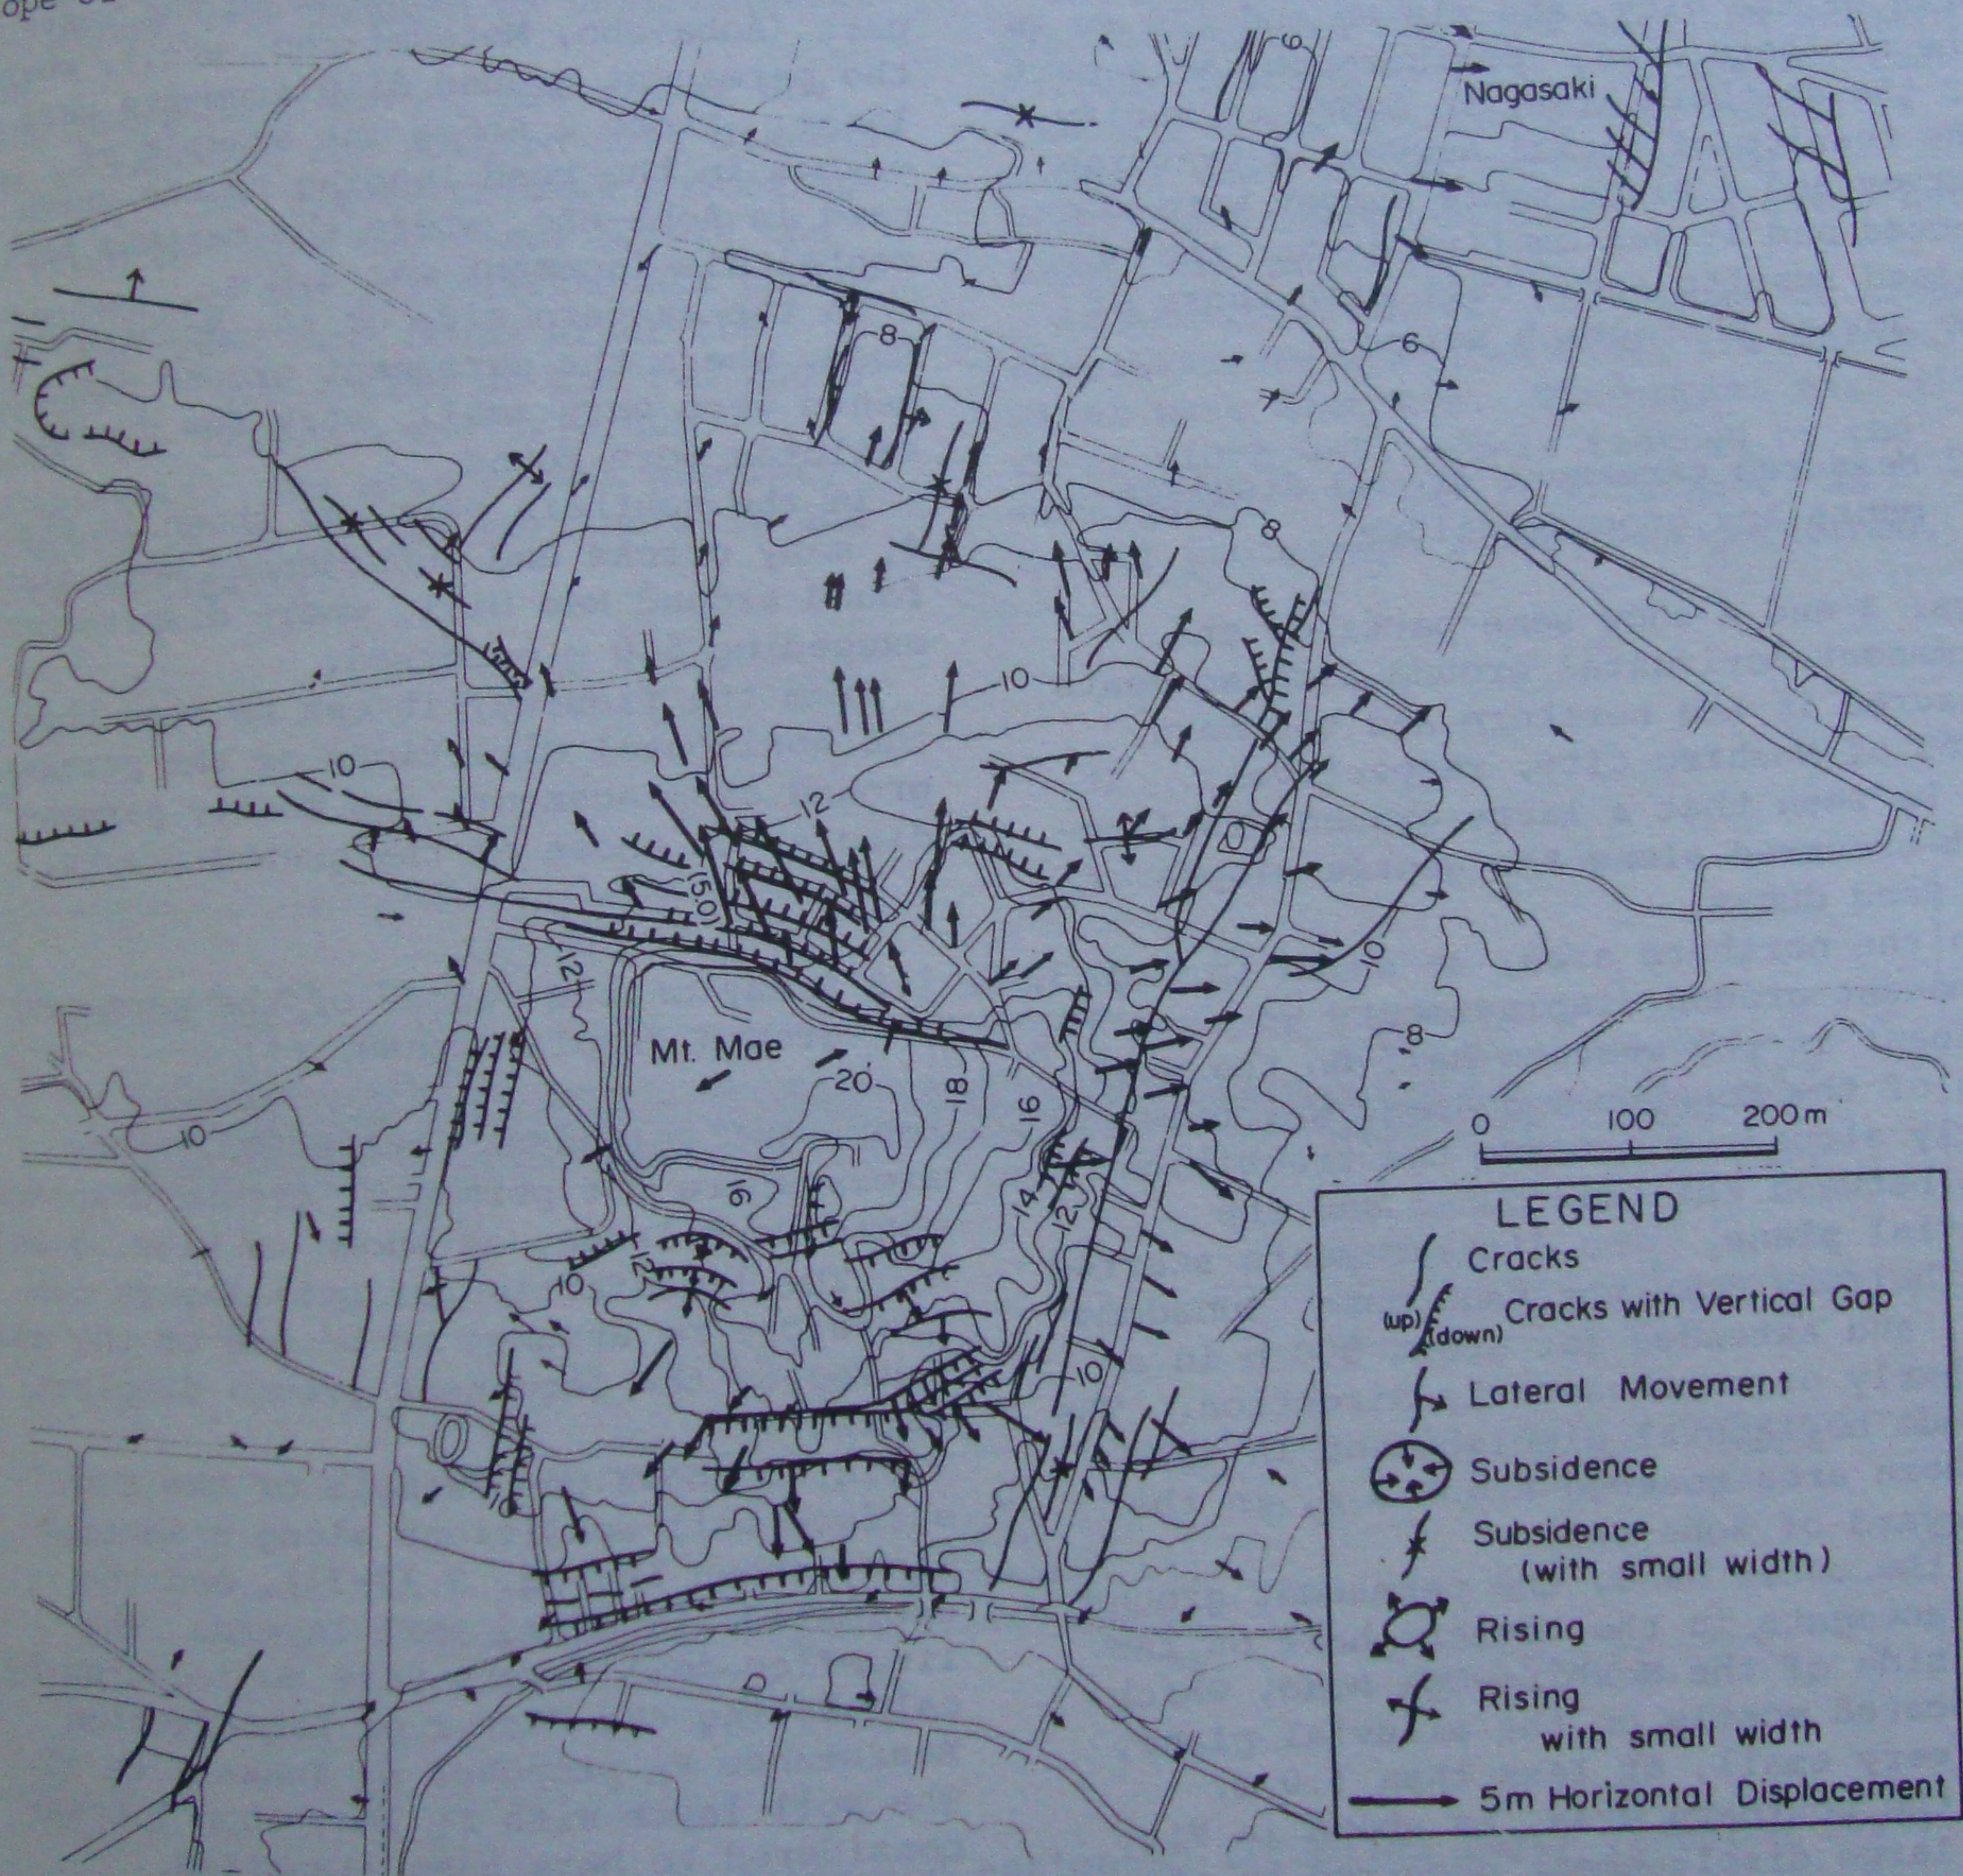
Fig. 4 Permanent horizontal ground displacements in the southern part of Noshiro City

In the southern area, as shown in Fig. 4, a large displacement occurred on the slope of Mae Hill, a sand dune about 10 m

The displacements on the southern slope of Mae Hill extended horizontally for about 300 m from the top to near the road running east-west at the toe of the slope. The displacements on the eastern slope also extended to near the north-south road, where the ground surface was mostly flat.

In the southern part, as shown in Fig. 4, many cracks and subsidences were also found around Mae Hill, where displacements exceeding 5.0 m occurred.

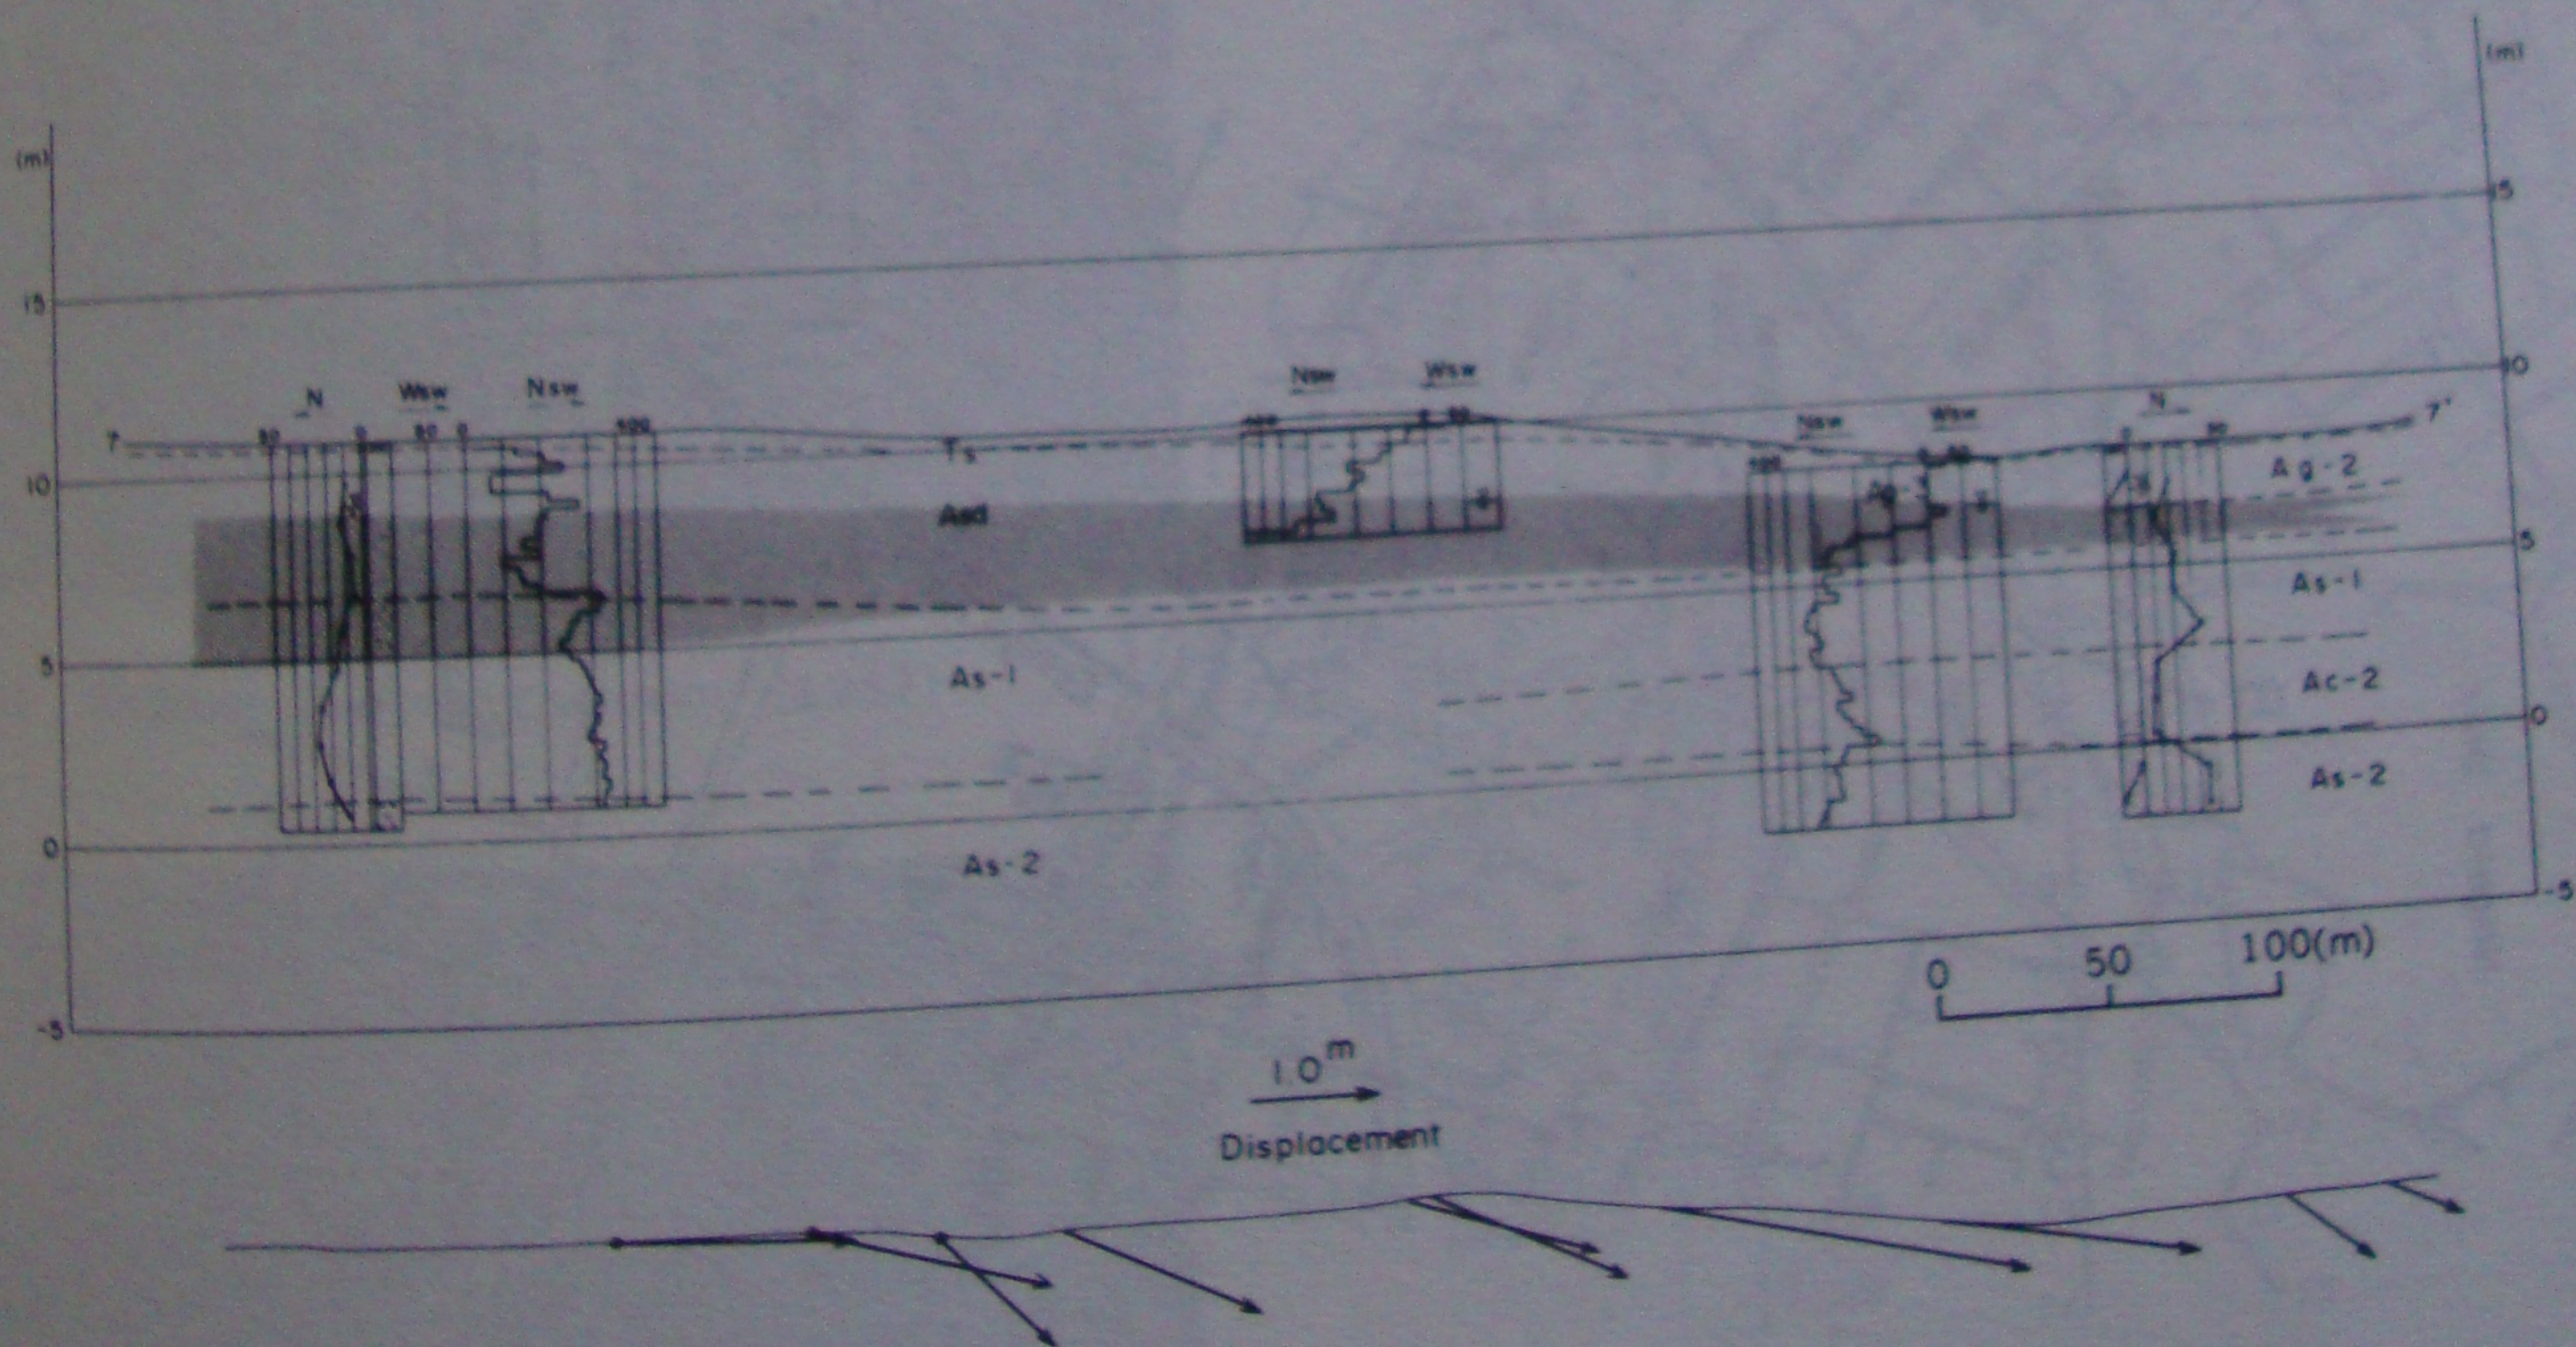
Fig. 5 Soil layer profiles and estimated liquefied layer (Section 7-7')

Fig. 5 shows one example of the subsurface soil conditions along a section line, shown in Fig. 3 (7-7'), and the estimated liquefied soil layers. The liquefied soil layers were conjectured by calculating the Factor of Liquefaction Resistance FL proposed by Iwasaki et al. The soil layer with FL less than 1.0 was considered to have been liquefied.

From the figure it can be found that a liquefied layer with a thickness of 2-5 m

exists under the sloped ground surface. Near the toe of the slope where the liquefied layers become thinner and the ground surface is flat, the permanent ground displacements become smaller. Therefore, the gradient of the ground surface and the thickness of the liquefied layer can be considered as the influential factors for the magnitude of the displacement.

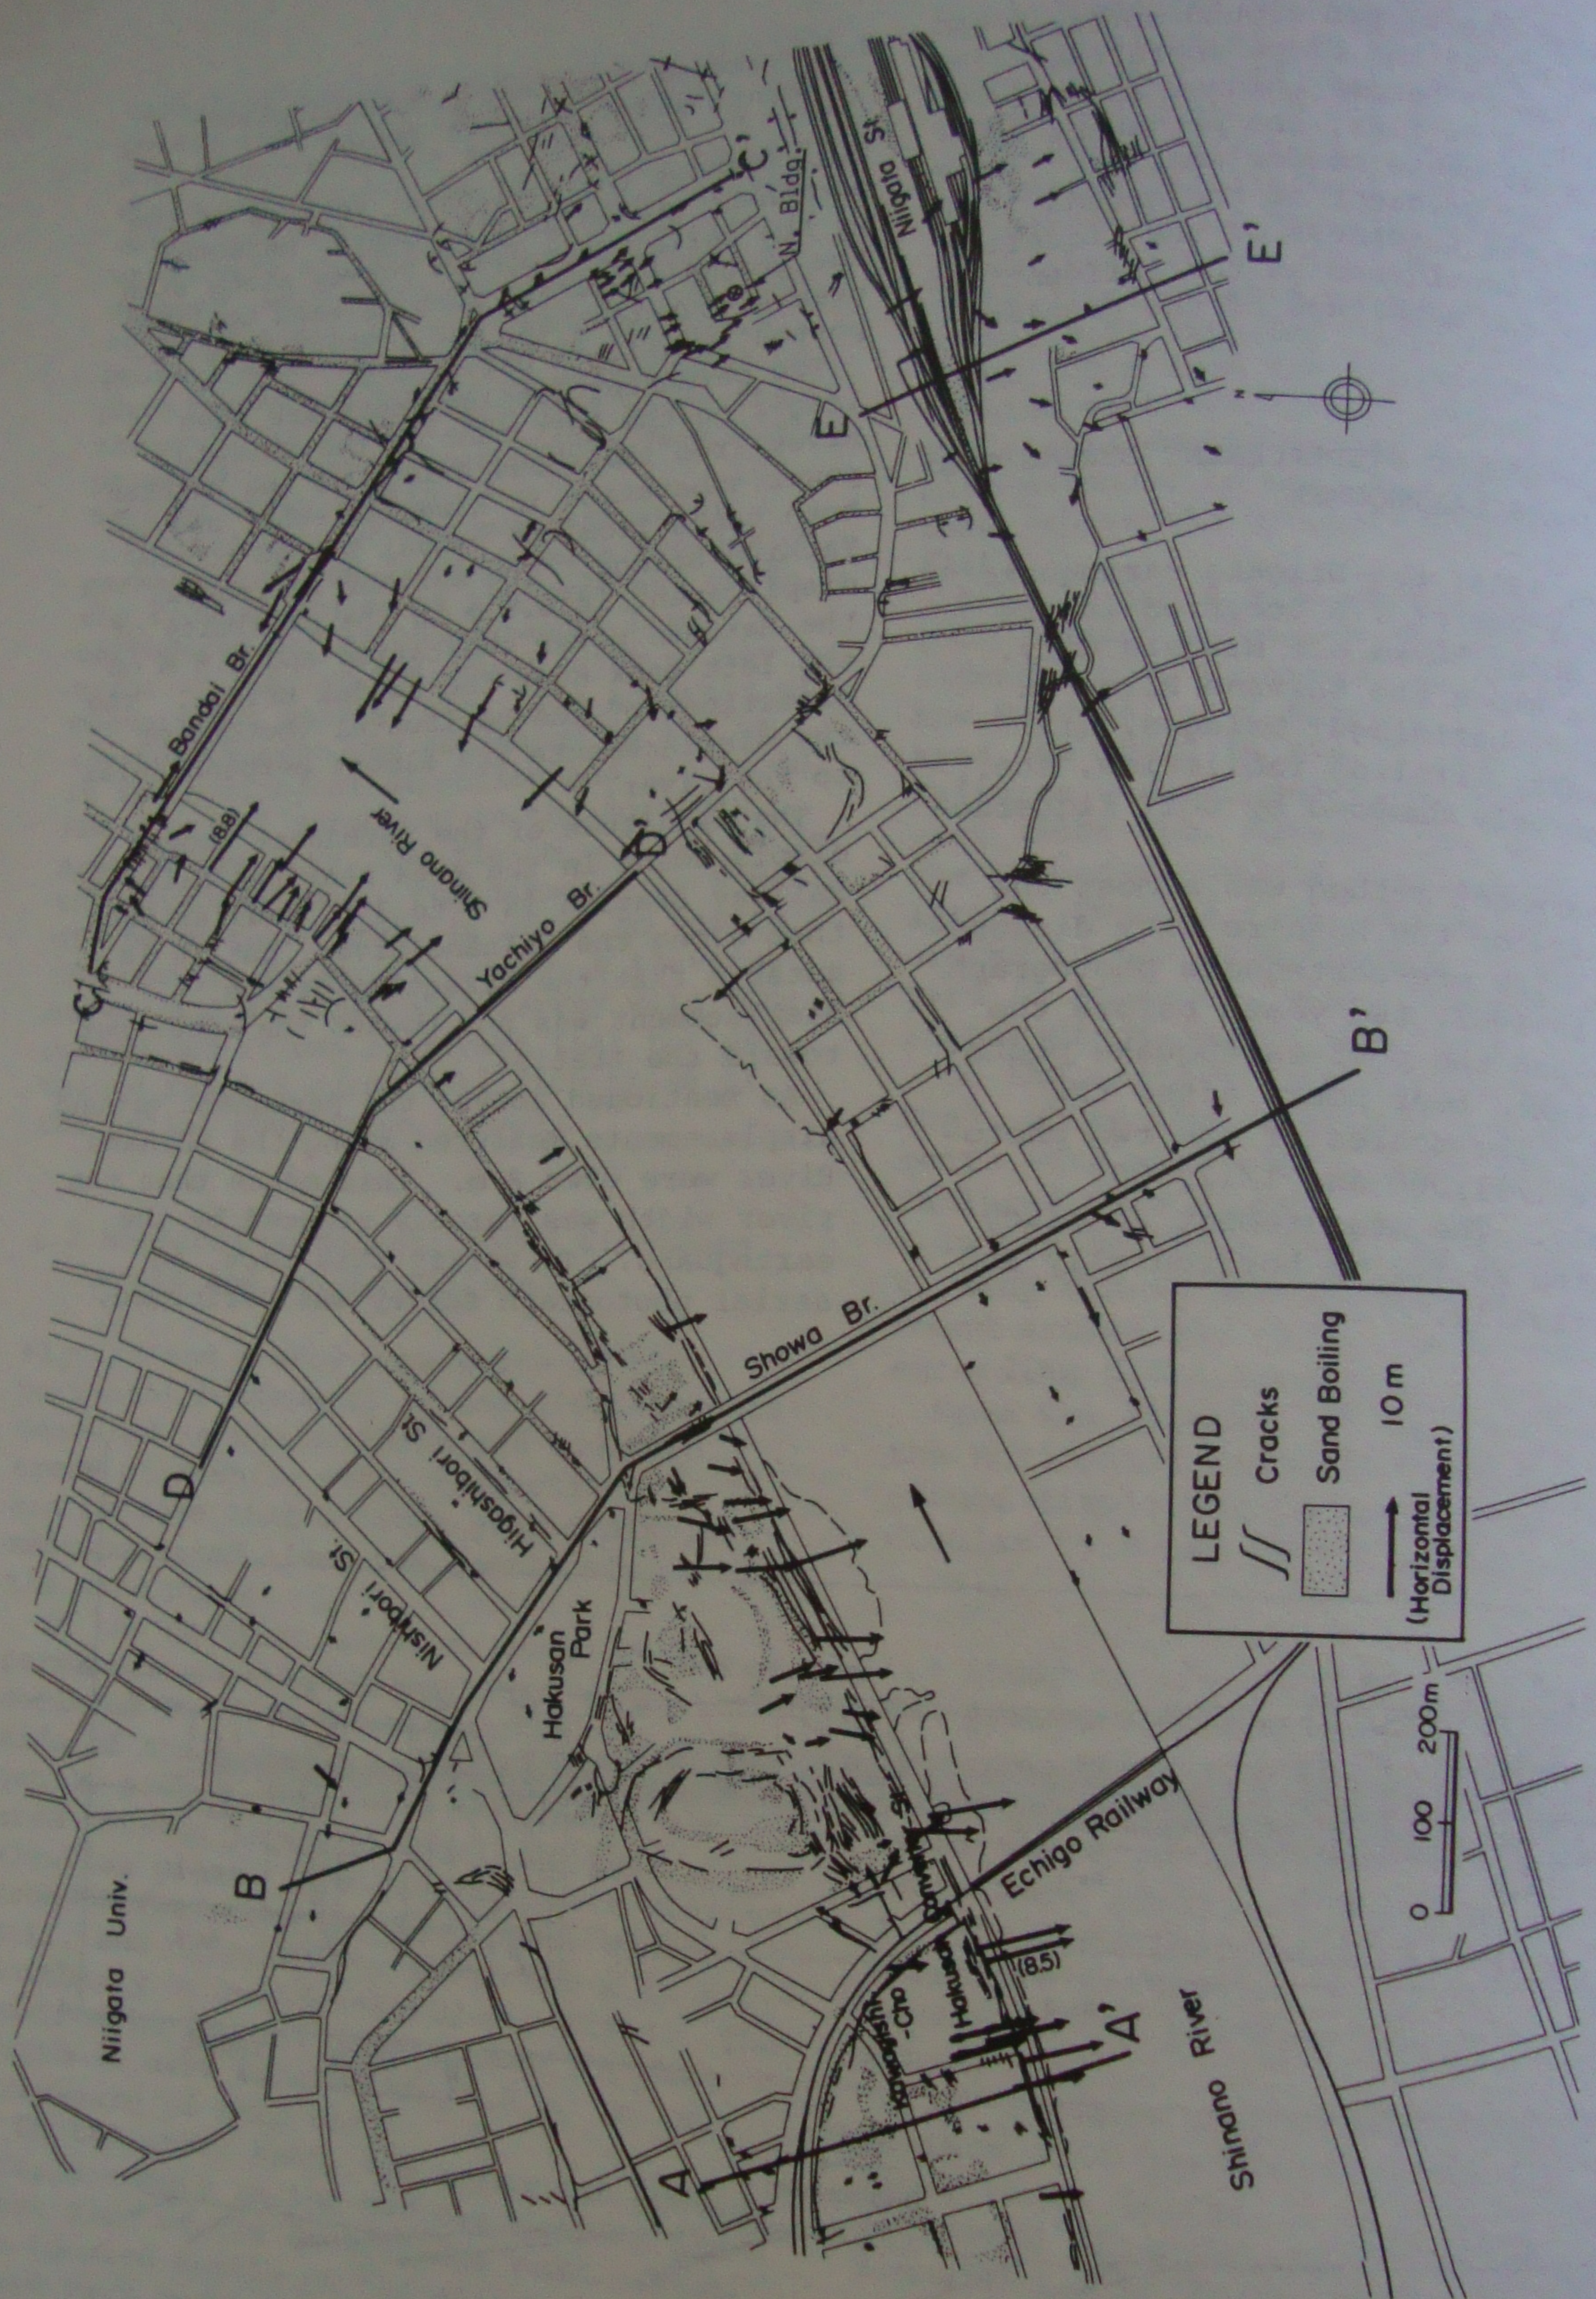
Fig. 6. Permanent horizontal ground displacements in Niigata City during the 1964 Niigata earthquake

Fig. 6 shows the horizontal vectors of the permanent ground displacements, measured by the aerial photograph survey along with the ground failures, such as sand boiling, cracks, subsidences, etc., which were reported by Niigata University.

The permanent displacements are much larger on the left bank of the Shinano River from the Showa Bridge to the Hakusan power substation in Kawagishi-cho, and on both banks from the Bandai Bridge to the Yachiyo Bridge. The maximum horizontal displacement is 8.5 m in the proximity of the Hakusan power substation and 8.8 m on the left bank near the Bandai Bridge. The directions of the horizontal vectors of the displacements are almost perpendicular to the river.

The magnitude of the permanent ground displacement in the area near the Niigata Railway Station is 2 to 3 m, smaller than that along the Shinano River, but it is notable that the direction of the displacement was not toward the river but toward the station.

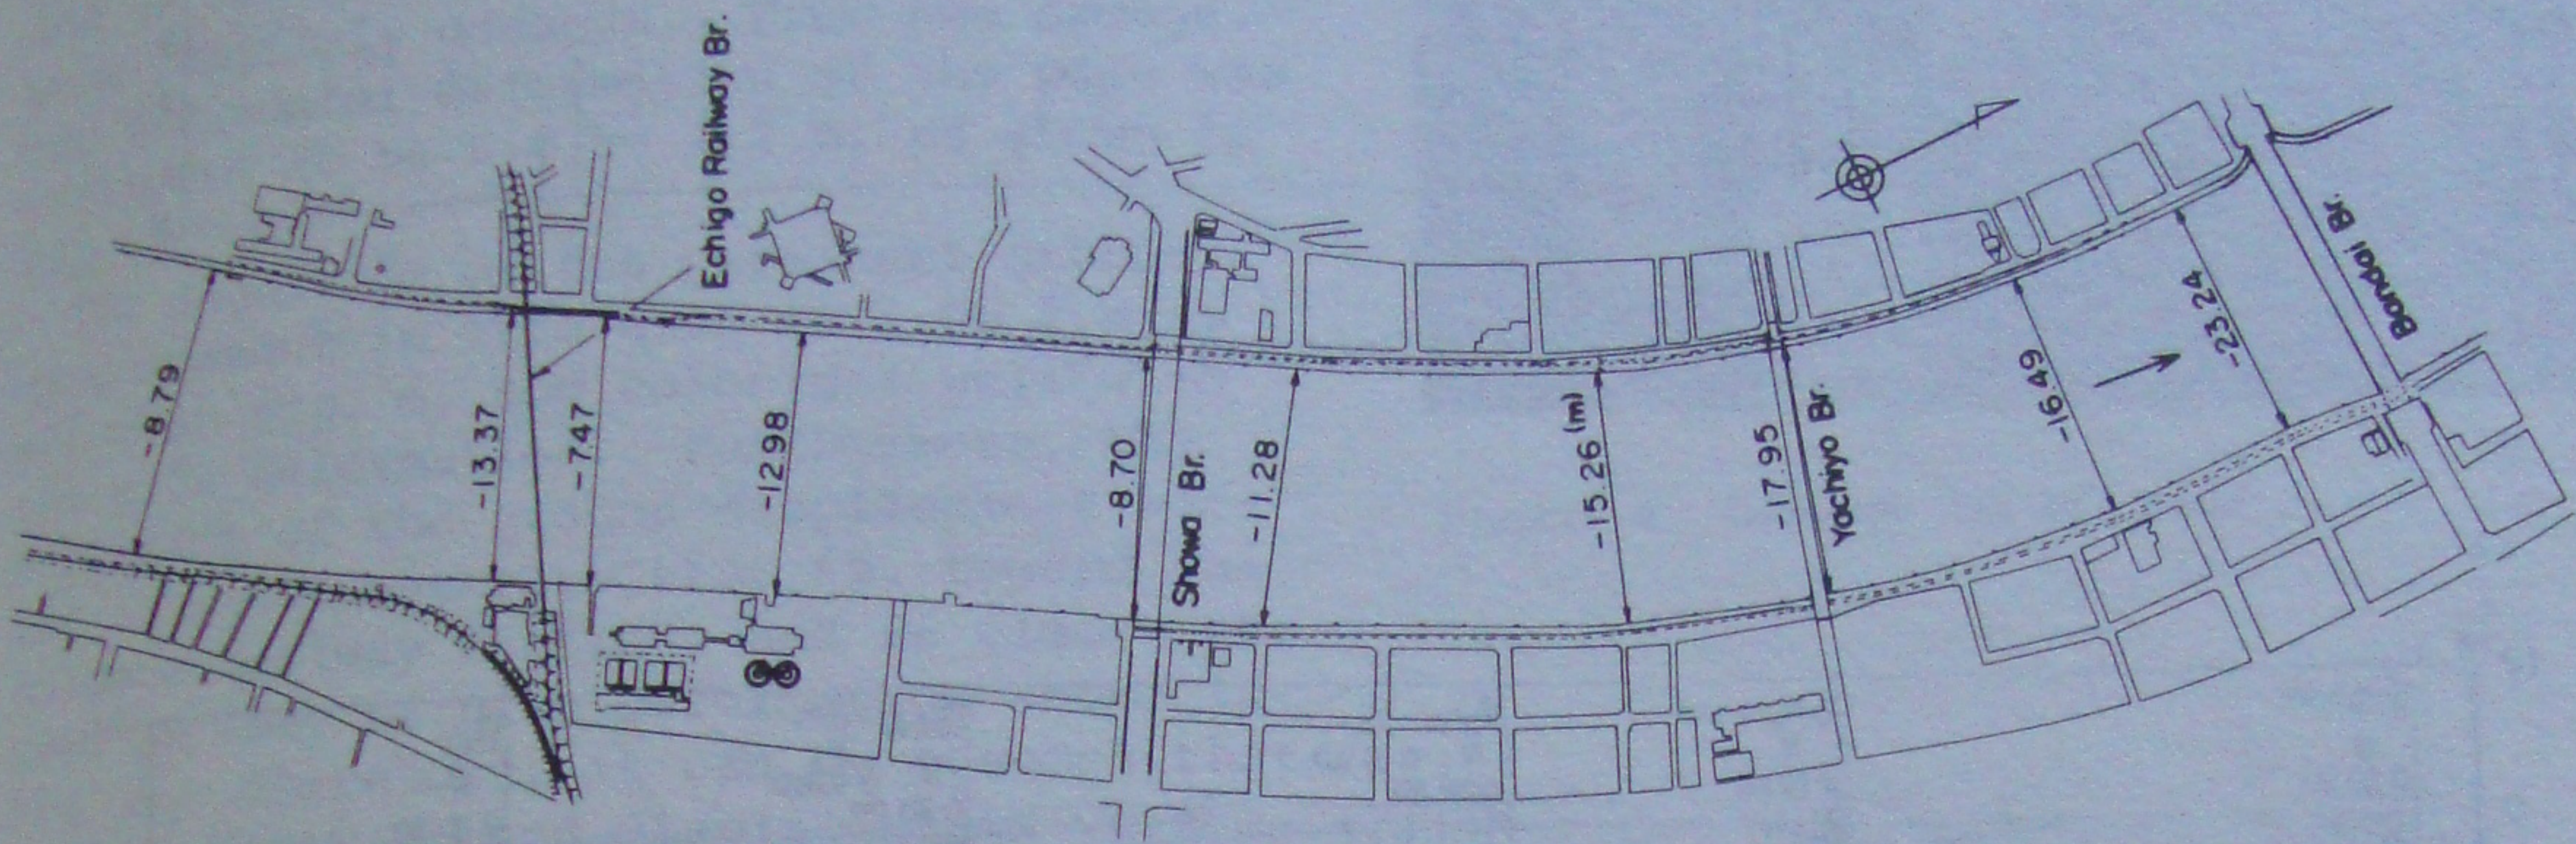
Fig. 7 Reduction of river width during Niigata earthquake (m)

Fig. 7 shows the reduction of the river width. Between the Bandai Bridge and the Yachiyo Bridge, where large permanent ground displacements occurred on both banks, the river width was reduced by 16 to 23 m, while between the Showa Bridge and Kawagishi-cho, where large permanent

ground displacements occurred only on the left bank, the river width was reduced by 7 to 13 m.
