Permanent ground displacement induced by soil liquefaction during 1983 Nihonkai-Chubu and the 1964 Niigata earthquakes

ABSTRACT: Permanent ground displacements caused by liquefaction during the 1983 Nihonkai-Chubu and the 1964 Niigata earthquakes were measured by pre- and post-earthquake aerial survey, and the causes of the ground displacements based on the geological and the topographical conditions, are discussed.

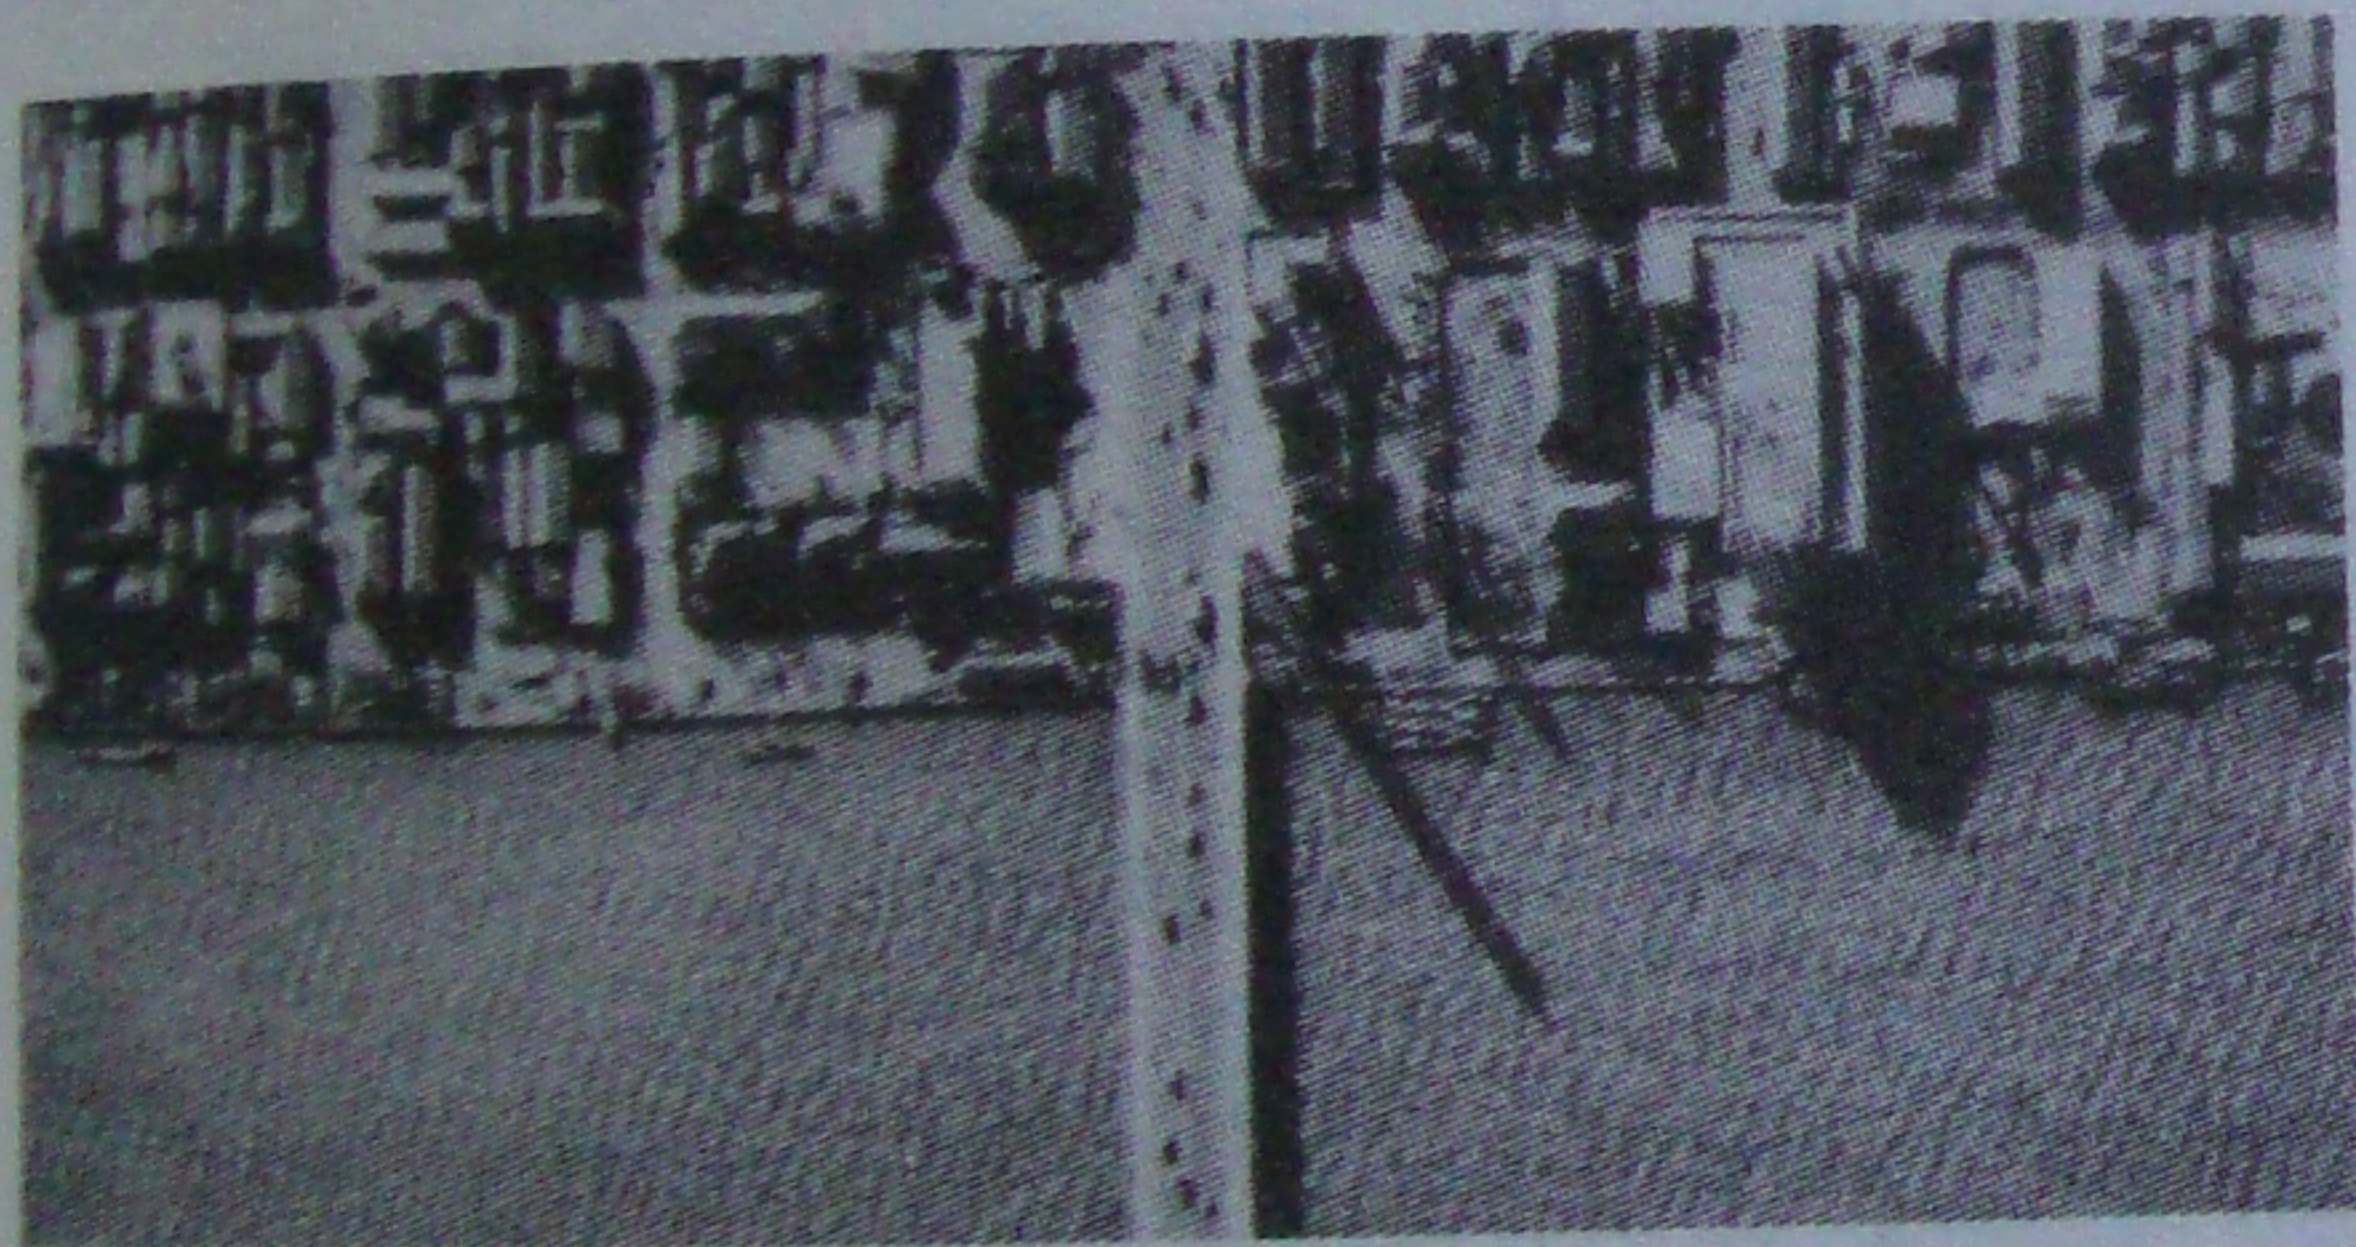
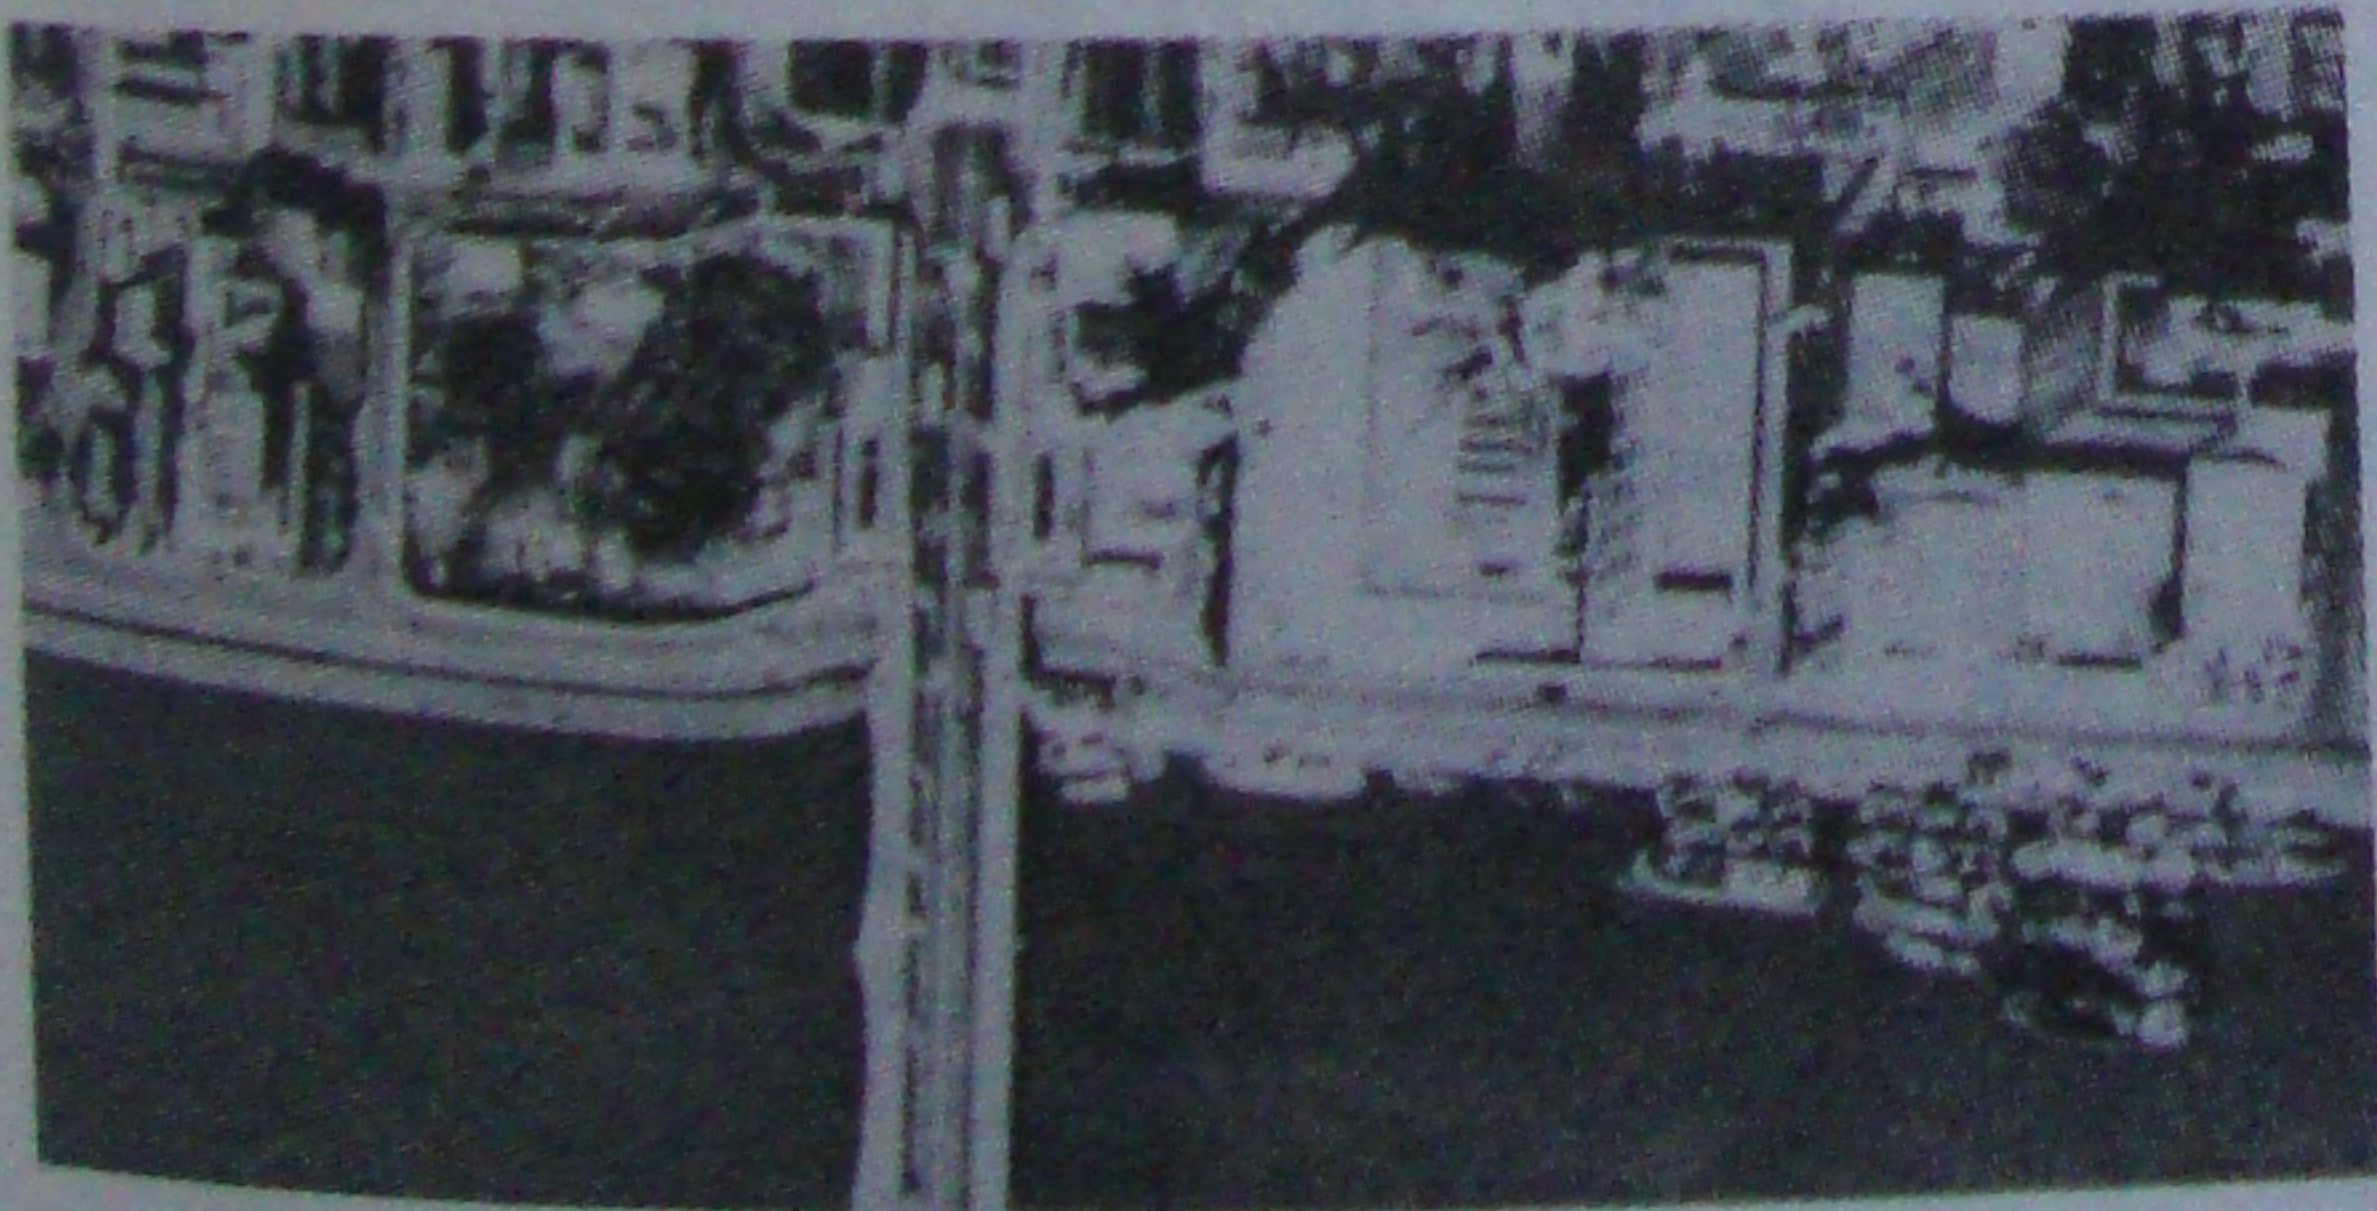
Photo 3 Left bank of the Bandai Bridge

Photo 3 shows the left bank of the Bandai Bridge before and after the earthquake. Photo (a) was taken in 1962, two years before the earthquake, while photo (b) was taken in 1971 by which time the revetment had been completely restored. By comparing these photographs it can be seen that the revetment, which was straight before the earthquake, became curved at the bridge abutment after the earthquake. This shows that in the vicinity of the abutment, the permanent ground

displacements were reduced because of the rigidity of the Bandai Bridge, a stone masonry arch bridge.

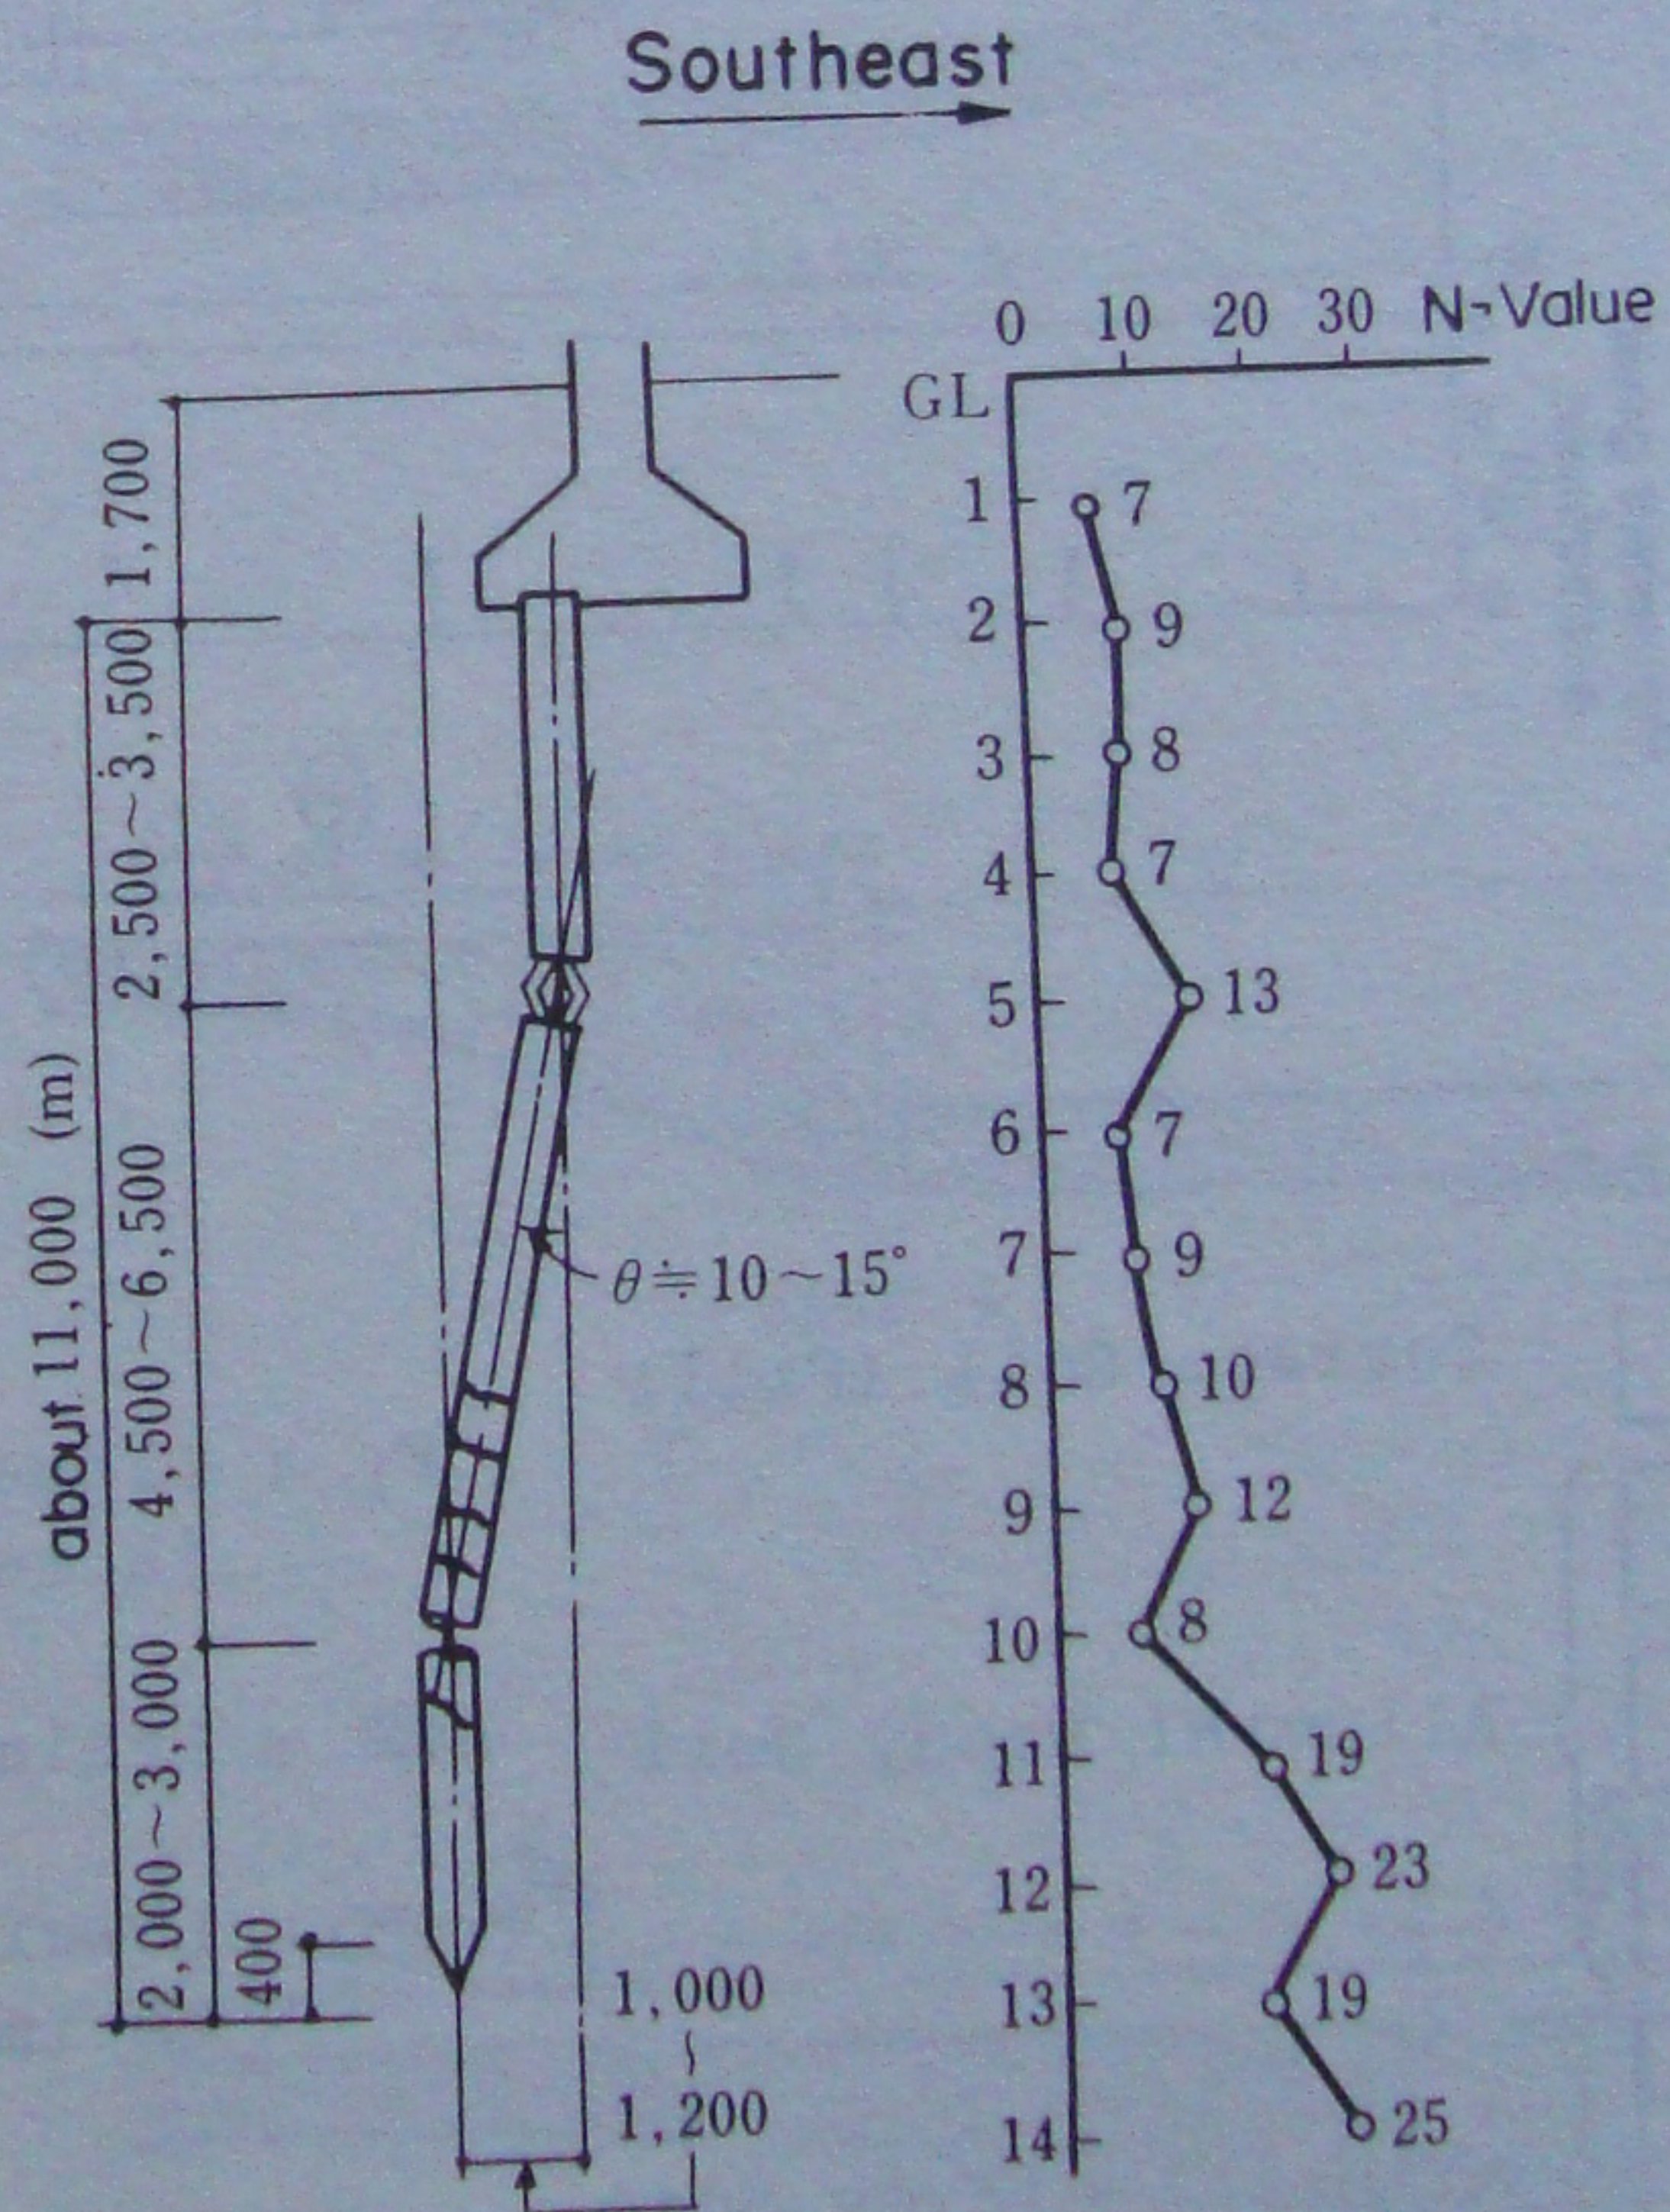
Fig. 8 Broken RC pile and soil condition

As shown in Fig. 8 and Photo 4 the piles were found to be broken at two positions, 2.5 to 3.5 m from the upper end and 2.0 to 3.0 m from the bottom. Seventy four of the total of 304 piles were investigated and it was found that most of the piles were similarly damaged. From the damage, the horizontal deformation of the pile was estimated to be 1.0 to 1.2 m, as shown in Fig. 8.

The magnitude of the permanent ground displacement in this area is 1 to 2 m as shown in Fig. 6, and coincides well with the pile deformation. Furthermore, the direction of the ground displacement vector is southeasterly, that is, toward the Niigata Railway Station, and is almost the same as that of pile deformation shown in Fig. 8. Therefore, it can be assumed that the permanent ground displacements were the cause of the damage to the piles.

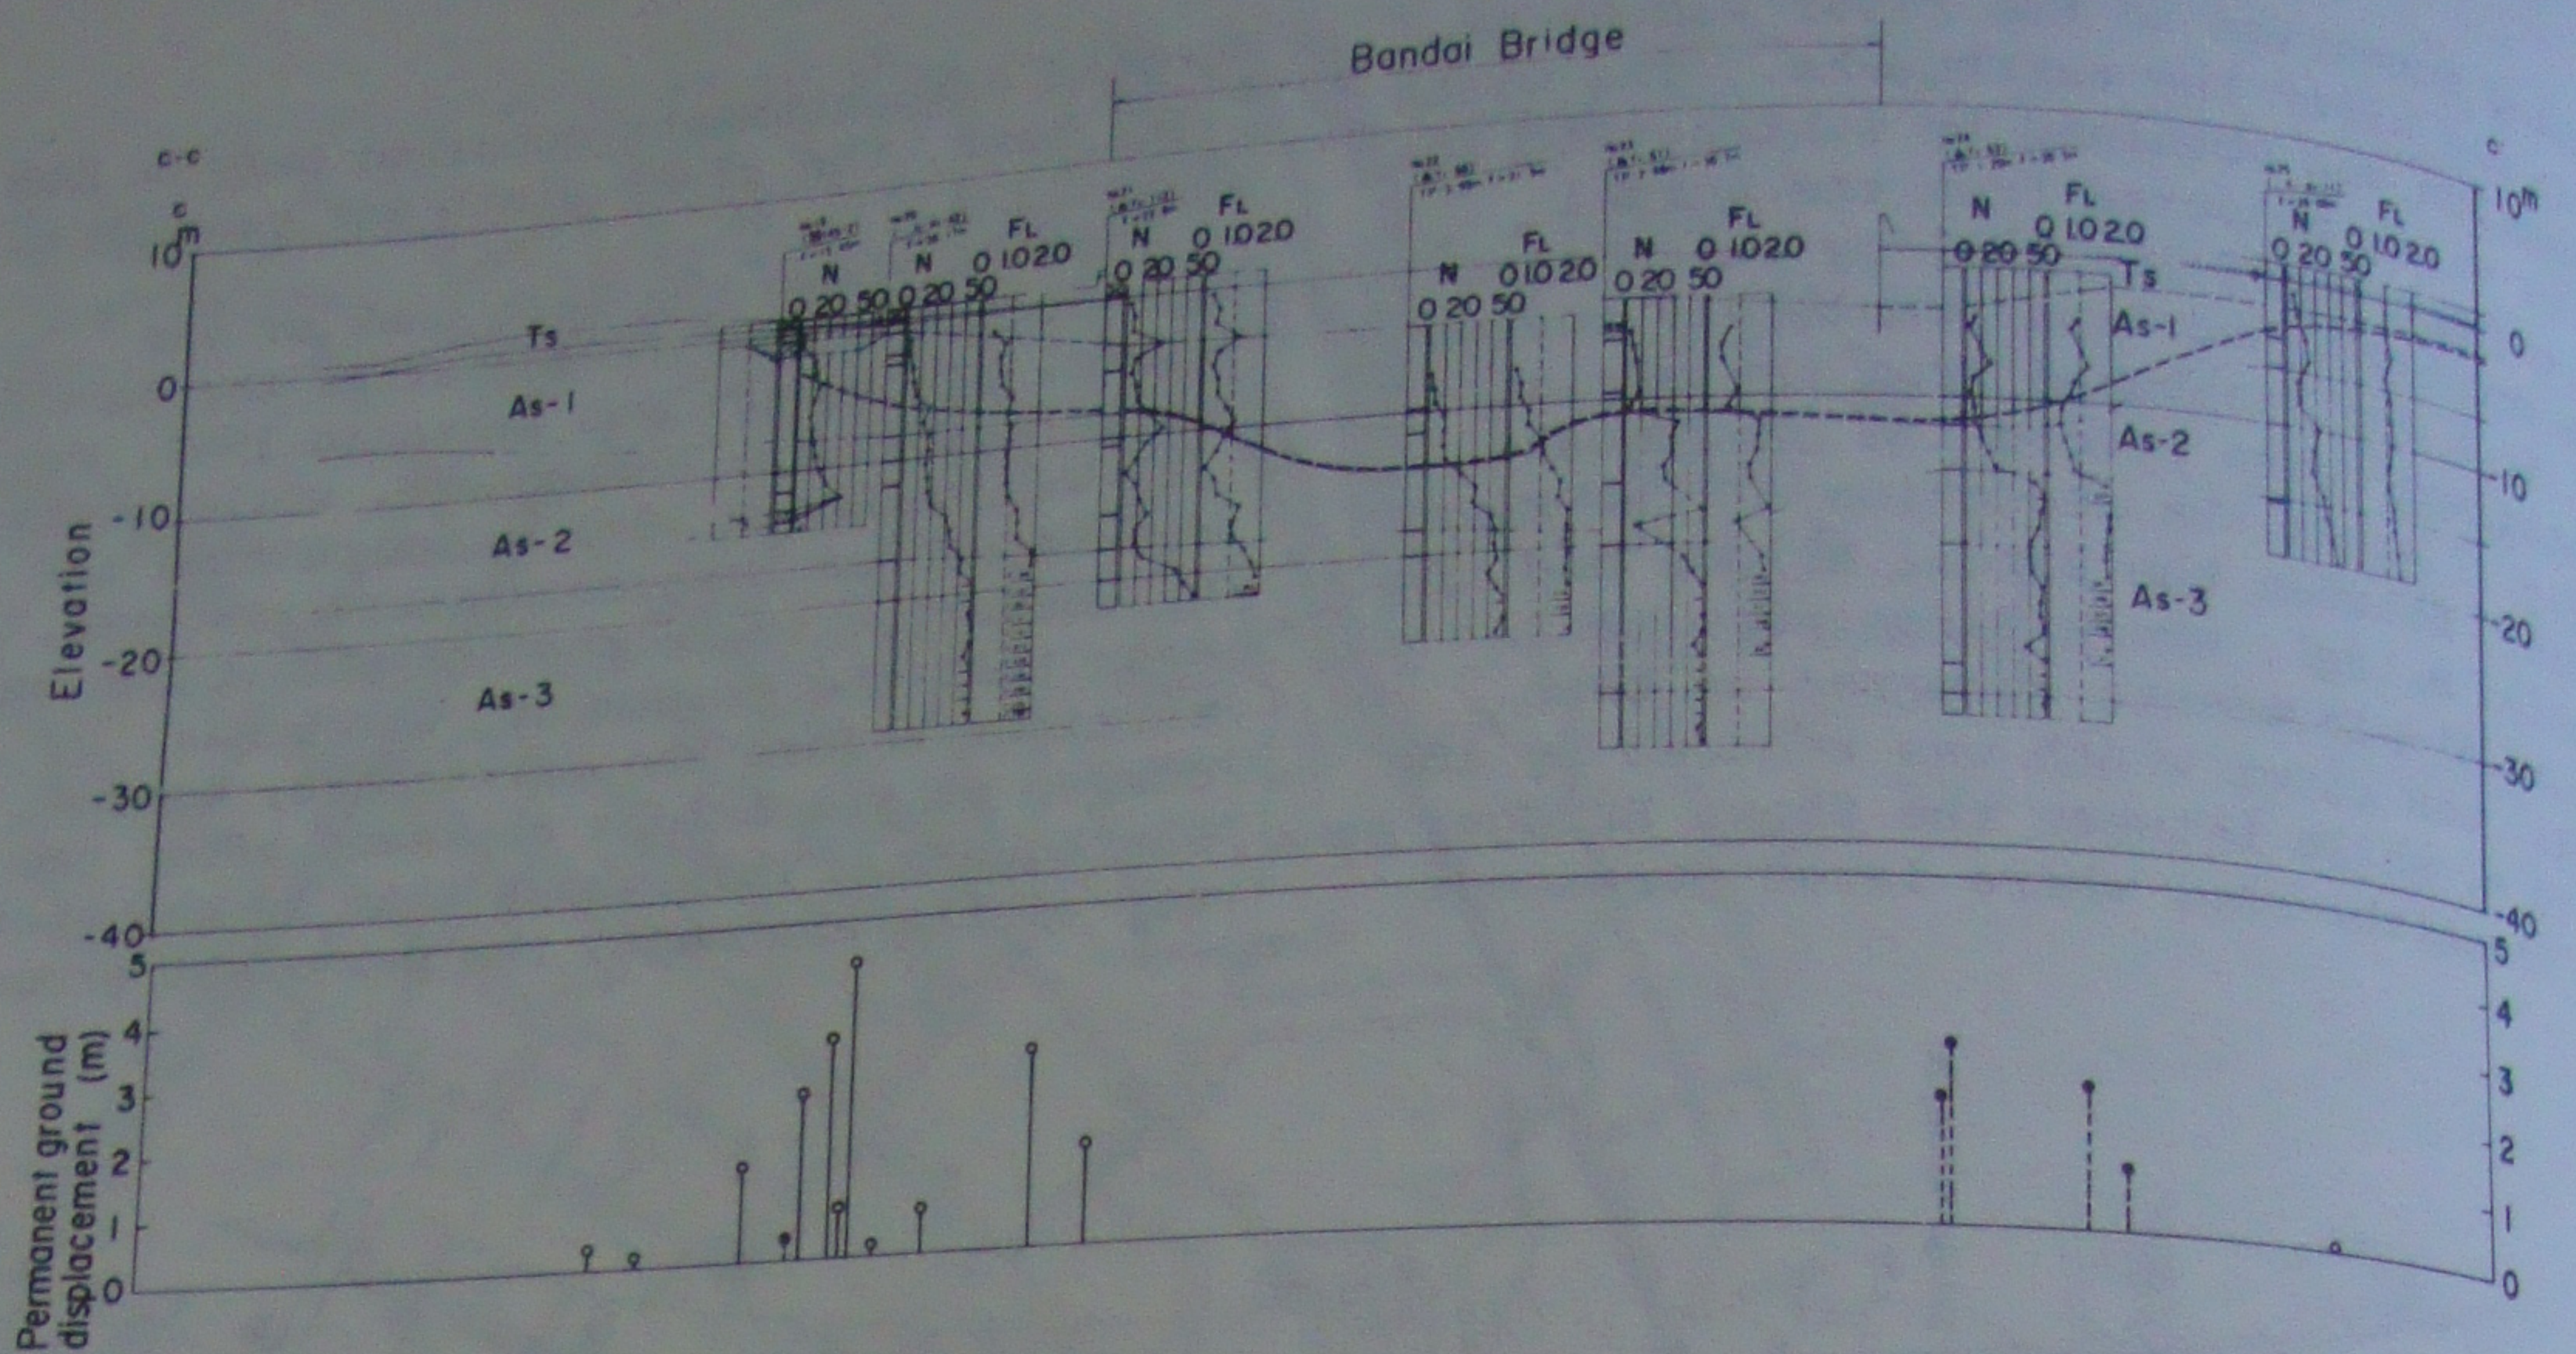
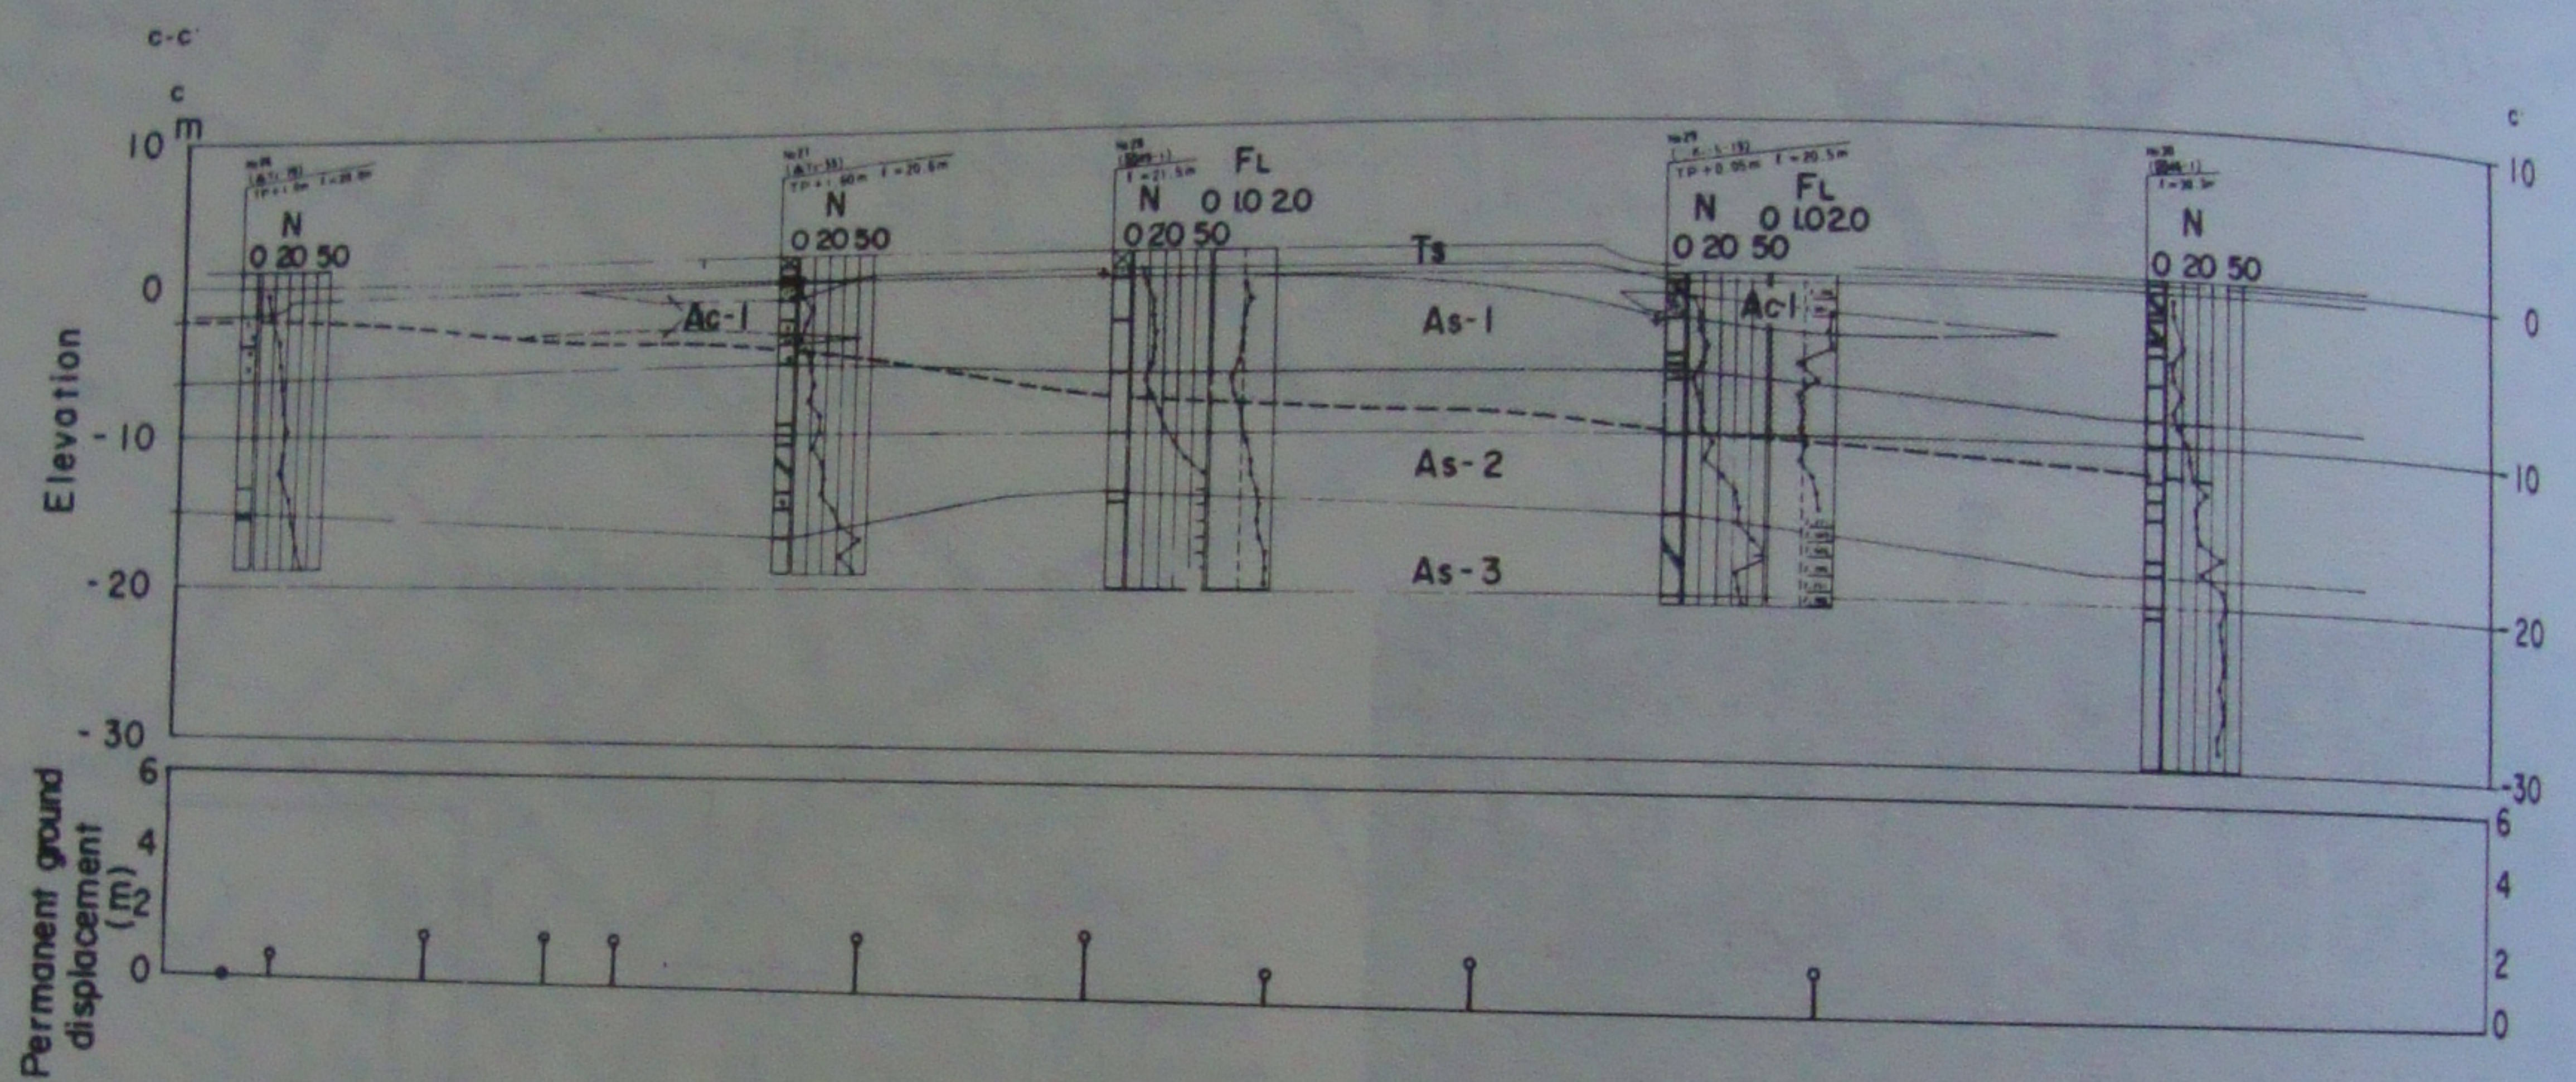
Fig. 9 Soil layer profile and estimated liquefied layer

Fig. 9 shows one example of subsurface soil condition and liquefied layers estimated by the Factor of Liquefaction Resistance F_L , along the section line C-C' shown in Fig. 6. The displacements in the figure show the horizontal component in the direction of the section line.

As mentioned previously, large permanent ground displacements toward the river occurred on both banks. From the soil profile in this area (Fig. (a)), the depth of the liquefied layer increases suddenly toward the river center and the lower boundary face of the liquefied layer is sloped. It can be assumed that the magnitude of the permanent ground displacements depends on the thickness and the inclination of the liquefied layer, and also on the topographical condition of the existing revetment.

About 300 m from the river toward Niigata Railway Station, permanent ground displacements of 1 to 2 m occurred in the direction away from the river (as shown in Fig. (b)). The ground surface in this area is flat, but the lower boundary face of the liquefied layer is estimated to be

sloped with a small gradient of 2 - 3% toward Niigata Station. For this reason, the permanent ground displacements in this area were in the direction away from the river.

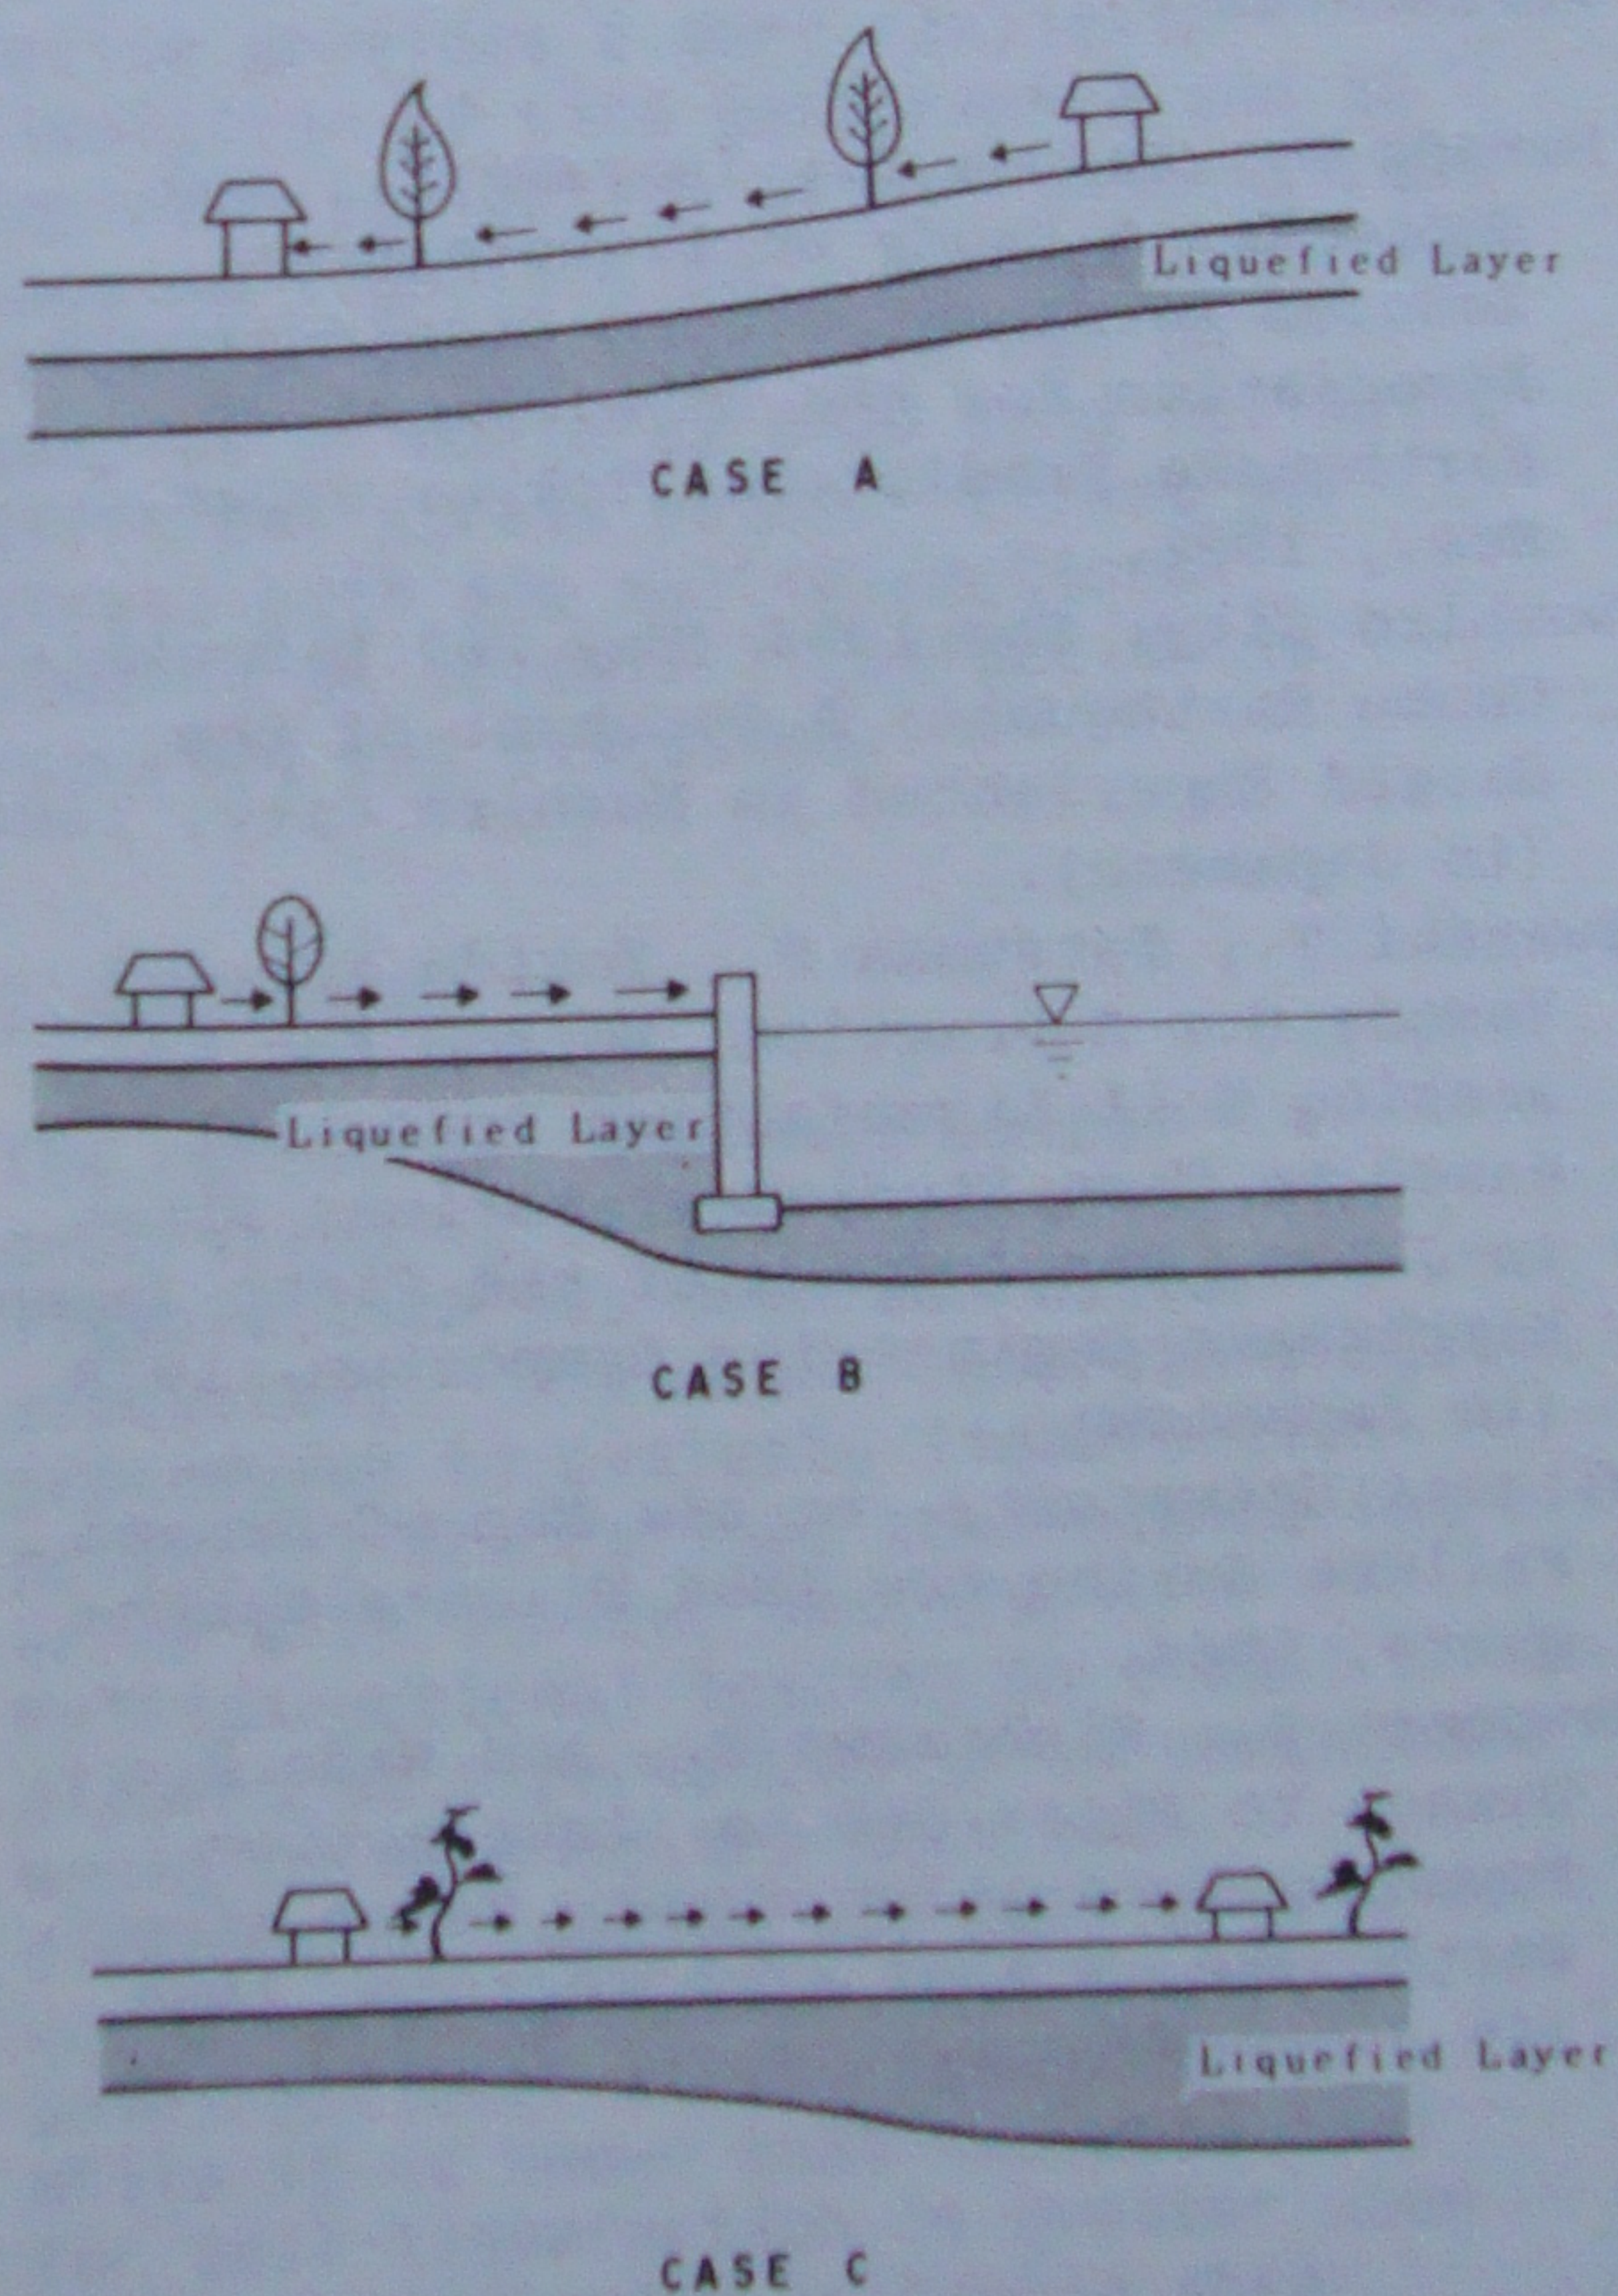
Fig. 10 Types of permanent ground displacements

The types of permanent ground displacements caused by soil liquefaction during the two earthquakes can be summarized as shown in Fig. 10. Case A depicts the type of the displacements that occurred in Noshiro City; the ground surface is slightly inclined and the liquefied layer exists along the surface. Cases B and C depict the types found in Niigata City. Case B shows that the ground surface is flat on the land but has an abrupt vertical discontinuity at revetments of the river, and the lower boundary face of the liquefied layer is inclined towards the river center. Case C was found in the area around the Niigata Railway Station, where the ground surface is almost horizontal but the lower boundary face of the liquefied layer is inclined.
