Behavior of steel frame buildings with infill brick

Sigmund A. Freeman¹

ABSTRACT

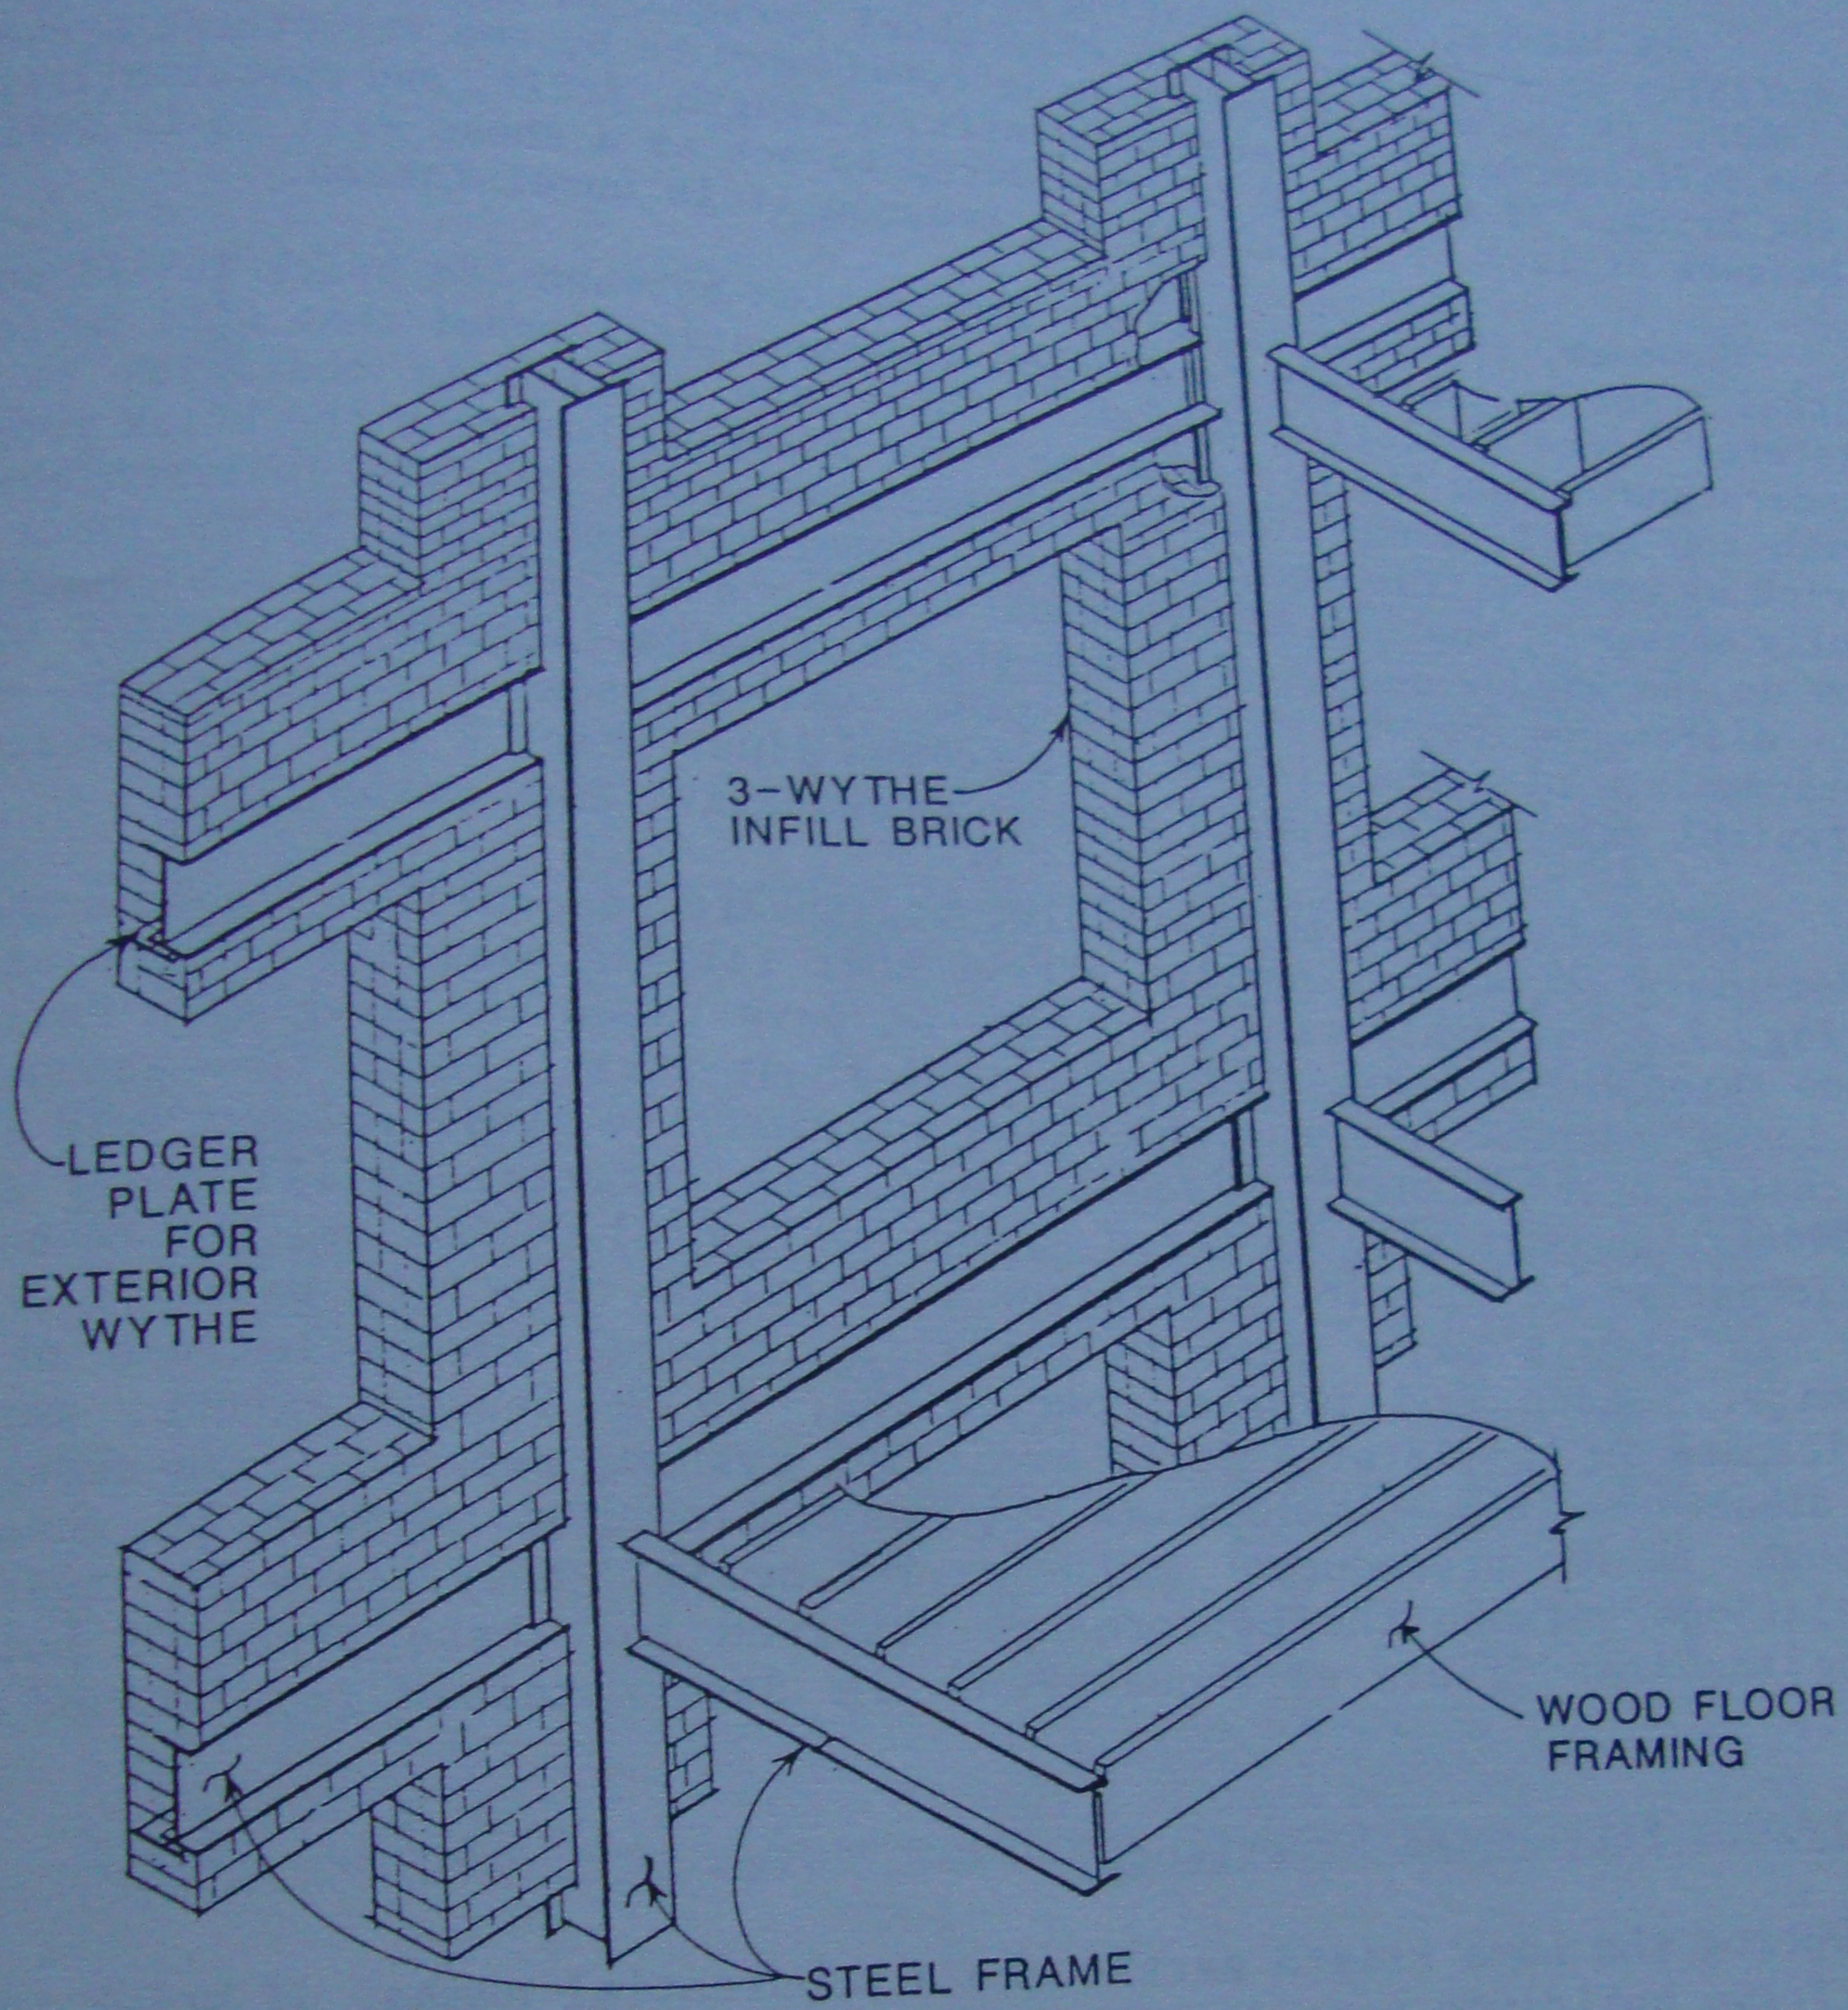
Figure 1. Schematic representation of brick infilled steel frame

The infill masonry generally consists of three wythes of brick. Two interior wythes are supported by the top flange of the beam. The exterior wythe often includes decorative terra-cotta elements and its method of support varies for different buildings. In some cases a steel ledger plate cantilevers out from the steel beams. In other cases, it is supported by the keying action of header bricks interlocked with the interior wythes. Whereas the brick is generally tightly fitted above and below by the steel beams, the details of the brick interfacing with columns on each side are not usually well known.

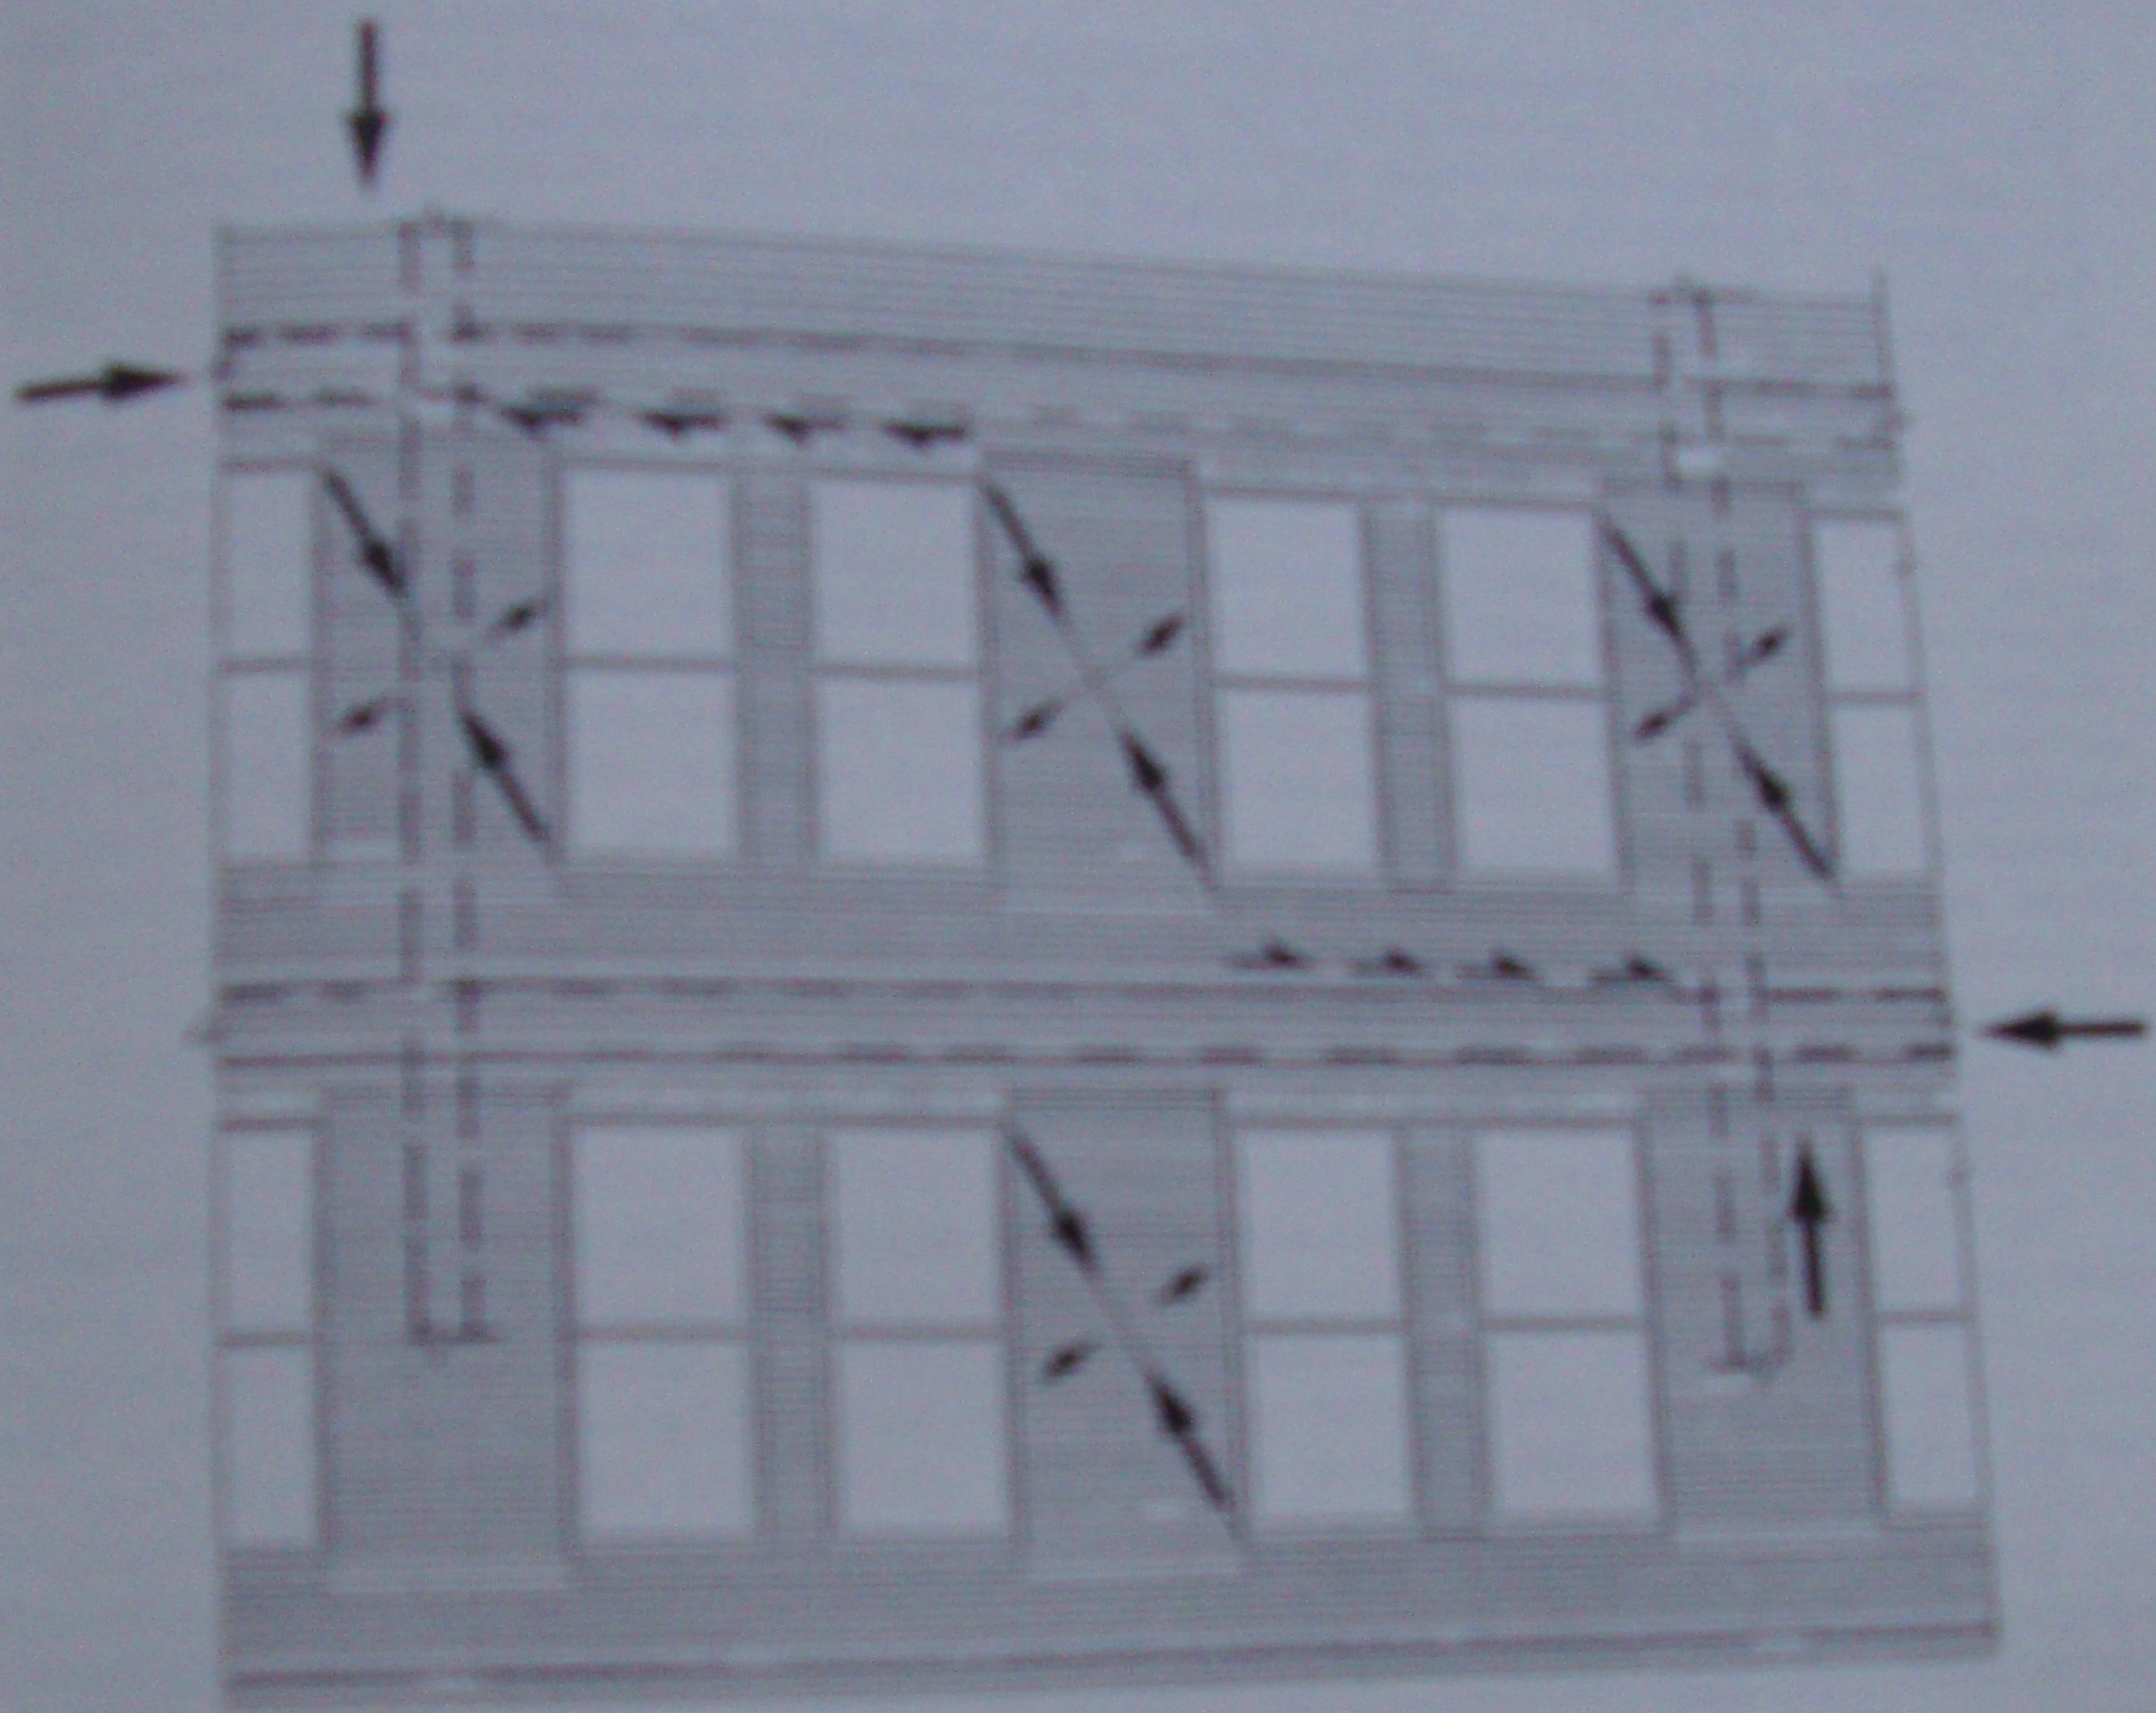
Figure 3. Partial wall elevation with representative load paths

However, if we consider the interaction between the brick infill and the steel frame we can begin to develop a mathematical model that will define the lateral force resisting system. There are still some obstacles to fully understanding how the system works. For example, how does the brick interface with the steel frame? Is there horizontal shear transfer between beam and brick by bond or friction, or is the column confined enough by the brick to be fully engaged? What are the vertical reactions at the beam-column connections? How do the window openings affect the load paths through the brick? What is the difference between a brick pier that encases a steel column and an intermediate pier that is not on a column line? Fig. 2 shows an elevation of a typical exterior wall with some representative load paths.

Until better data is available, it appears reasonable to assume that the wider piers act as compression struts that fail in diagonal tension as shown in Fig. 2. For evaluation purposes, we have taken the area of a horizontal plane through the piers as an effective shear area. It is then assumed that the loads transfer to the steel frame and that the steel columns work axially to resist overturning. In addition to the exterior infill frame system, consideration must also be given to the horizontal diaphragms and to possible participation of interior partitions. If hollow clay tile partitions exist, they can play a major part in resisting lateral forces because of their rigidity. Lath and plaster partitions, to a lesser extent, can also participate in the lateral force resisting system; especially in cases where the diaphragms are flexible (e.g., wood flooring instead of concrete). Although these procedures may appear crude, they provide reasonable correlations between the performance observed for these types of buildings during the Loma Prieta earthquake and the data obtained from ground motion records.

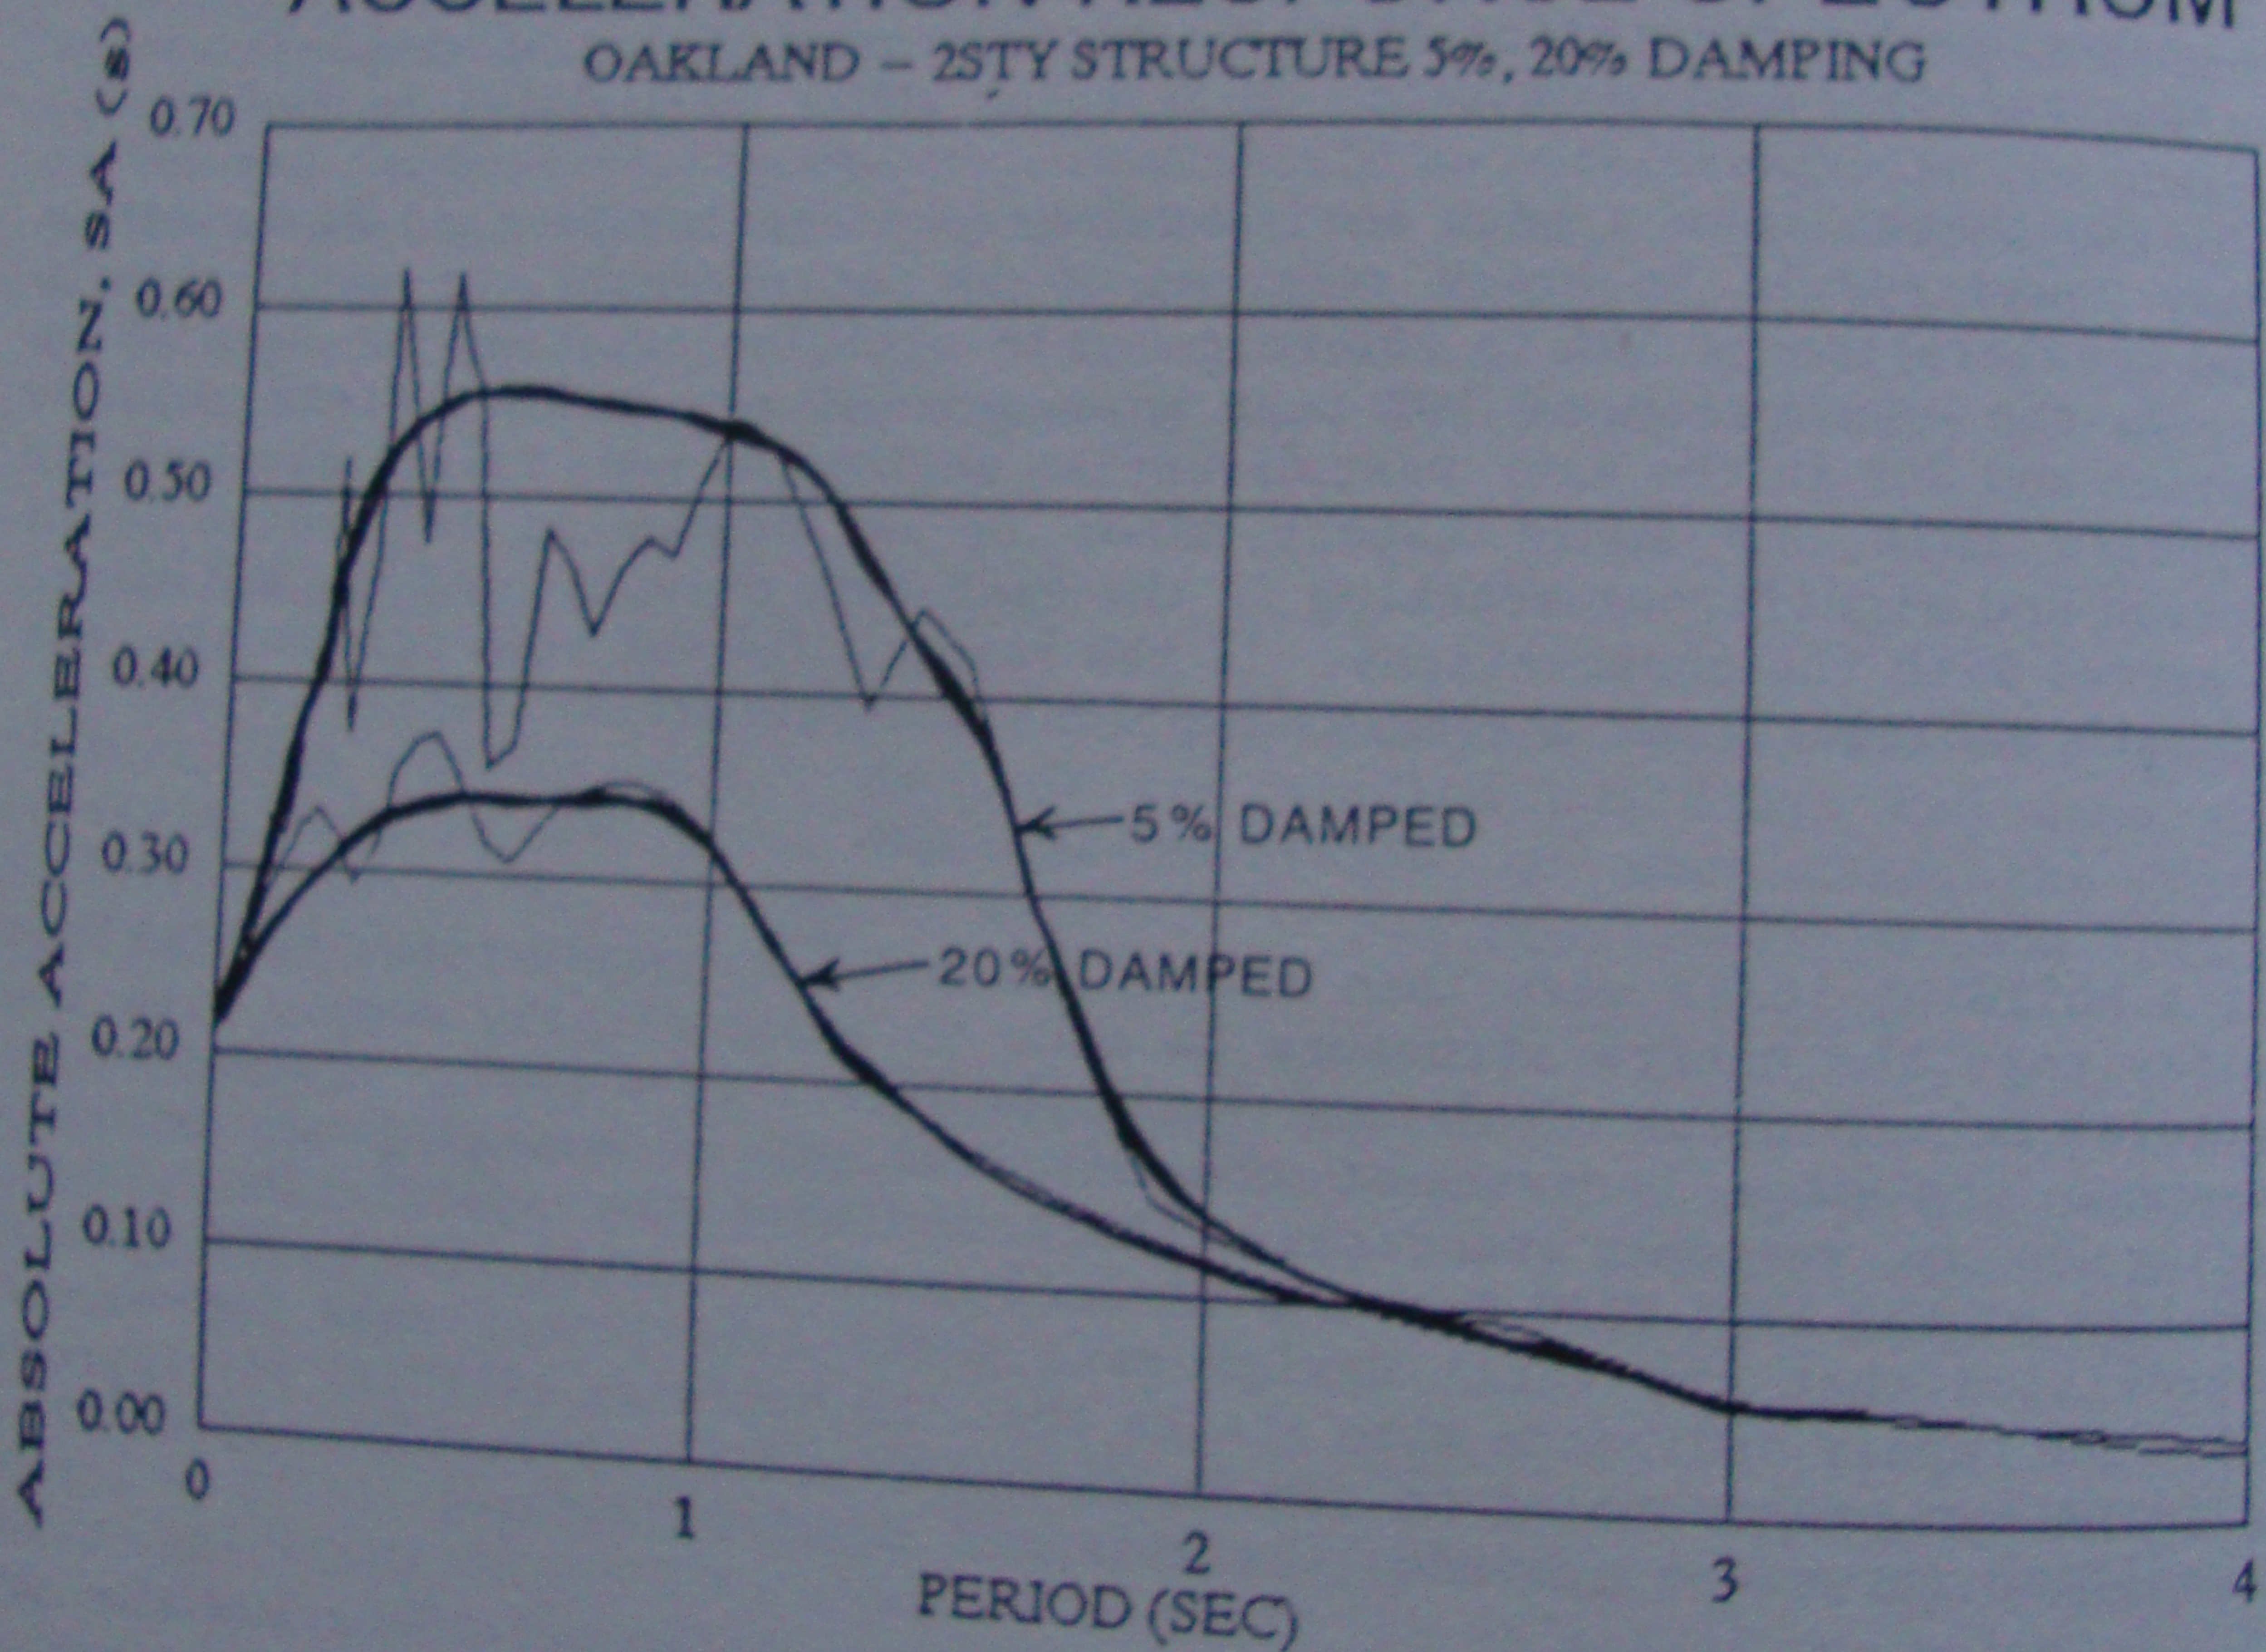
Figure 3. Smoothed response spectra, Oakland, October 17, 1989

recordings were fairly broad in shape indicating a significant ground motion amplification in the 0.5 to 1.0 period range (Fig. 3).

A_G = peak ground acceleration (acceleration at zero period of response spectra) obtained from ratio of S_A value above to S_A value in Fig. 3

This indicates that a peak horizontal ground acceleration of 1% or 2% of gravity could result in brick stresses of 12 psi; however, it would take a ground acceleration of 13% to 20% to reach an ultimate cracking strength of 75 psi. On the assumption of 10% peak ground acceleration in the north-south direction and 20% in the east-west direction during the Loma Prieta earthquake, it appears that one would expect minor or no damage in the north-south direction and significant cracking in the east-west direction of the building. This agrees with the observations. If the results did not seem reasonable, one would take a closer look at the assumptions and try again.
