Impact of the 1989 Loma Prieta earthquake from a Canadian perspective

D.T. Lau^I, A.M. Jablonski^{II}, K.T. Law^I, J.-R. Pierre^{III}, and J.H.K. Tang^{IV}

ABSTRACT

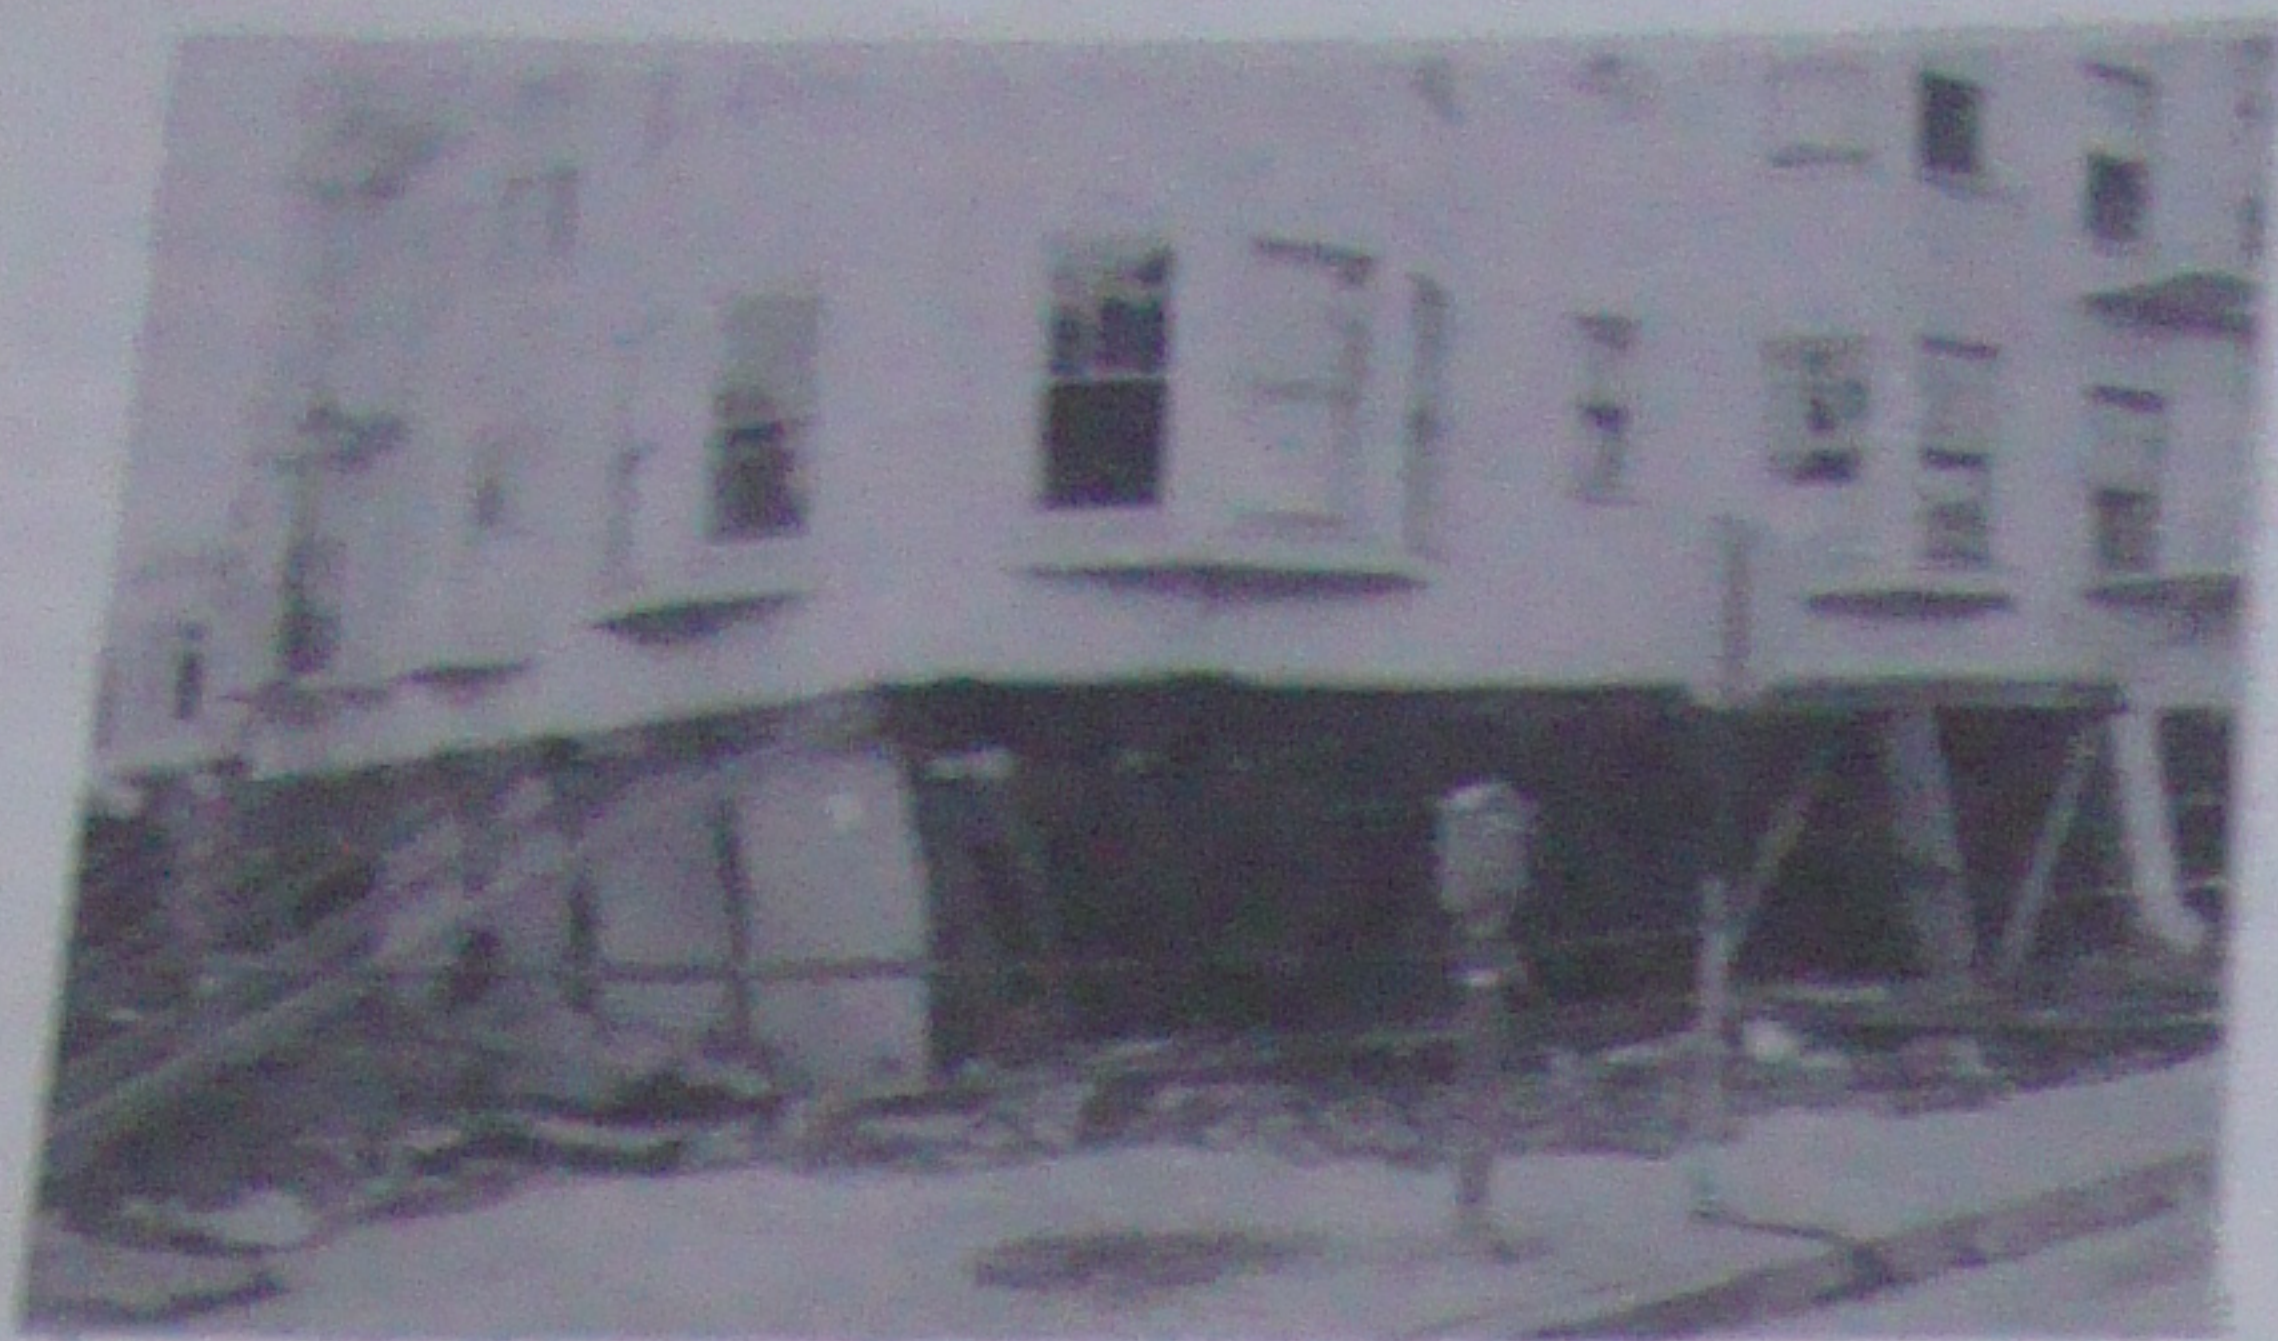
(35.6 cm) high), but may reach a height of one full storey in modern wood villas. Improper bracing and inadequate connections to the foundation and the upper-floor framing system caused many older buildings displaced from their foundations. In general, majority of wood houses performed well except those situated on large ground fissures. Outside the epicentral region, extensive structural damage occurred in the Marina District in San Francisco. The highest recorded acceleration nearby, 0.21 g, was recorded in Presidio on rock, a few blocks northwest from the Marina District. The garage floor of the typical townhouses and apartment buildings in the area behaved like a "soft storey" usually without bracing, or in some cases with only limited lateral resistance provided by sheathed walls (horizontal boards nailed to posts) (Fig.3).

Fig.3 Soft storey effect in Marina District

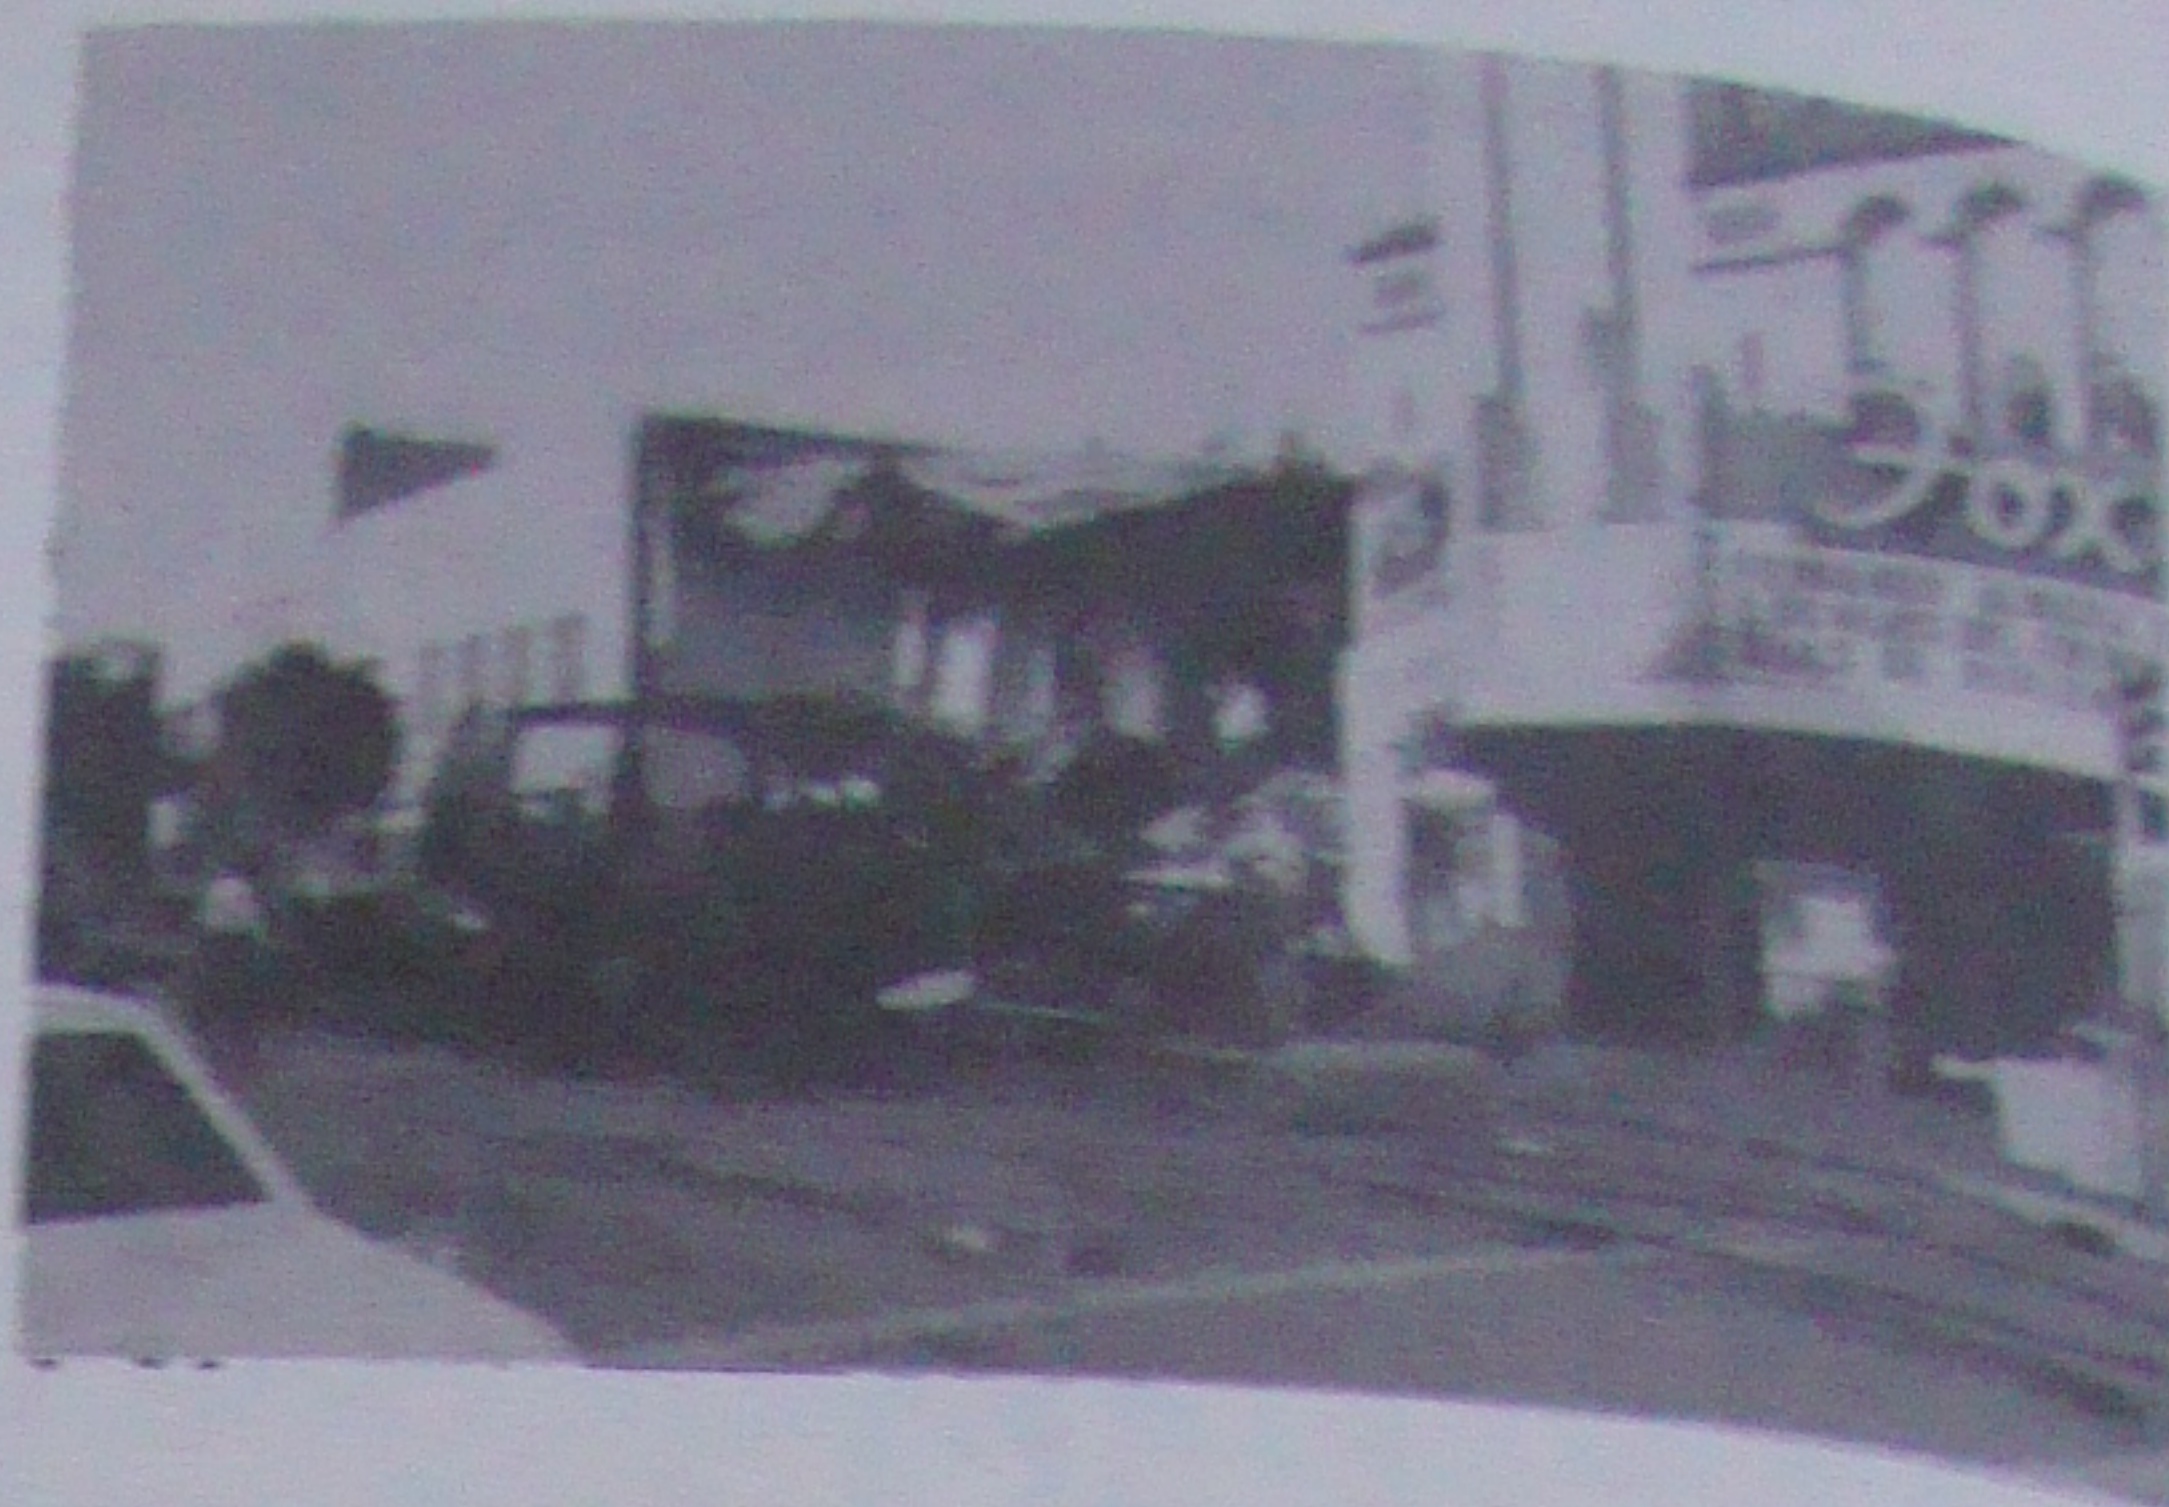
Many unreinforced masonry buildings (especially older ones) suffered severe damage and in some instances complete collapse. Examples of damage include out-of-plane collapses and large in-plane distress of the masonry walls, and brick veneer, bearing walls, parapets, and in-fill masonry walls. Severe damage to masonry buildings were reported in Santa Cruz (the Pacific Garden Mall), Los Gatos and Watsonville (Fig.4). Upgraded old stone masonry buildings at Stanford University campus in Palo Alto performed well.

Fig.4 Collapsed unreinforced masonry building in Watsonville

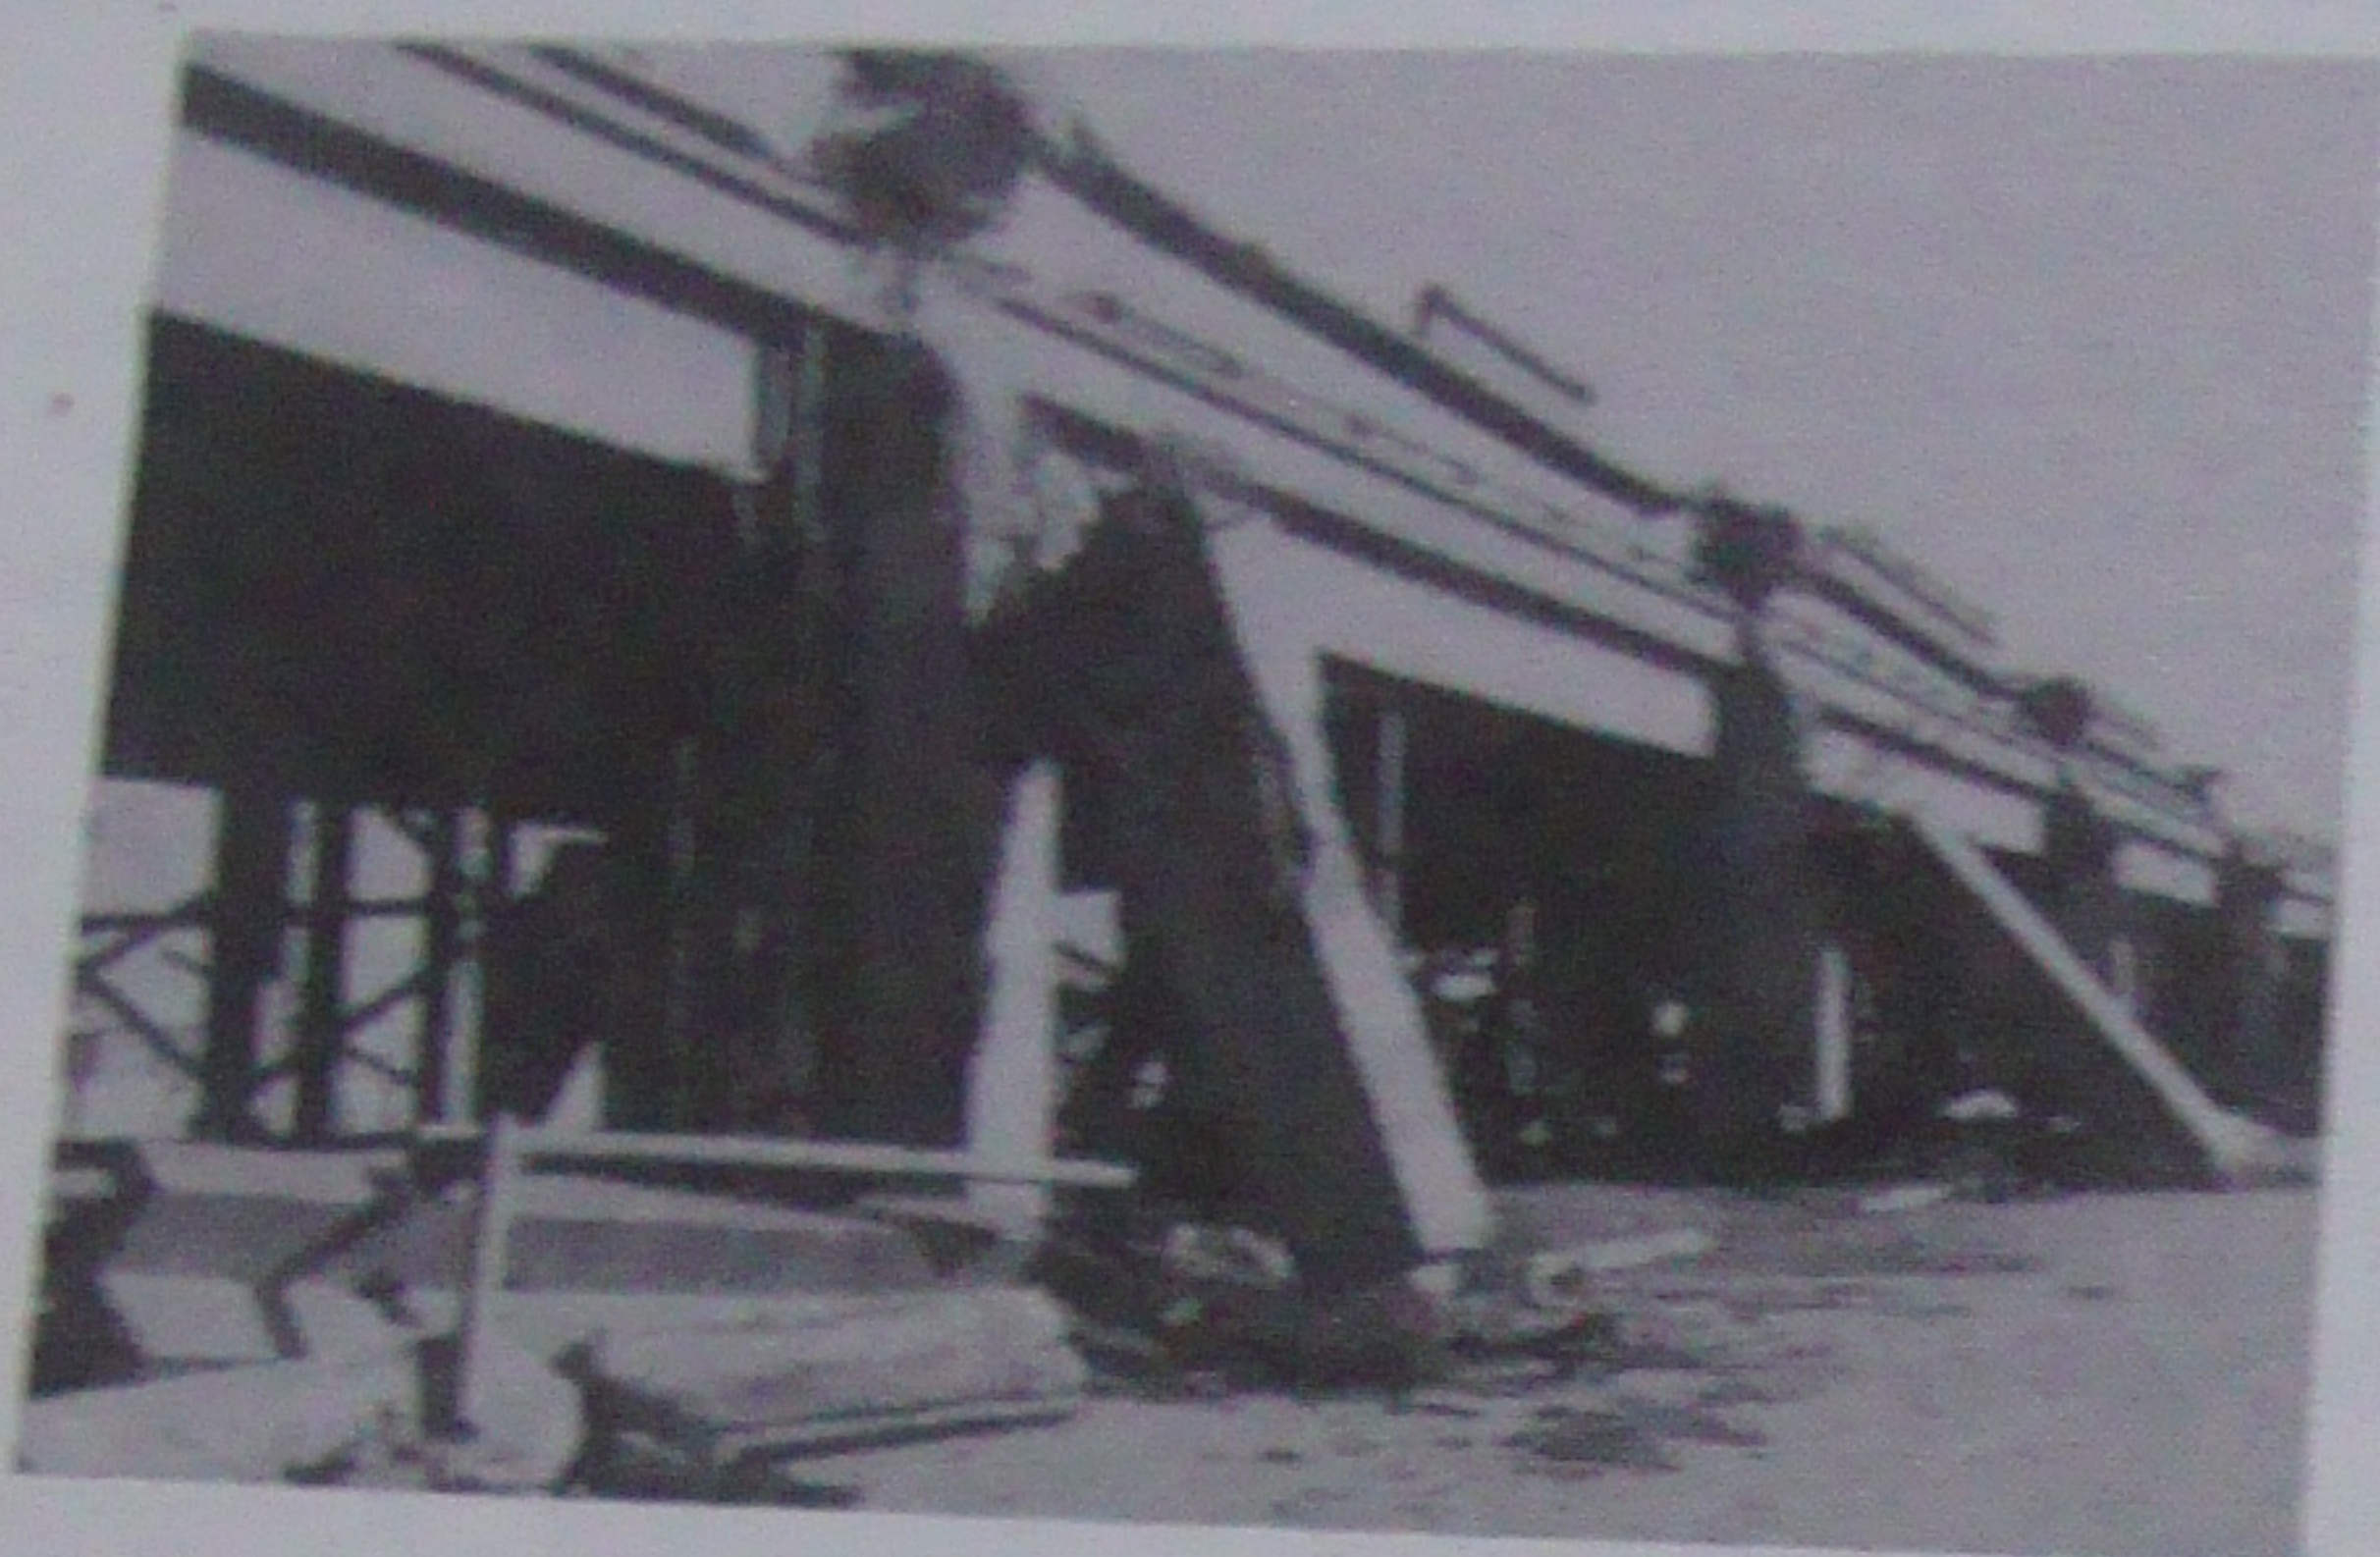
The collapsed freeway was located a short distance south of the east side entrance intersection of the San Francisco-Oakland Bay Bridge, approximately 100 km from the epicenter. The double deck freeway was designed in 1954 and constructed according to the design standards applicable at the time. There were two common types of design layouts, different mainly in the placements of pin connections in the upper frame structure. For most of the collapsed bents along the 1.2 km failed sections shown in Fig.5, the columns failed at the hinge joint regions due to shear force from the lateral load induced by the ground motion. Other details are reported by Jablonski et al. (1990) and others.

Fig.5 Collapsed Nimitz viaduct of I-880

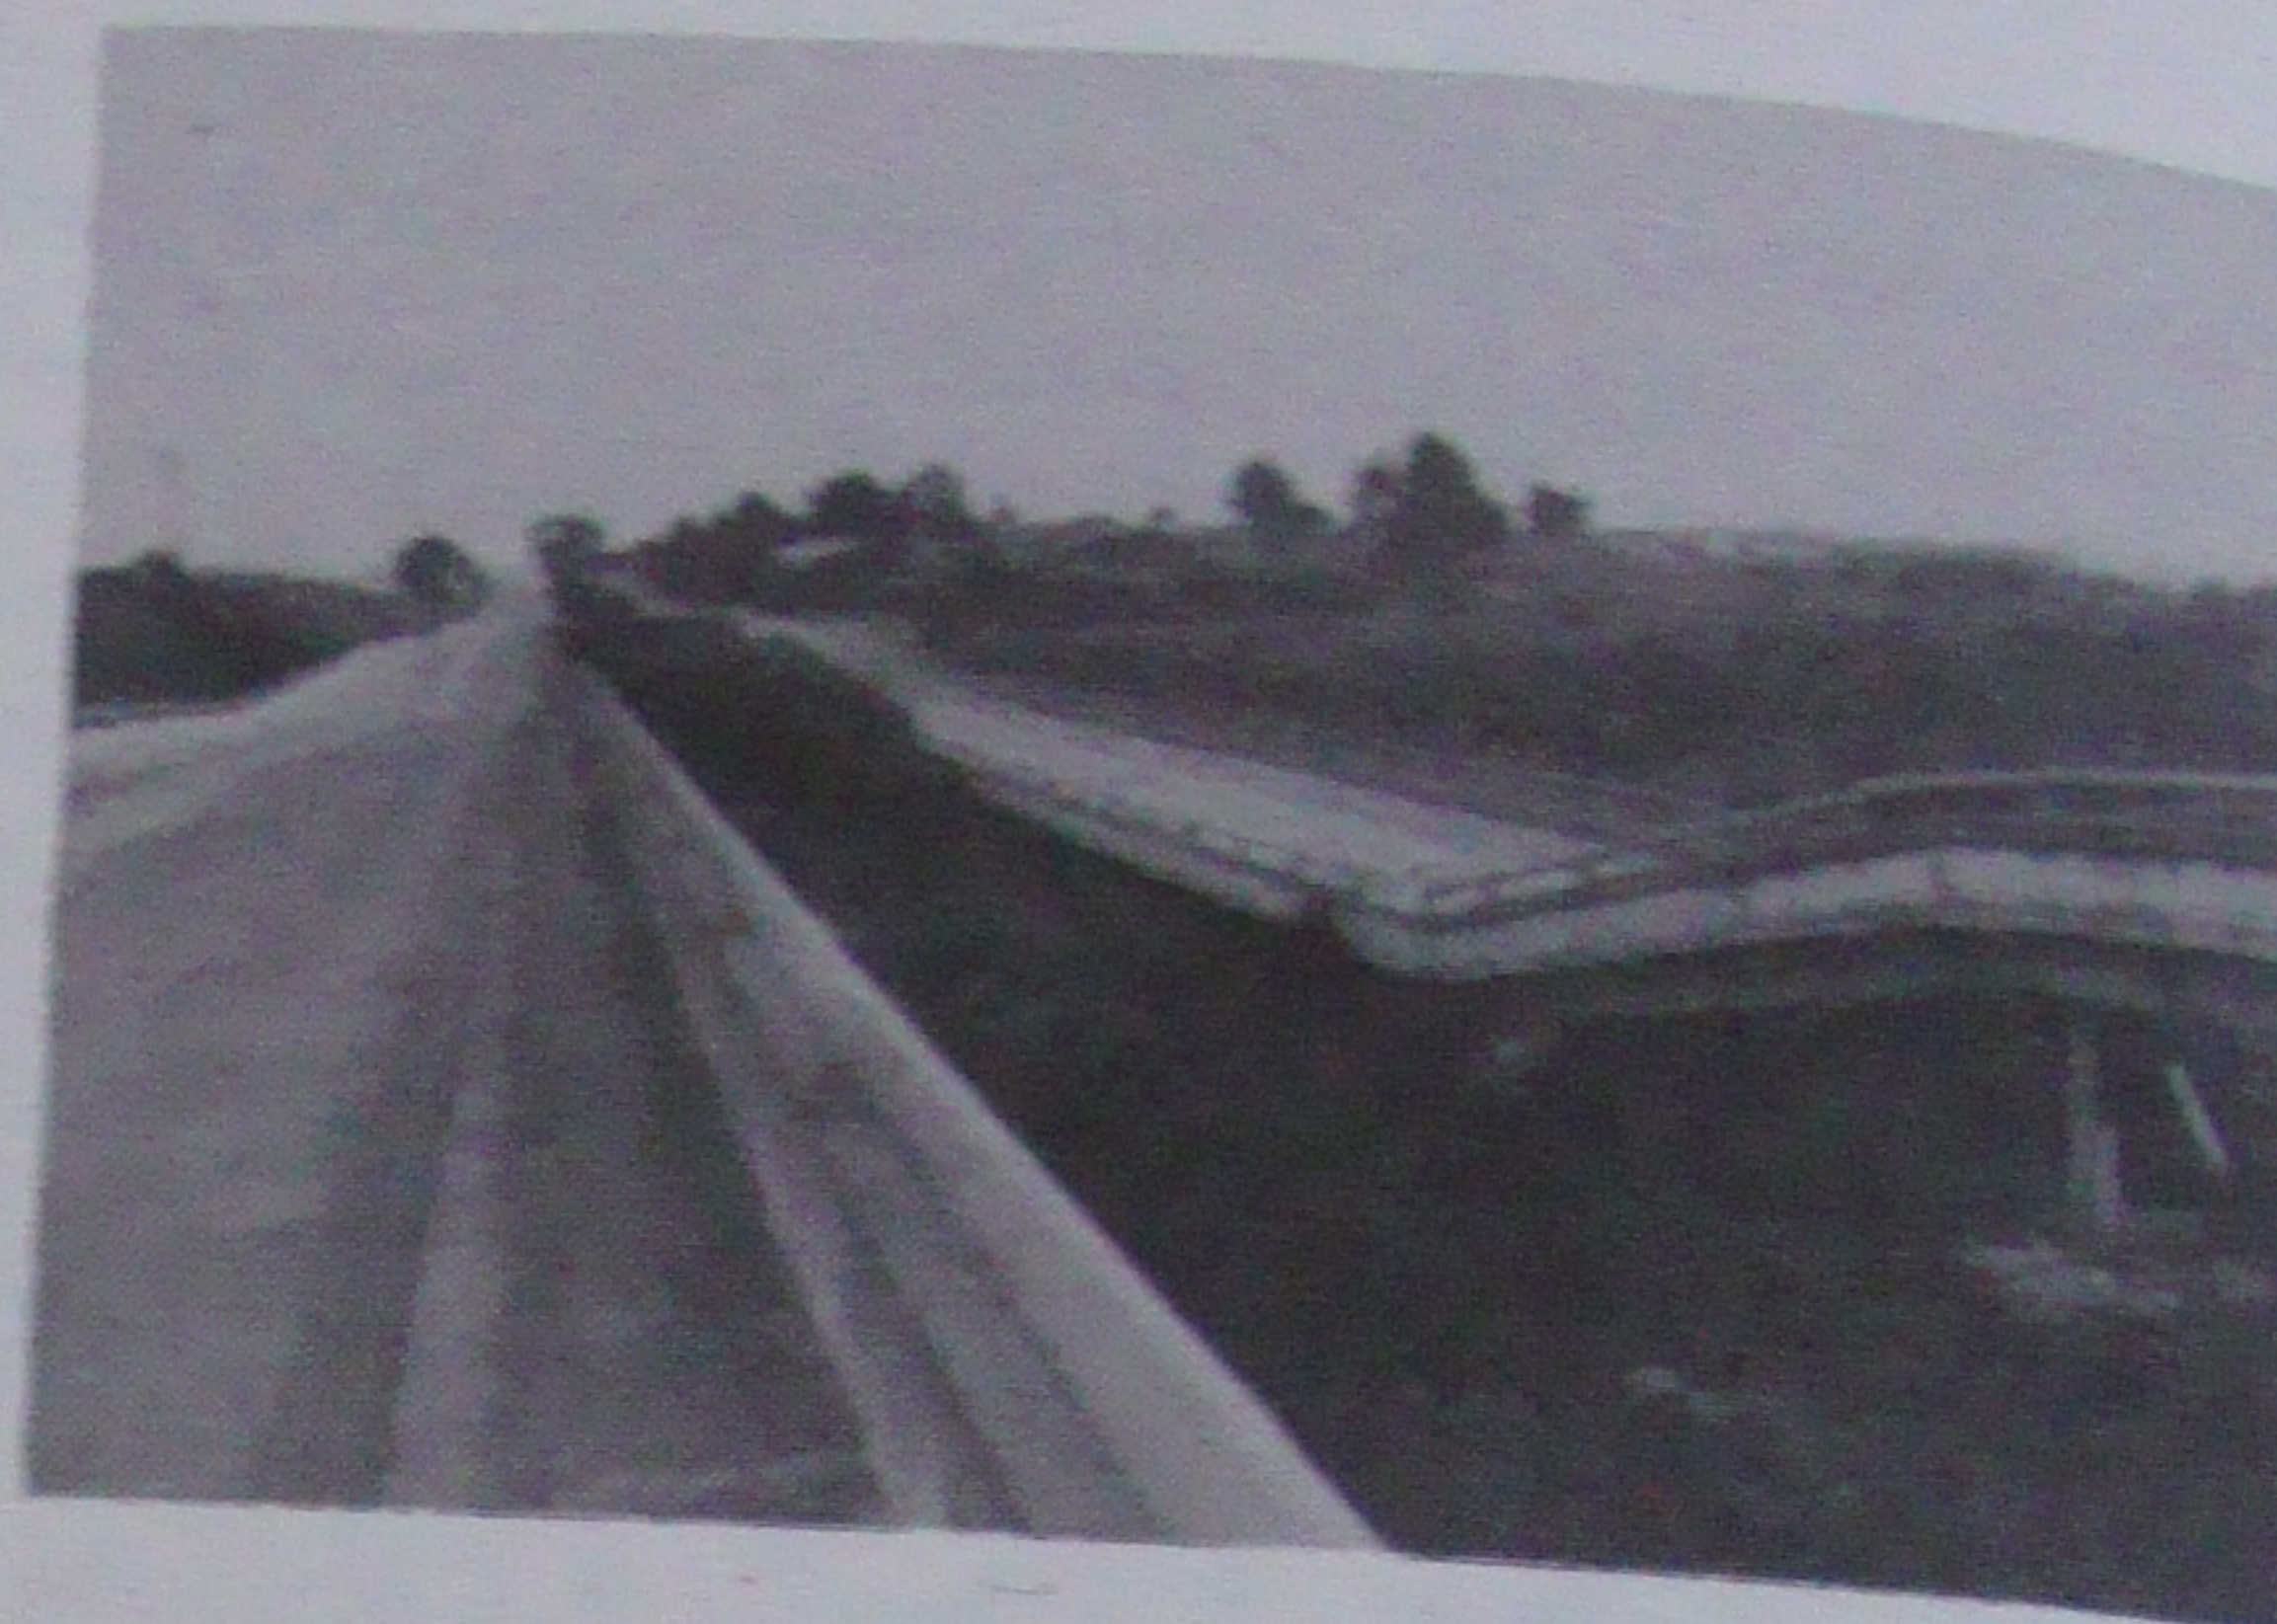
The Struve Slough Bridge is actually two bridges for the north and south bound traffic. Due to large horizontal displacement associated with laterally shifted old river bed, some columns were sheared off and displaced from the external bridge girders as shown in Fig.6. The southern deck dropped about 30 cm down and many columns punched through it. The northern deck columns barely withstood the earthquake.

Fig.6 Damaged Struve Slough Bridge near Watsonville

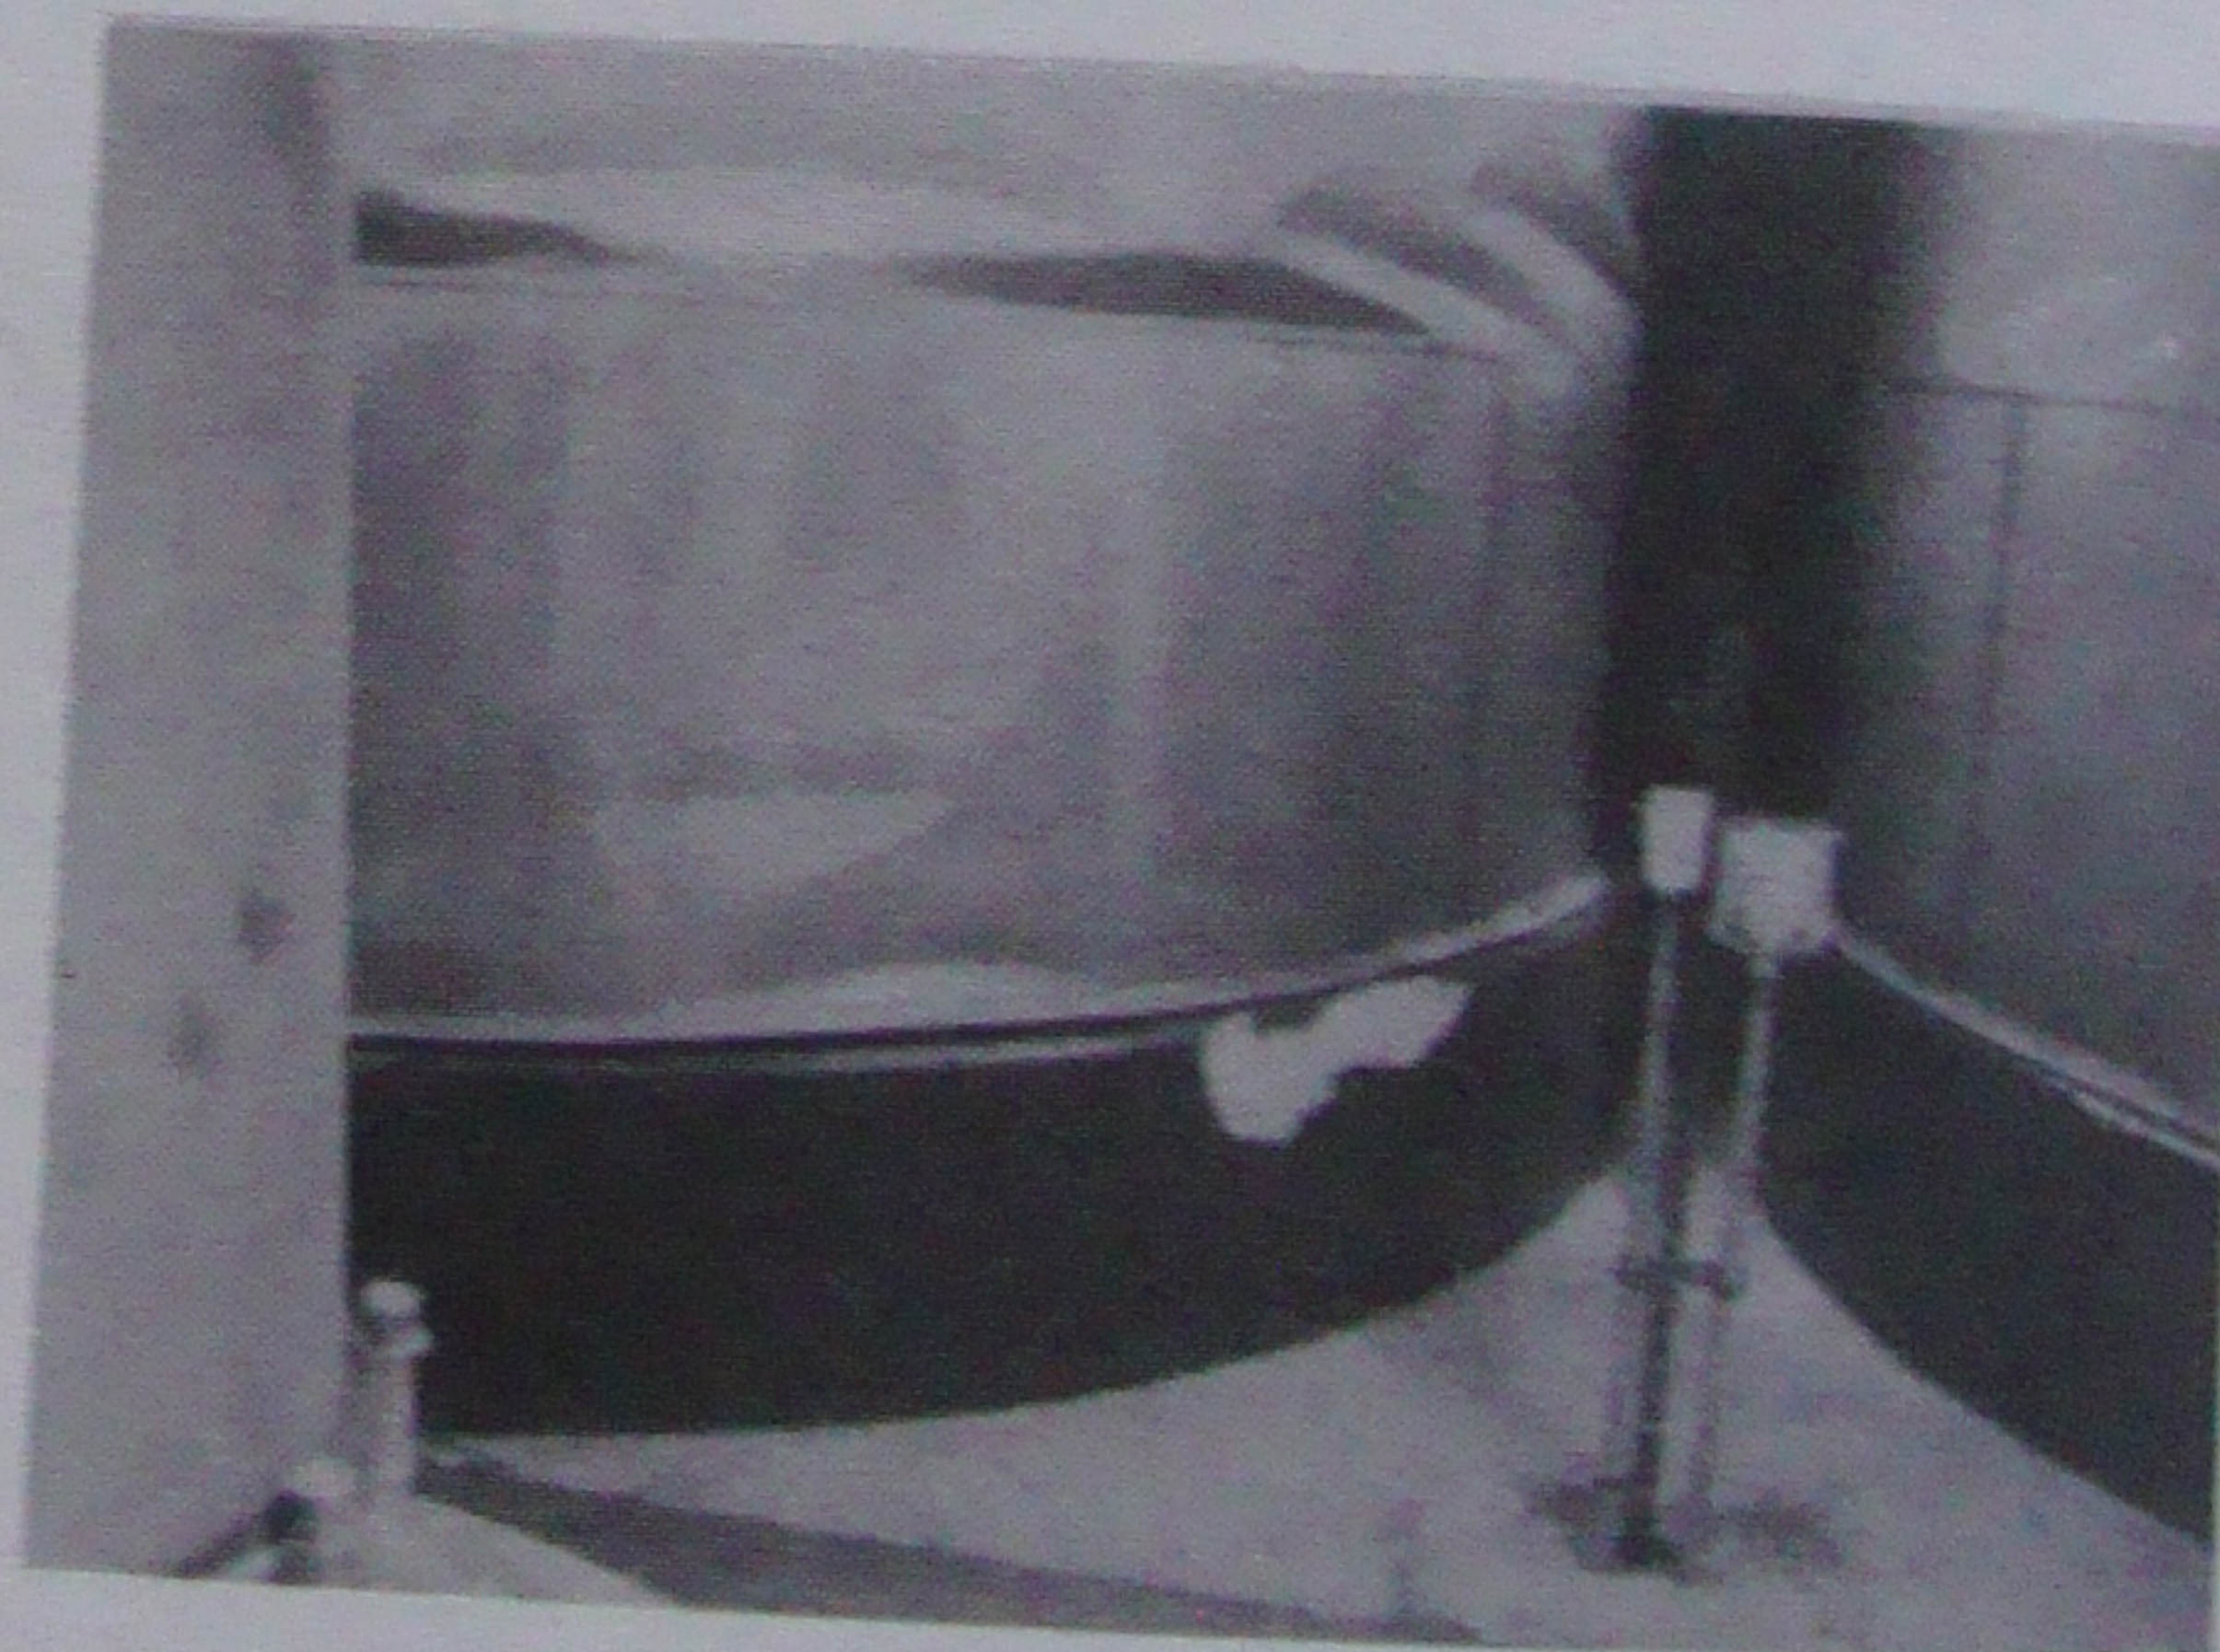
Many thin-walled, stainless steel wine storage tanks in a winery facility, located approximately 20 km east of the epicenter, suffered earthquake damage. The severity of the damage depended on the liquid content level at the time of the earthquake. In general, empty tanks suffered little or no damage. In other cases, the anchored bolts of many tanks were pulled off the concrete pad of the foundation (Fig.7) as the tanks rocked in response to the sloshing liquid during the strong ground motions. Following the failure of the anchorage system, the high compressive axial stress from the rocking motion of the tanks buckled the tank shells.

At least two 25,000-gallon anchored, stainless steel fermentation tanks suffered the commonly known "elephant foot" type of buckling, of which the characteristic is that the buckling is generally located just above the tank base and spreads around the entire or most of the circumference. Nearby, several 19,000-gallon tanks suffered the diamond-shaped type of buckling shown in Fig.8.

Fig.8 Buckling failure of tank
