# Observation of structural pounding damage from 1989 Loma Prieta earthquake

K. Kasai<sup>I</sup> and B.F. Maison<sup>II</sup>

The survey results on pounding incidents during 1989 Loma Prieta earthquake are summarized. They include the distribution of pounding damage in the specific areas, types of pounding damage, and examples for pounding damage involving major multi-story buildings.

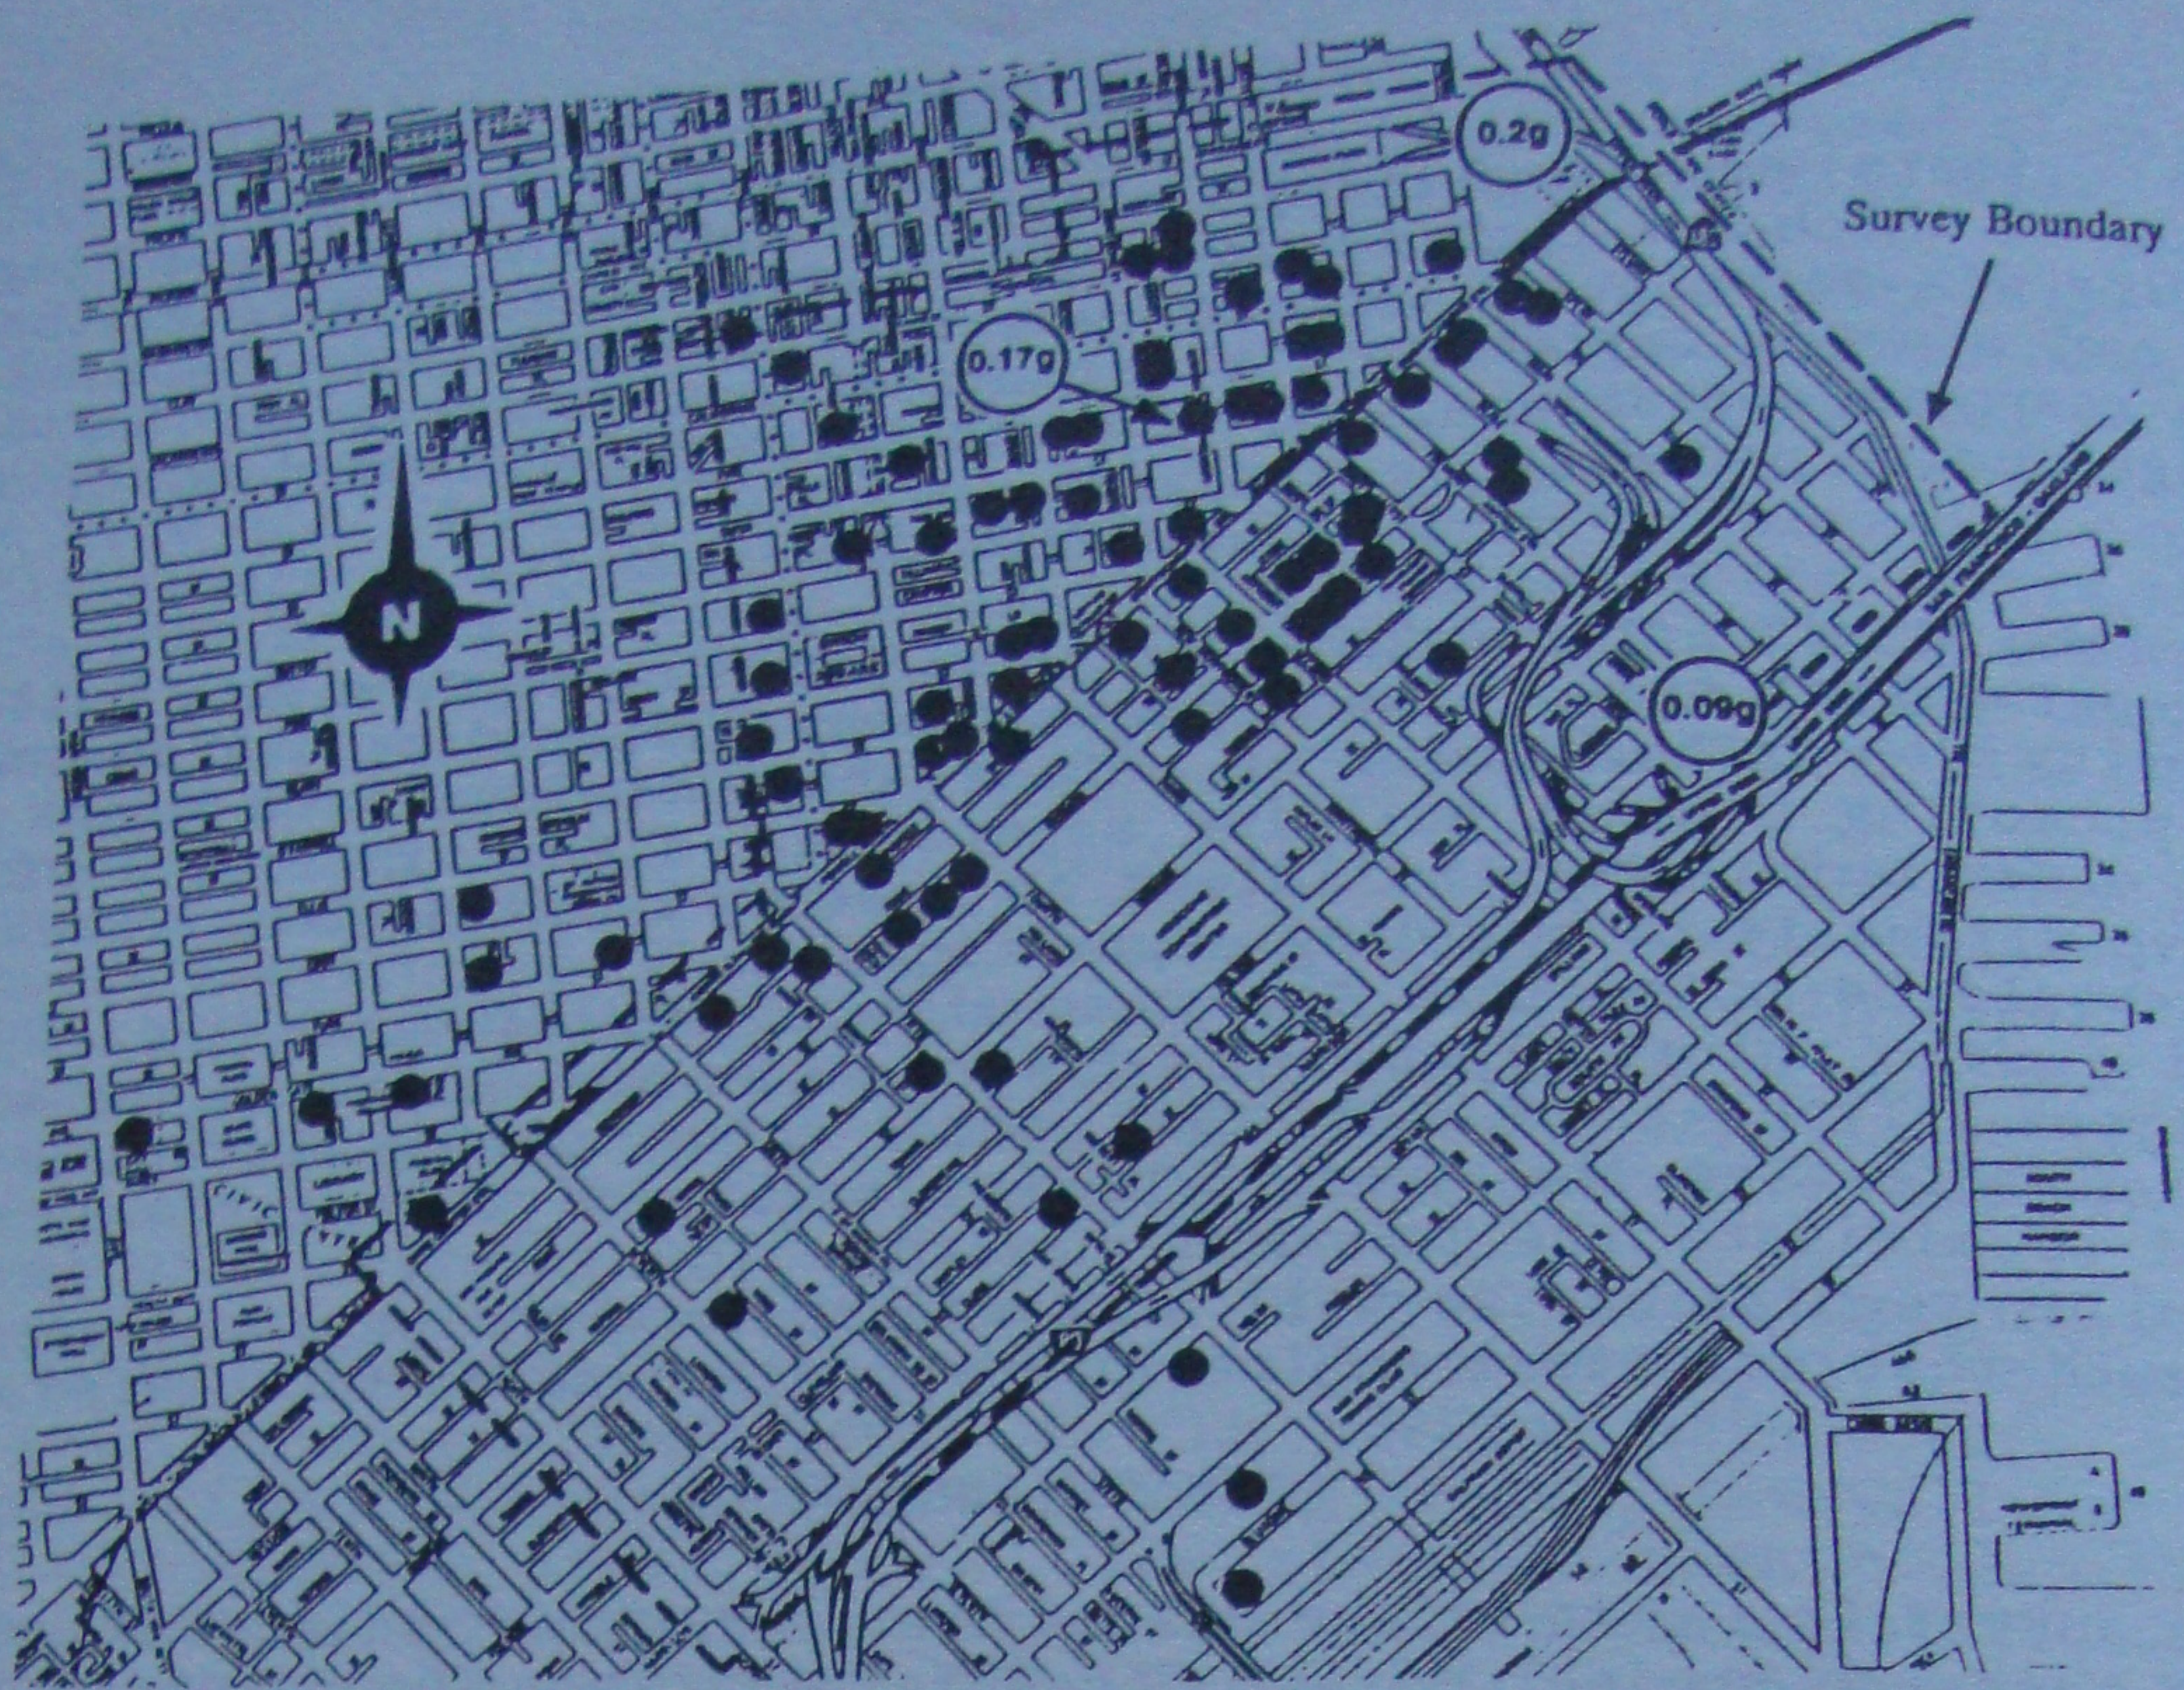
**San Francisco Financial District and South-of-Market Area.** - The writers conducted a block-by-block survey of this area. Fig. 1 shows the concentrated study area as specified by the dashed lines, and incidences of pounding are indicated by solid dots. Multi-story office buildings are the typical structures in this area. Heights typically range from 2 to over 20 stories. The area has a mix of older masonry buildings and modern high-rise buildings of concrete and steel construction.

North of Market street, pounding damage is concentrated near the eastern edge of the area associated with loose soil fill where liquefaction was reported. This area was filled in the late 19th century and recorded large ground deformations and soil liquefaction in the 1906 San Francisco earthquake. South of Market, pounding damage is widespread and somewhat concentrated at: (1) south of Mission street between 4th and 7th Streets including the area that was filled in the late 19th century which recorded large ground deformations and soil liquefaction during the 1906 San Francisco earthquake; and, (2) south of Market between 1st and 3rd Streets, which is near the same shore line.

Fig. 1 Distribution of pounding damage in San Francisco Financial District and South-of-Market area.

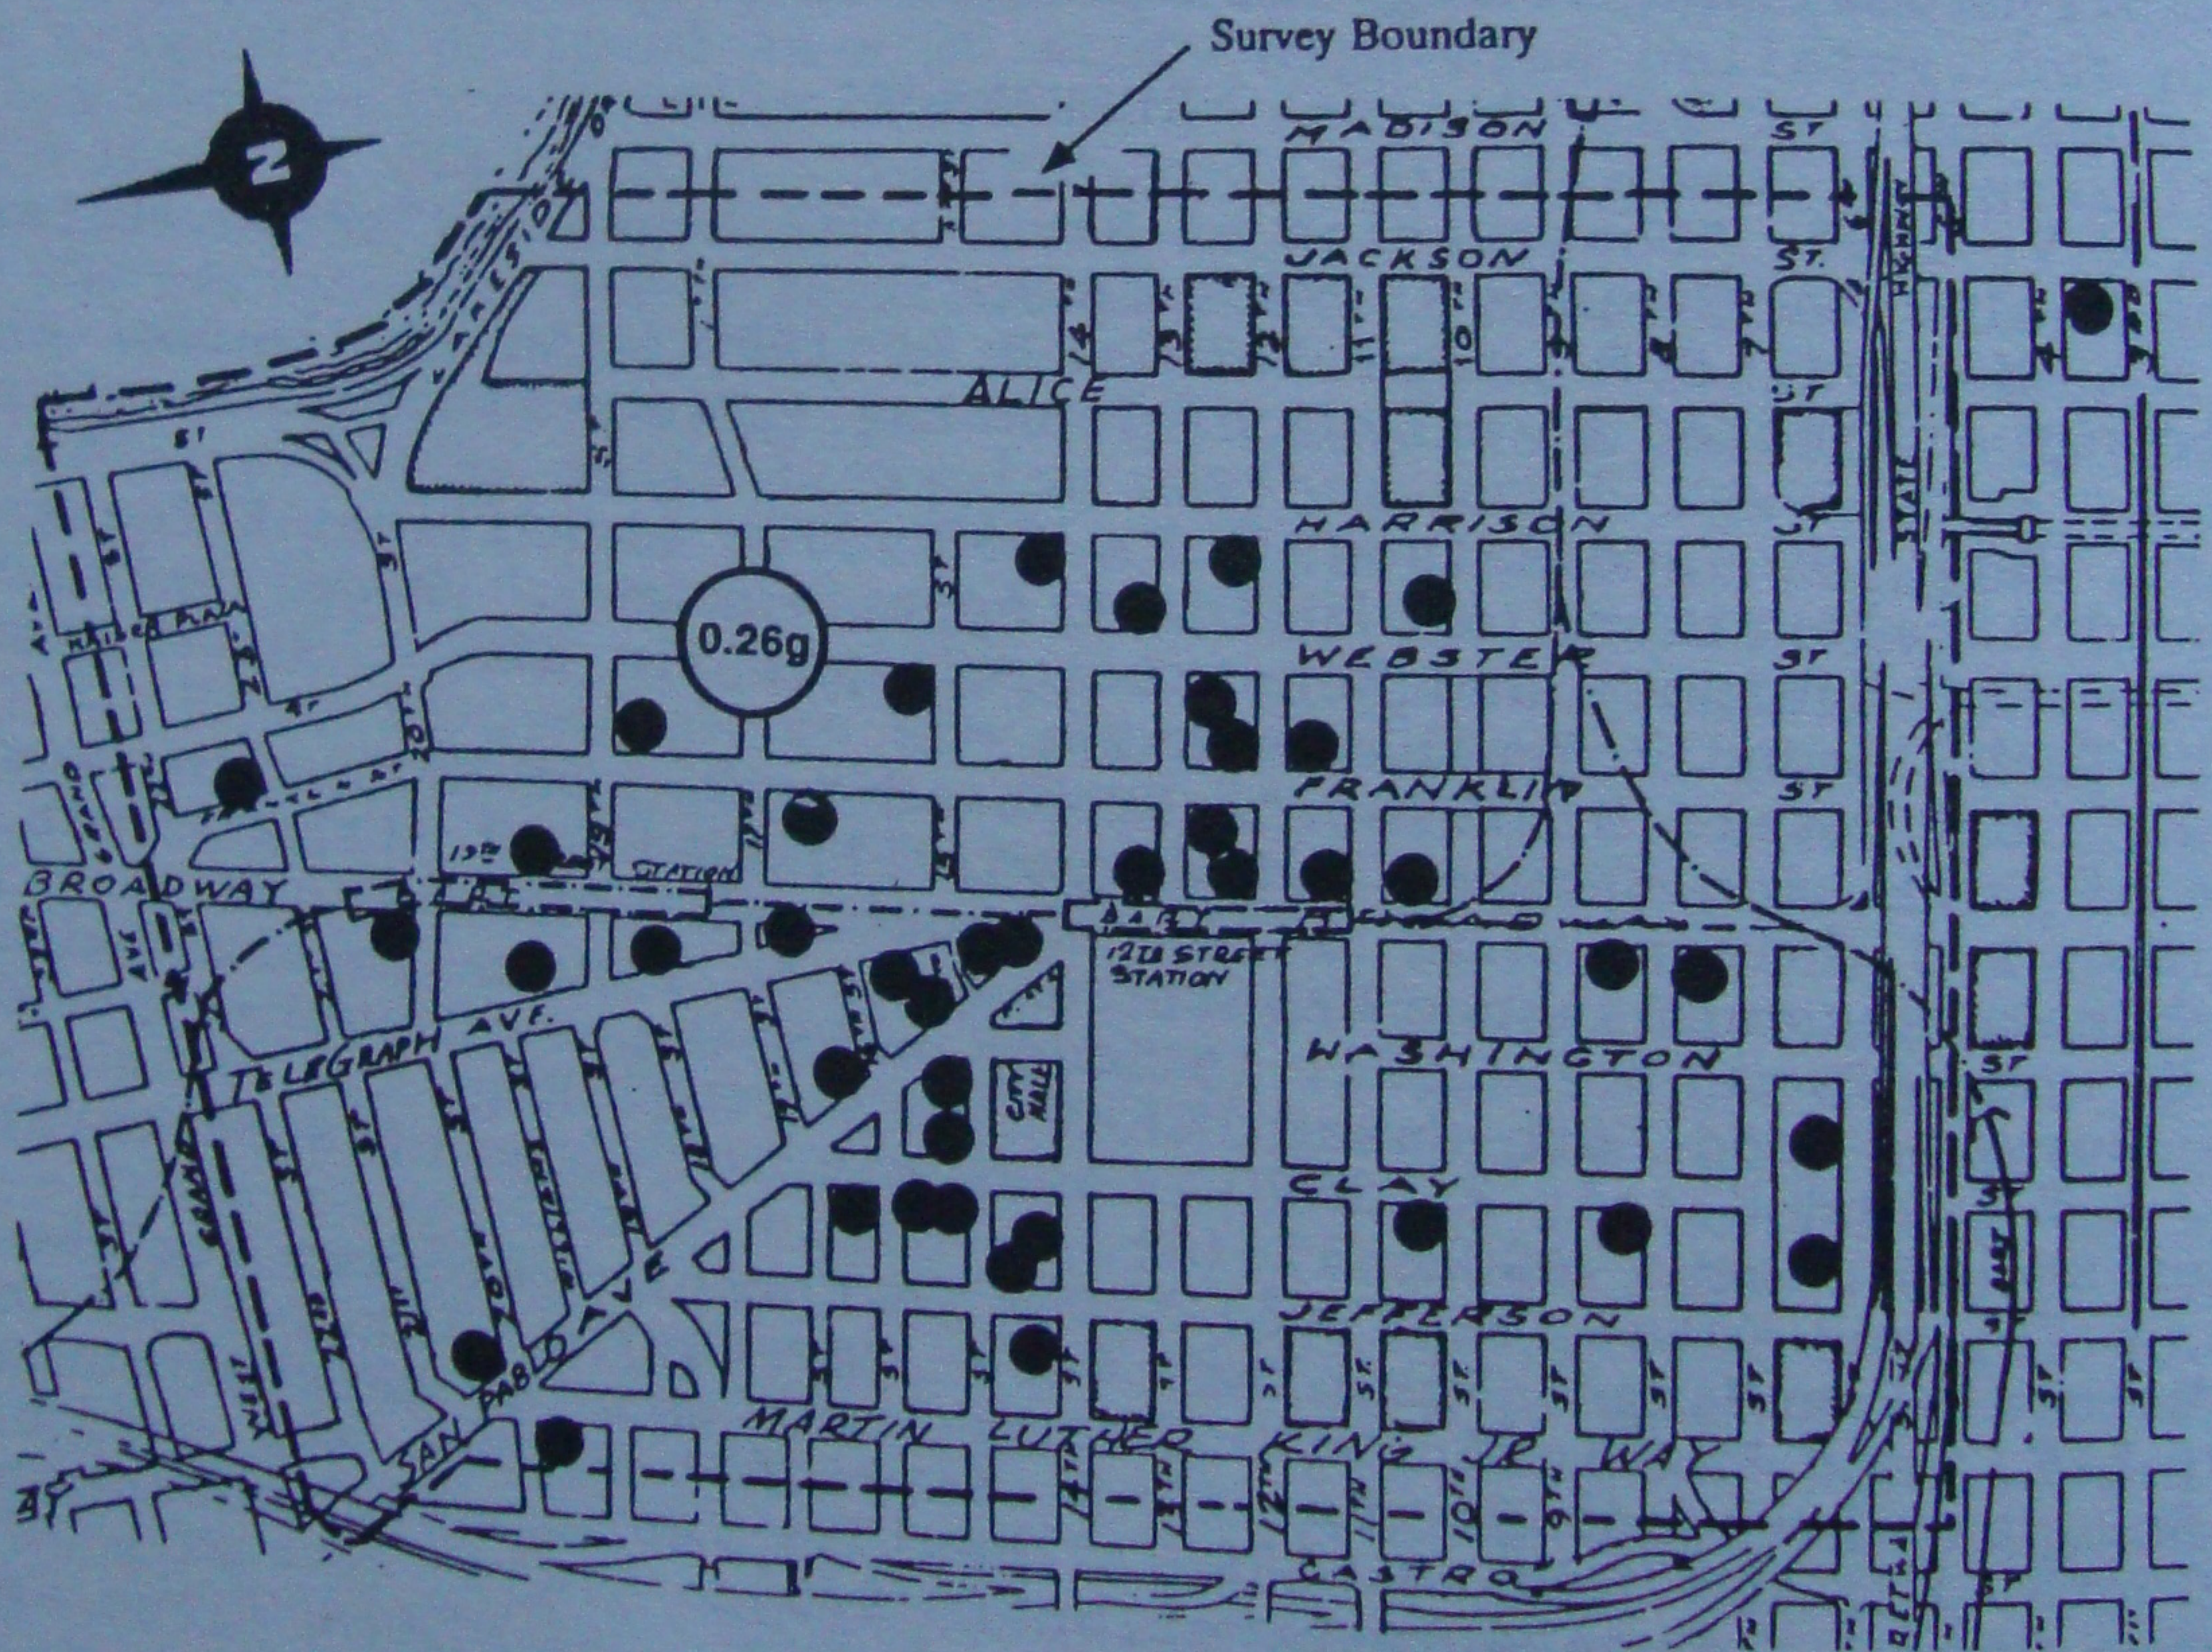
**Oakland City Center:** The writers also conducted a block-by-block survey of this area. The survey area is shown by the dashed line in Fig. 2, and occurrences of pounding are shown by solid dots. The area has a variety of

This survey area, which is smaller and having less building density than the San Francisco Financial District, still showed a high occurrence of pounding damage probably because of high ground accelerations in this area. Fig. 2 shows that the pounding damage is concentrated in a densely built area on Broadway and San Pablo Avenues. Significant pounding was present in older masonry as well as wooden buildings.

Fig. 2 Distribution of pounding damage in Oakland City Center.

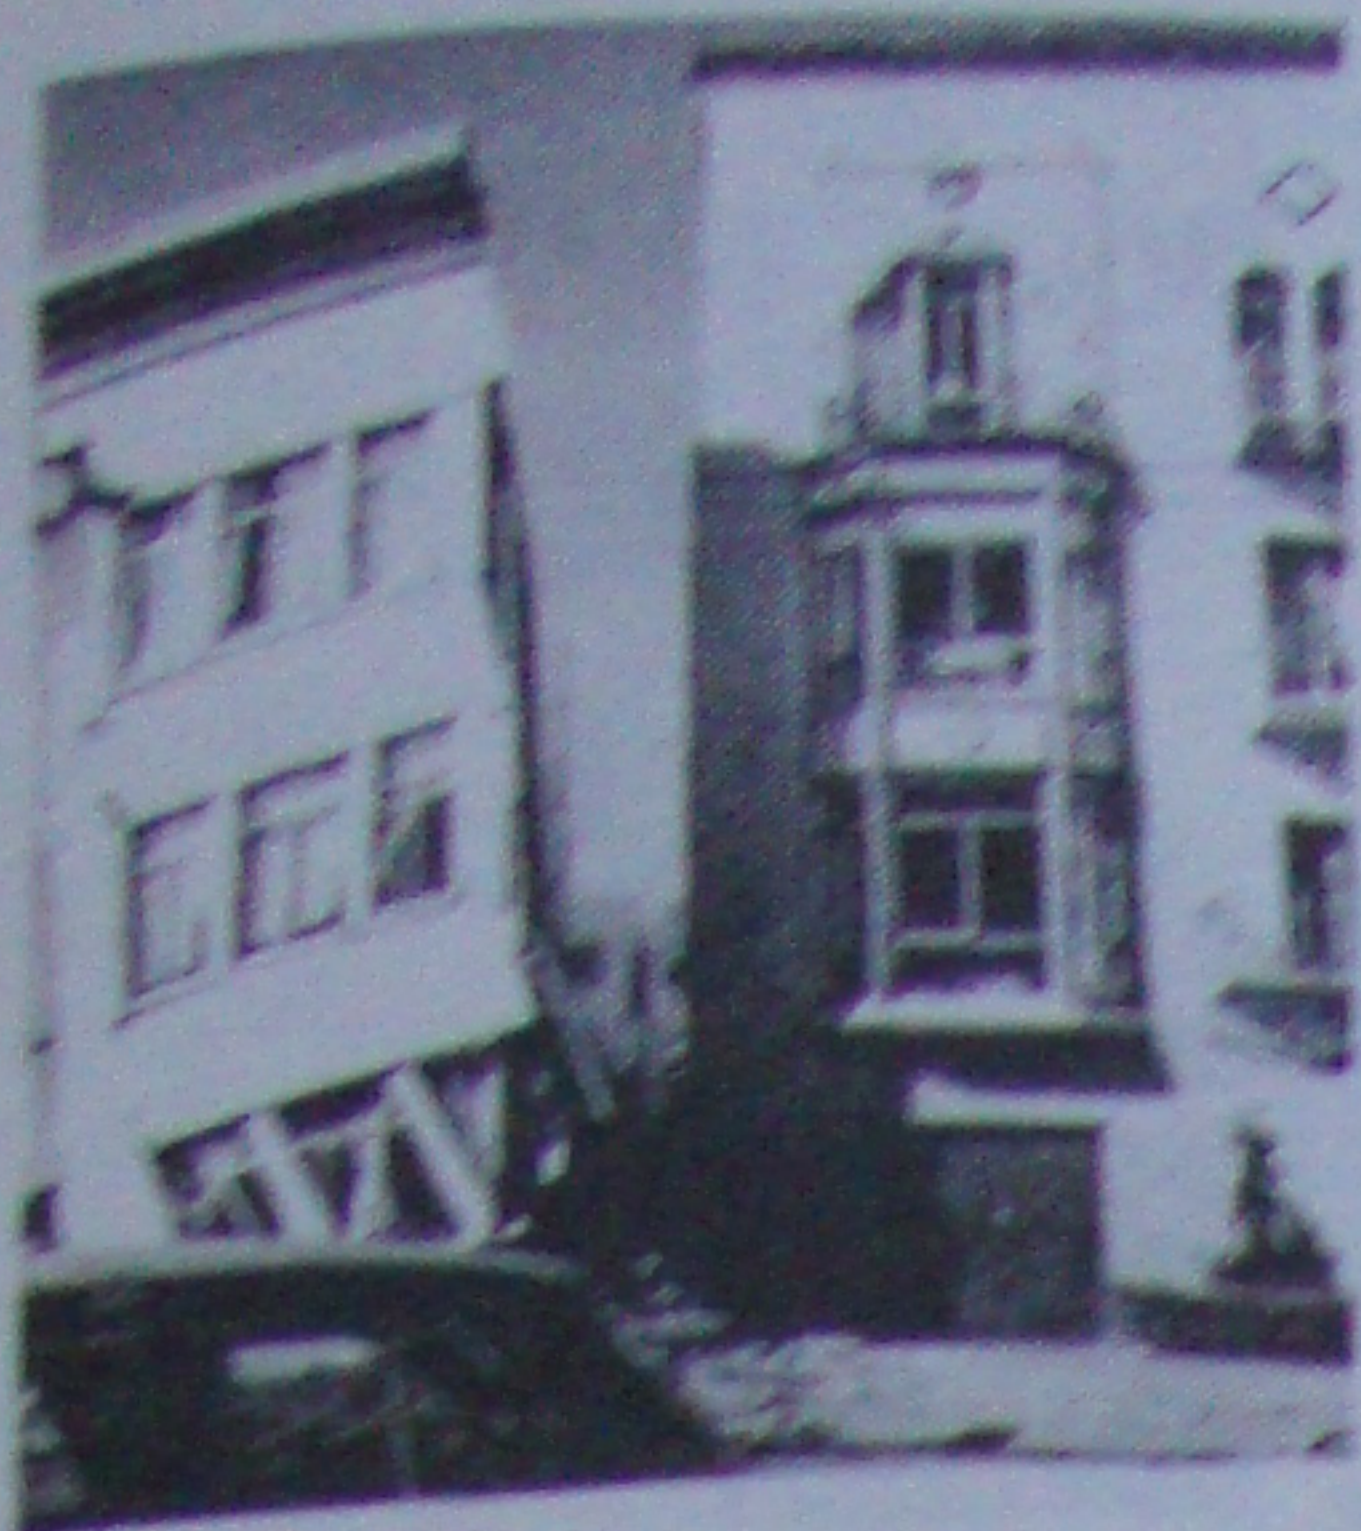
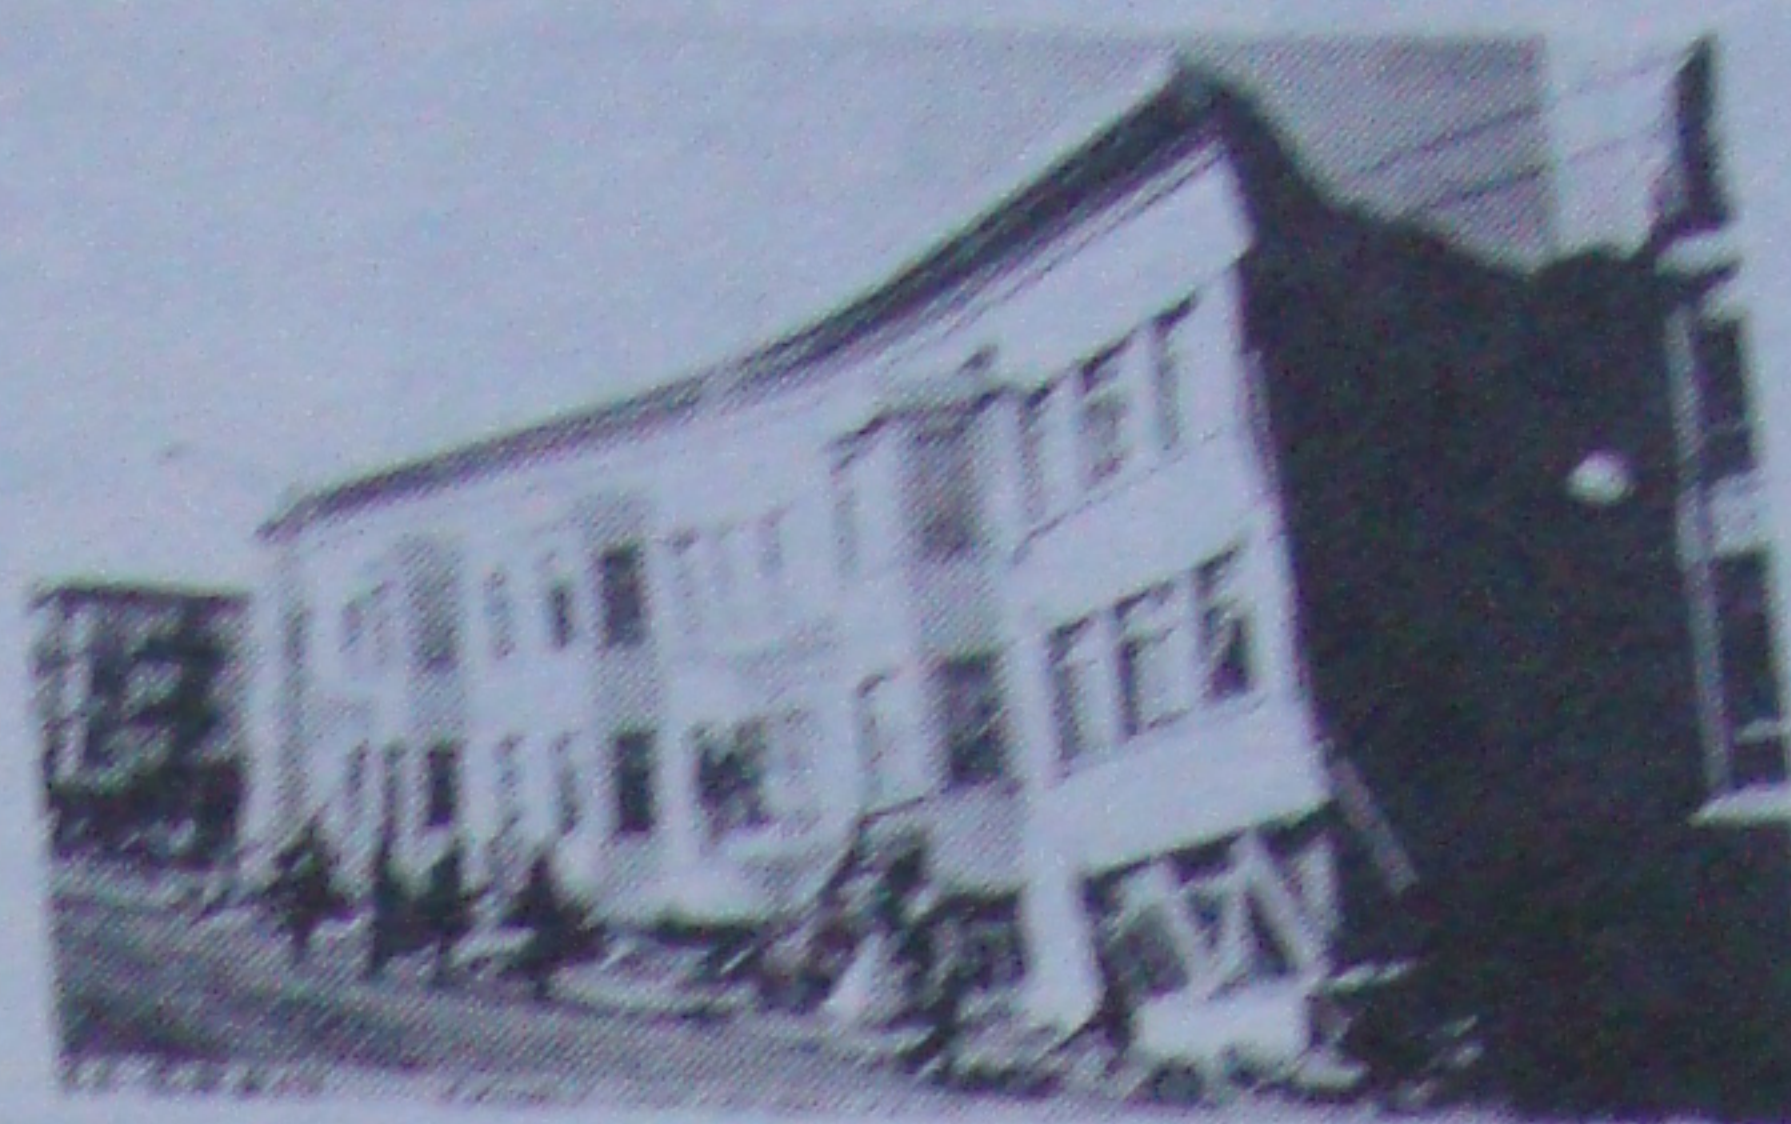
**Other Areas.** - The writers also performed a block-by-block review of other areas. The areas are: (1) San Francisco Marina District (MM IX), where 3 and 4 story residential buildings of wood construction are most common (e.g., Fig. 3); (2) The Pacific Garden Mall area (MM VIII) in downtown of Santa Cruz, where most buildings were constructed around the turn of the century. The heights range from 1 to 7 stories but most are typically up to 3 stories. Most of the severely damaged structures are of unreinforced masonry; (3) Watsonville downtown area (MM VIII), where the building heights are typically 2 to 3 stories. Most of these buildings were of masonry construction.

Fig. 3 Damaged corner buildings in San Francisco Marina district.

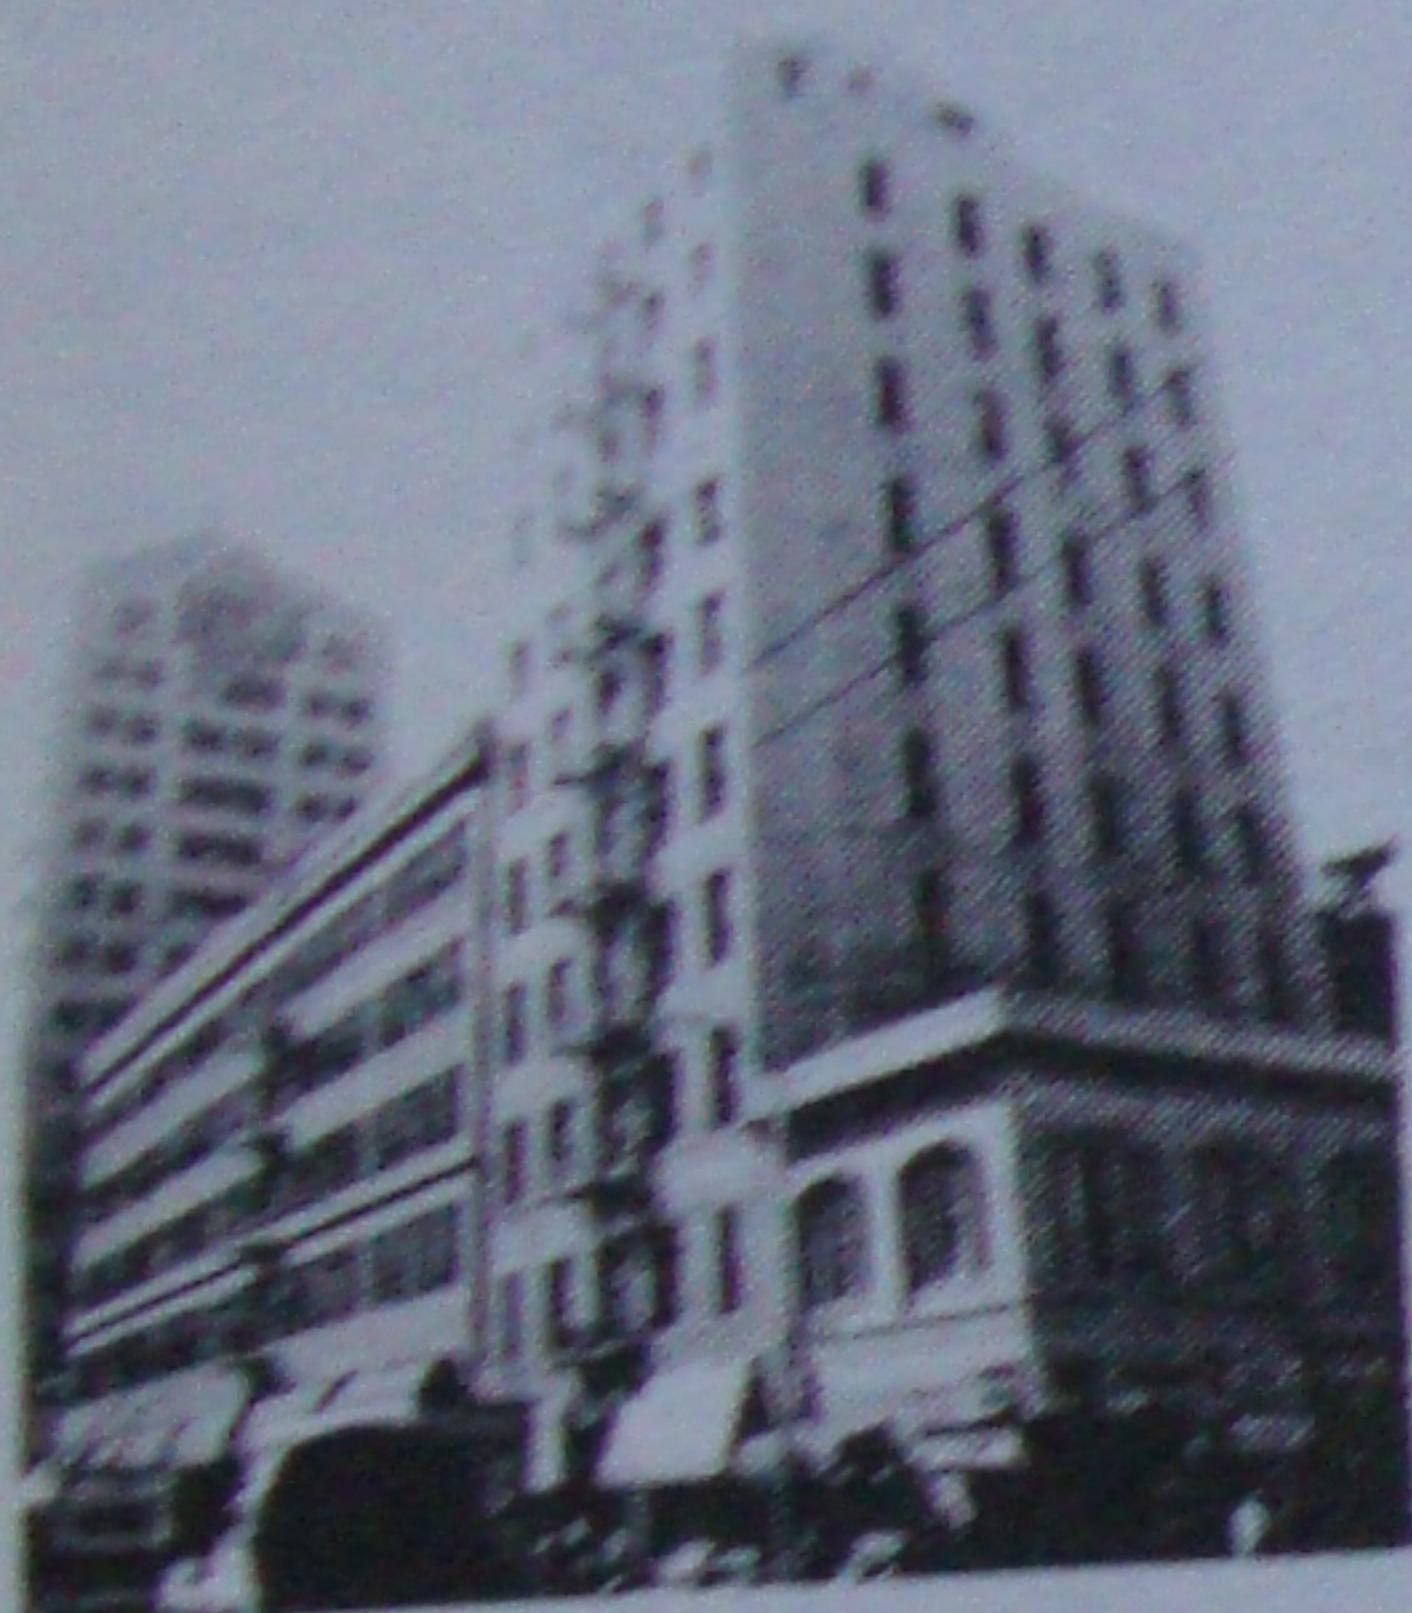
(a)

**Mission Street, South-of-Market, San Francisco:** The building is 10 stories and constructed of masonry combined with a steel skeleton (Fig. 4). It was built in 1904. This building experienced pounding with an adjacent massive 5 story building which occupies most of the city block (Fig. 4(a)). Pounding was located at the 7th level in the 10 story building and at the roof level in the 5 story building. About 1 to 1.5 inch building separation is present. The 10 story building suffered structural damage above the pounding elevation as evidenced by the large diagonal shear cracks in the masonry piers (Fig. 4(b)). This case is classified as Type-1 damage.

Fig. 4 Example pounding damage (Mission Street, San Francisco)

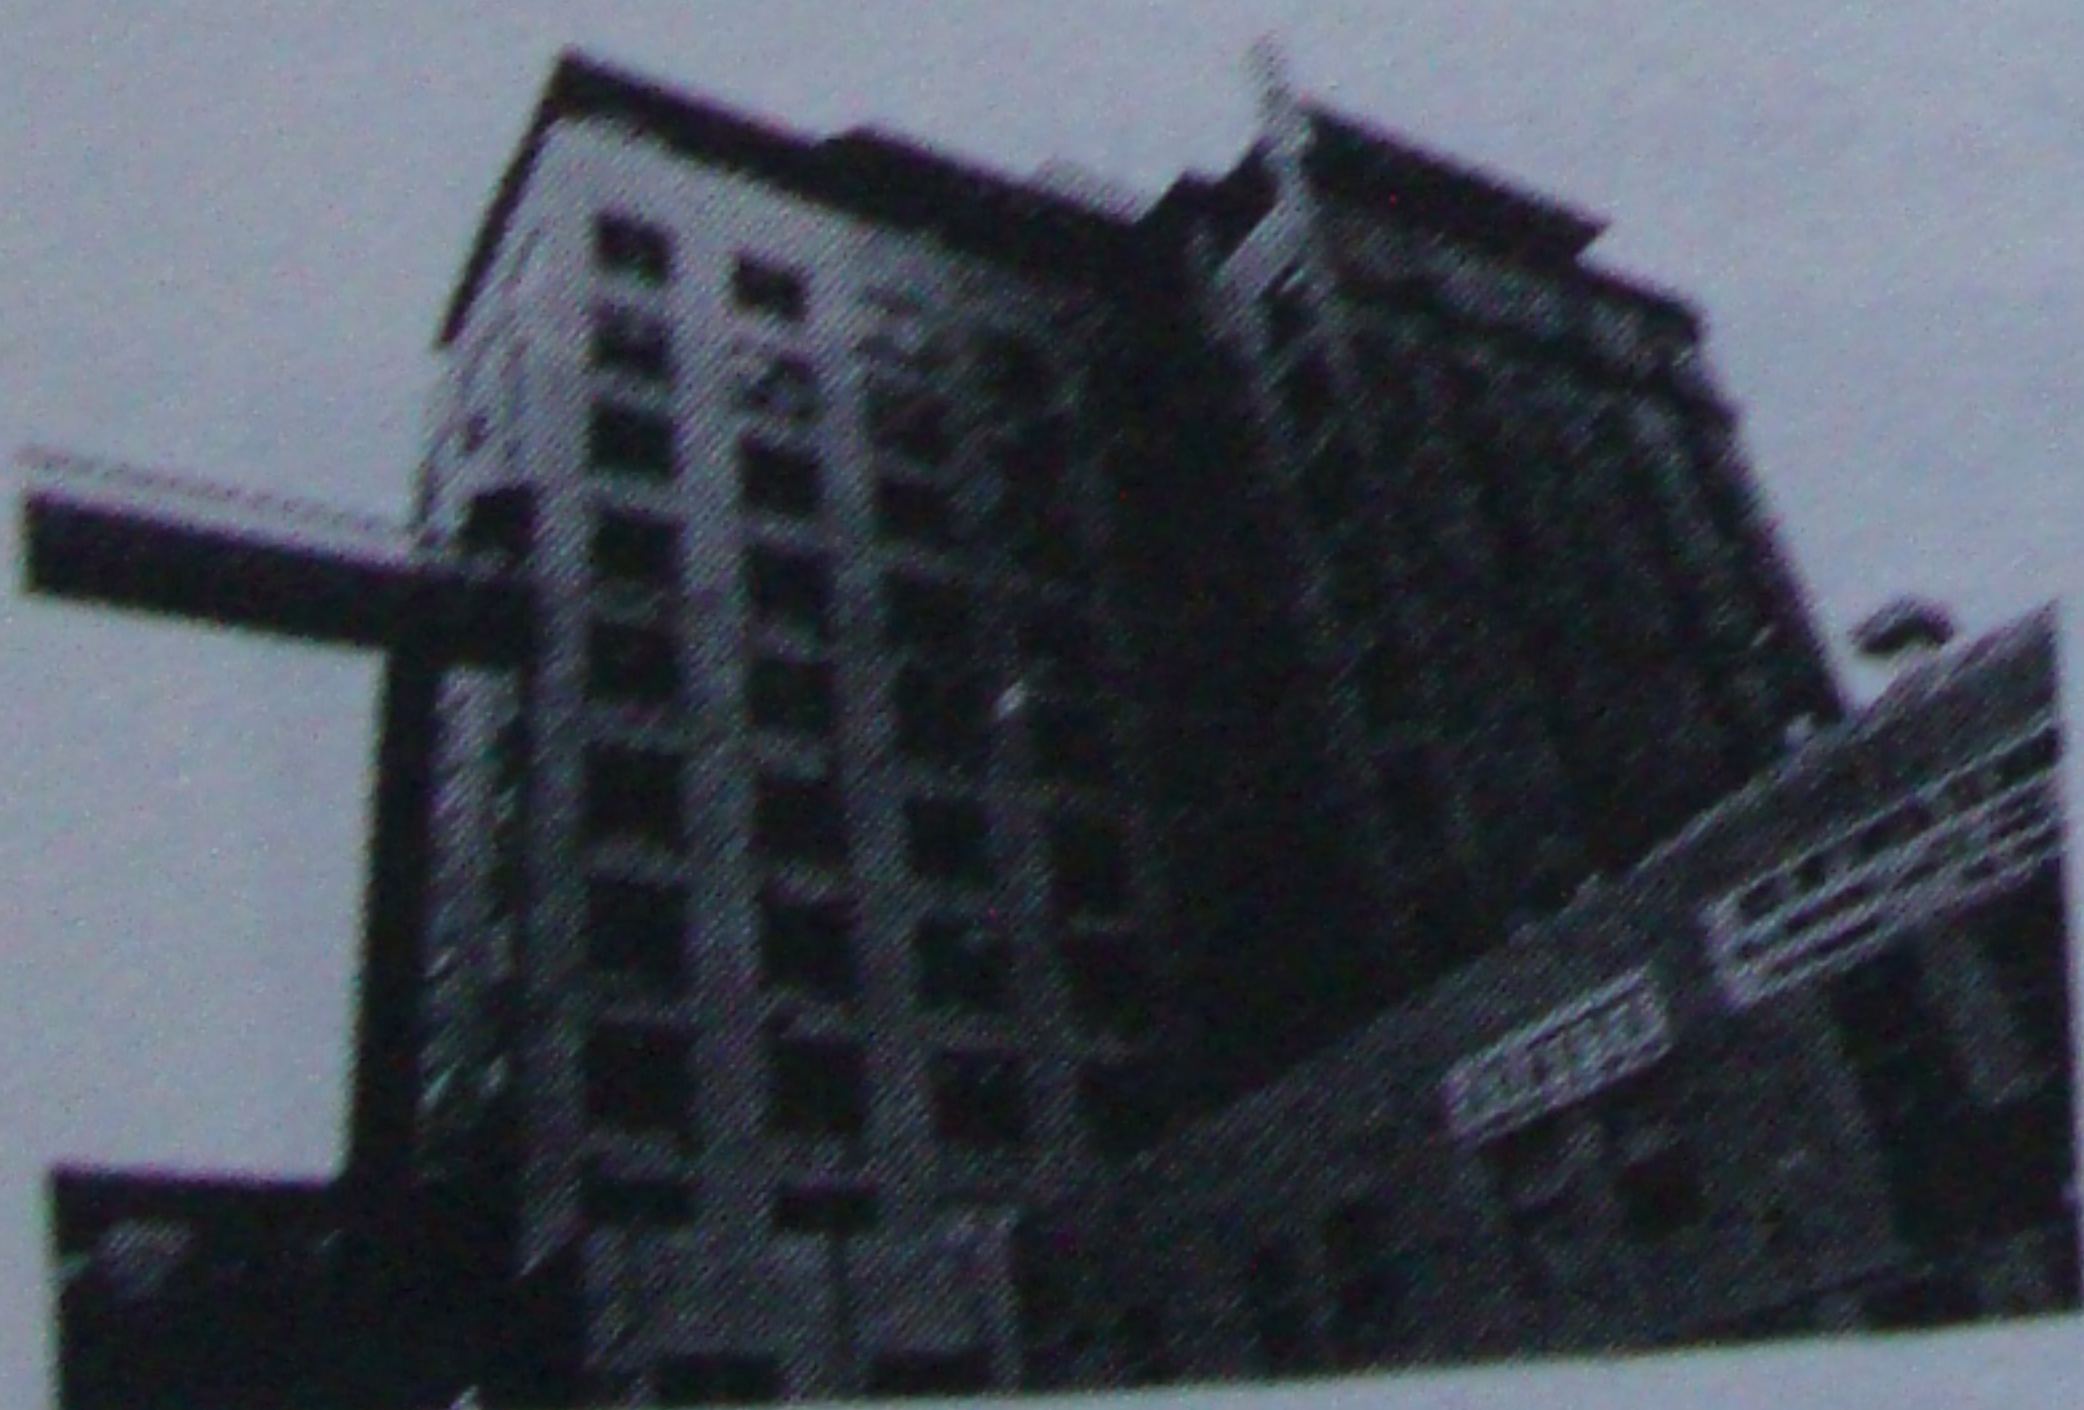
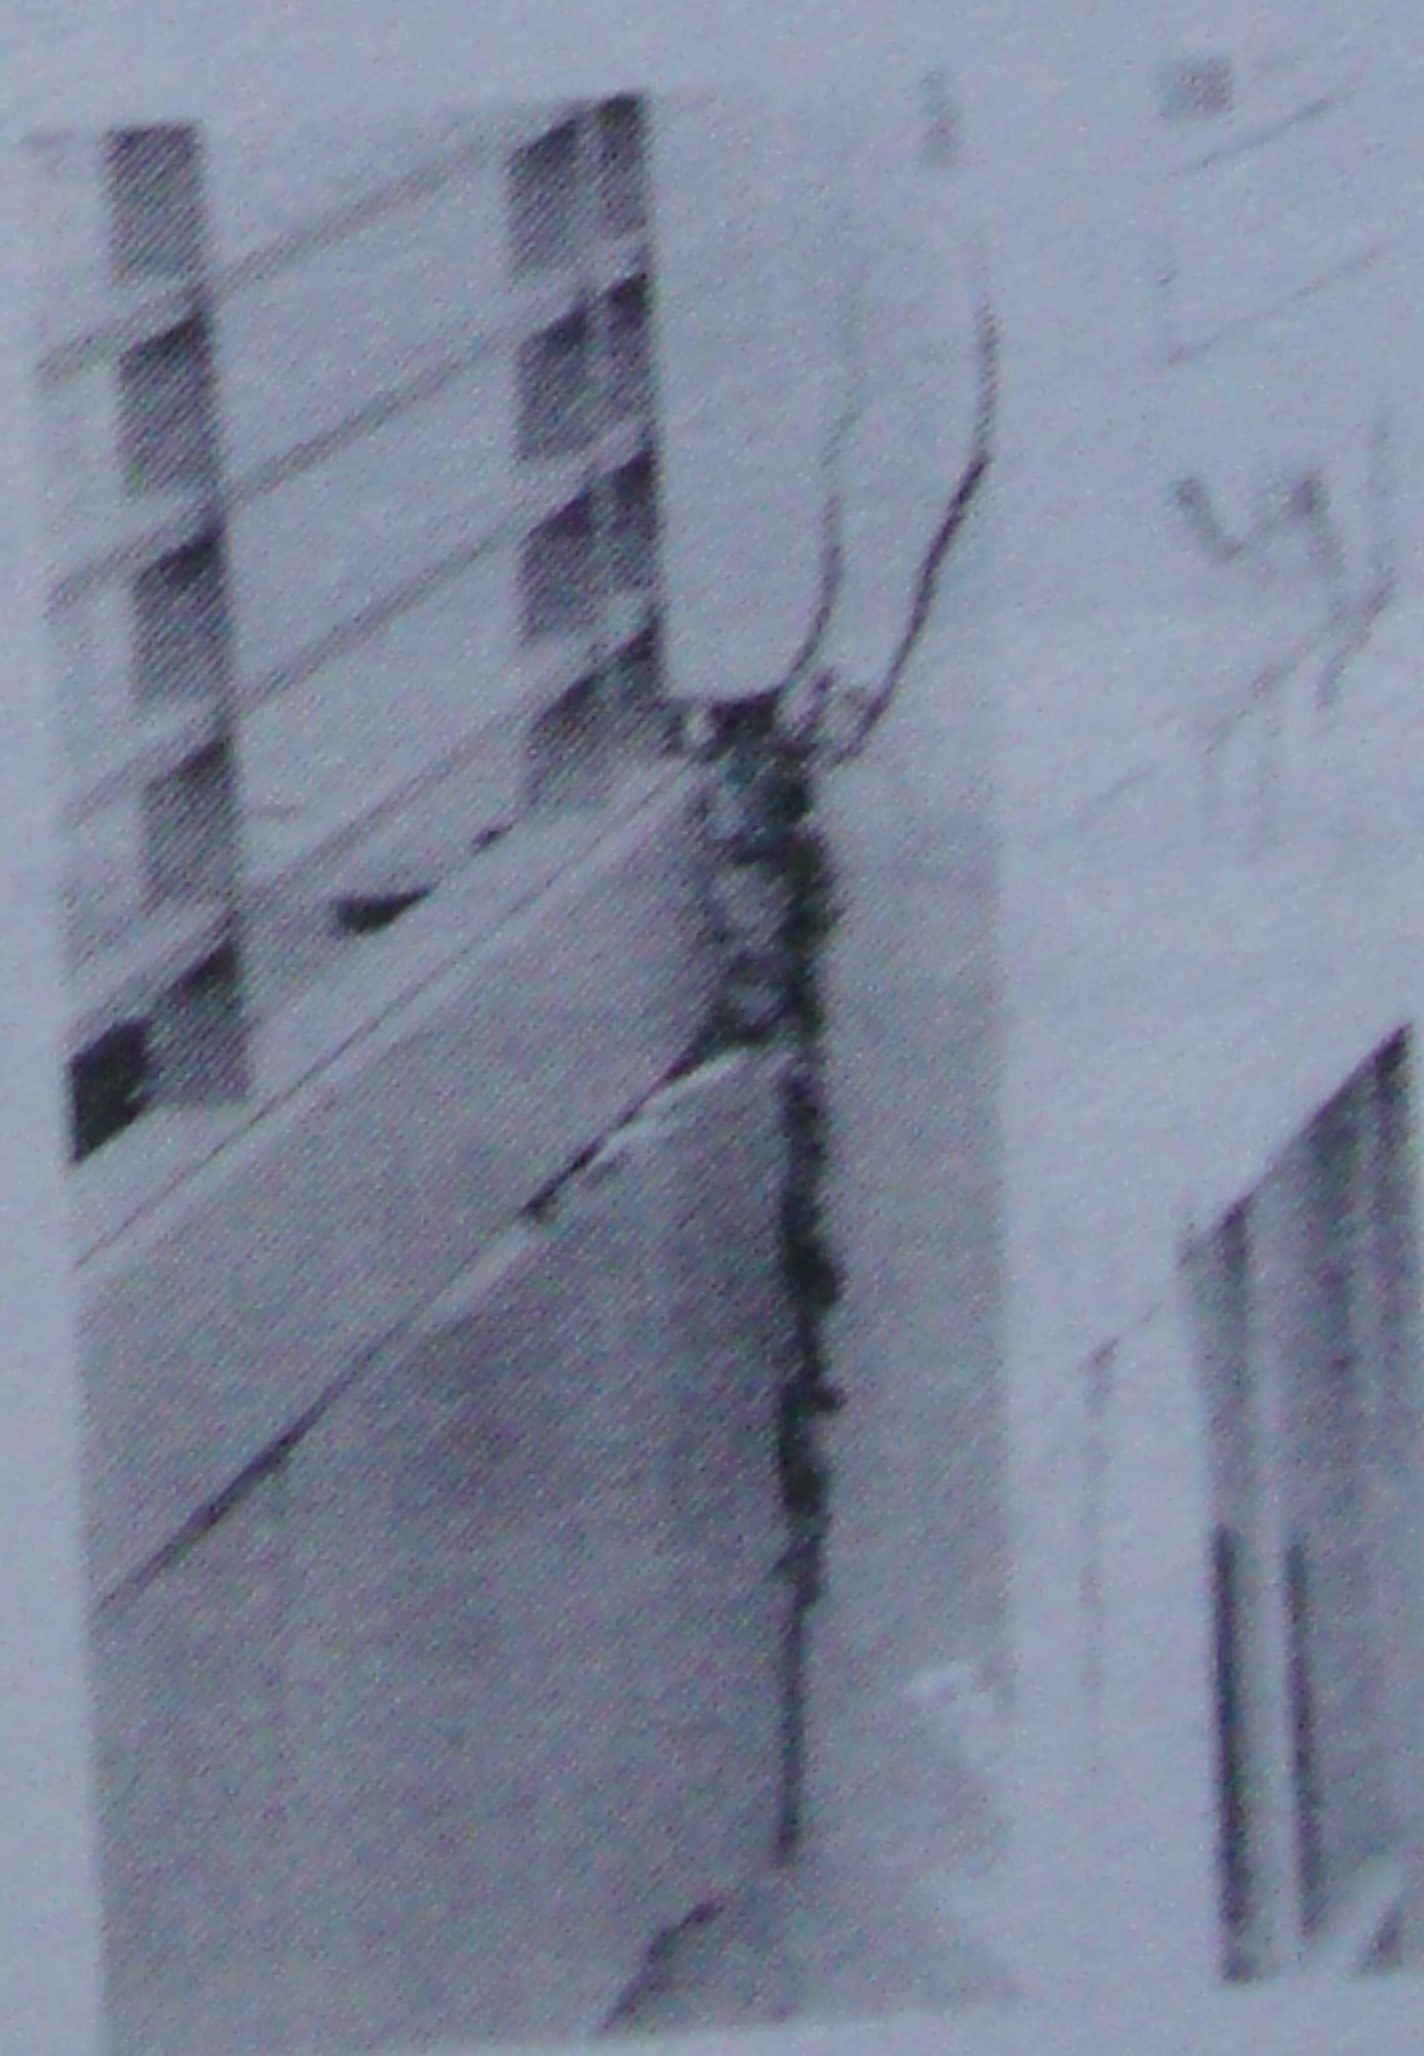
**Broadway Street, Oakland City Center:** The 12 story building consists of an 11 story reinforced concrete structure constructed in 1924 with a penthouse steel structure added in the 1950's (Fig. 5(a)). The adjacent building is a modern 6 story reinforced concrete parking garage. A bridge spans from the parking garage top level to the building at the 8th floor level. The bridge has a sliding connection at the building that provides for about 4 inches of relative building movement. Severe pounding occurred resulting in extensive cracking of the building at the bridge location (Fig. 5(b)). Large interior diagonal shear cracks in the columns above and below the bridge elevation indicated the large magnitude of the local collision forces. After inspection, it was found that at least 4.5 inches of relative displacement must have occurred at least twice during the earthquake. The building also experienced extensive window glass cracking and falling, but whether pounding was the primary cause is uncertain. This building is classified as having Type-1 damage and possibly Type-2 damage as well.

Fig. 5 Example pounding damage (Broadway Street, Oakland)
