# Observation of structural pounding damage from 1989 Loma Prieta earthquake

K. Kasai<sup>I</sup> and B.F. Maison<sup>II</sup>

The survey results on pounding incidents during 1989 Loma Prieta earthquake are summarized. They include the distribution of pounding damage in the specific areas, types of pounding damage, and examples for pounding damage involving major multi-story buildings.

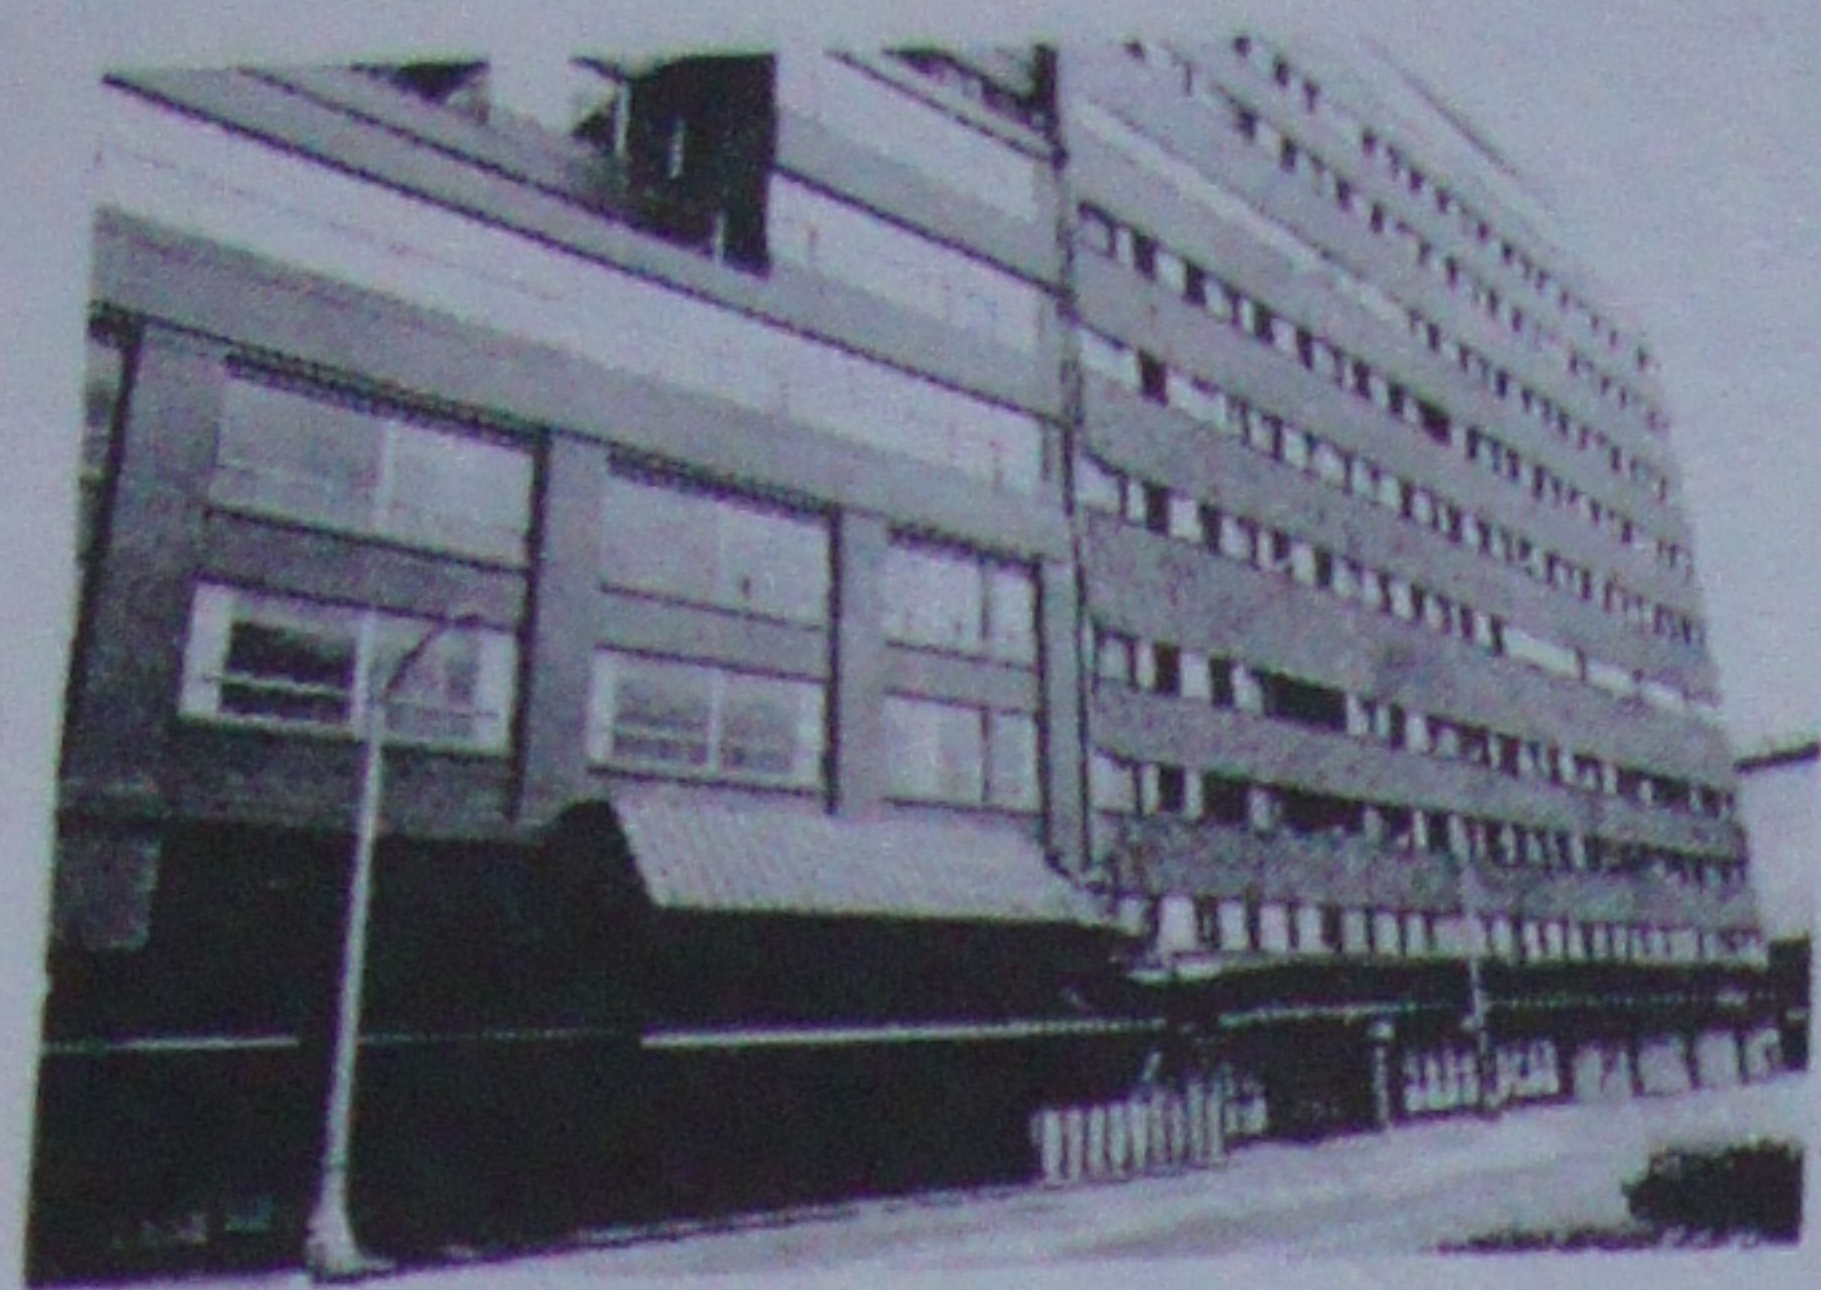
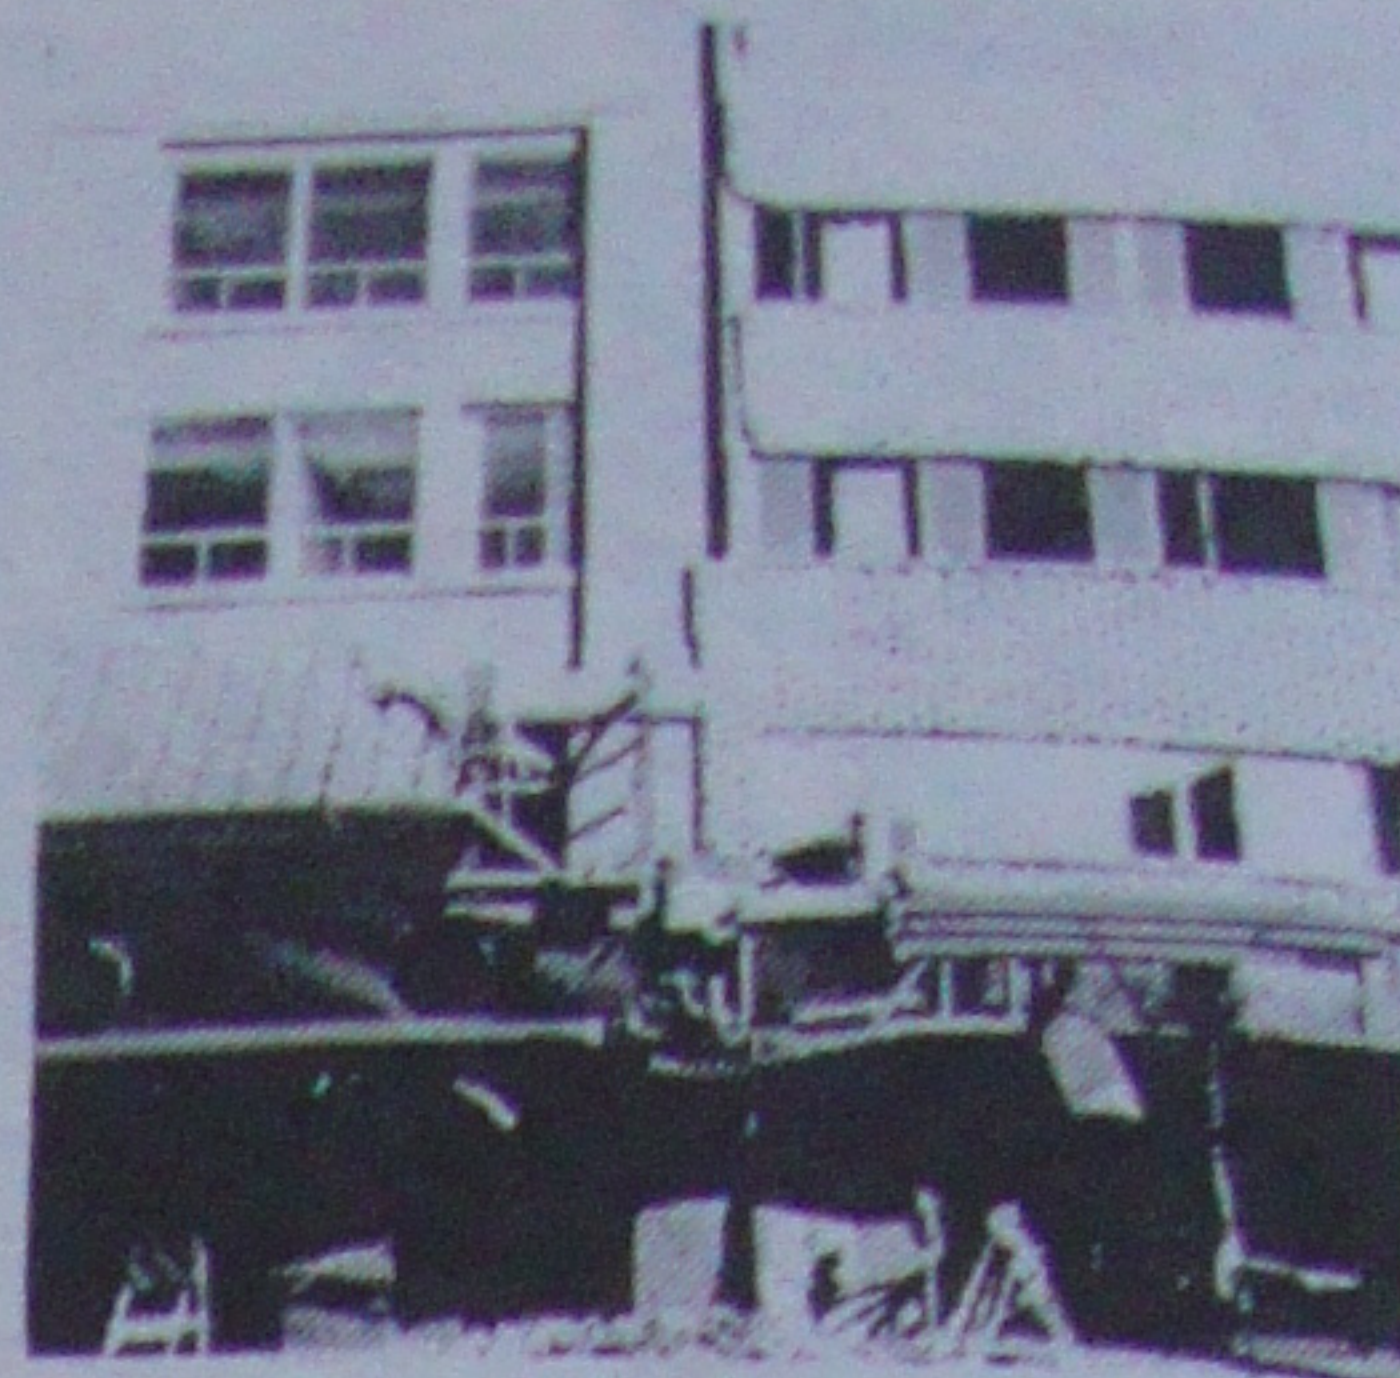
(Fig. 6(a), building at right). It was built in 1965. This building pounded with an older 7 story building whose lower 4 stories are composed of reinforced concrete, and its upper 3 stories are of steel construction (Fig. 6(a), building at left). The buildings have about 2 inch separation.

The 10 story building suffered significant damage. Its lateral load capacity deteriorated due to severe damage at the slab-to-column connections. The horizontally placed reinforcing bars for the spandrel masonry walls were pulled out from the adjacent columns. Further study is needed to determine whether this damage is attributed to pounding. However, pounding caused the seismic hazard of falling building debris. Fig. 6(b) shows the debris that fell on and through the canopy located at the 2nd floor level. The brick veneer at the boundary of the two buildings was damaged due to impact, and a large amount of falling debris destroyed the canopy. This is classified as Type-2 damage and possibly Type-1 damage as well.

Fig. 6 Example pounding damage (Franklin Street, Oakland)

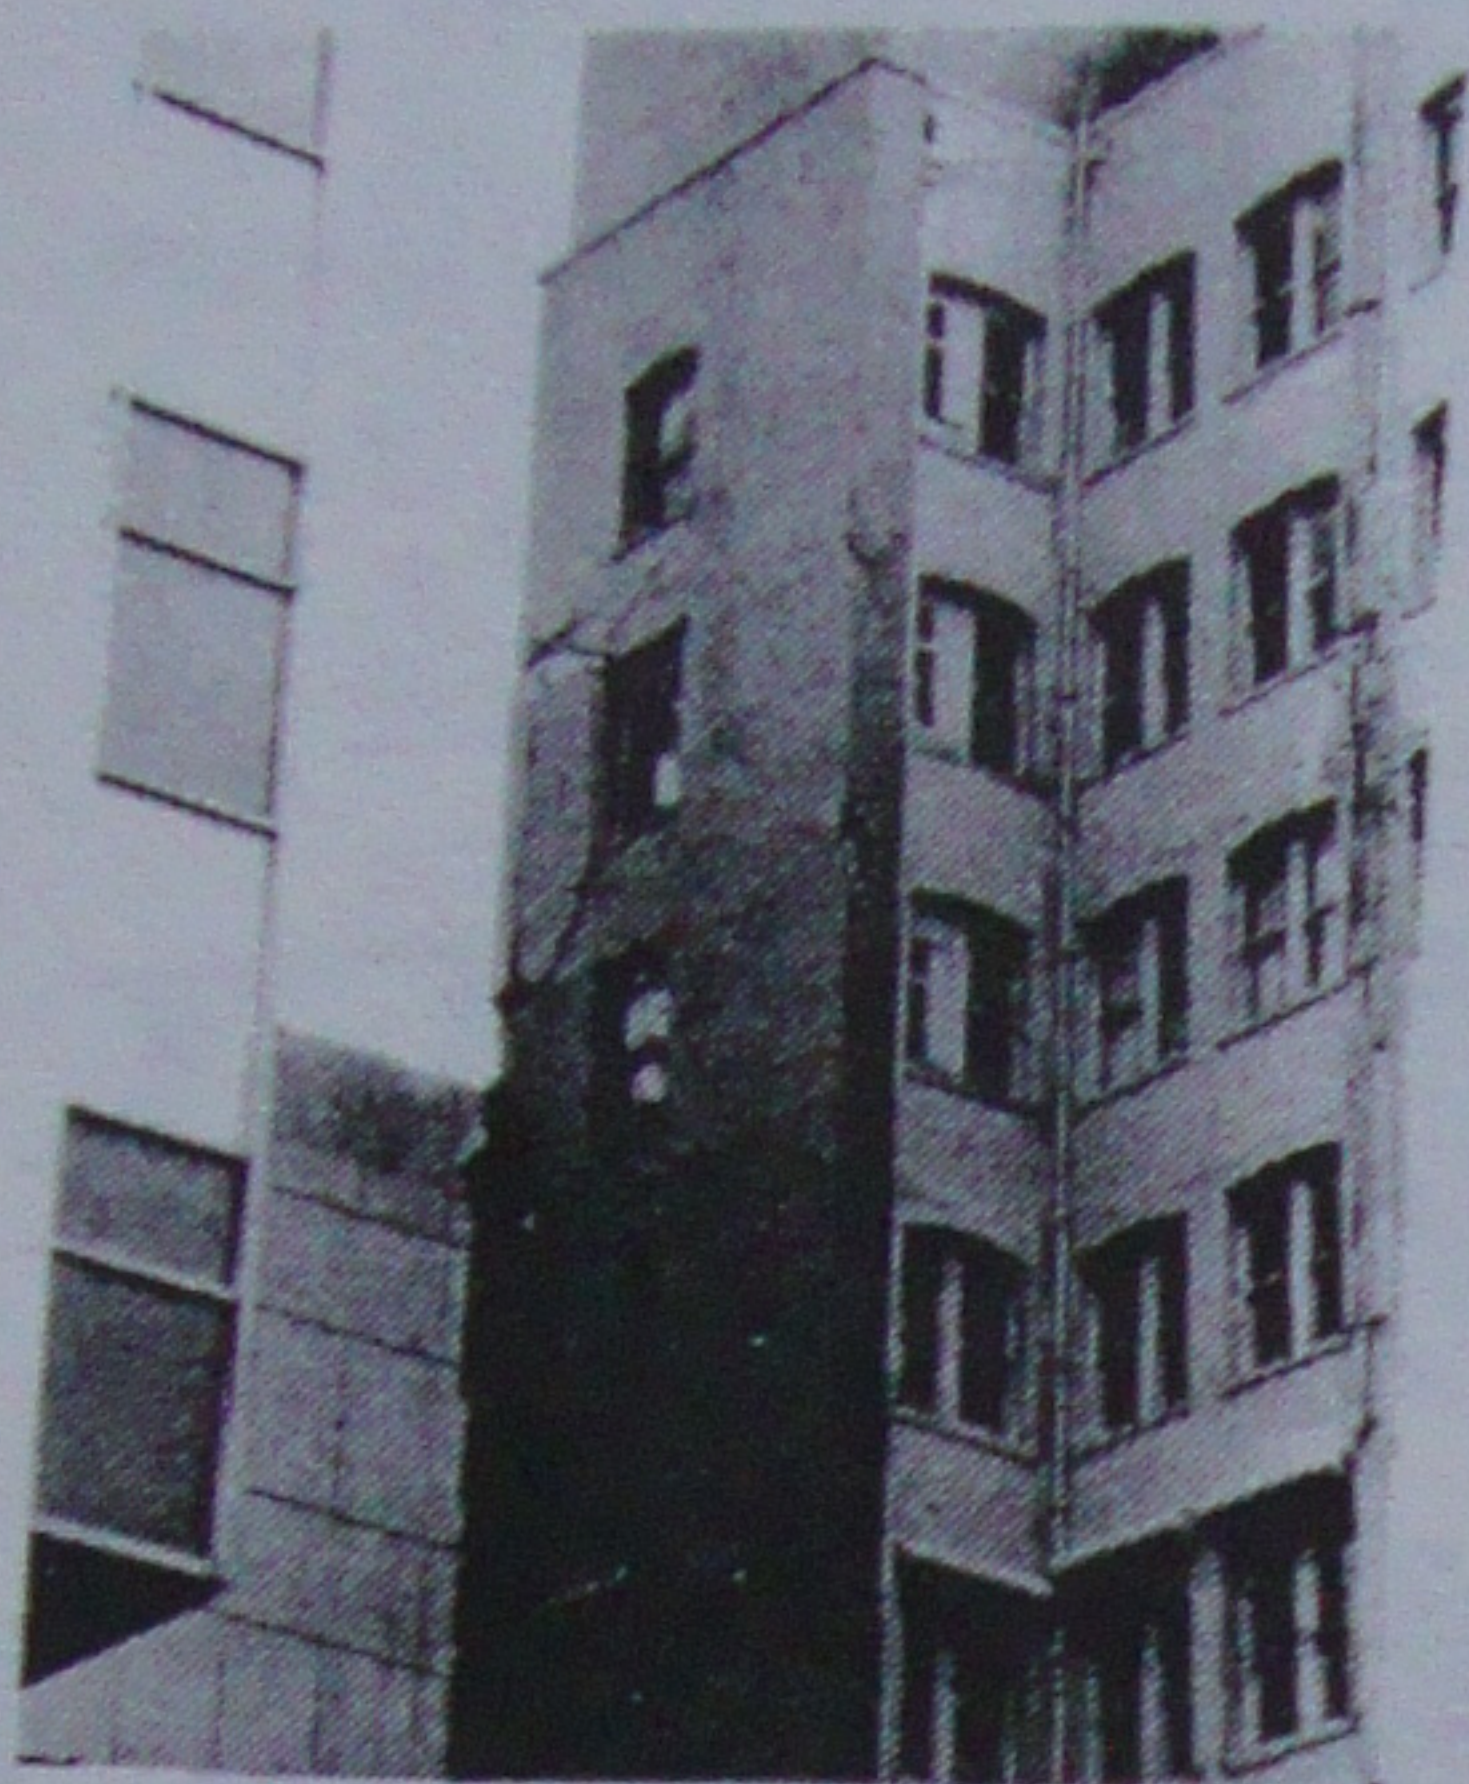
(a)

13th Street, Oakland City Center: The building is 11 stories plus a 2 story penthouse constructed of masonry combined with a steel skeleton. It was built in 1904. The building pounded between its 9th and 10th floors with the roof of an adjacent reinforced concrete parking structure (Fig. 7(a)) built in 1957. The buildings have about 2 inches wall-to-wall separation, but wooden formwork remained in this gap thus reducing the separation between the two buildings.

Fig. 7 Example pounding damage (13th Street, Oakland City Center)

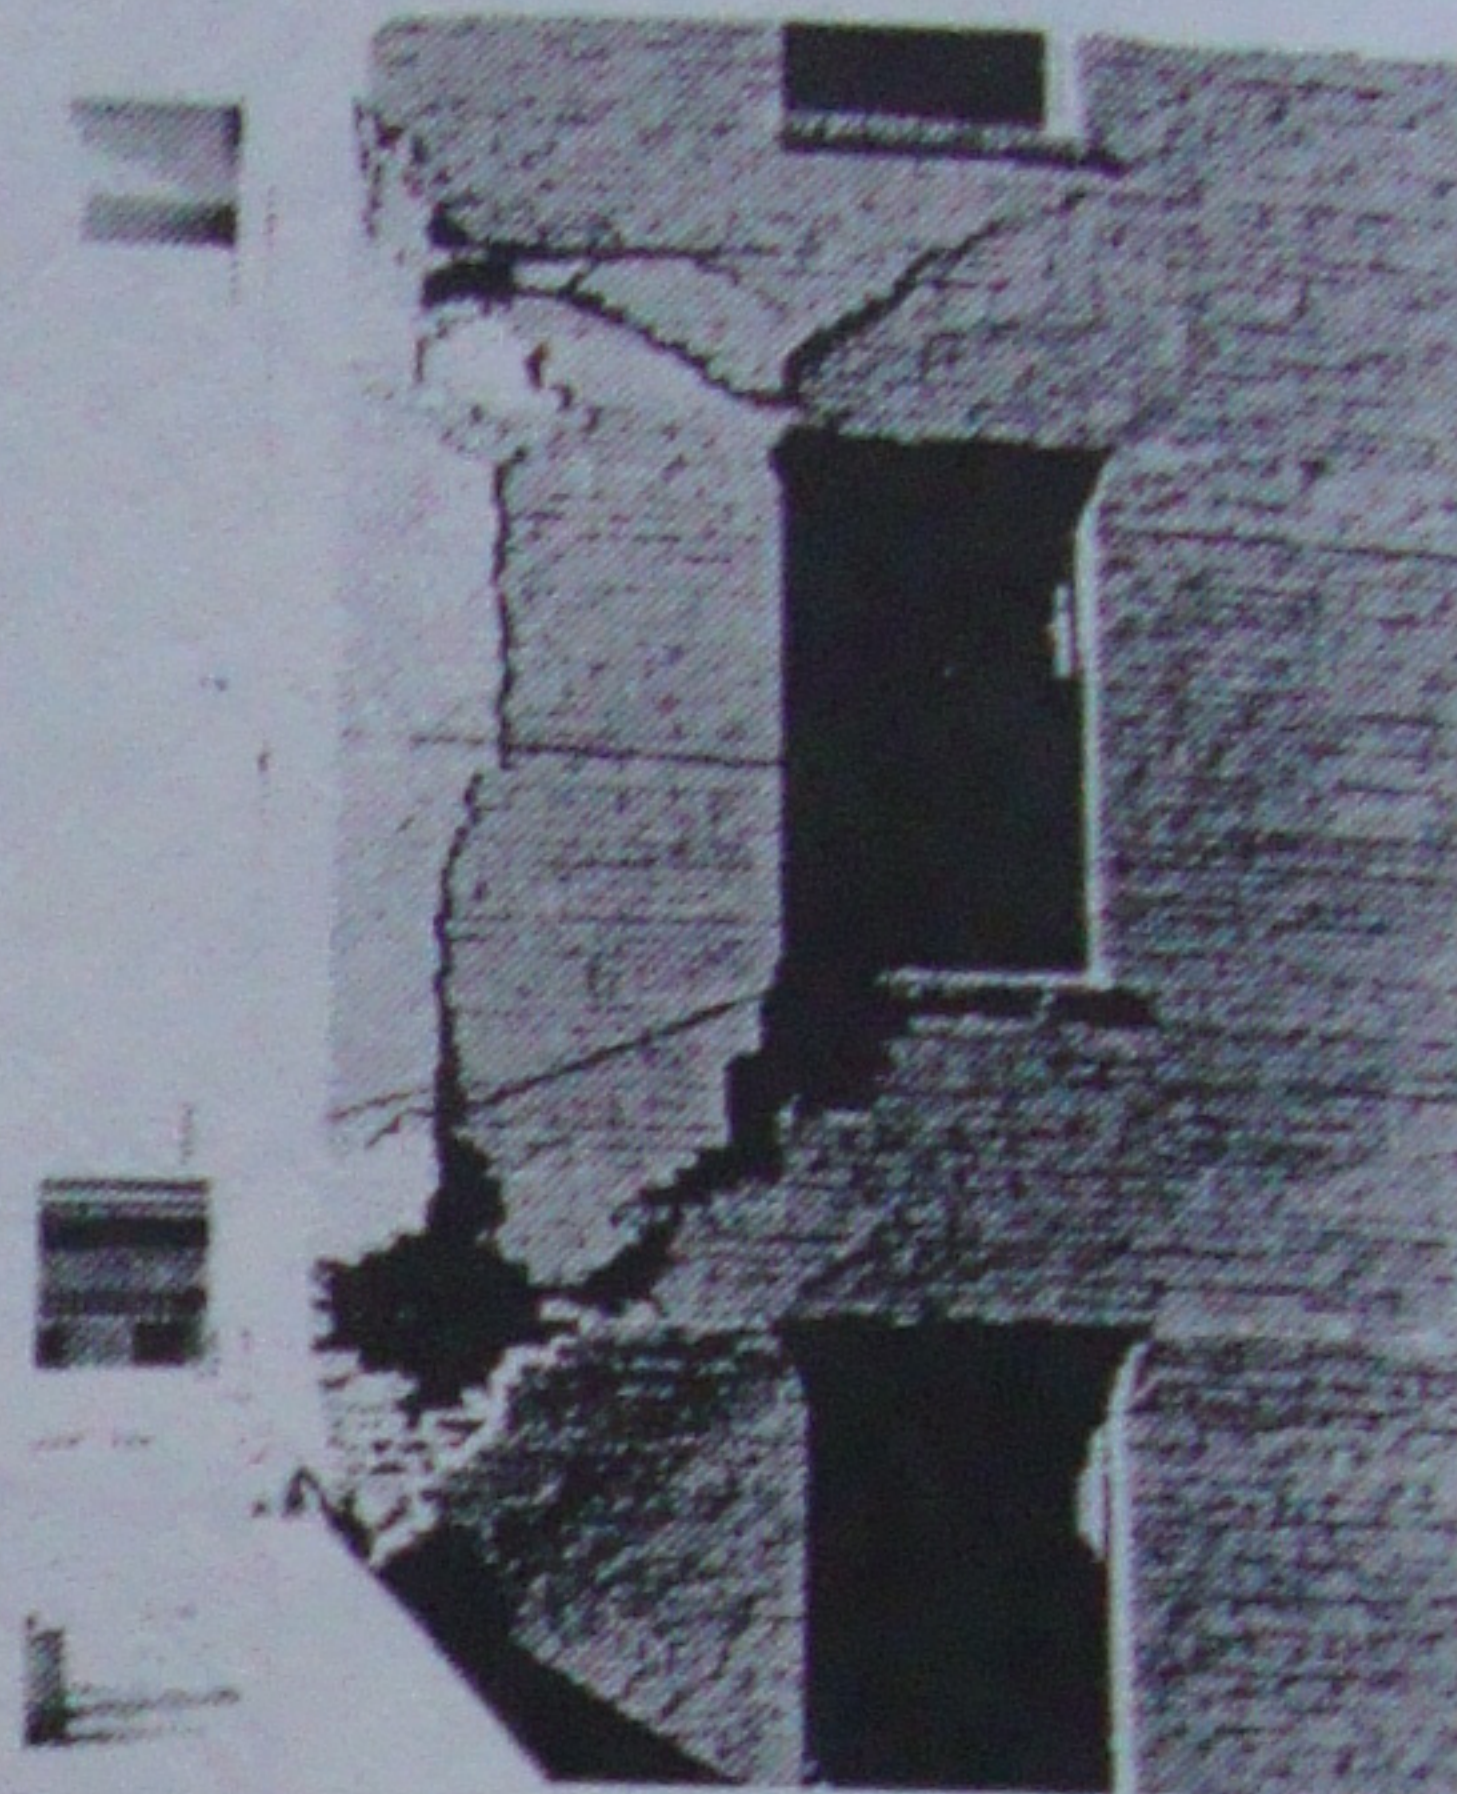
(b)

Pounding damage was observed along the entire contact length. Fig. 7(b) shows the location of severe pounding damage. The stairway is enclosed by the wall which pounded at the roof level of the parking structure. Since the stairway lacks a floor diaphragm at the pounding region, the wall was impacted and buckled out-of-plane (Fig. 7(b)). The stairway then collapsed at the pounding level and fell onto the lower levels, resulting in complete loss of the stairway. The pounding damage is classified Type-1 with incipient Type-2 damage.

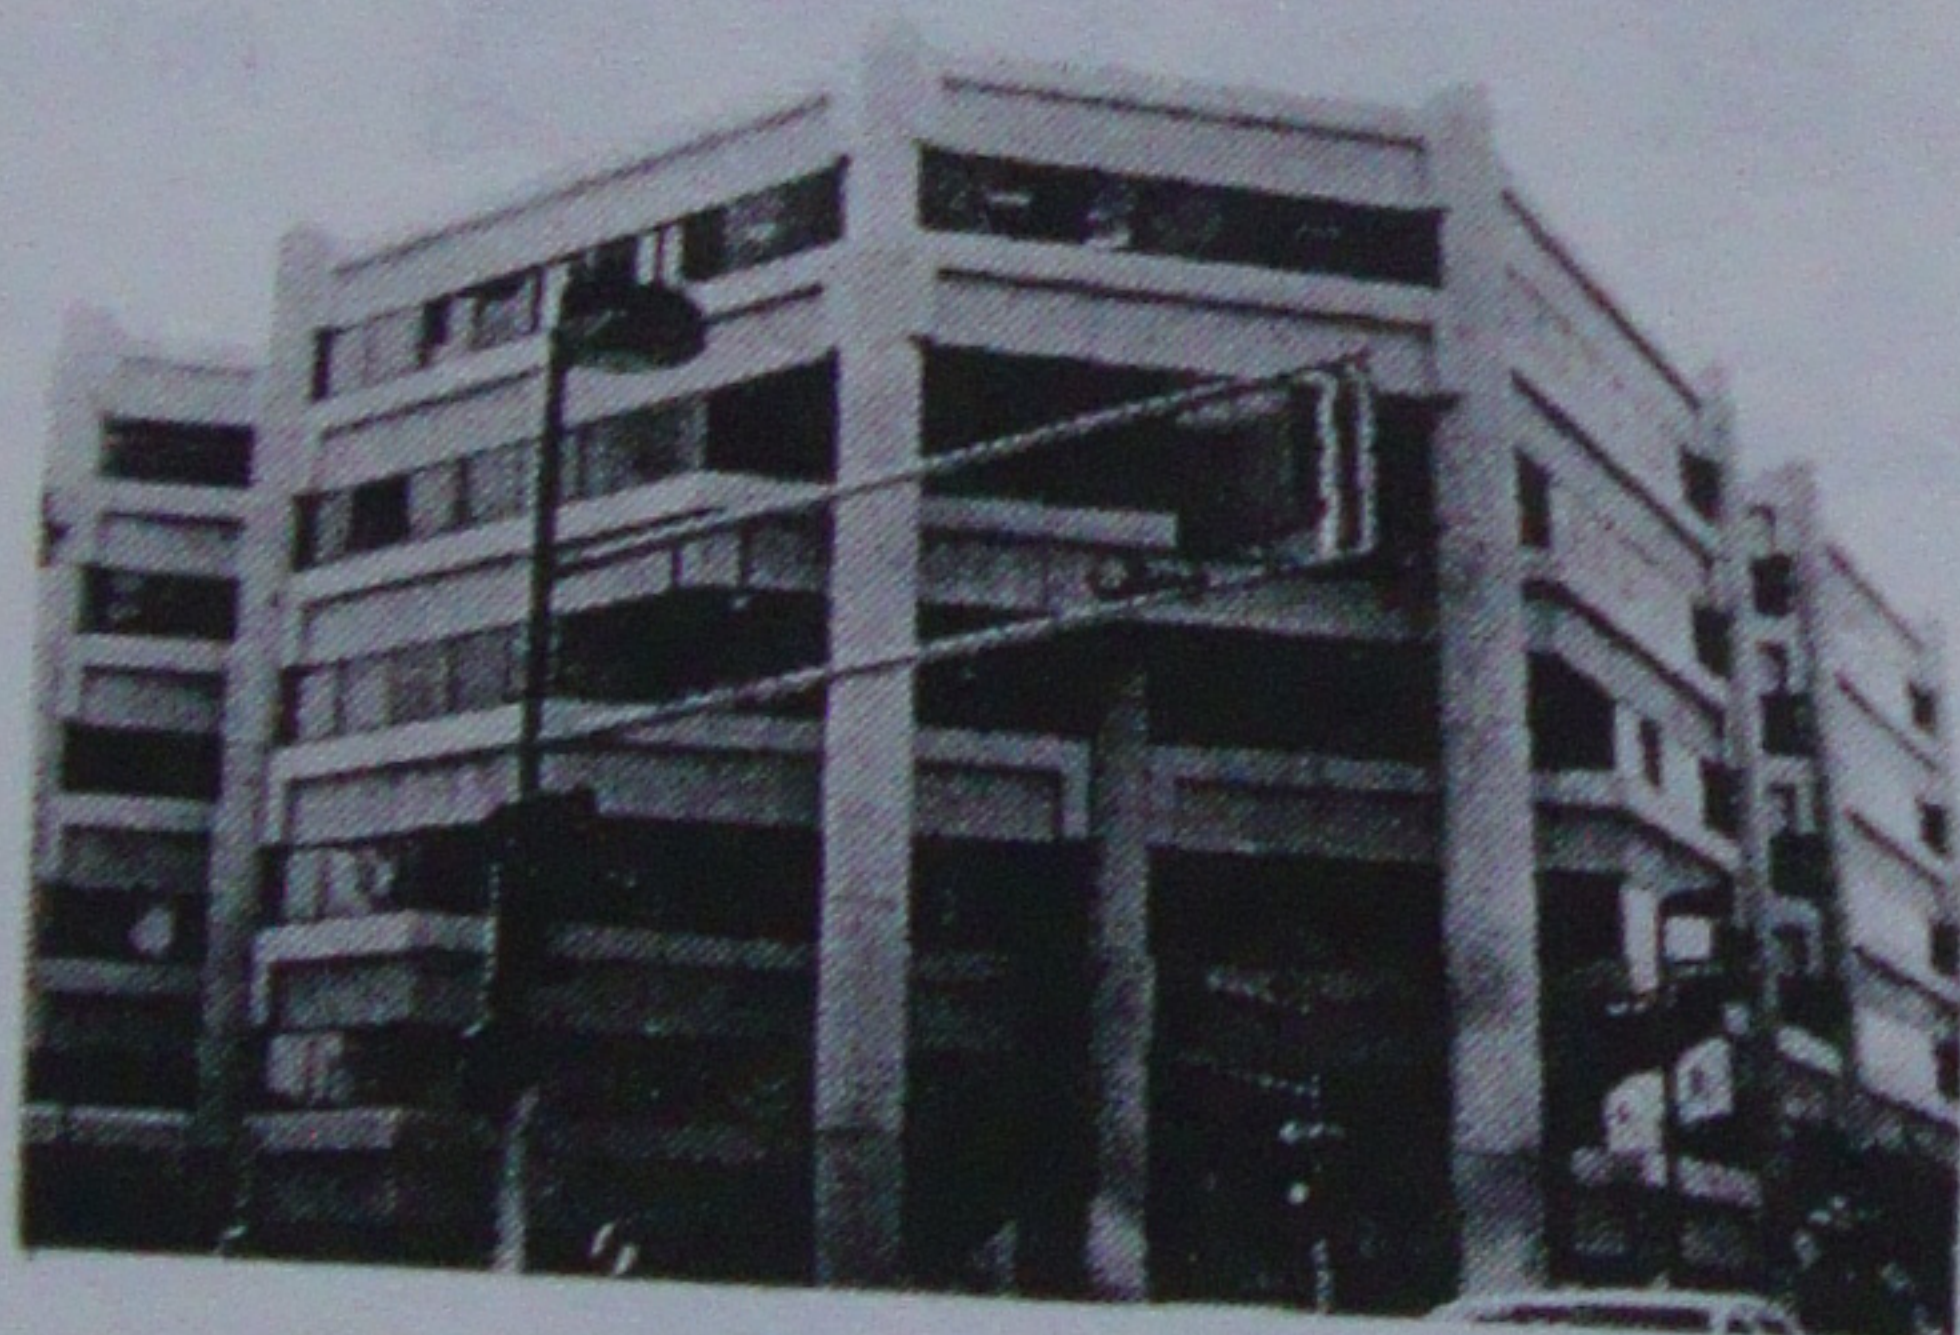
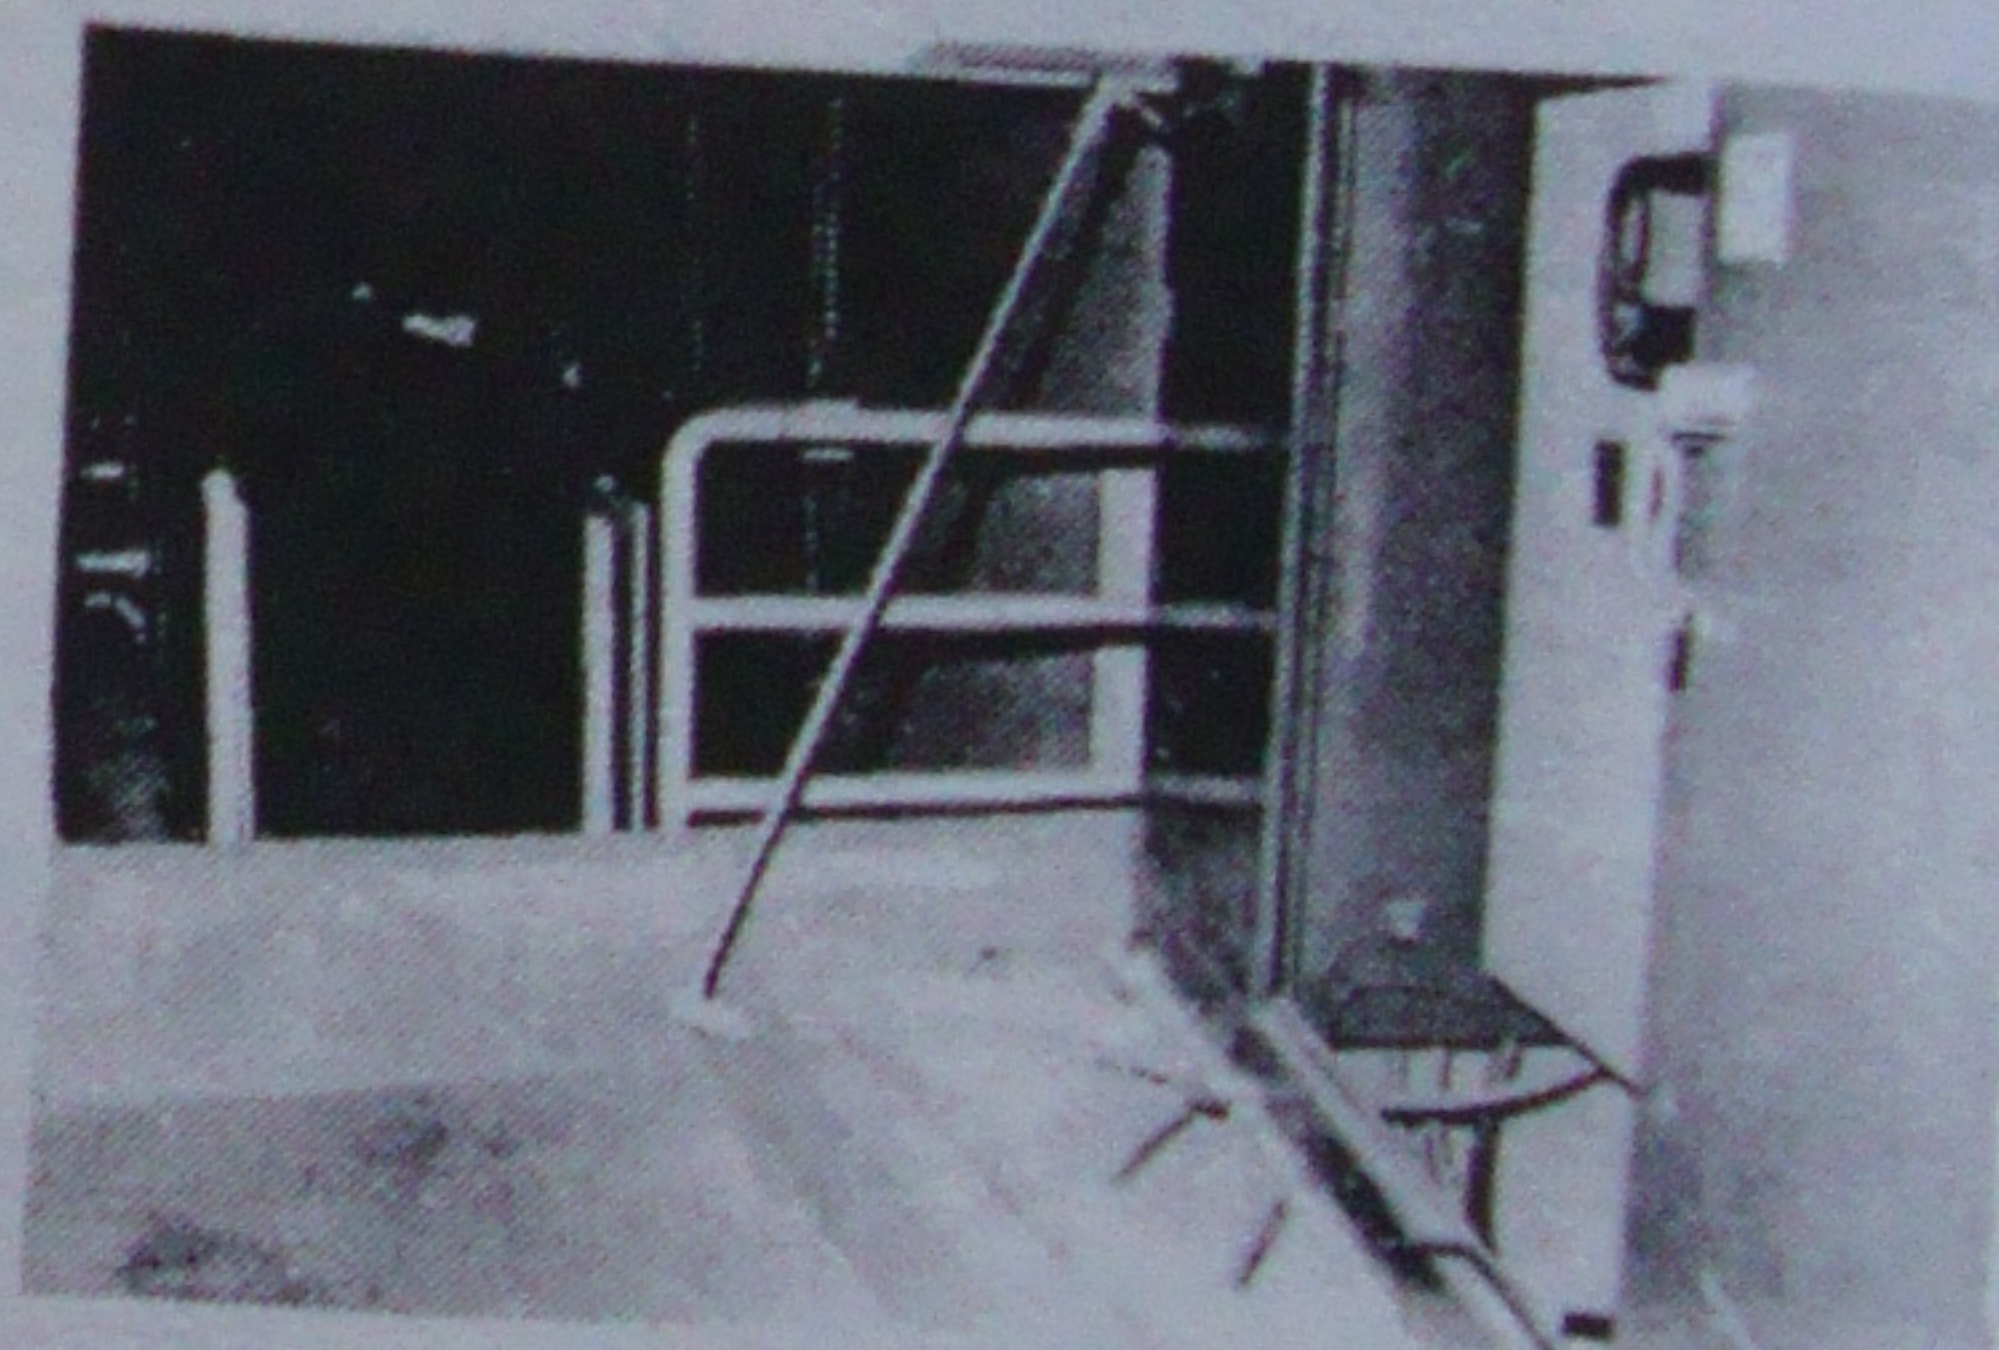
11th Street, Oakland City Center. - The building is a large 6 story steel structure occupying an entire city block (Fig. 8(a)). It was built in 1981. The building in plan, consists of three segments separated by 4 inch expansion joints. All building segments have steel moment resisting frame systems. One segment was originally designed as a 20 story high-rise building, but only the bottom 6 story portion is presently constructed (this is the portion shown in the lower right corner of Fig. 8(a)). Accordingly, this segment is laterally much stiffer than the other two segments.

Due to the earthquake, these segments pounded at their floor slabs which are at common elevations. The slabs at the upper floors were locally damaged due to the contact forces, but there was no structural damage to the building. In general, pounding produces sharp irregular motions which results in large high frequency lateral accelerations (Kasai et al. 1990). It is possible that such accelerations contributed to other damage observed in the building. The windows facing the atrium fell down, and the computer equipments shifted and/or turned over. Heavy building equipments in the penthouse shifted significantly (Fig. 8(b)). Further, the plumbing for the fire protection system lacked seismic joints, and consequently it was destroyed at the building separations due to building relative motions. A considerable amount of water was released. The damage was quickly repaired and the separation distance between the slabs were increased. The pounding damage to this building is classified Types-2, 3 and 4.

Fig. 8 Example pounding damage (11th Street, Oakland City Center)

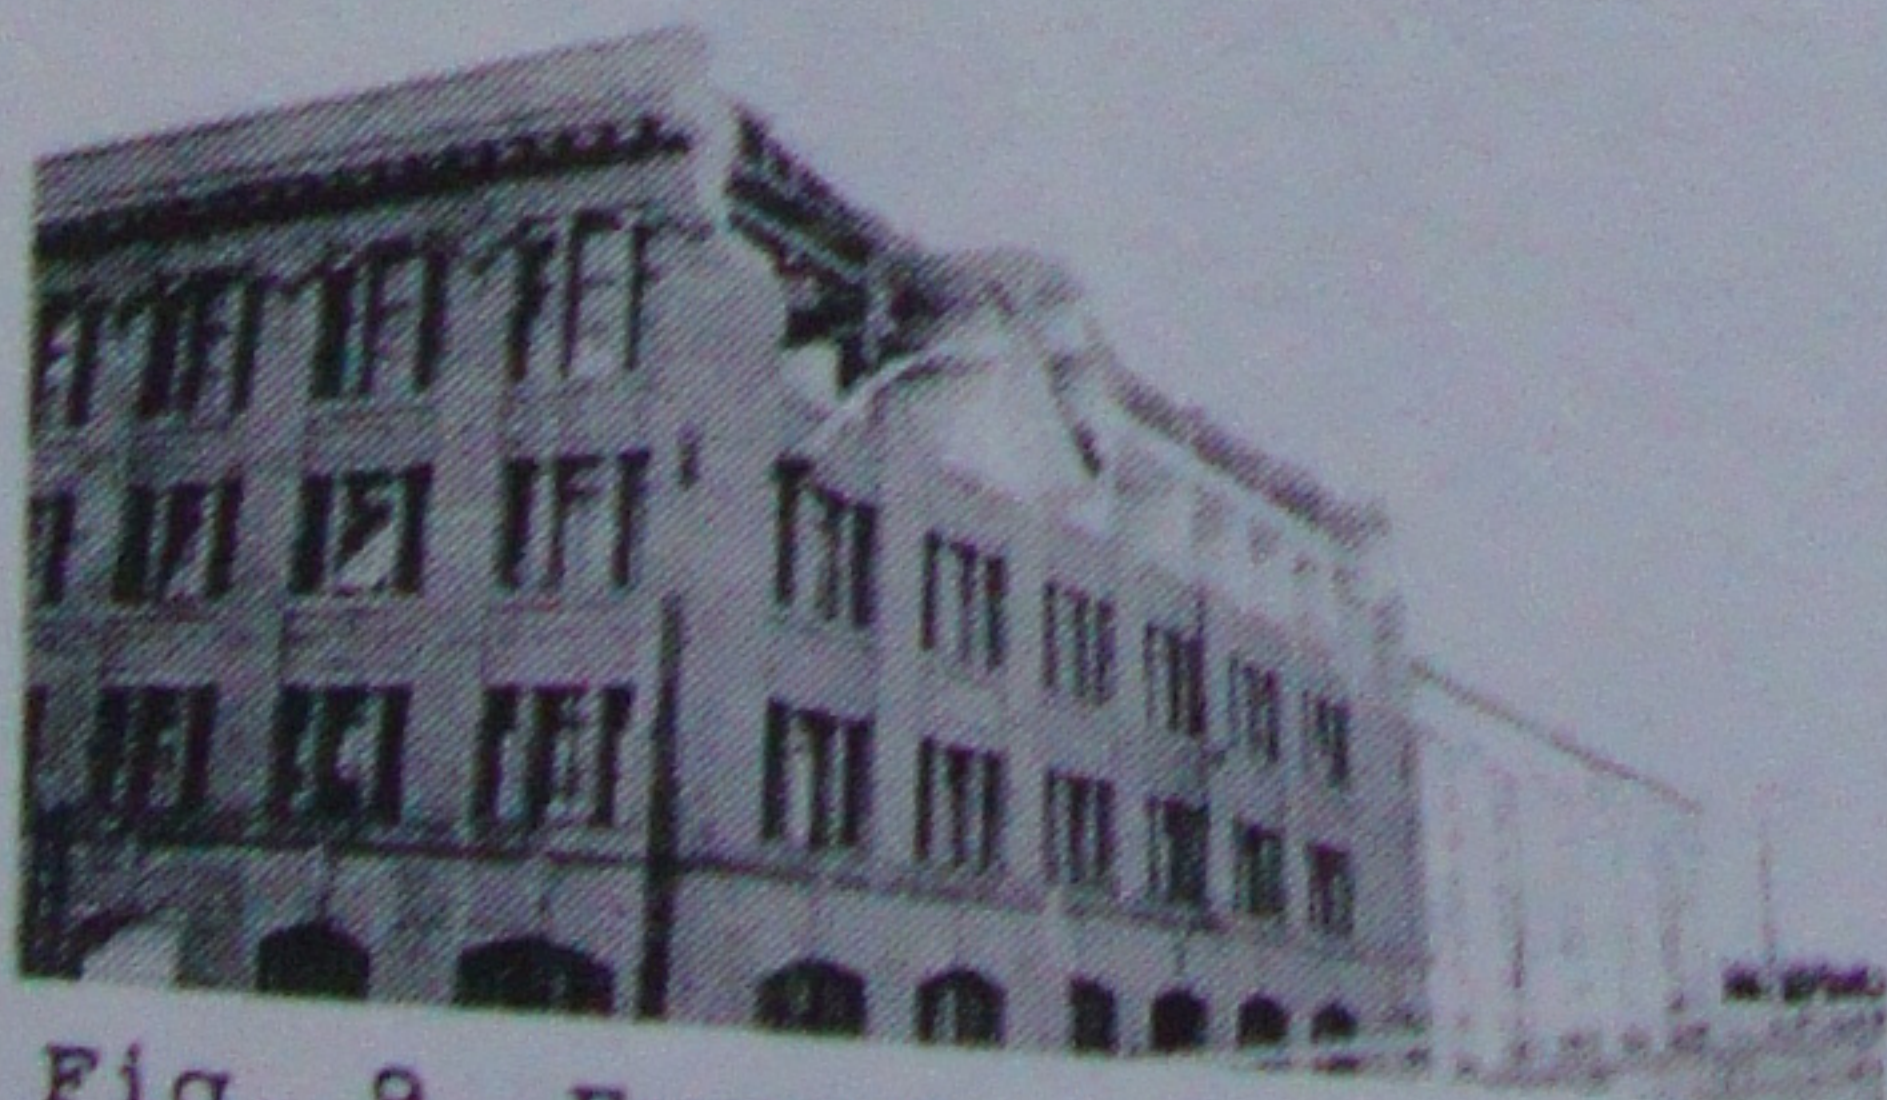
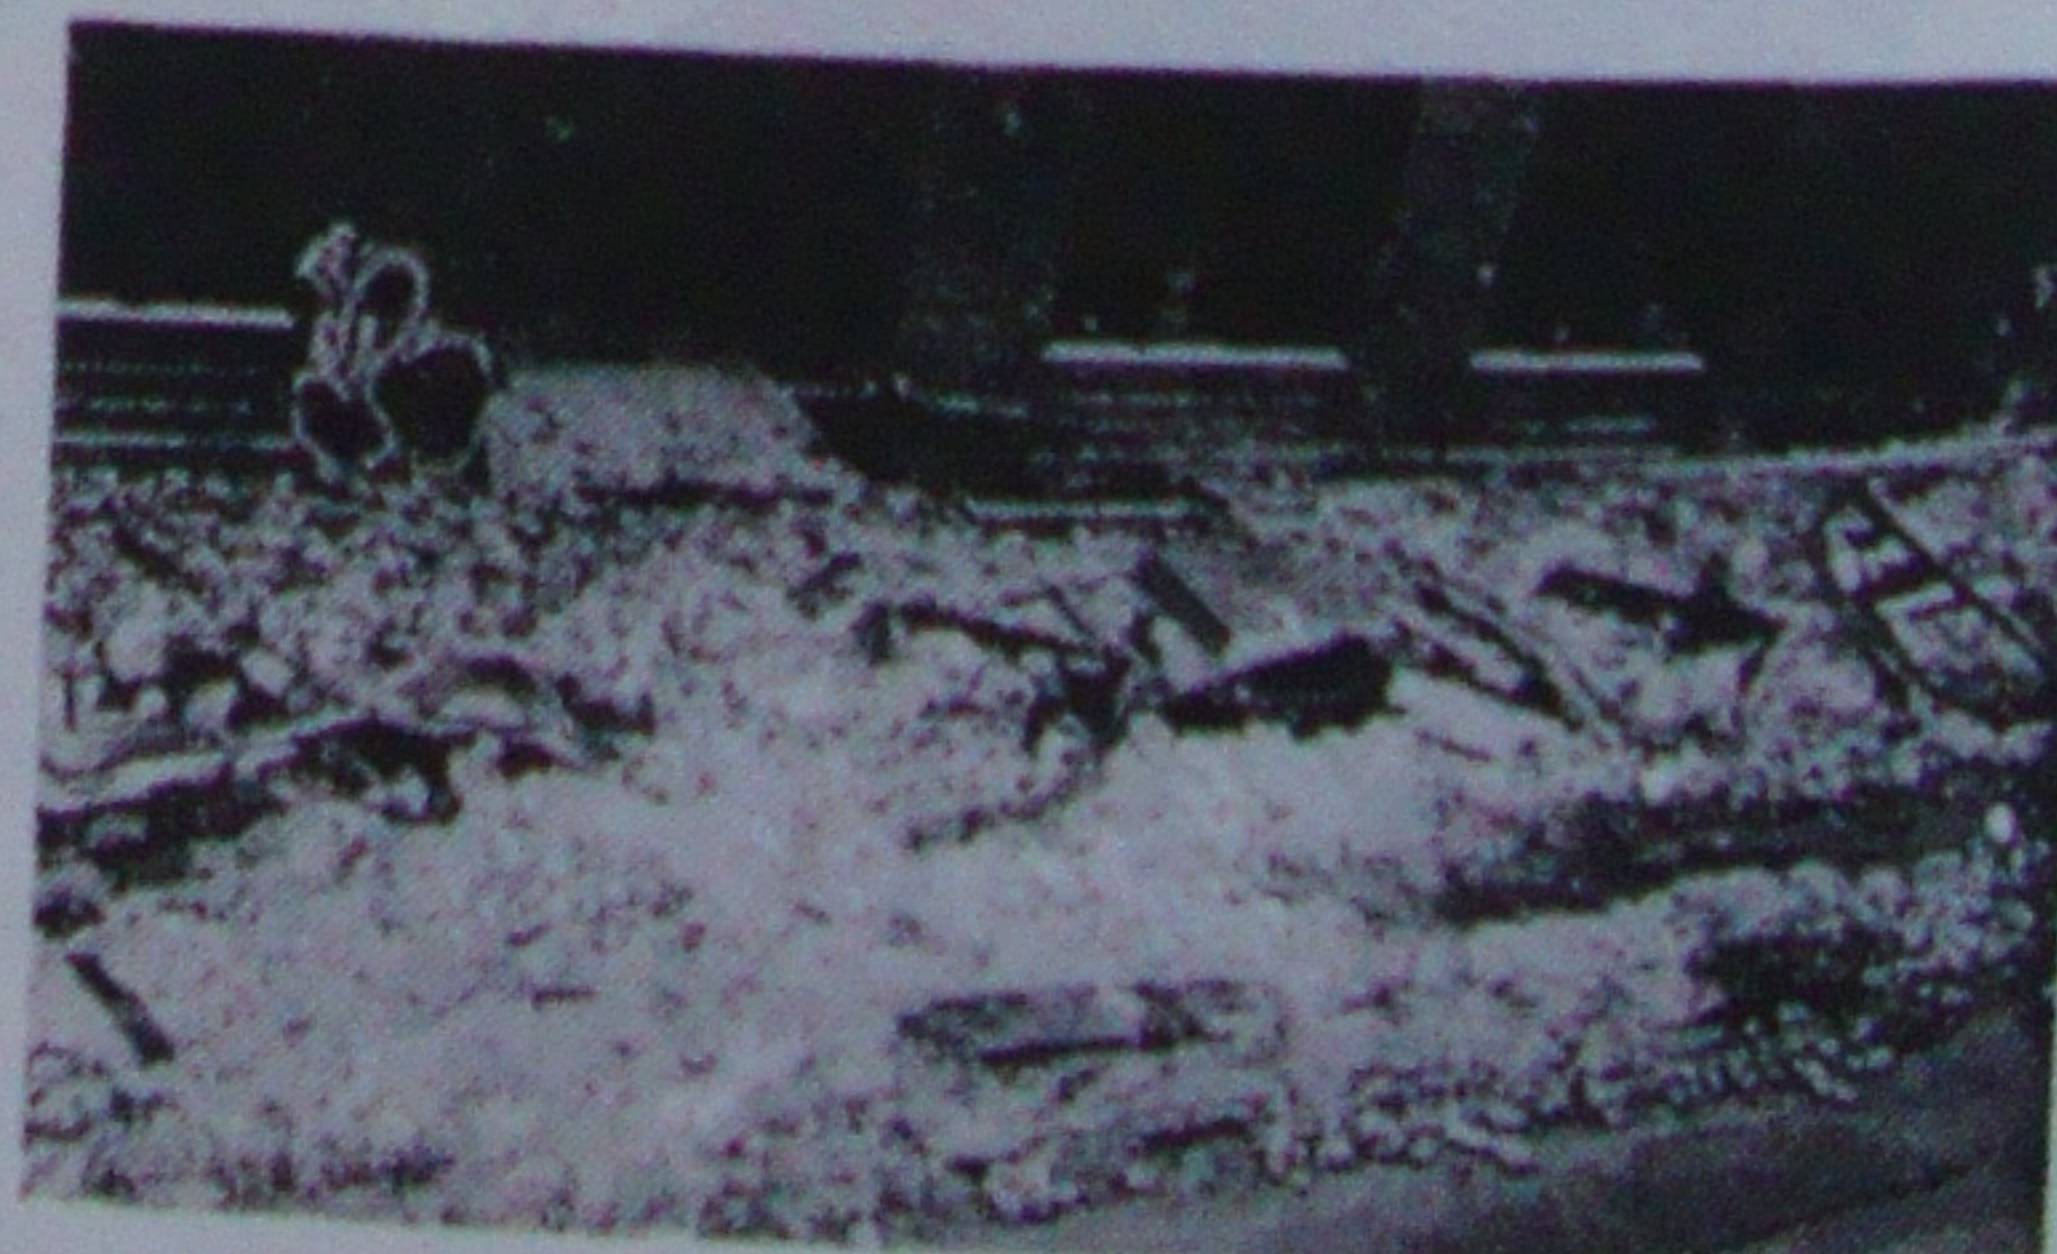
Bluxome Street, San Francisco: - The building is a 4 story masonry structure having a large floor area. It was built in 1922. The building is located adjacent to a relatively modern 3 story reinforced concrete storage building having nearly the same floor area (Fig. 9(a)). The exterior walls of these buildings have virtually no separation. The building pounded at the roof level of the adjacent building, and the wall above the pounding level collapsed (Fig. 9(a)). The clear pattern of damage above the pounding level suggests that pounding may have contributed to this catastrophic event. As Fig. 9(b) shows, the cars parking on the street were completely crushed by the large amount of falling bricks and 5 people were killed. This case is classified as Type-1 and 2 damage.

Fig. 9 Example pounding damage (Bluxome Street, San Francisco)
