Northridge: the Role of Welding Clarified

D.K. Miller¹

ABSTRACT

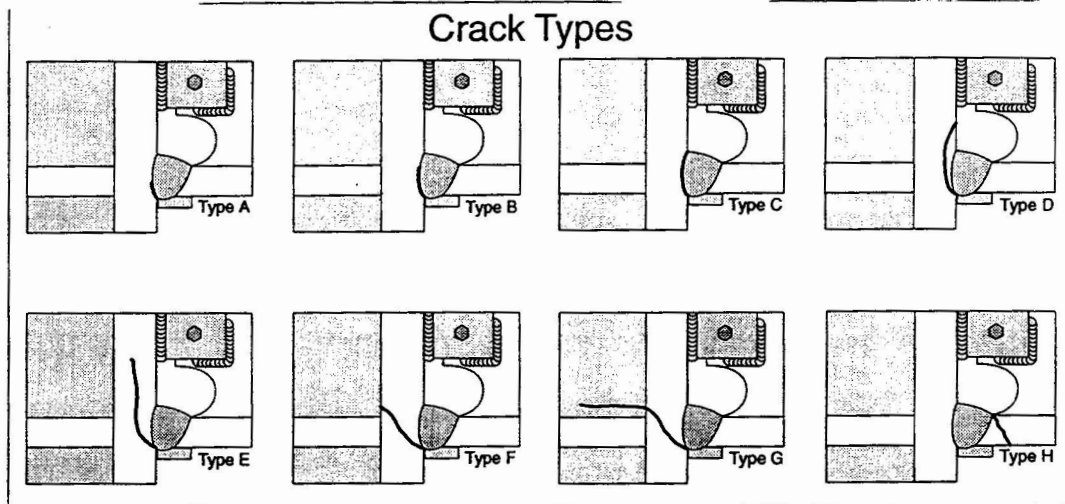
The nature of the fracture to the bottom flange, however, varied from structure to structure, and even within a specific building. The accompanying drawing illustrates the eight types of cracks that have been observed. Of the eight, seven have their point of initiation at the intersection of the bottom side of the bottom flange to the column flange. This is in the area where the fusible steel backing intercedes the column and beam.

Type A cracks initiate at the region of the backing bar where the beam flange and the column flange come together at a 90° angle. The cracks initiate at the root of the weld, following the zone immediately between the weld and the column flange material, that is, the fusion line. A Type A crack is defined as extending upwards less than one-half the beam flange thickness.

Type B cracks are similar to Type A, except by definition, they extend more than half-way through the bottom flange. However, they do not exit to a surface. Again, the only reason to distinguish between these two types of cracks is that the repair procedures employed are slightly different between the two details. From the underside of the beam, Type A and B cracks are evident in the separation of the backing from the column.

Type C cracks can be viewed as an extension of a Type B with a crack exiting at the weld toe. For purposes of definition, the exit point is at the weld face, weld toe, or within 1/4 inch of the weld toe in the column flange. These cracks typically follow immediately along the fusion zone. At first glance, this crack type has the general characteristics associated with either lamellar tearing or underbead cracking.

Type D cracks begin like Type A's, but the crack turns into the column flange material, and exits well above the toe of the groove weld. The fracture is clearly in the base metal. As viewed from the end of

the floor beam, looking toward the column face, Type D cracks usually occur on either side of the web, creating two flattened arch-like exit points. In the center of the face of the column flange, the Type D may become a Type C.

Type E cracks are very similar to Type D, but they are buried within the column flange and do not exit to a free surface. Type E cracks can only be positively identified with ultrasonic (UT) inspection. During repair of damaged structures, it has been found that fractures expected to be Type A or B are frequently Type E.

Type F cracks are similar to Type E, but the crack moves into the column flange, and may exit on the interior face of the column. The exit point is typically at the toe of the weld that joins the continuity plates to the inside of the flange. There are some reports of the exit point being below the continuity plate although this is the exception.

Type G cracks are akin to Type F, but the crack continues into the column web. Perhaps the most disturbing of all crack types in some structures, there are Type G cracks that initiate at either side of a column, resulting in complete horizontal fracturing of the column. Of course, the columns are in compression and some lateral stability is offered by the presence of the deck.

The final type of crack is identified as Type H. It initiates at the toe of the weld, or at the intersection point of the weld access hole and the bottom flange of the floor beam. The crack may go through the weld metal, the base metal, or a combination of the two.
