Lessons Learned from Damage to Water Supply Pipelines Due to the 1995 Hyogoken Nambu Earthquake in Japan

Earthquake damage to water supply pipelines during the 1995 Hyogoken Nambu earthquake (Kobe earthquake) was investigated. An overview of the damage to water supply pipelines in Kobe city was presented and the relationship between the damage to water supply pipelines, pipe diameter, geological features and so on was studied. The lessons learned from the damage in the 1995 Hyogoken Nambu earthquake was discussed.

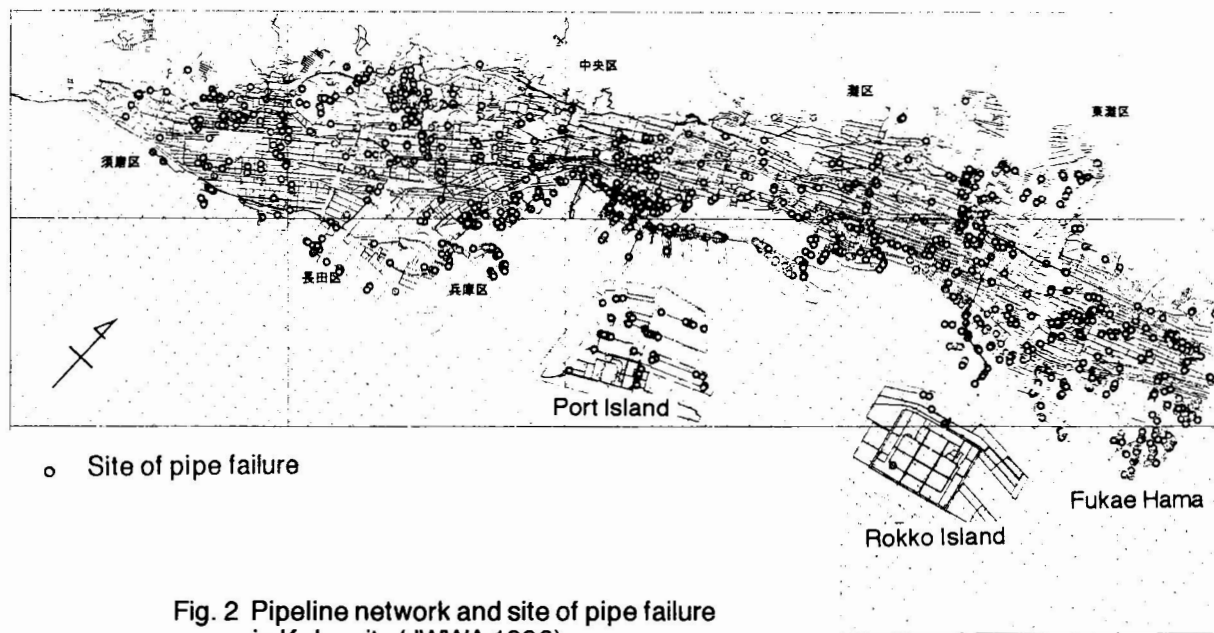
Fig. 2 shows the pipeline network and sites where the pipe failure occurred (Japan Water Works Association 1996). The total number of failures for distribution pipelines was 1,757. The damage rate, defined as the amount of failures per length of pipeline, was about 0.44/km. Fig. 3 indicates the percentage of damage occurrences related to the type of failure. About 55% of the total failures occurred at a joint and the separation of the pipes at joint was remarkable. Fig. 4 shows the relationship for damage rate, pipe diameter and type of failure. It is evident from this figure that the damage to pipe fittings such as valves, hydrants, etc. occurred mostly in the large diameter pipelines. Fig. 5 indicates the relationship for number of cases of damage, pipe diameter and type of failure. According to this figure, number of cases of damage to pipe fittings in large diameter pipelines is not so great. The high damage rate of pipe fittings in the large diameter pipelines seems to depend on the short length of the large diameter pipelines. It is conceivable that the strength

Fig. 2 Pipeline network and site of pipe failure in Kobe city (JWWA 1996).

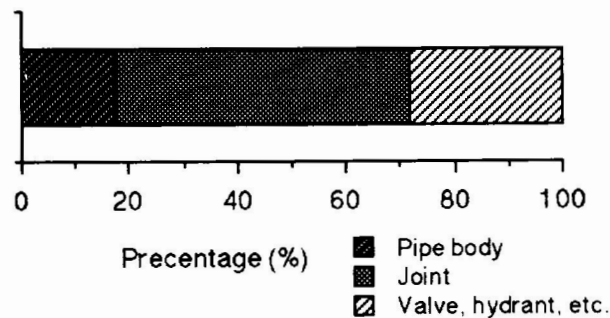
Fig. 3 Percentage of damage occurrences to type of failure in Kobe city.

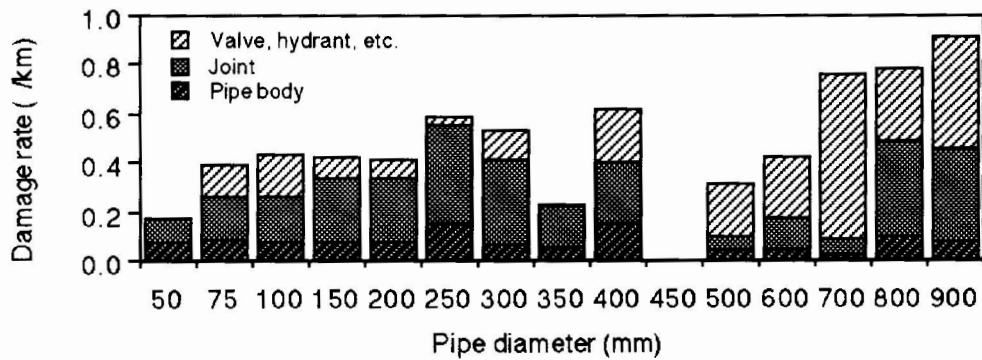
Fig. 4 Relation for damage rate, pipe diameter and type of failure in Kobe city.

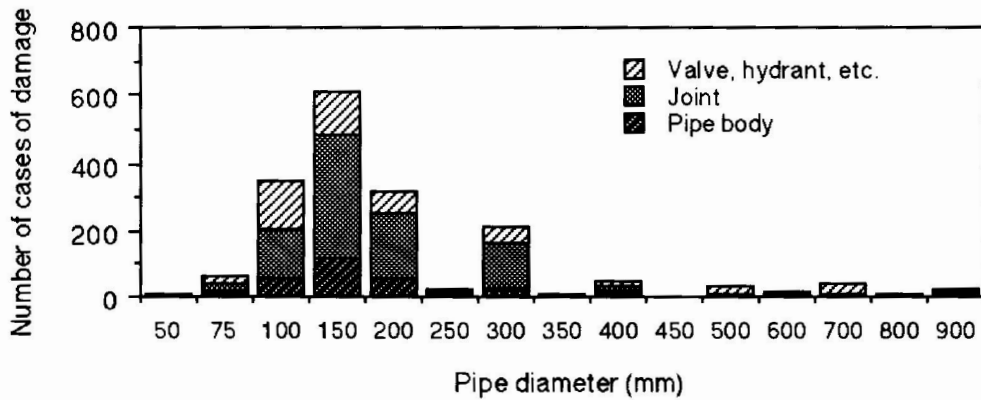
Fig. 5 Relation for number of damage occurrences, pipe diameter and type of failure in Kobe city.

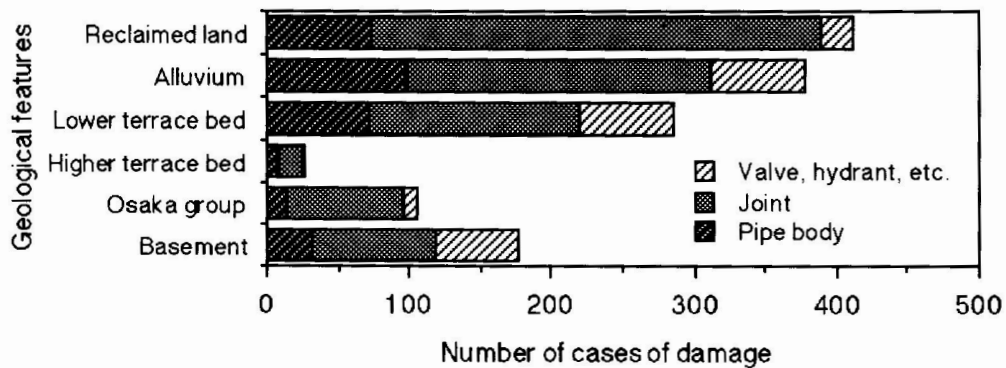
The urban area of Kobe city is situated on a narrow and long strip of land in the east-west direction and its height above sea level varies from 0 m to 300 m. The topography and geological features, therefore, change drastically there. There are some artificial islands and the reclaimed land is extensively located in the southern area of the city. The northern part is mountainous with granite bed rock. Fig. 6 shows the number of cases of damage related to the geological features. The number of cases of damage in reclaimed land was the highest and that within alluvium even greater. Pipe failures within soft ground were extensive and liquefaction in reclaimed land affected damage to pipelines strongly. Even the number of cases of damage in basement rock was not as small as expected. The ground deformation induced by the seismic faults seems to be one of the causes of damage to pipe failure. Since the length of piping in each area was not clearly defined unfortunately, the damage rate can not be discussed here (Kitaura and Miyajima 1996).

Fig. 6 Relation for number of damage occurrences and geological features for Kobe city.

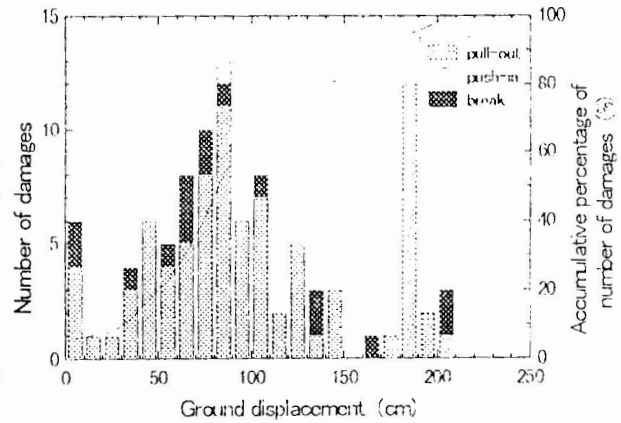
The relation between permanent ground displacement and damage to pipeline was investigated in three areas of reclaimed land, that is, Mikage-Sumiyoshi Hama, Uozaki Hama and Fukae Hama in Kobe city. These areas were reclaimed by decomposed granite between 1960 to 1970. Fig. 7 indicates the relationship between horizontal permanent ground displacement and the number of cases of damage. The horizontal permanent ground displacement in this figure indicates the nearest one within 50m from the site of each pipe failure. It is evident from this figure that the pull-out of the pipes at joint was remarkable. This figure also suggests that many pipe failures were caused at sites where the permanent ground displacement was greater than about 70 cm. The permanent ground displacement was divided into the axial direction and the direction of perpendicular to the axis. Figs. 8 and 9 show the relationship between the horizontal permanent ground displacement in each direction and the number of cases of damage. There is no marked difference between two figures (Miyajima et al. 1998). Fig. 10 shows the principal ground strains and sites of pipe failures in northern part of Fukae Hama. According to this figure, pipe failures were occurred at sites where the large ground strains appeared.

Fig. 7 Relationship between number of damage occurrences and horizontal ground displacement.

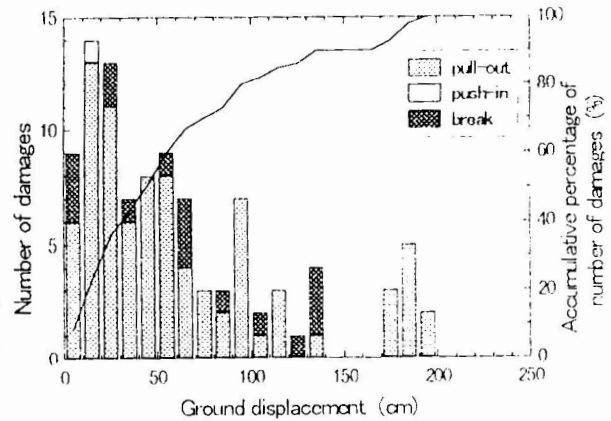
Fig. 8 Relationship between number of damage occurrences and horizontal ground displacement in axial direction.

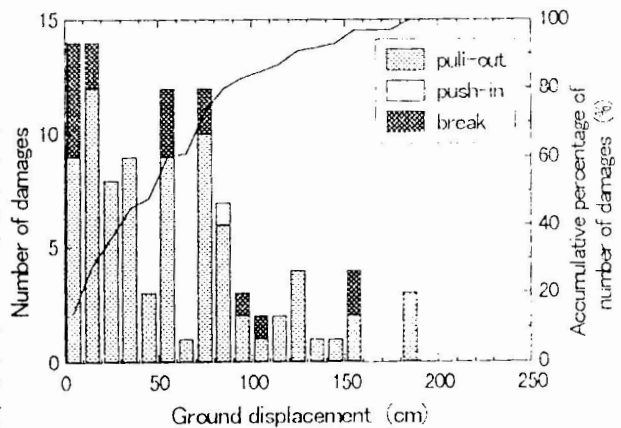
Fig. 9 Relationship between number of damage occurrences and horizontal ground displacement in direction of perpendicular to the axis.

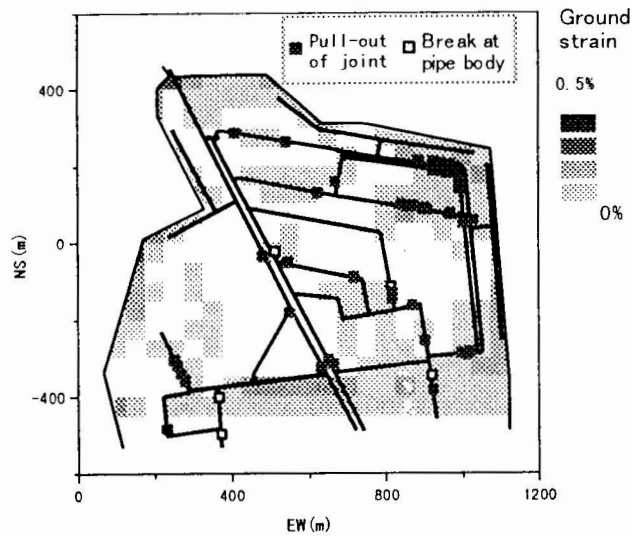
Fig. 10 Distribution of principal ground strain in Fukae Hama.

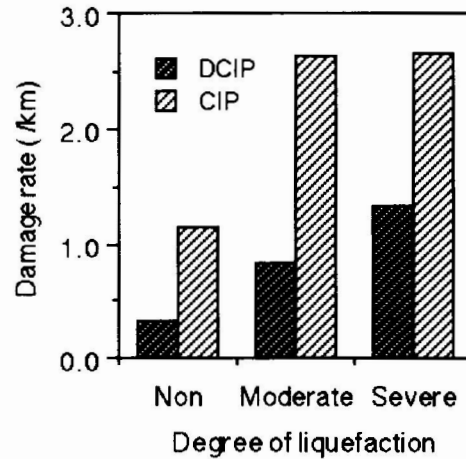
Fig. 11 shows the relationship between damage rate and degree of liquefaction (Japan Water Works Association 1996). The degree of liquefaction was evaluated by the area covered by sand erupted by liquefaction. The damage to pipelines installed in Kobe, Ashiya and Nishinomiya cities was totaled. According to this figure, the damage rate of cast iron pipe constructed in severely liquefied areas was two times greater than that in non-liquefied areas and the damage rate of ductile cast iron pipe with mechanical joint installed in severely liquefied areas was four times greater than that in non-liquefied areas. Ductile cast iron pipelines with earthquake-proof joints, however, did not suffer damage even in severely liquefied areas. Fig. 12 shows the cross section of mechanical (K type) and earthquake-proof (S type) joints. The expansion-contraction value of the earthquake-proof joint is 1.0% of the length of the pipe.

Fig. 11 Relationship between damage rate and degree of liquefaction (JWWA 1996).

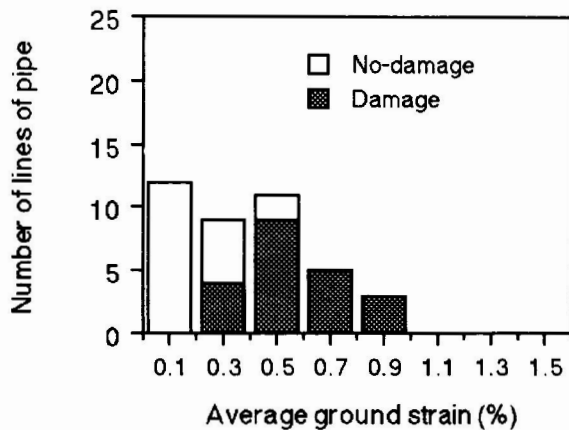
Figs 13 and 14 displayed the relationship between number of lines of pipe, that means the pipeline between a junction and other junction, and average ground strain (Japan Water Works Association 1996). The number of lines of pipe that suffered damage by the earthquake, was indicated by shadow in these figures. The average ground strain means the average value of axial and transversal ground strains at the line of pipe. The pipelines installed in some reclaimed land, that is, Port Island, Rokko Island and Ashiya-Hama was summed up in this figure. Ductile cast iron pipe with mechanical joints suffered damage when the average ground strain was 0.2 to 0.4% and damage occurred at all of lines of pipe when the average ground strain was greater than 0.6%. On the other hand, ductile cast iron pipe with earthquake-proof joints did not suffer damage even at the average ground strain of 1.0%. This coincides with the fact that the expansion-contraction value of the earthquake-proof joint is 1.0% of the pipe length as mentioned above.

Fig. 13 Relationship between number of lines of pipe and average ground strain (Mechanical joint).

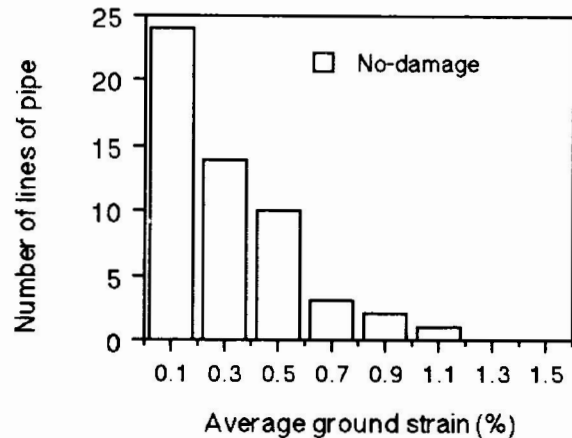
Fig. 14 Relationship between number of lines of pipe and average ground strain (Earthquake-proof joint).
