## **Repair of Three Long Span Steel Bridges Damaged During the 1995 Hyogo-ken Nanbu (Kobe) Earthquake**

John C. Wilson<sup>1</sup>

The 1995 Hyogo-ken Nanbu (Kobe) earthquake was the world's first experience with an earthquake that caused moderate damage to long-span bridges. This paper reviews damage and describes techniques used to repair three major steel bridges along the Wangan Route (Bayshore Route) in Kobe: the 485 m Higashi-Kobe Bridge, the 217 m Rokko Island Bridge, and the 252 m Nishinomiya Port Bridge. These bridges had been in service for less than three years. Failure of bearings and seismic restrainers were principal initiators of the damage to these bridges. Significant constraints on repair of these bridges included confined working space and requirements for maintaining maritime navigational clearances. Repairs utilized heavy-lift floating cranes (up to 4,100 ton capacity) and various capacities of jacks to realign the spans. In one case reconstruction of a collapsed span was required, with lifting weight a prime concern. The back-to-service time for these three bridges ranged from three to nine months.

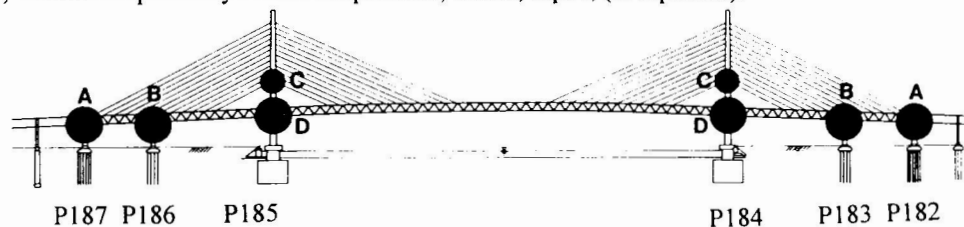
The Higashi-Kobe Bridge (Figure 1) is a three-span (200 + 485 + 200 m; deck width 13.5 m) continuous all-steel double-deck cable-stayed bridge. The bridge was opened to traffic in 1992. A unique feature of the seismic design is that the main girder was allowed free longitudinal movement at all piers and towers (no bearings were used), to achieve a long sway period (approximately 4.4 sec). Two pendulum supports were provided at all piers to provide this longitudinal freedom. Oil vane dampers were used at the end piers for longitudinal displacement control of the girder during an earthquake. Wind shoes on the piers and towers were used to transfer transverse wind loads.

The significant damage to this bridge occurred at west pier P187 (Figures 1 & 2) where the connections between the girder and the two pendulum tension supports, wind shoe, and two oil dampers were all severed. The large pendulum shoe plates (keeper plates) holding the pin in the upper eye of the pendulum were bent away from the pendulum as a result of transverse motions of the girder, and the bolts on the wind shoe and oil dampers failed in a combination of tension and shear at extremely large deformations. The tension in the cables lifted the end of the girder at P187 by approximately 0.5 m. On P187 there was shear-induced buckling in the cross-beams and compression buckling in one leg. Shear-induced buckling also occurred in the cross-beams of P186 and P182 and on some of the approach piers. The wind shoe at P182 was also damaged, as were earthquake restrainers on the approach span at P187.

Figure 1 The Higashi Kobe Bridge (200 + 485 + 200 m spans): pendulum supports at A,B; wind shoes at A,B,D; oil vane dampers at A (Hanshin Expressway Public Corporation).

Repairs to the pendulum supports required extensive work. The bent shoe plates were first cut from the girder, and the pendulum support arm was cut just below the upper eye (Figure 2). This was done to facilitate removal of the damaged part of the pendulum from the pier, as there was limited clearance between the pier top and girder, and also because the original field connection on the pendulum arm was near the lower eye. These parts, along with the 0.5 m diameter pins, were removed for shop inspection, repair and reassembly. The two pendulum supports at P187 were restored by lowering the girder using 130 tons of counterweight (trucks parked on the deck) and 8 x 100 ton jacks. The reassembled components were then reconnected to the pendulum arms using new bolted splices (Figure 2).

Wind shoes on P182 and P187 were temporarily repaired with new bolts increased in size and strength as much as possible. Cracking in one of the shoes was repaired with welding. The wind shoes were eventually replaced with new shoes designed for higher seismic force levels. The oil dampers at P187 were damaged beyond repair and were replaced with new ones of the same design.

Buckling in the leg of P187 was repaired by welding T-shaped rib plate reinforcement on the outside surface of the leg, extending about 1 m on either side of the buckled area. Cover plates were installed over the rib reinforcement. Where major shear buckling had occurred in the pier cross-beams this was repaired by replacing the web steel. Repair of less minor shear buckling was done by heating the buckled plates and adding additional reinforcement. Finally, cable tensions were checked. The bridge was re-opened in April 1995.

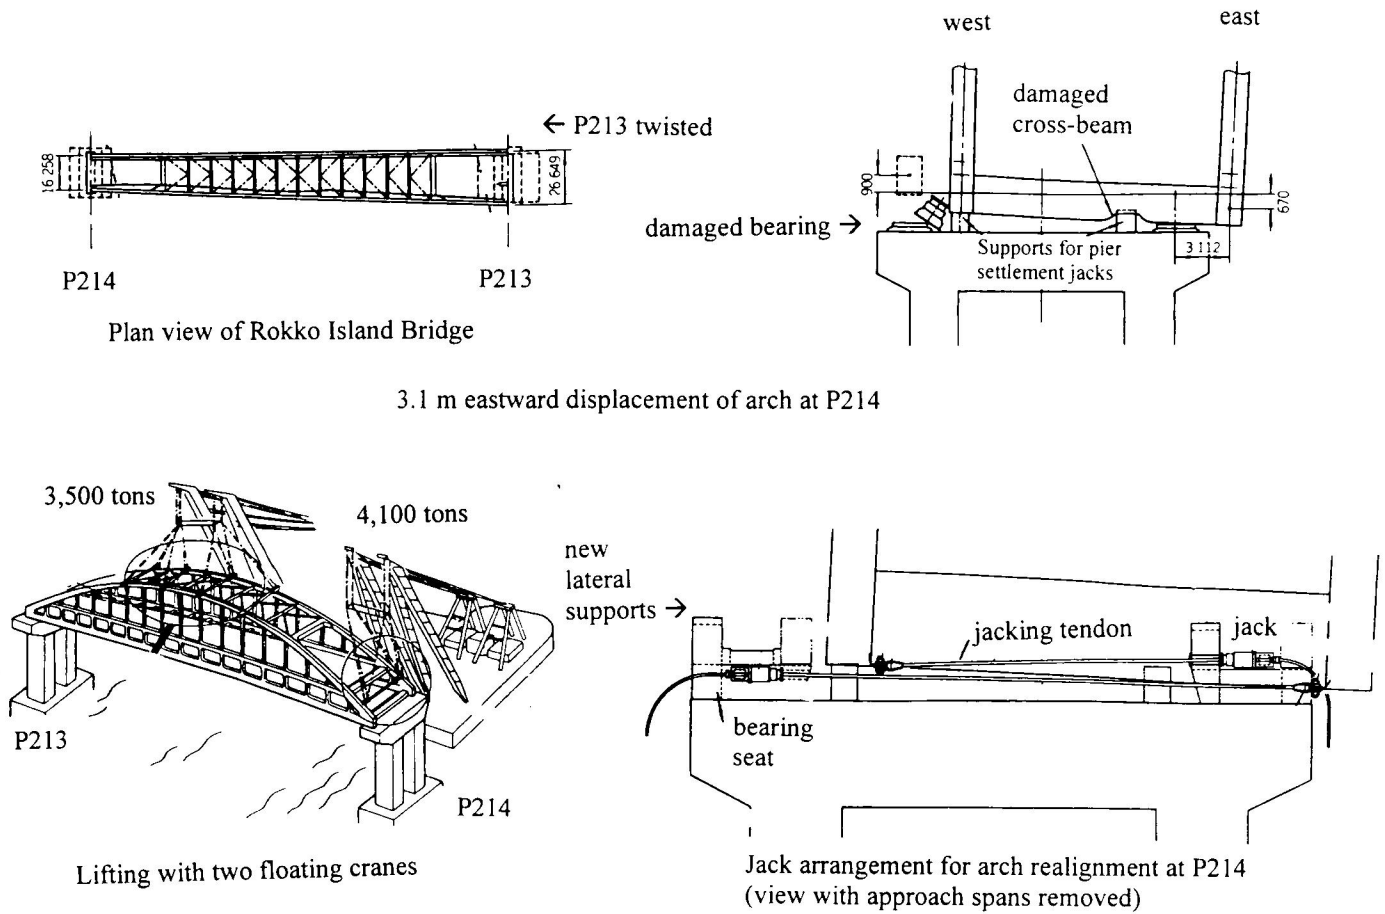
The Rokko Island end of the arch at P214 was displaced transversely (to the east) by 3.1 m (Figure 4) destroying the bearings at this end of the bridge. This left the south end of the east arch unsupported by the pier. The north end pier P213 was twisted as a result of this lateral displacement. The approach spans were dragged eastward by the displacement of the arch and contacted the upper deck columns on the approach pier. Buckling occurred in the upper lateral bracing between the two arch ribs. Shear-induced buckling was observed in the cross beams of several approach piers and on

P214, similar to that observed on the Higashi-Kobe Bridge. There were also failures of the earthquake restrainers and expansion joints at P214 due to the large transverse displacement of the end of the arch span. Large ground settlements were observed around the south approach piers due to movement of the quay walls.

Figure 4 Damage and repairs to the Rokko Island Bridge (Yonekura et al., 1996)

To realign the arch span, the south double deck approach spans between P214 and P215 were temporarily removed (Figure 3). There was not sufficient vertical clearance under the cross-beam to lift the end of the span with jacks, and so two floating cranes were used; a 4,100 ton crane lifting at the damaged end, and a 3,500 ton crane lifting at the centre (Figure 4). These cranes were used for lifting only. Transverse realignment was completed using a system of 200 ton jacks and tendons on top of P214, jacking against the bearing supports and pulling on the ends of the arch ribs (Figure 4). New bearings of the same design as the originals were installed. Lateral stoppers were added to the bearing mounts, a modification to the original design. The upper and lower cross-beams were repaired as well as the top lateral bracing. After all this work was completed the approach spans were re-erected. The bridge was re-opened in October 1995.

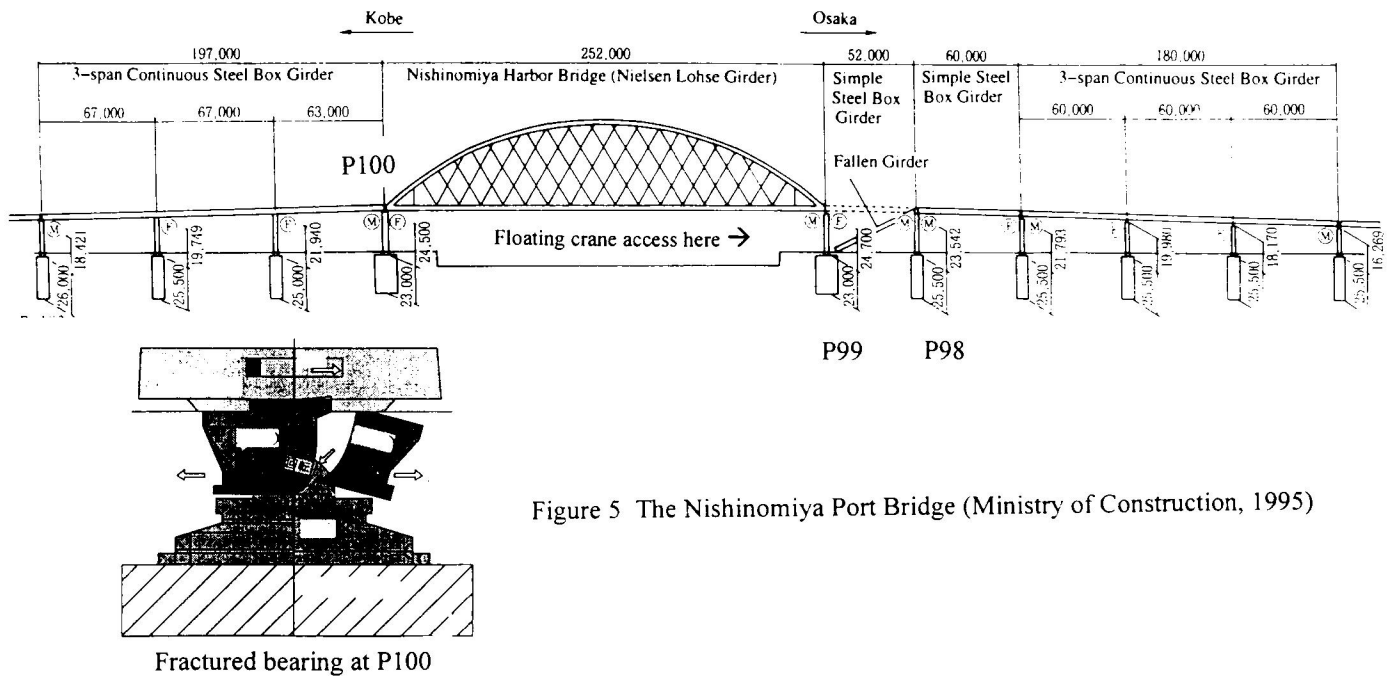
The Nishinomiya Port Bridge (Figure 5) is a 252 m cable arch bridge with a single level steel deck with width that varies from 27.3 m to 31.2 m. The total weight of the arch span was 12,000 tons. The approach spans immediately to the east, between P97 and P99 were simply supported box girders composite with a concrete deck. All other approach spans were continuous construction. The bridge was completed in 1993.

At the west (Kobe) end of the bridge at P100 the cast bearings supporting the arch span were fractured (Figure 5). At the east end, the 52 m approach span slipped off its bearings at P99 and collapsed. This was caused by the main arch span being pulled westward at the same time as the east arch pier rotated about its base as a result of liquefaction and lateral-spreading induced deformations at the base of the pier immediately adjacent to the quay walls along the port entrance channel. This resulted in 17 cm of permanent movement of the top of P99 towards the channel (west). Two single-bolt restrainers were provided at P99 between each of the three approach box-girders and the cross-beam of the arch span. However, the restrainer connecting plates tore out and there was insufficient seat width to accommodate the displacement at the top of P99. In addition to Bruneau, Wilson and Tremblay (1996), detailed descriptions of the damage and damage mechanisms are also given by Ministry of Construction (1995).

Figure 5 The Nishinomiya Port Bridge (Ministry of Construction, 1995)

At P100, six 1,200 ton jacks were used to temporarily stabilize the end of the span while the damaged bearing assembly was replaced. Fabrication of a new bearing took approximately 2-1/2 months, a time shorter than usual because the company still had the mold from production of the original bearing. Tensions in all the cables were also checked.

Replacement of the collapsed approach span was more problematic. The span was too heavy (1,900 tons) to be lifted out in one piece by floating cranes. Consequently, the concrete deck was cut into blocks weighing approximately 200 tons and removed. After the deck had been removed each of the three steel box girders were removed in one piece by a 3,600 ton floating crane. The new span was shop-constructed as a steel deck box girder span to minimize lifting weight. This was placed in a single lift using Japan's largest floating crane having a 4,100 ton capacity (Figure 5). As part of the repair, the seat width on P99 for the approach span was increased from 110 cm to 170 cm. Seismic restrainers of the same bolted slotted plate design as the originals were used again to connect each box girder (two restrainers per girder) to the arch span. The bridge was re-opened in April 1995.
