Seismic behavior of masonry buildings - Lessons from the Bovec earthquake of April 12, 1998

Tomažević, Miha¹, Klemenc, Iztok², Lutman, Marjana³

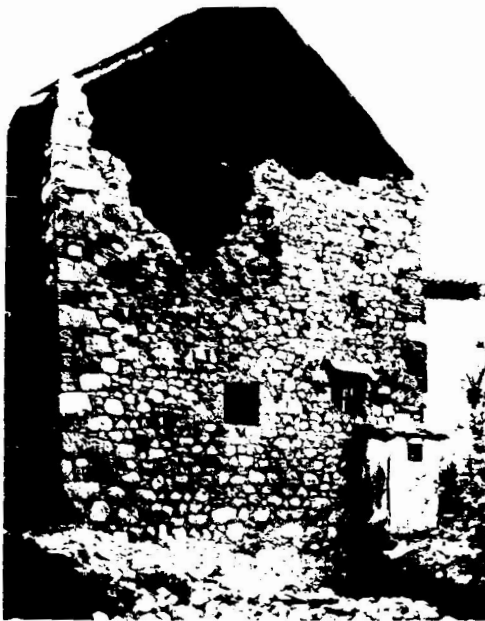
Fig 1. Typical partial collapse of a gable and disintegration of walls of a traditional stone-masonry house

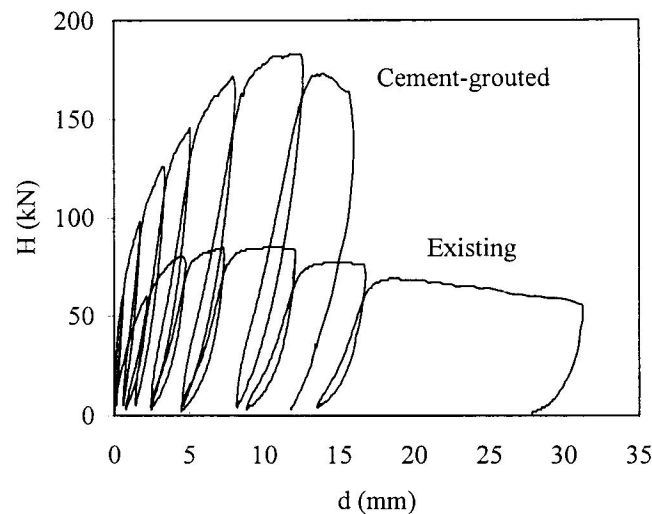
Typical lateral load - deformation relationships, obtained during the in-situ tests of existing and cement-grouted walls, are shown in Fig.5. As can be seen, the tensile strength of stone-masonry, which determines the seismic resistance of stone-masonry buildings of the particular type considered, is significantly improved by cement-grouting of stone-masonry walls.

Fig. 5. Typical lateral load - deformation relationships, obtained by in-situ lateral resistance test of existing and cement-grouted stone masonry wall (building C)
