FULL-SCALE COLLAPSE SHAKING TABLE TEST OF REMOVED AND RECONSTRUCTED HOUSE OF EXISTING WOODEN FRAME CONSTRUCTION HOUSE

K. Miyazawa¹, C. Tsuda², T. Akiyama³ and H. Isoda⁴

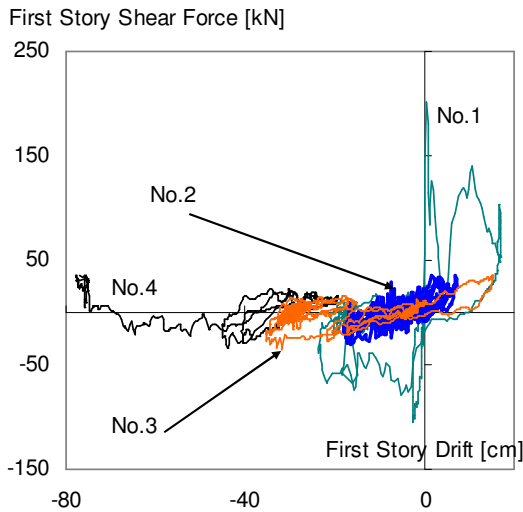
Figure 2. First story shear-story drift

It was not collapsed in the shaking table test No.1, though the X-direction story drift of Y1 frame line in the first story is 23.3cm, Y12 is 25.8cm, and the average is 24.6 cm (Table 5), The maximum average story drift of the first story is up to 1/11rad. (positive and negative are same, Fig. 2). The maximum residual story drift of the first story is as large as 1/60 rad. on the frame line Y1 shown in Table 5.

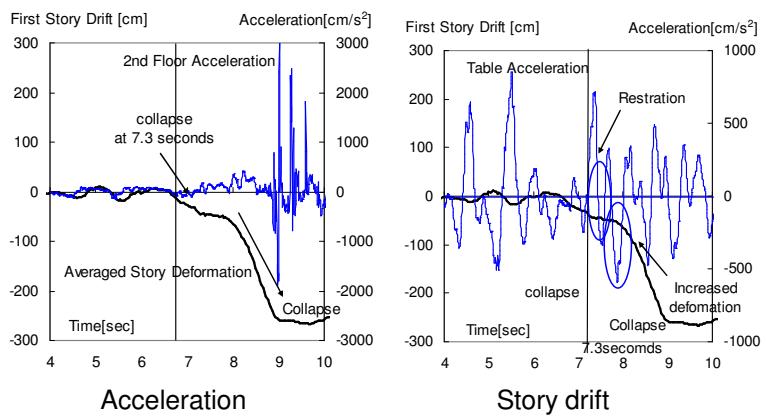
Figure 5. Collapse process (No.4).

Finally, the specimen collapsed in No.4 excitation. At the time of a maximum in-put acceleration of a shaking table, the specimen suffered large vibration in a positive and negative direction shown in Fig. 5, and after the time of 6.5 second, the specimen vibrates in negative direction. At about 7.3 seconds (in-put acceleration is 713cm/s^2 and first story drift is about 1/6rad.), the pull return force to a positive direction is shortage, and began to collapse. And then, it is thought that it greatly distorts and become to collapse into a negative direction at the time of 7.87 seconds.
