RELATIONSHIP BETWEEN STRONG MOTION AND DAMAGE TO HOSPITALS IN THE 2004 NIIGATA-KEN CHUETSU EARTHQUAKE IN JAPAN

M. Miyajima¹, T. Ikemoto², N. Achour³ and J. Inagaki³

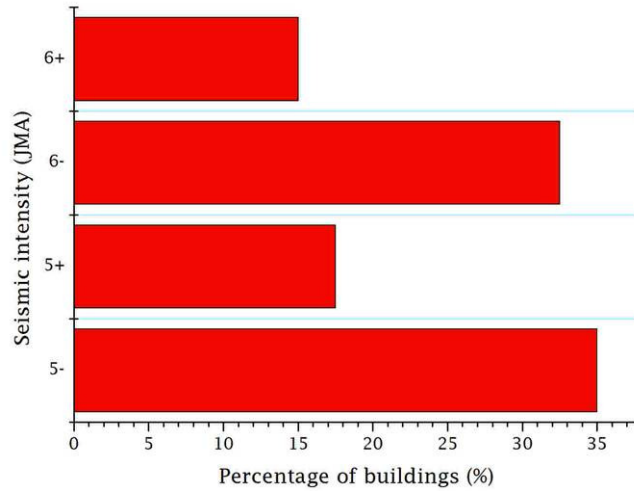
Figure 1. Proportion of buildings and the seismic intensity.

The earthquake caused damage to at least 27 hospitals, which varied between very severe and slight damage. The minimum intensity registered at the site of the facilities was 5⁻ (Japanese Meteorological Agency seismic intensity scale) while the maximum registered intensity was 6⁺. Fig. 1 illustrates that the majority of the facilities suffered intensity 5⁻ and 6⁻. At least 5% of the facilities suffered problems to their entrances, balconies and some of their equipment was displaced and even turned over in some cases. In more than 10% of the facilities there were some cracks in their external and internal walls. Further more, several facilities suffered damage to their lifelines, internal installations and medical equipment, see Tables 2 and 3, respectively for more detail. It should be mentioned that in these tables the sign “●” indicates that the ratio of facilities suffering that type of damage exceeds 10%. While the sign “○” indicates that at least 5% of the facilities have experienced that type of damage. As these tables illustrate, the intensity 6⁺ caused damage to all investigated elements in more than 10% of the facilities.

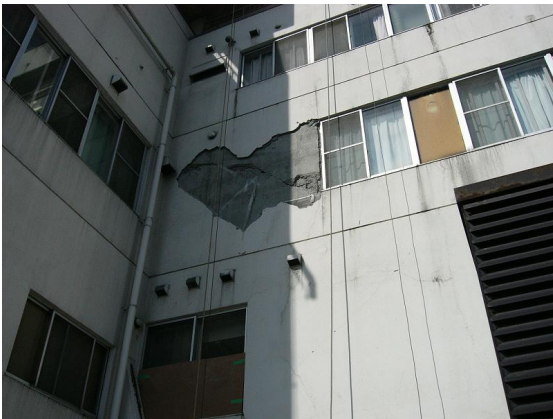
The external walls of various facilities began experiencing cracks at an acceleration of less than 200cm/sec². Concrete started to peel off at about 300cm/sec² as shown in Photo 1. Facilities built before 1970 had the reinforcement of their walls exposed as shown in Photo 2, while those built between 1971 and 1980 did not suffer more than the peeling off of their concrete. Newly built structures did not experience severe damage; only some cracks were found in three facilities. The situation of internal walls was not very different from the external ones; see Photo. 3. Pillars withstood more than walls as the majority of them did not suffer a lot of damage. However, for facilities built before 1970, the reinforcements were exposed. The state of ceilings and flooring was not very different from the main structure, as both elements suffered slight damage to falling and cracks to peeling off of the concrete respectively; see Photo 4.

Photo 1. Exterior wall peeled off, Ojiya Hospital.

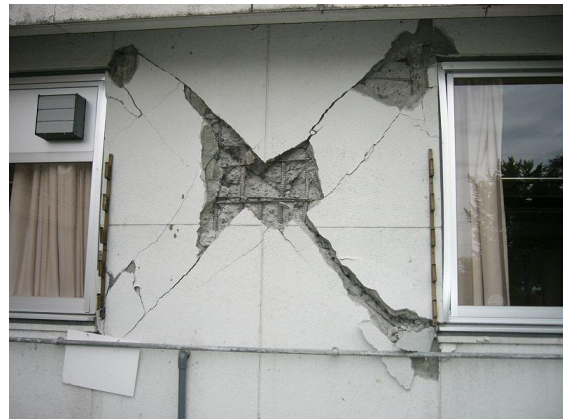
Photo 2. Exposure of reinforcement, Ojiya Hospital.

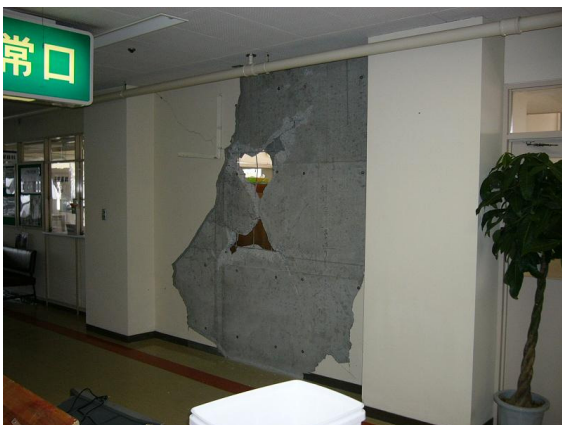
Photo 3. Interior wall peeled off, Ojiya Hospital.

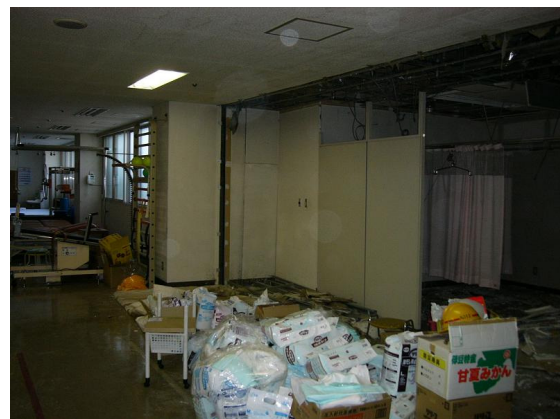
Photo 4. Damage to ceiling, Ojiya Hospital.

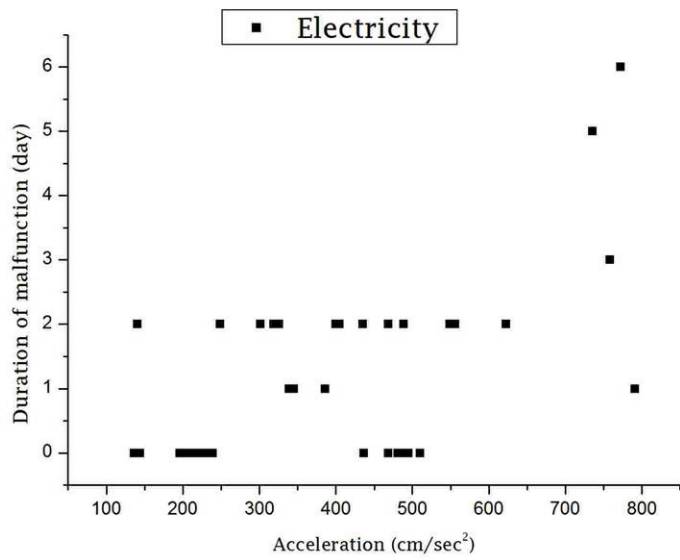
Figure 2. Duration of malfunction of electric power.

150cm/sec² acceleration was able to render some hospitals without electric power for about two days, while an acceleration of 750cm/sec² caused the loss of the electric power for six days, see Fig. 2. Due to the fragility of the piping system, water and gas supplies was damaged more than the electric power system.

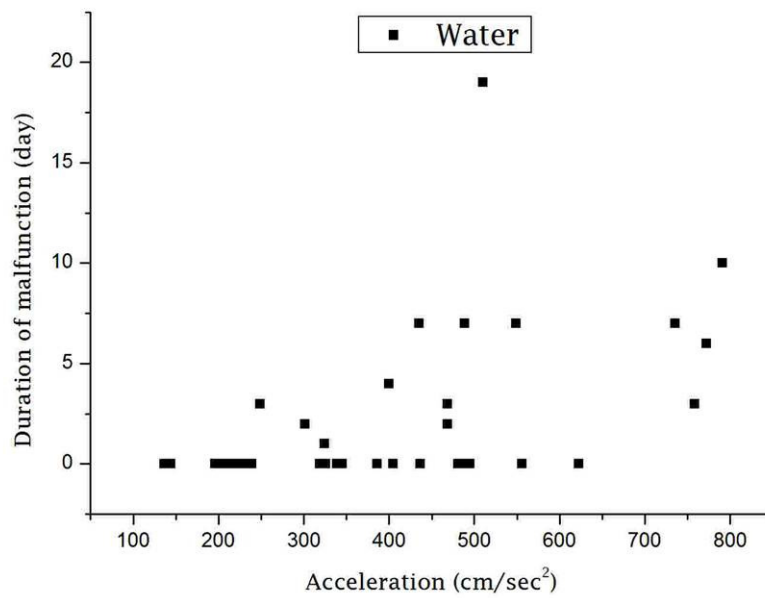
Figure 3. Duration of water supply shortage.

The shortage of water and gas was up to 18 days. An acceleration of 200cm/sec^2 caused a 2-day period of shortage; while higher acceleration can cause the shortage period longer, see Figs. 3 and 4.
