Ninth Canadian Conference on  
Earthquake Engineering  
Ottawa, Ontario, Canada  
26-29 June 2007

## PERFORMANCE OF STRUCTURES DURING THE KASHMIR (PAKISTAN) EARTHQUAKE OF 8 OCTOBER 2005

Shamim A. Sheikh<sup>1</sup>

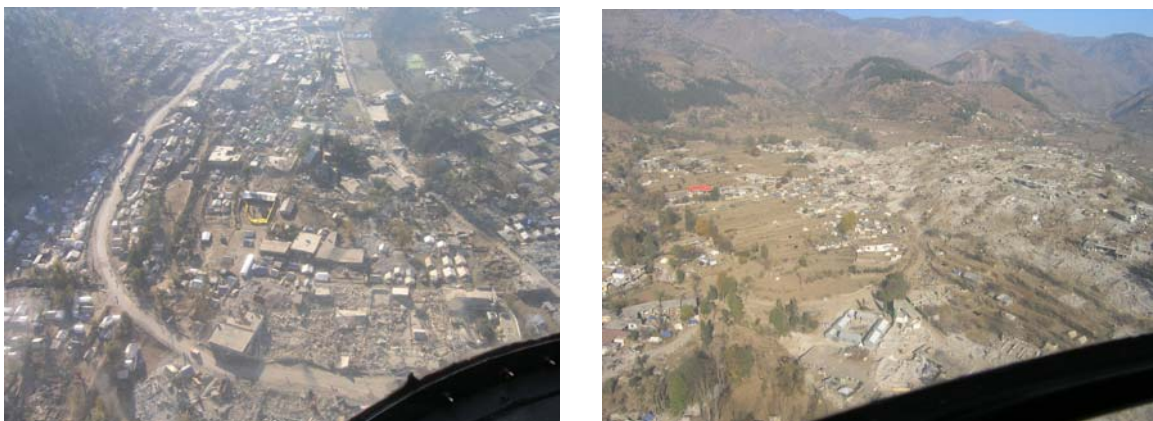
The earthquake left widespread destruction in its wake. The death toll varies from a low estimate of 76,000 to over 100,000 while in excess of 80,000 people were injured. Approximately 300,000 square kilometer of area was affected by the earthquake. The population of this area is about 3.5 million of which 2.8 million were made homeless. As of November 12, 2005, the Asian development Bank (ADB) and World Bank (WB) estimated that of the 787,583 housing units in the area surveyed, 203,579 units were completely destroyed and 196,574 were damaged (ADB-WB 2005). Later reconnaissance showed that in some areas of Kashmir, almost all the housing units were destroyed or severely damaged. Over 60% of the housing units in AJK were completely destroyed and over 30% were severely damaged leaving only about 15% of the units inhabitable. The Government of Pakistan data shows that about 272,019 structures including housing units, educational institutes, medical facilities and government buildings were completely destroyed and 182,886 were severely damaged. Most of the housing units were un-engineered structures while commercial and government buildings, and high-rise structures were mostly engineered or semi-engineered. Figure 3 shows an aerial view of widespread damage around Muzaffarabad.

Figure 3. Aerial view of damage around Muzaffarabad.

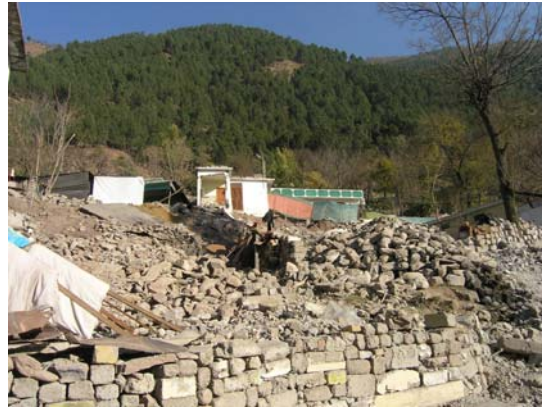
Most housing units in the area were non-engineered. The materials of choice are the stones, mud and wooden beams that are locally available. A typical older low cost house has load bearing walls made of mud and/or stones and roof consists of a combination of wooden beams, corrugated sheets and mud. Mud roofs, although heavy, provide insulation in the extreme cold winters. The stone walls are generally un-plastered (undressed) and the mortar is mud- or lime- based. A slightly more affluent house may have the reinforced concrete slab supported on similar load bearing walls in which the stones are plastered (dressed). In some cases, bricks are used in place of stones. These types of buildings represent about 15% of the housing units in the affected areas and almost all of them were completely destroyed or severely damaged (NWFP 2005). Figure 5 shows a collapsed stone masonry house in Balakot which was the most severely affected area during this earthquake. The heavy roof dead loads caused large inertia

forces that the structures were incapable of carrying. There was minimal connectivity between the roof and the walls. Most of the walls suffered out-of-plane collapse under the roof dead load as soon as the lateral ground motion occurred. It should be noted that in most cases, foundations for these houses primarily consists of bearing of stone walls on a thin (~100 to 150 mm) layer of concrete several centimeters below the ground level.

Figure 5. Collapsed Stone houses in Balakot.

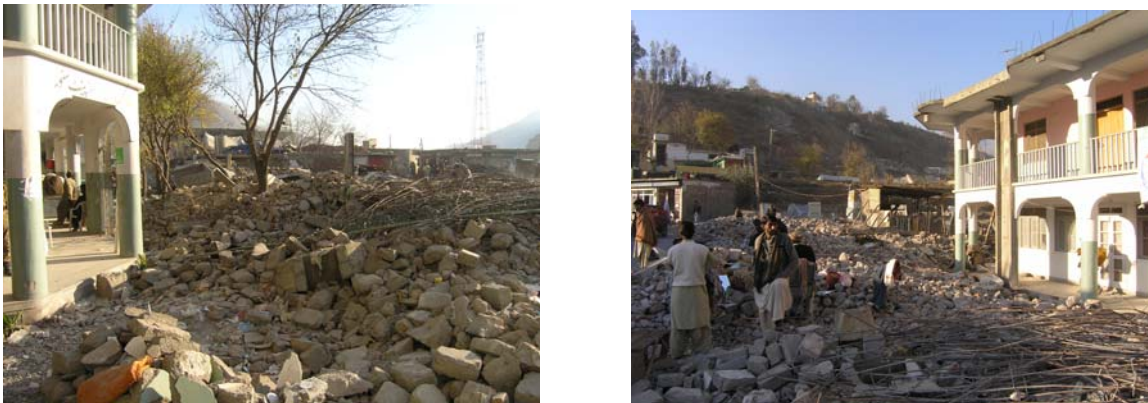
A more modern house construction consisted of un-reinforced concrete block masonry walls and roof made of corrugated sheet or reinforced concrete slab. In general the connectivity between the vertical and horizontal floor elements was poor. The concrete blocks were mostly solid. Foundations of these buildings were mostly in stone masonry and there was minimal anchorage to the ground. In most of these houses cement-sand mortar was used as a binder but with very low cement contents and high water-cement ratio. Approximately 50% of the total buildings in the affected areas were of this type. Although their performance was relatively better than the stone masonry buildings, over half of these structures collapsed or suffered severe damaged. Figure 6 shows a number of un-reinforced concrete masonry structures converted into a heap in Balakot.

Figure 6. Collapsed un-reinforced masonry buildings in Balakot.

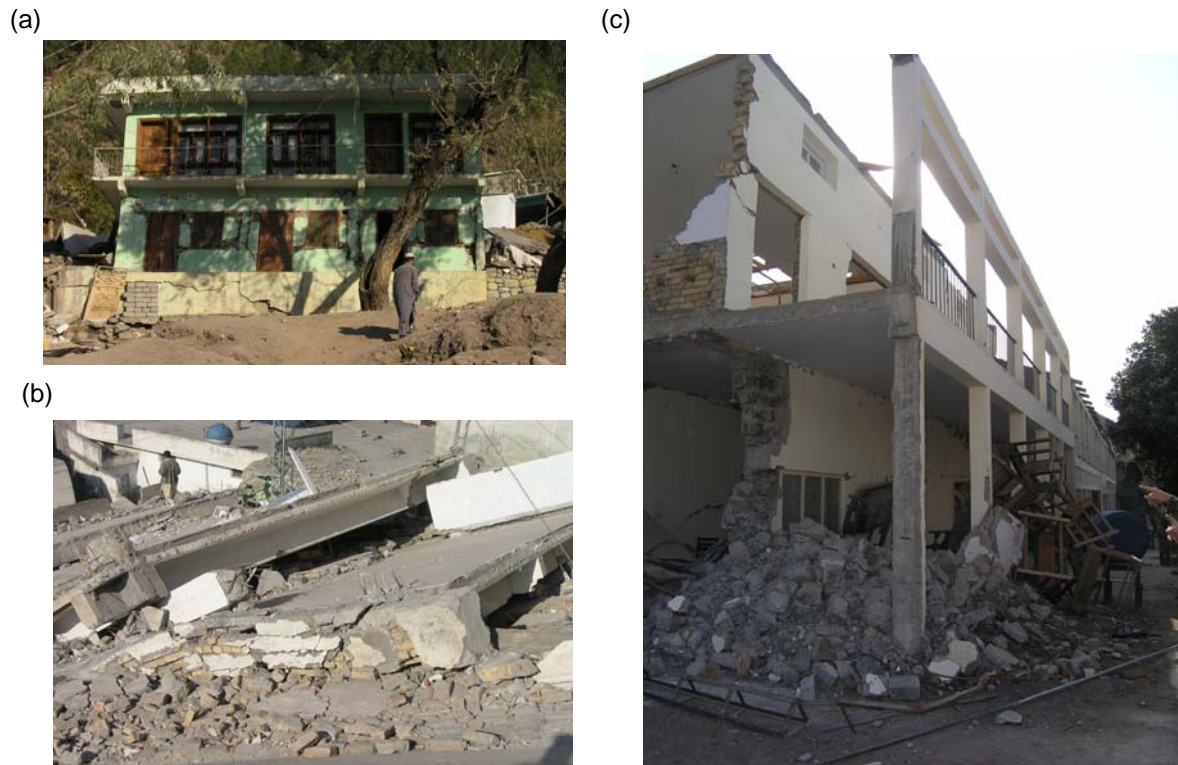
were severely damaged. Foundations in most of these structures were made of stones which contributed to their poor performance. Figure 7 shows three structures one in Balakot and two in Muzaffarabad in which brick masonry was used. The buildings in Muzaffarabad collapsed partially or completely while the house in Balakot survived with only minor damage. A three-storey hotel with reinforced concrete framed structure about 50 m from this house in Balakot collapsed completely as shown in Figure 8a.

Figure 7. (a) A well-built house in Balakot; (b) A collapsed R.C. building with brick masonry in Muzaffarabad; (c) Partially collapsed R.C school building with brick masonry.

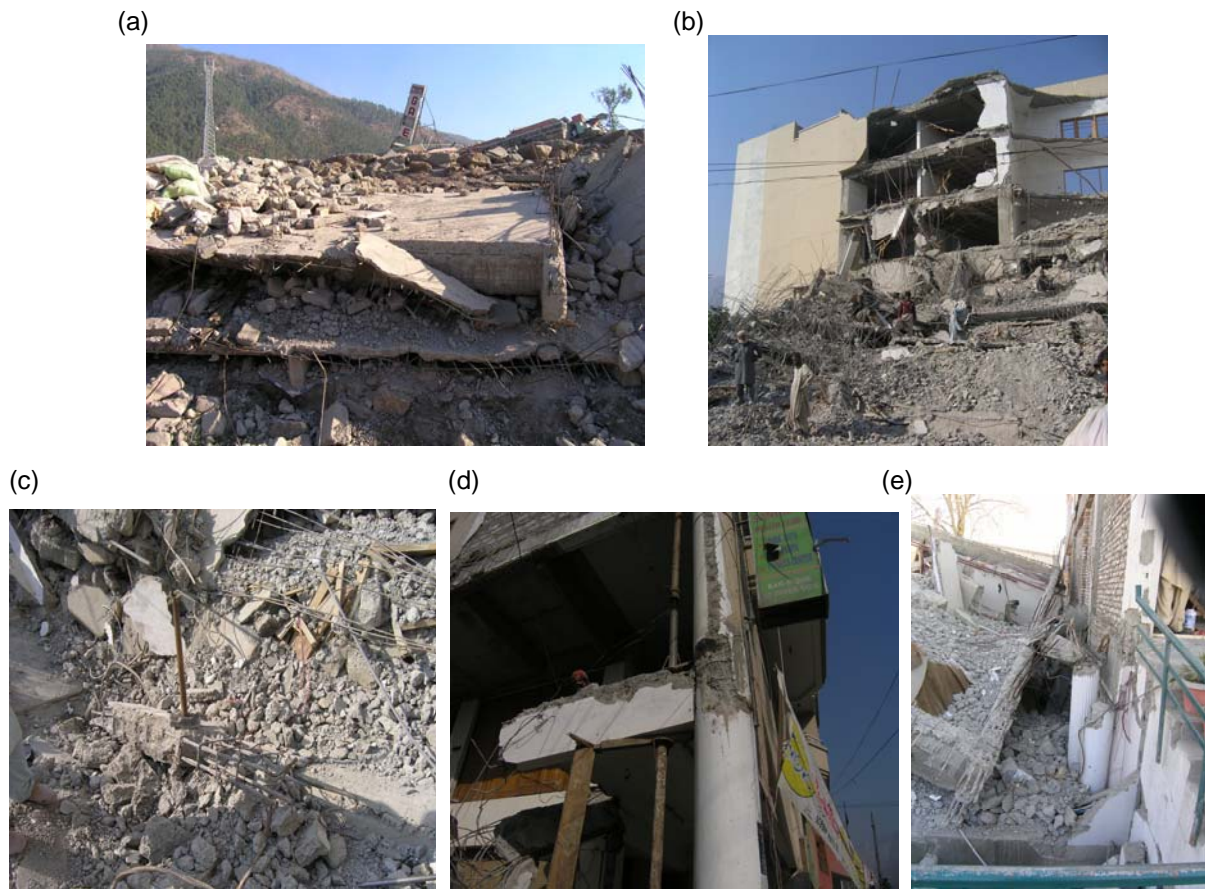
A number of deficiencies could be observed in failed buildings in addition to poor quality construction. These included soft storey, weak column-strong beam system, lack of continuity, location of lap splices in the most stressed regions, insufficient lap splice length, insufficient lateral reinforcement for shear and confinement, poor reinforcement detailing, use of smooth steel bars and poor material properties. Figure 10 shows a two story hotel in Balakot that survived the earthquake with relatively minor damage. The structure was symmetric, well-planned and well-designed. It was a reinforced concrete framed building with masonry infill walls. The damage was limited to infill masonry block walls as shown in Figure 10b. Most of the structures around this building were severely damaged or collapsed as shown in Figure 6.

Figure 8. (a) A three-storey reinforced concrete structure in Balakot; (b) R.C. building in Muzaffarabad; (c) Lack of confinement in columns; (d) Ductile columns contributed to collapse prevention; (e) A collapsed hotel building in Abbotabad.

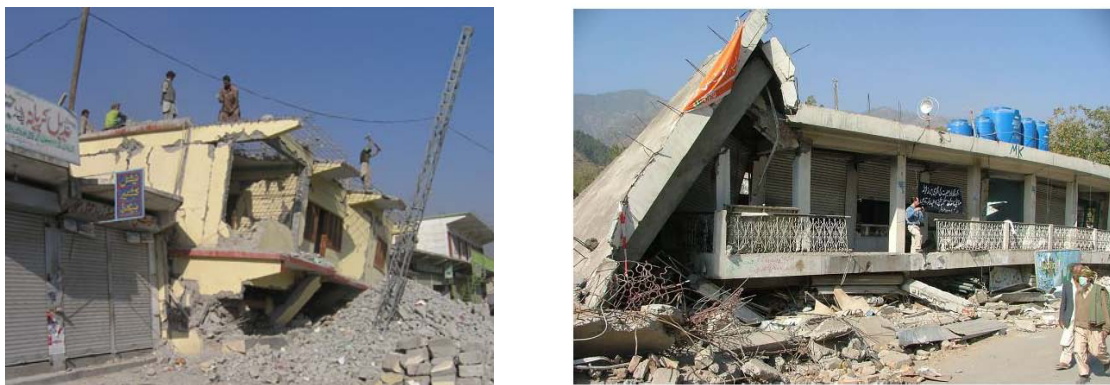
A typical reinforced concrete building in Balakot and Muzaffarabad consists of a frame with infill block or brick walls. A great majority of these buildings were not engineered by qualified structural designers. Some can be classified as semi-engineered where little consideration was given to earthquake effects. Survey of the damaged buildings clearly shows a lack of implementation of design codes. Many of these buildings collapsed or experienced severe damage. Figure 8b shows a five-storey reinforced concrete building in which the failure seems to have been caused by a soft storey, lack of connectivity between elements and weak non-ductile columns (see Figure 8c). A building next door avoided complete collapse (Figure 8d) partly because of superior confining reinforcement in circular columns. A similar failure of a hotel in Abbotabad is shown in Figure 8e. Figure 9 shows building failures in Muzaffarabad and Balakot which appear to be caused by the soft storeys at the ground floor level.

Figure 9. Soft storeys in buildings in Muzaffarabad and Balakot (Durrani et al 2005).

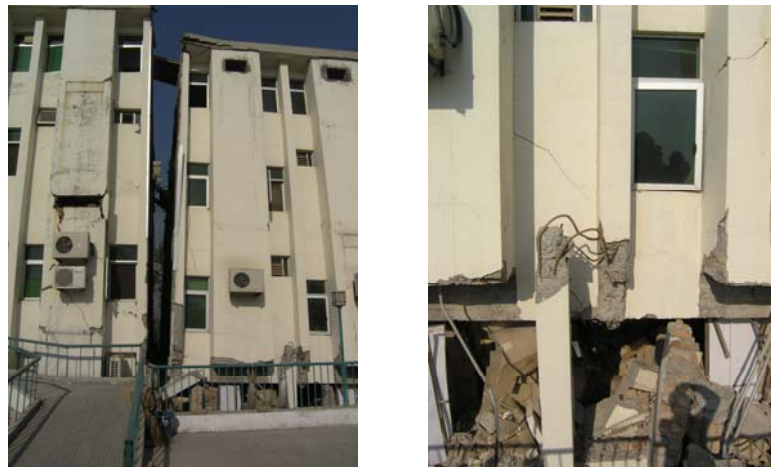
Figure 11a shows two adjacent buildings of a military hospital in Muzaffarabad that suffered severe damage. The building on the left had an elevator shaft in which the elevators had not yet been installed.

Shear walls in the elevator core provided a robust lateral load resisting system that minimized the damage. The building on the right only had columns as vertical structural elements which were unable to provide the required strength and ductility to resist the earthquake loads. Almost all the columns of the ground floor sheared off and the building dropped down by up to two meters. Lack of lateral reinforcement in columns is obvious in Figure 10b.

Figure 11. Hospital in Muzaffarabad.

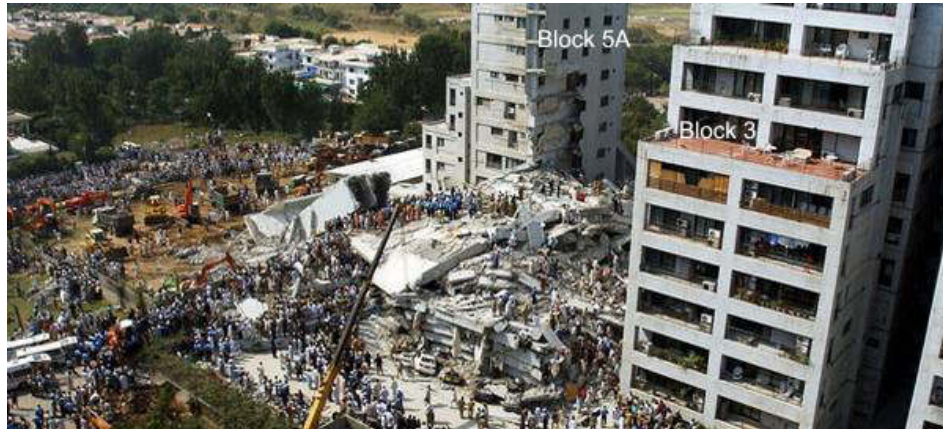
**Failure of high-rise buildings:** Islamabad is in a moderate seismic zone. Among the three sites for which the ground motion records are available, Nilore is closest to Islamabad at about 10 km and both places are approximately 100 km from the epicentre. The ground motion experienced by Islamabad thus is not expected to be significantly stronger (see Table 1). Margala Towers in Islamabad is a group of condominium buildings in 5 blocks. Blocks 1 and 5 had two buildings each that had common basement while Blocks 2 to 4 had one building each. During the earthquake, the building of Block 4 and one building of Block 5 (5B) completely collapsed while Building 5A was severely damaged (Figure 12) resulting in the death of approximately 80 people and several injured. A preliminary analysis of the building was carried out to study the causes of failure (ABS 2006). Brief details of the analysis and observations from the site are summarized below.

Figure 12. Margala Towers in Islamabad.

A check of demand to capacity ratios of various elements indicated serious deficiencies in the buildings. Although the design capacity of the soil was  $130 \text{ kN/m}^2$  for dead and live loads, the maximum stress generated under dead load alone was found to be  $164 \text{ kN/m}^2$  representing 26% overstress. Considering

the combined effects of dead, live and seismic loads, the soil stresses would certainly have exceeded the allowable design values by a wide margin. This would also have contributed to excessive deflections of the buildings. The demand to capacity ratios (DCR) of several beams and columns exceeded unity indicating serious strength deficiency. Table 2 shows flexural and shear DCR values for beams and columns in both the buildings. Only the worst and the best values are shown for each building in the table. In general, Building 5B that collapsed completely, shows a more serious deficiency than Building 5A. All the beams and about half the columns were found to be deficient. It should be noted that the demand and capacity values used were factored. This may explain why Building 5A did not collapse completely.

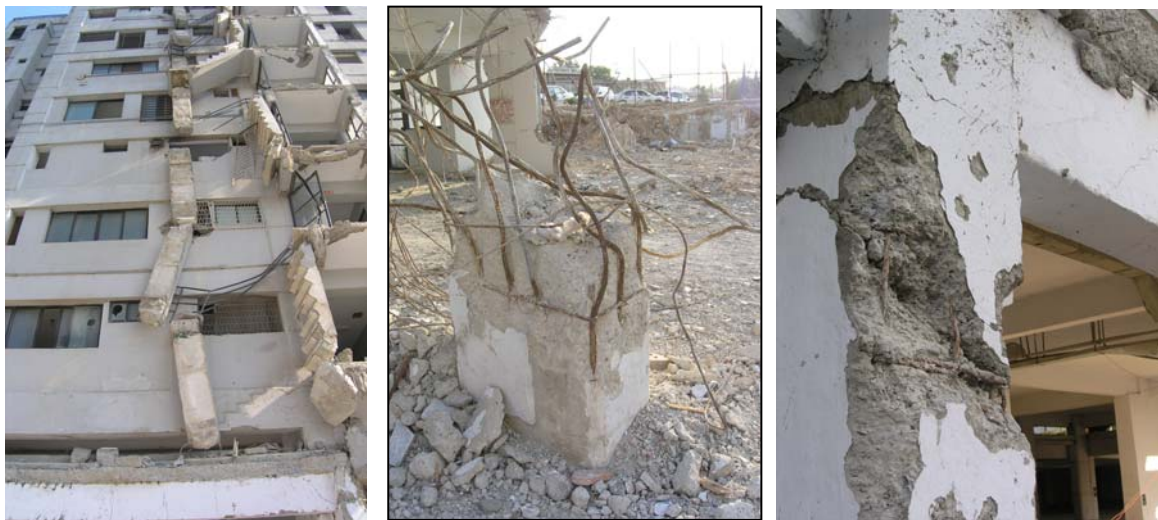
Figure 13. Structural and reinforcement details in Margala structures.

The separation between the two buildings was only 30 mm wide. The analysis showed that a gap in excess of 750 mm was needed to avoid pounding between them. Figure 13 shows part of Block 3 building in which a lack of continuity between different floor levels is obvious. The figure also shows typical inadequate reinforcement details in a rectangular column. Rectangular columns reinforced with single hoops at small spacing display brittle flexural behaviour even when the shear capacity is not exceeded (Sheikh 1980). Spacing of hoops in potential plastic hinge regions of the columns was found to be in excess of 300 mm.
