EARTHQUAKE RISK AND PROTECTIVE MEASURES

Karl V. Steinbrugge*

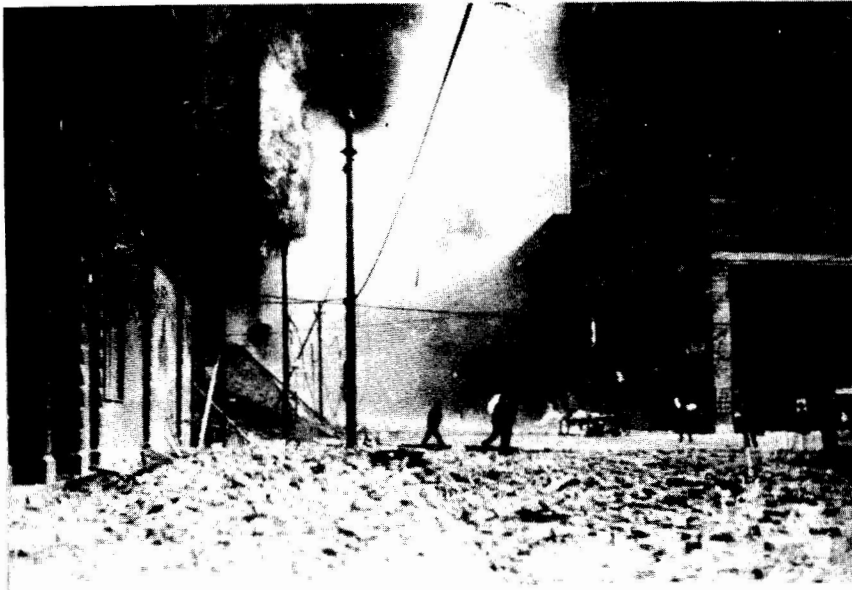
No. 781

The first slide on the screen (781*) illustrates downtown San Francisco with the fire advancing towards us. The masonry on the sidewalks indicates damage, and quite likely structural damage. The next slide (776*) shows significant structural damage, but not building collapse. Certainly the earthquake came nowhere near leveling San Francisco after the wood frame construction had been burned. What is not recognized by engineers who have not been on damage surveys is that earthquake damage often is not spectacular up to the point of collapse, although this non-spectacular damage may require that the structure be demolished. This observation will come up again in this discussion. A critical restudy of the 1906 earthquake damage has shown that this earthquake damage was about 20% of the total damage, with the remaining 80%

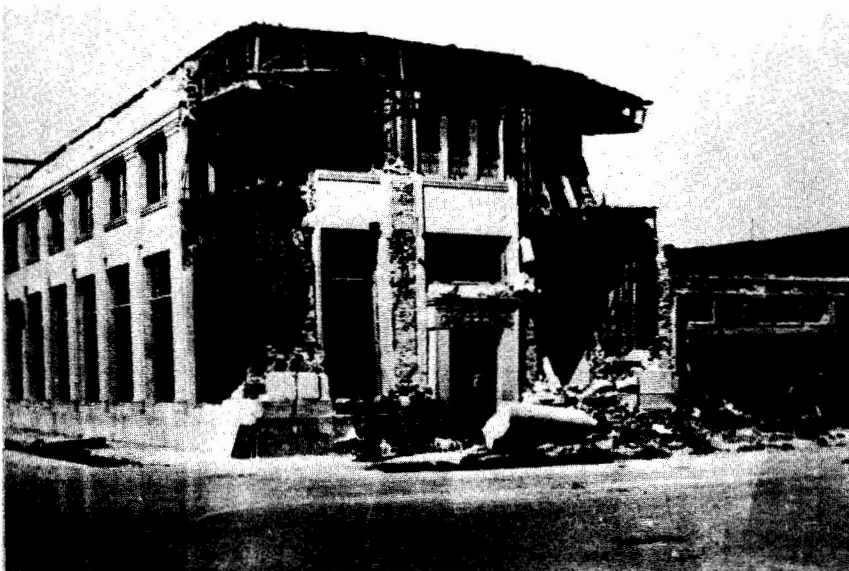
No. 1002

Slide (1002*) shows building damage by class of construction which followed age-old patterns. Structures with walls of brick masonry having sand-lime mortar and with wood roofs and floors suffered severely. An interesting study by R. R. Martel on the performance of brick-joisted structures led to the conclusion that damage to buildings of this type was somewhat less on soft, water-logged soil than those on more firmly consolidated soil. This is curious and interesting in view of contrary observations in other earthquakes.

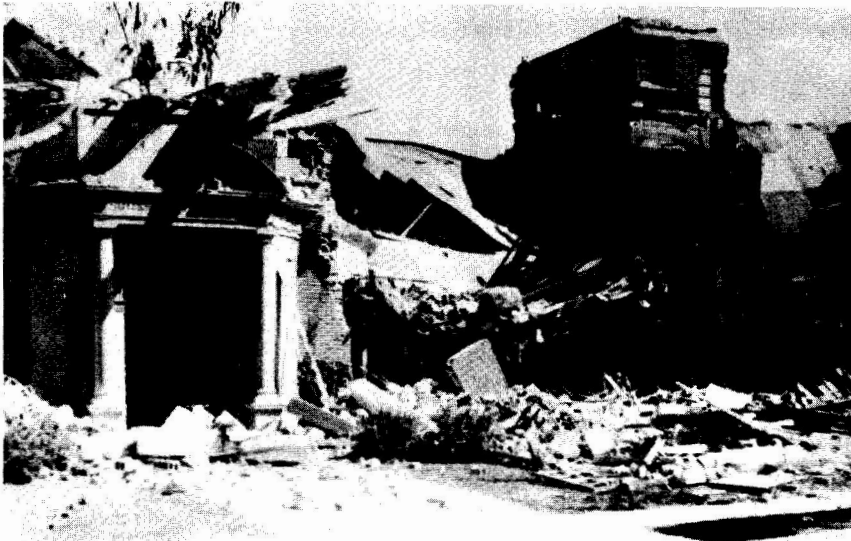
No. 1006

Slide (1006*) is of a public school. Public schools with unit masonry construction deserve special mention. Exterior walls of many schools were brick, or in some cases hollow clay tile. Roofs and supported floors were wood. The destruction to this type of school construction was most spectacular. Slide (1007*) is another example. Fortunately, the earthquake occurred after school hours and a potentially catastrophic situation was averted. However, the destruction was so extensive that the legislature of the State of California passed a bill which became law on April 10, 1933. This law, known as the Field Act, required all new public school construction to be highly earthquake

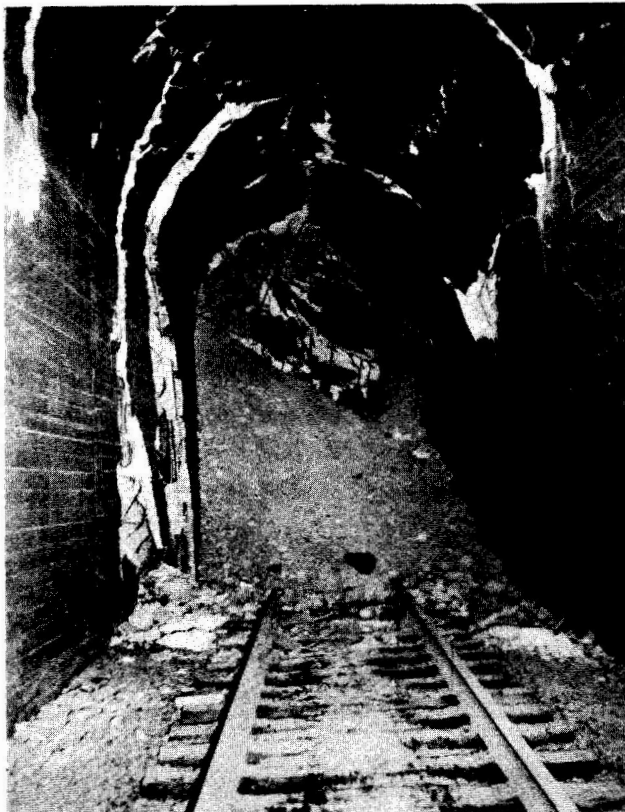
No. 753

Slide (753) shows fault damage to a tunnel. Of the then total of 15 tunnels between Bakersfield and Tehachapi, the four which were seriously damaged were in the fault zone. It is to be expected that very heavy loss, if not total loss, must occur to buildings, canals, tunnels, etc., which are astride ground breakage resulting from fault movement. This need not be true for structures located in the immediate vicinity of the fault trace; this subject is discussed in more detail from the 1959 Hebgen Lake shock.

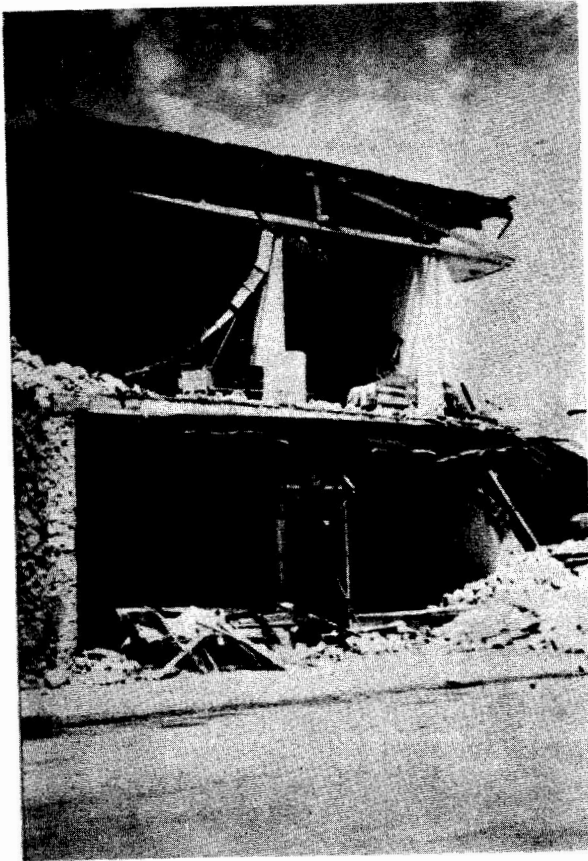
No. 41

Slide (41) shows damage to a brick building. Unreinforced brick bearing wall structures, with its conventional sand-lime mortar in general use until the advent of earthquake resistive reinforced grouted brick masonry, was common in the older sections of the cities of Tehachapi, Bakersfield, and Arvin. Damage to this class of construction was severe just as it has been in all previous major earthquakes. This performance of non-earthquake resistive brick masonry is of interest since it may be compared with the successful performance of masonry materials put together in a manner to resist seismic forces.

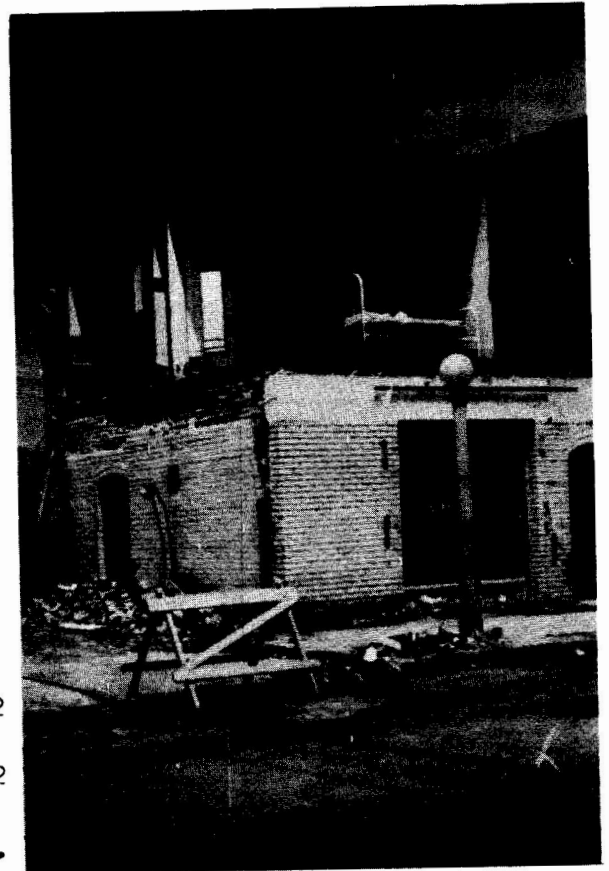
No. 42

Let us look closely at this slide. The bearing walls are gone and collapse is prevented by the non-structural walls. Slide (42) is another example of the second line of defence sometimes provided by "non-structural" walls. Slide (49) shows the ceiling of the second storey now supported by the piano and chairs in this lodge hall assembly room. In the next slide (51), the support given by the piano is obvious. In this case, the lack of non-structural partitions materially increased the life hazard.

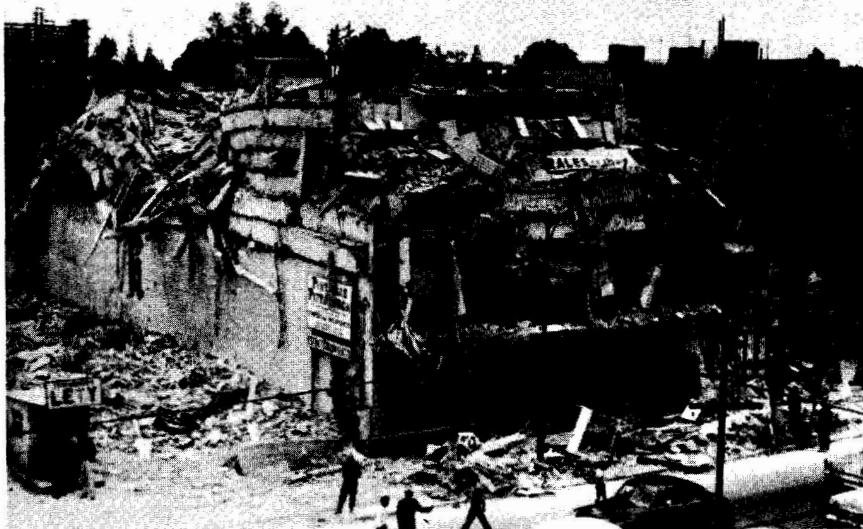
No. 1113

Mention should also be made of the long period effects which occurred in the Mexican earthquake of July 28, 1957. Slide (1113) shows the collapse of a 7-storey reinforced concrete building. Details of the "pancake" failure are shown in slide (1133). Slide (1116) shows another collapsed multistorey building. Predominant ground motion has been estimated at 1.5 to 2.0 seconds at Mexico City. The shock's epicenter has been reported as 170 miles from Mexico City by one source and 220 miles by another. The fact that the collapsed as well as the seriously damaged multistorey structures were usually quite weak or of defective design should not obscure the observation that the ground motion did not proportionately damage weak and poorly designed low rigid buildings.

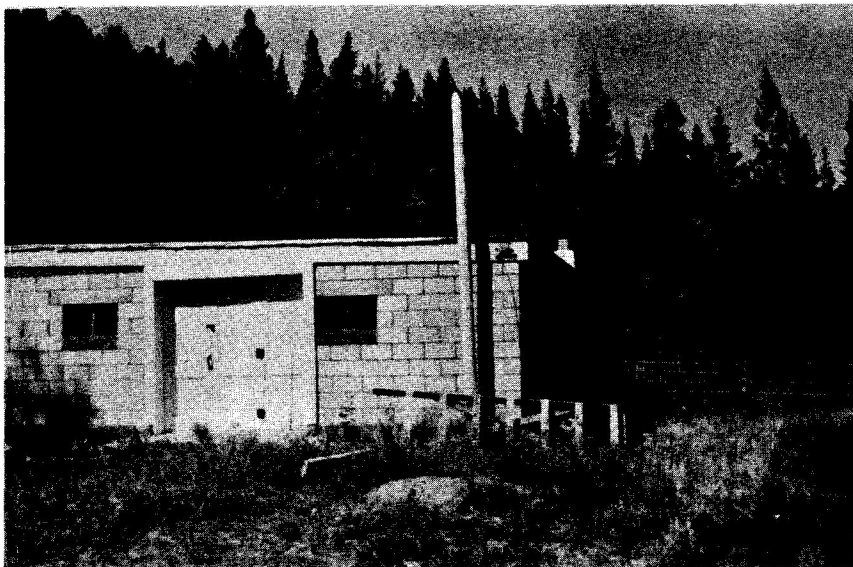
No. 1493

rarely anchored to their foundations. Chimney damage was general but far from universal, and few wooden structures left their foundations. Hollow concrete block buildings as a class did not perform quite as well as did wooden structures. Again damage was remarkably small considering the usually complete lack of construction features held mandatory in earthquake resistant design. One example, located almost on the fault, is shown in slide (1493); I would be very surprised if there was any wall reinforcement.

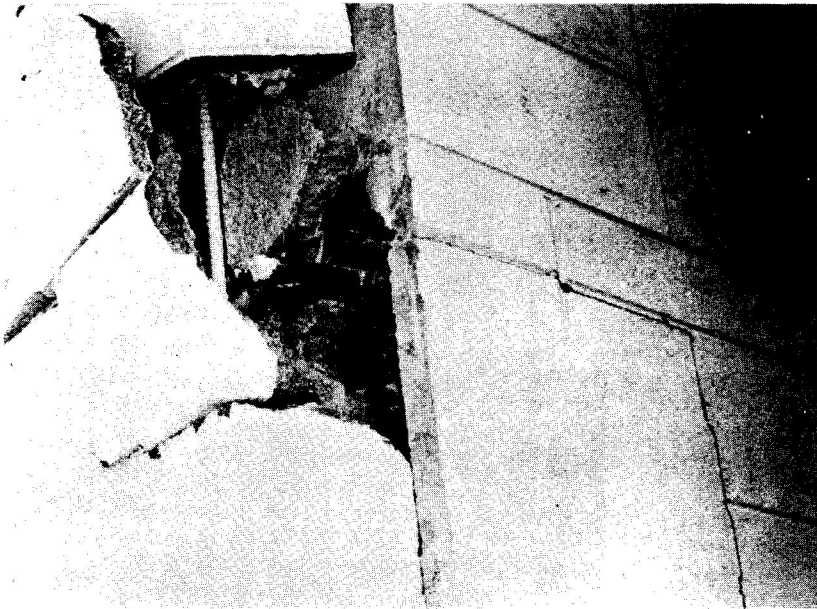
No. 2407

Slide (2404) shows a typical damaged hollow concrete block building. Slide (2407) shows the corner detail, and we can readily observe that the cells containing steel were not grouted. Slide (2384), taken at the partially collapsed Gay Airways, clearly shows a cell which was not grouted.

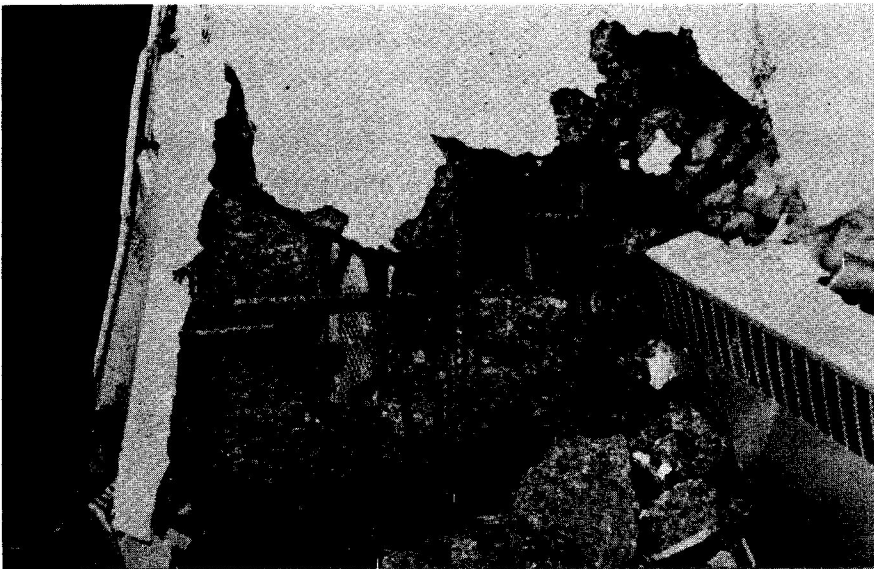
No. 2177

Slide (2177) shows damage to an interior shear wall. Slide (2182) shows a classic example of movement along a construction joint; the vertical bars have snapped.

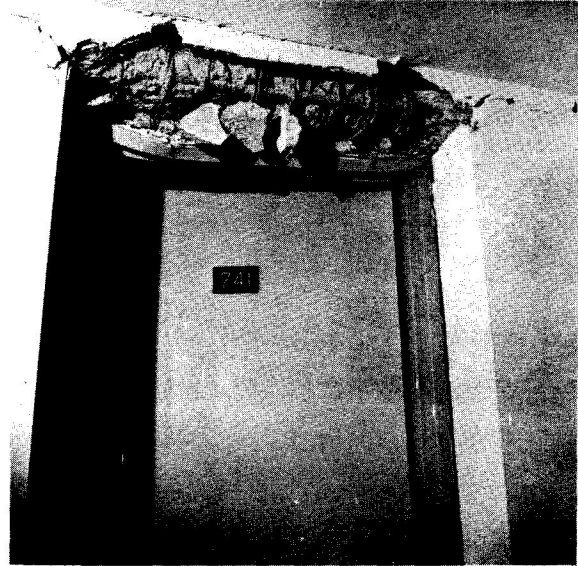
No. 2160

Doorway lintels were damaged as may be seen in slide (2159). This is at room 441. The next slide (2160) is at room 741. Slide (2161) is at room 941. From the room numbers, it is apparent that there is a vertical alignment of damage from storey to storey. This also occurred over other doorways. Here again we see the results of vertical shear damage similar to that described for the exterior walls of the last two buildings.

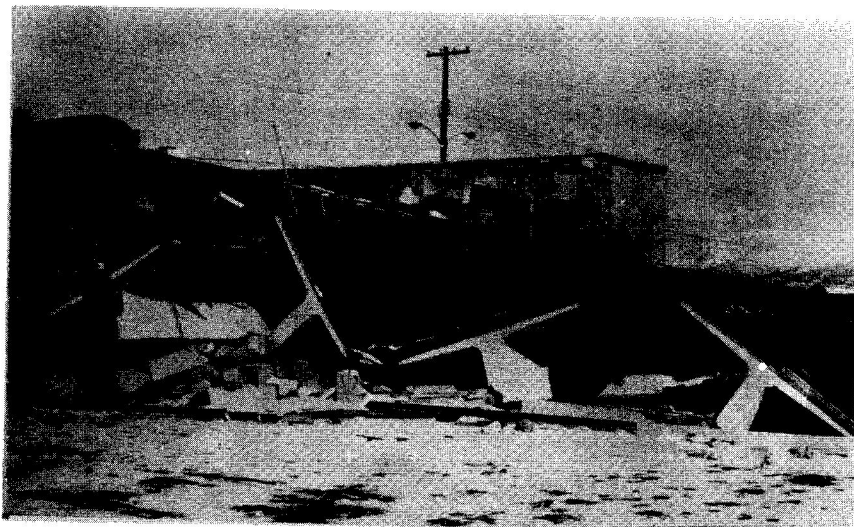
No. 2377
March 27, 1964
Chrysler Bldg.
Anchorage, Alaska

Slide (2377) shows the same general area after it collapsed. The next slide (2379) shows the failed connections between the tee-beams. The 1-1/2" thick flange of these tee-beams has been criticized as being too thin from a practical standpoint, and I tend to agree with them. One school of thought has questioned the lack of blocking, or its equivalent, at the tee-beam seats in the glass wall areas.
