Report on
Earthquake Reconnaissance of
*The M7.8 Gorkha, Nepal Earthquake on
April 25, 2015 and its Aftershocks*

Canadian Association of Earthquake Engineering (CAEE)
L'Association Canadienne du Génie Parasismique
Reconnaissance Team

2017

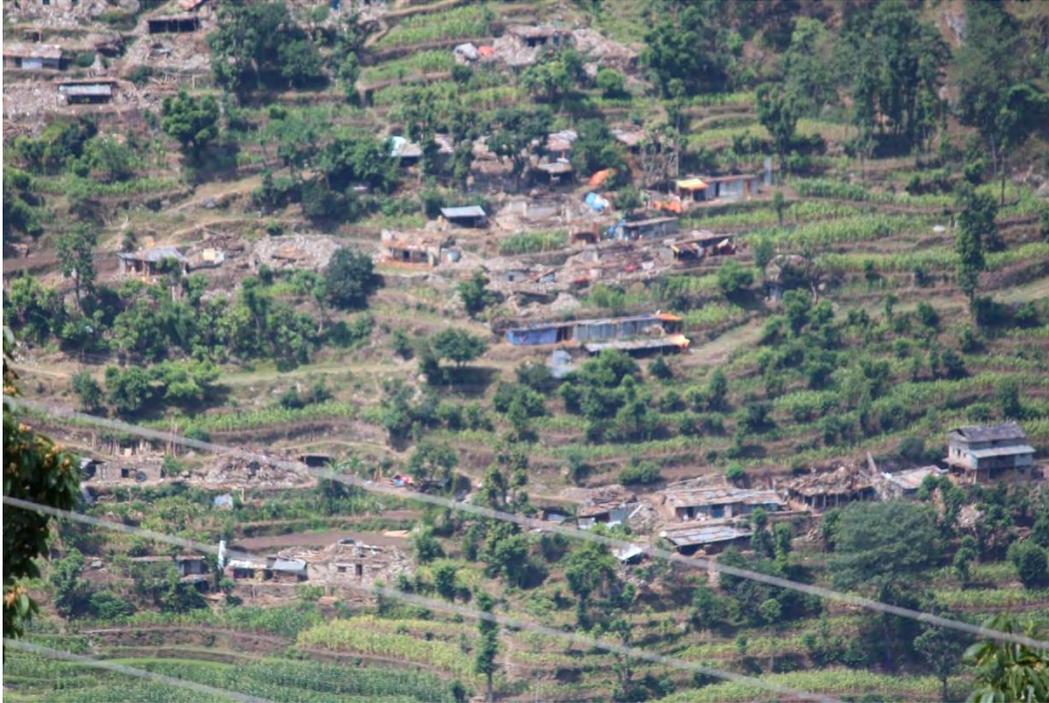
Figure 1.1: Extensive damage of rural stone masonry housing in Sindhupalchowk District (Photo: B. Pandey)

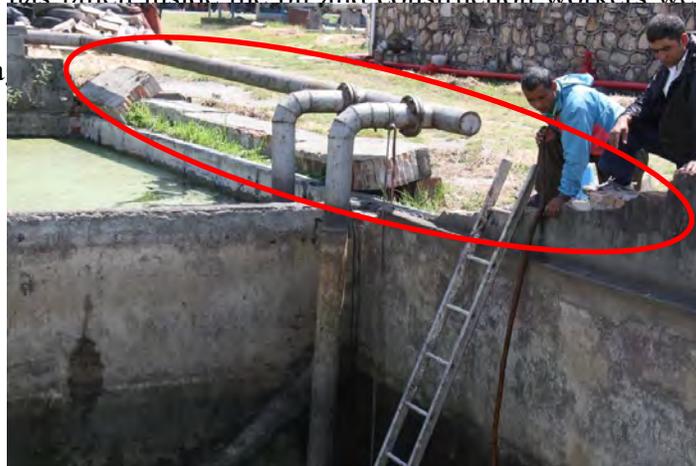
Two fire water pits are located in between the tank areas and in the upper terrace. The pit walls of the tanks are constructed out of unreinforced cement mortar bricks with the perimeter walls raised about 0.6 to 0.9 m above the surrounding ground surface. Some damage was visible to the above-ground portions of the pit wall. It appears that part of the wall has fallen inside the pit and construction workers were in the process of bailing out the pit walls (Figure 3.14). No damage

Figure 3.14: Repairing the fire water pit walls

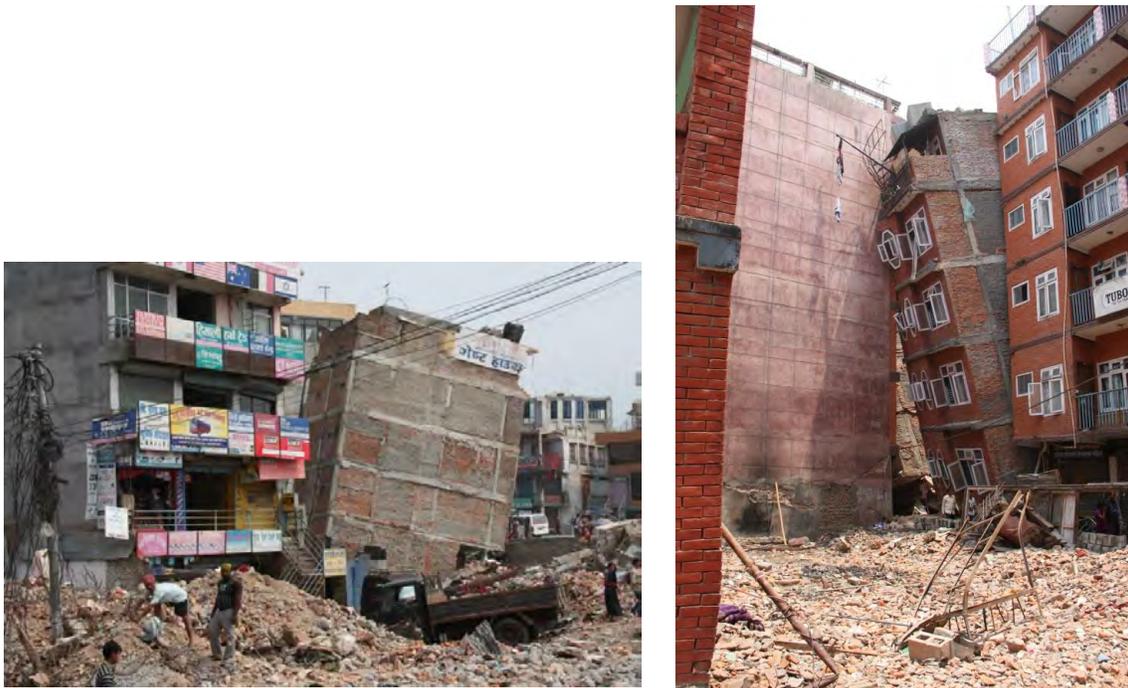
A combination of foundation failure and soft-first-storey damage may have led to the significant damage experienced by these 5-to-6 storey non-engineered structures.

Figure 3.19: Severely damaged guest houses in Balaju and Gongobu, June 11, 2015 (a.k.a. Bus Park)

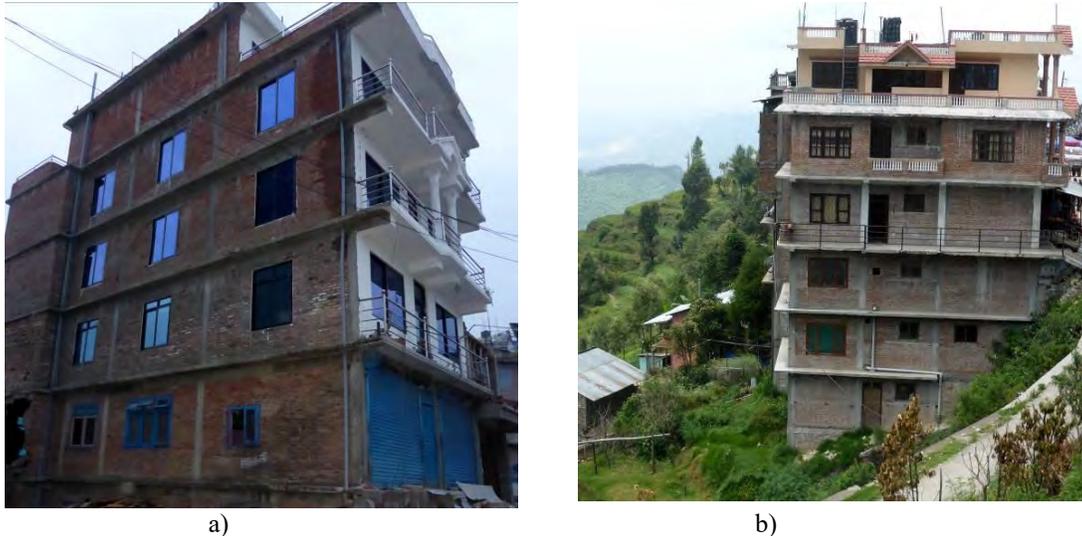
Many buildings in hilly areas of Nepal are built on sloped ground and as a result have a vertical stiffness irregularity. As an example, these buildings are three- or four-storeys high at the top of the slope, but five- or six-storeys high at the bottom of the slope (Figure 5.3b).

Figure 5.3: Vertical irregularities in typical low-rise RC buildings in Nepal: a) building with a setback at the top floor level and b) a building on sloped ground in a hilly area (Photos: Svetlana Brzev)

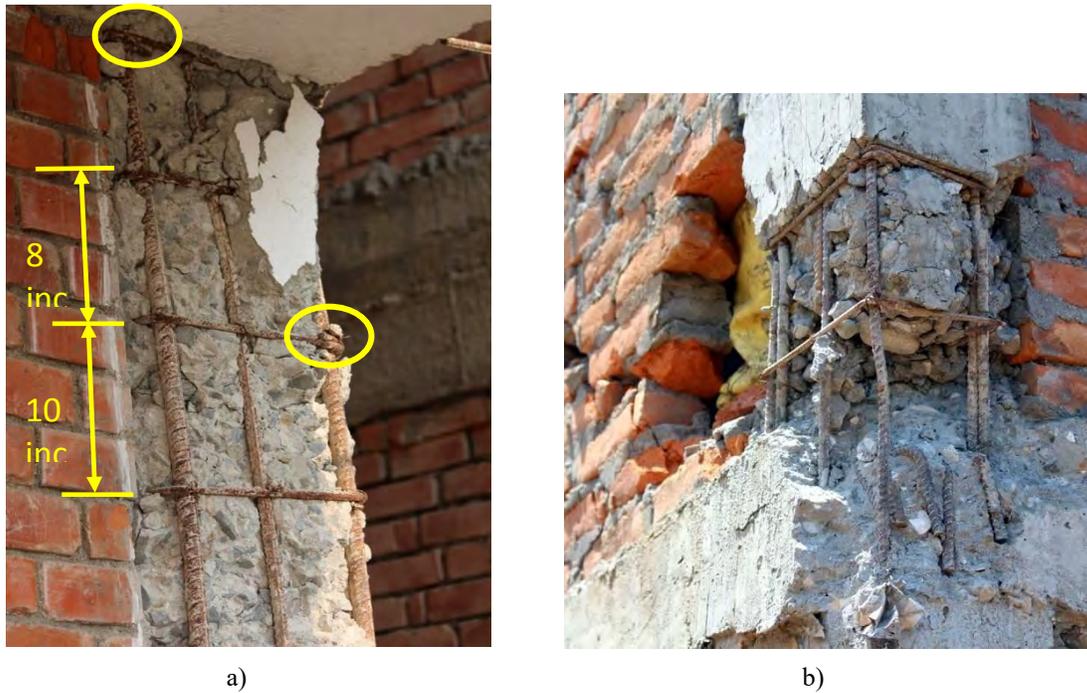
Figure 5.5: Inadequate RC construction and detailing: a) excessively wide tie spacing and 90 degree anchorage and b) lap splices provided at the floor level (Photos: Bishnu Pandey)

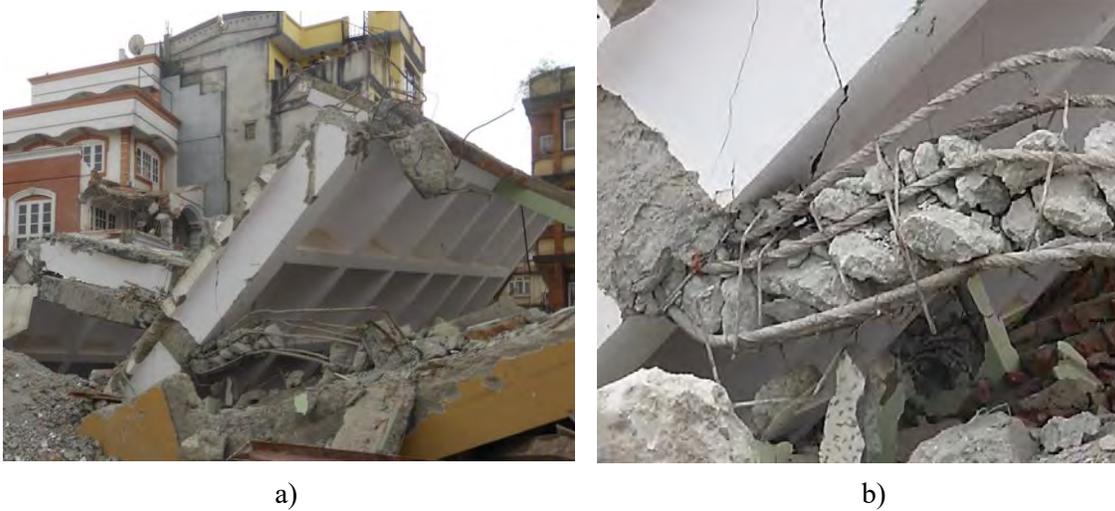
Figure 5.6: A collapsed 5-storey building at Khulesor, Kathmandu: a) ground floor level and b) detailing of column reinforcement (photos: Svetlana Brzev)

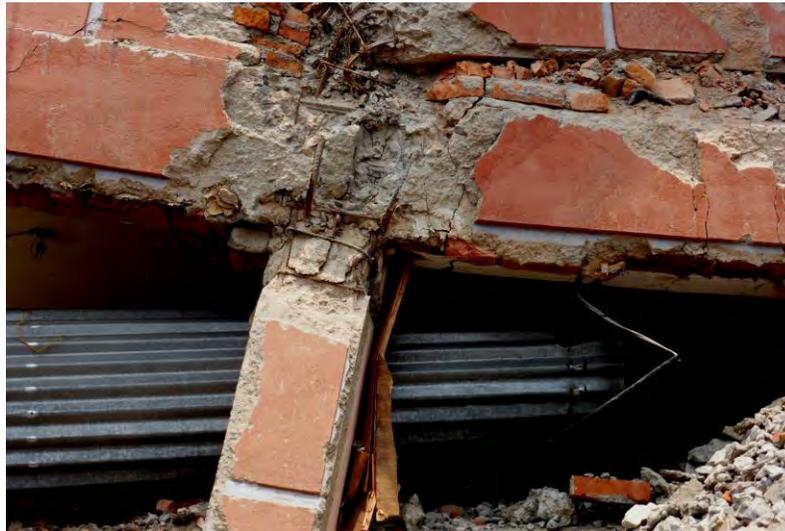
Figure 5.14: Details of a collapsed RC structure at Dipjyoti School in Kathmandu: a beam-column joint showing an absence of flexural hinging in RC beams and columns (photo: Svetlana Brzev)

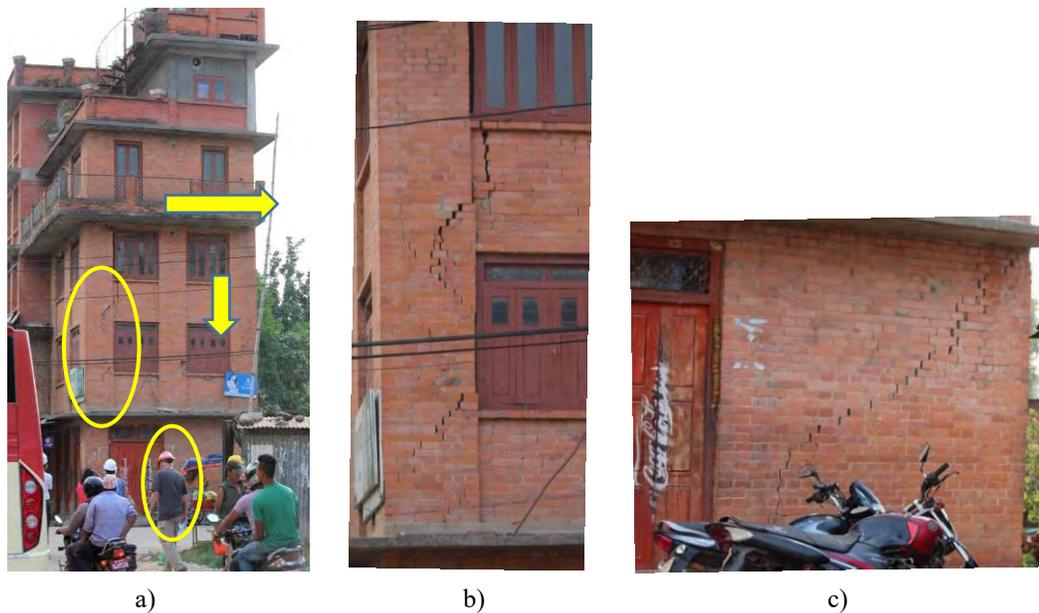
Figure 5.15: Earthquake damage due to a setback at the top storey level: a) a building elevation showing directions of lateral seismic force and compression stresses due to earthquake-induced overturning moments, b) a masonry pier showing cracks due to flexural tensile stresses and c) a wall at the base showing shear-induced diagonal tension cracks (photos: Bishnu Pandey).

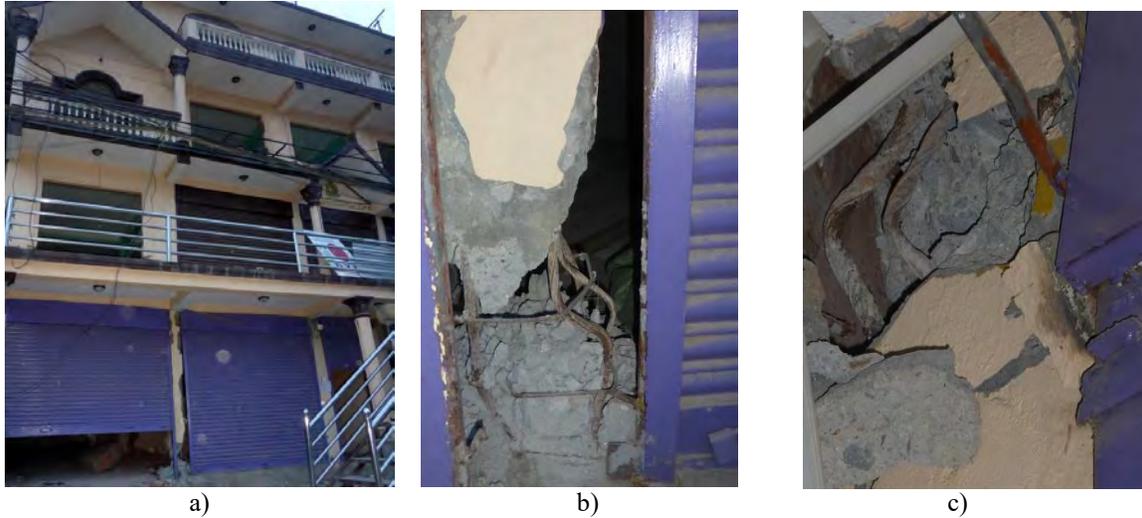
Figure 5.17: A building with an open storefront with the “weak column-strong beam” failure mechanism: a) a building elevation, b) a flexural hinge at the base of the column, and c) a flexural hinge at the top of the column (photos: Svetlana Brzev)

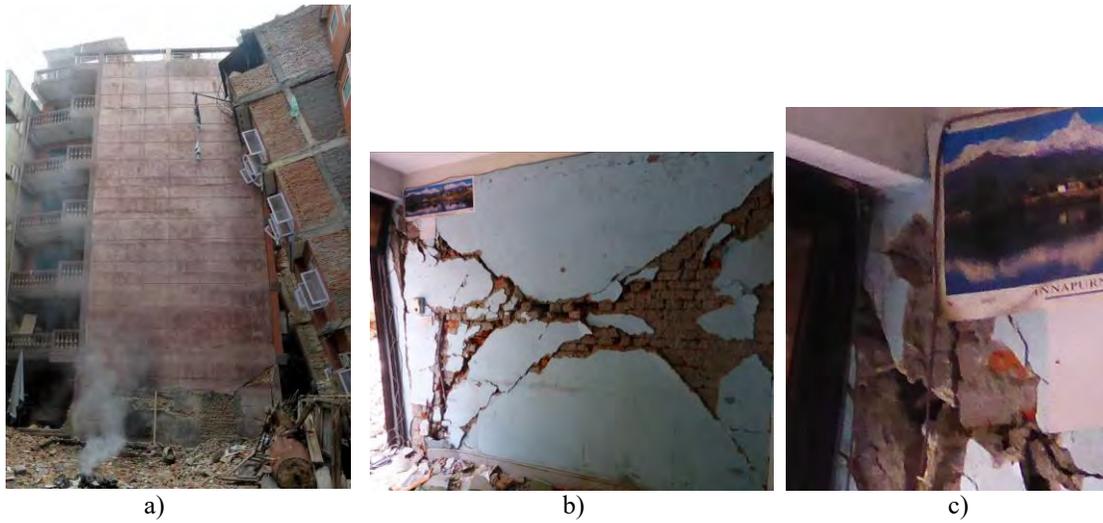
Figure 5.19: Shear failure of a RC frame building with masonry infills in the Gongobu area of Kathmandu: a) an exterior view of the building in longitudinal direction, b) an interior transverse wall showing in-plane diagonal shear failure of masonry walls, and c) diagonal cracks extended into the RC columns (photos: Svetlana Brzev)

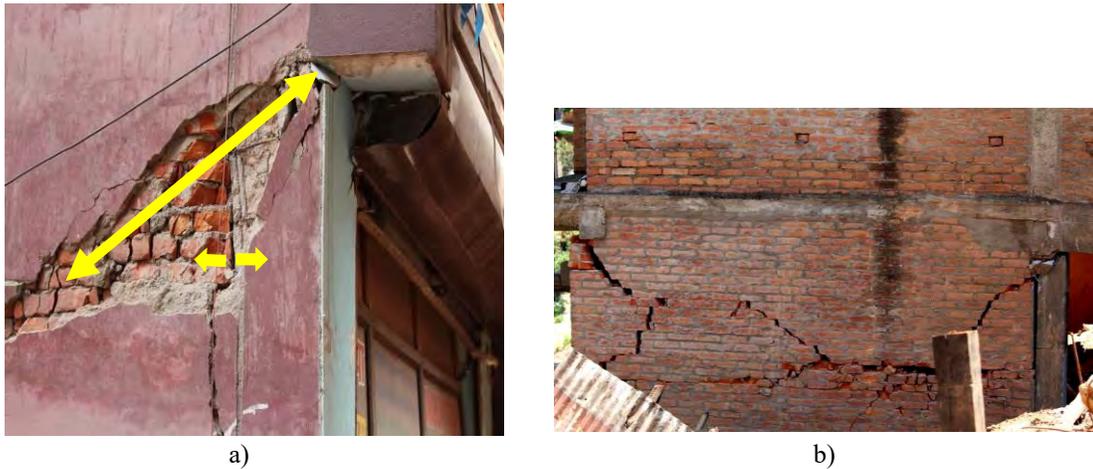
Figure 5.20: Examples of RC frame and wall interaction: a) a vertical separation crack between wall and the RC column and a diagonal shear crack extending from the wall into the column and b) in-plane shear cracking of the wall extended into adjacent RC columns (photos: Bishnu Pandey)

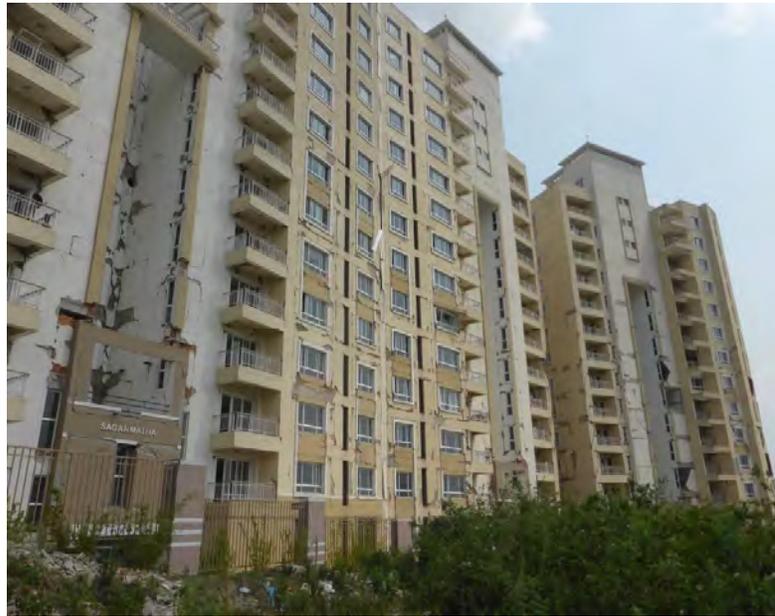
Figure 5.21: Medium-rise RC apartment building complex that experienced damage in the earthquake (photo: Svetlana Brzev)

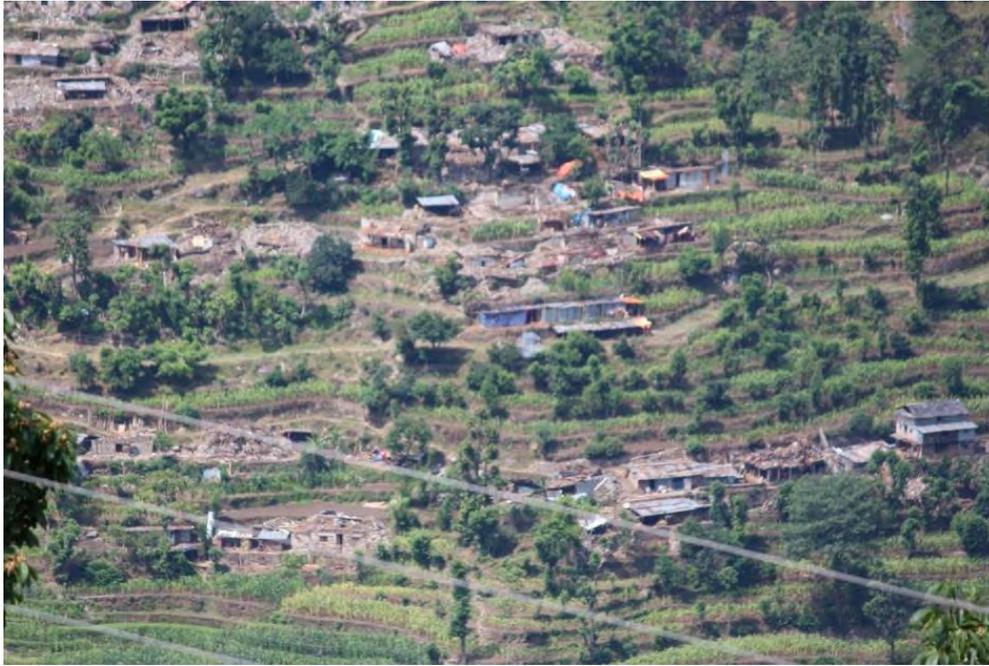
Figure 6.5: Extensive damage to rural stone masonry houses, Sindhupalchowk District (Photo: B. Pandey)

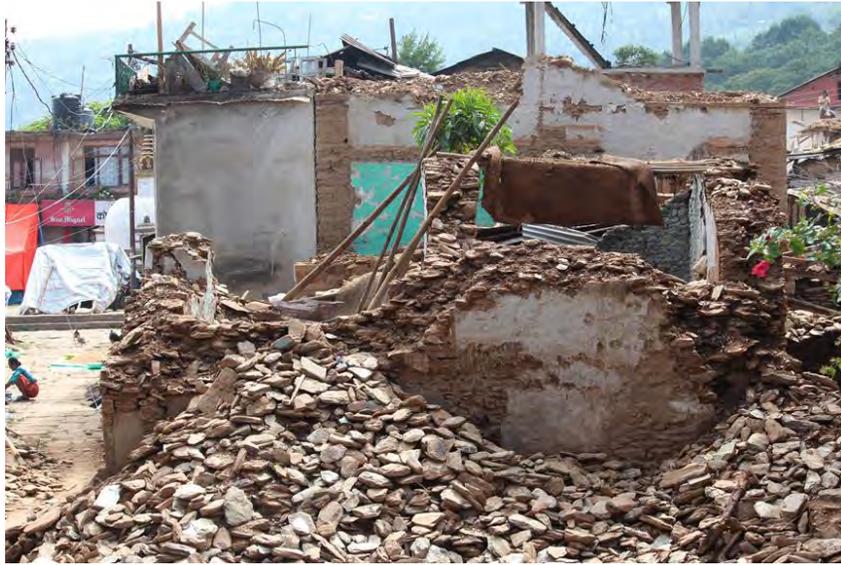
a) Extensive damage/collapse of stone masonry houses

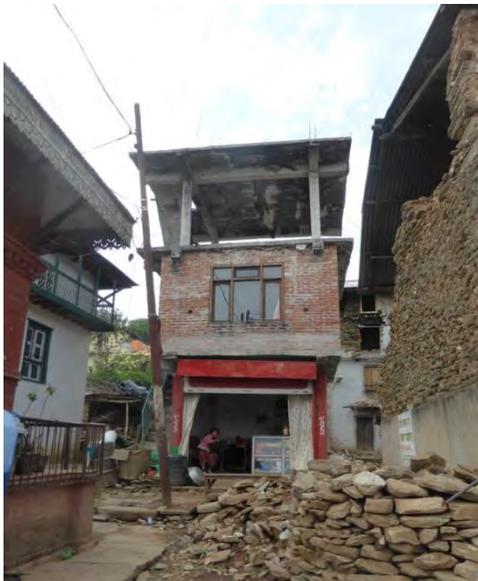
b) No visible damage to non-ductile RC frame with infill adjacent to a heavily damaged stone masonry house

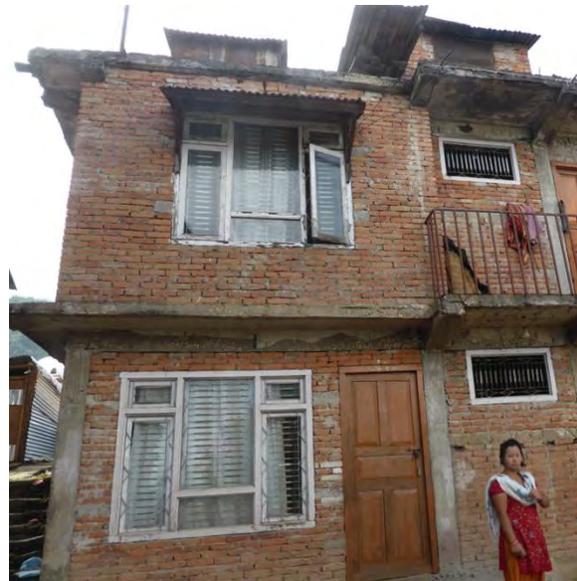
c) No damage observed in the concrete building next to damaged stone houses.

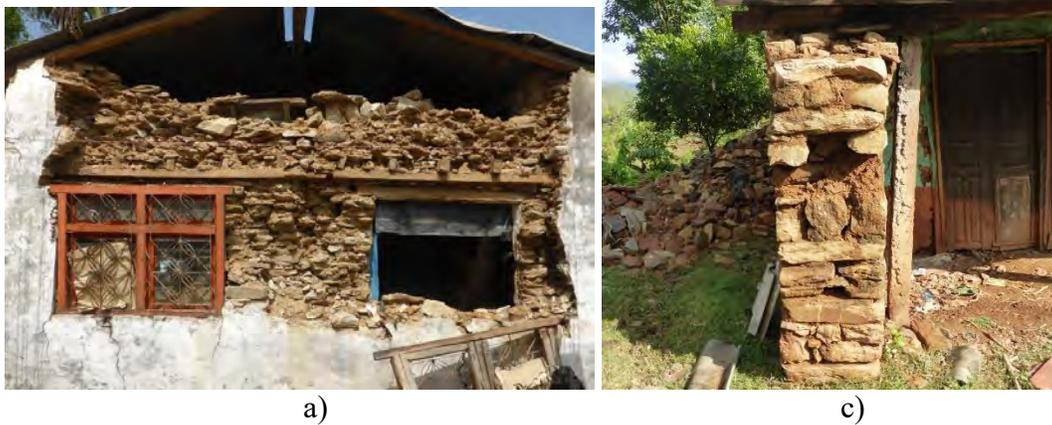
Figure 6.7: Delamination of stone masonry walls: a) an example of delamination, and b) through-stones provided in this wall are effective in preventing delamination (Photo: B. Pandey).

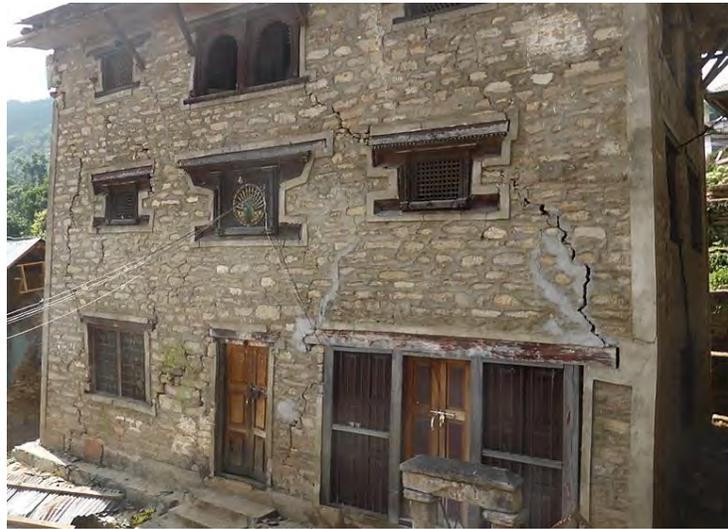
Figure 6.8: In-plane shear cracks in stone masonry walls (Photo: S. Brzev)

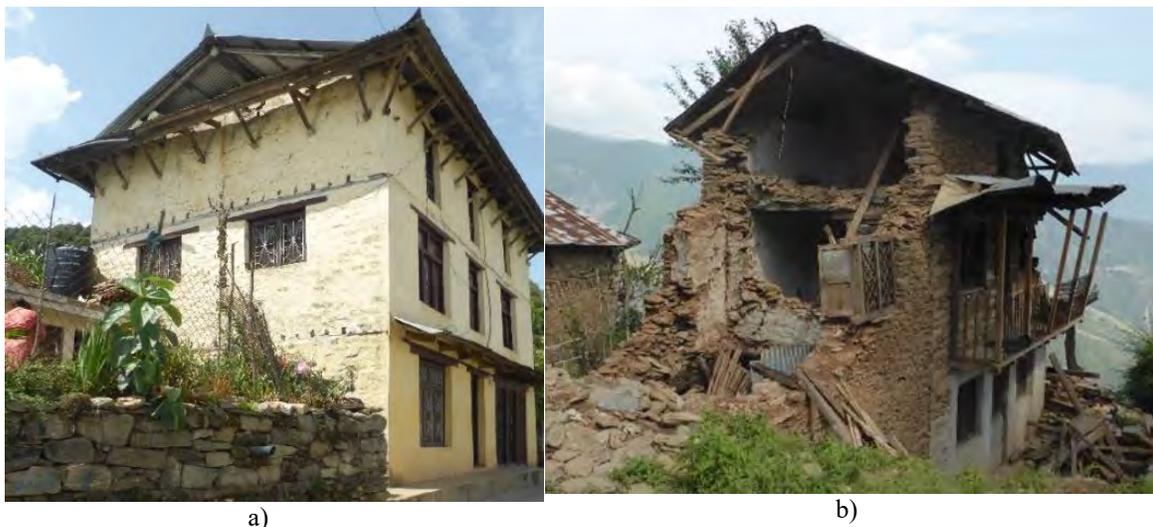
Figure 6.9: Out-of-plane failure wall collapse: a) collapse of a gable wall in an otherwise undamaged building and b) complete collapse of a transverse wall (Photos: B. Pandey)

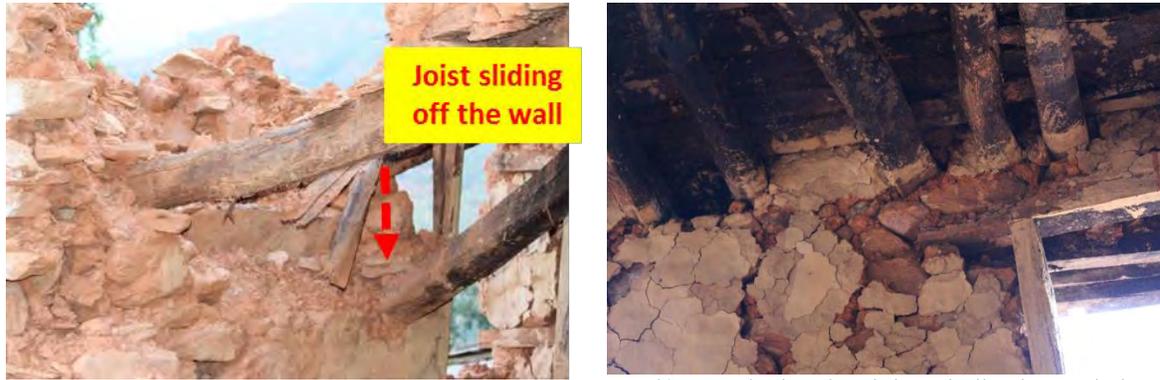
a) Floor joist about to slide off the wall

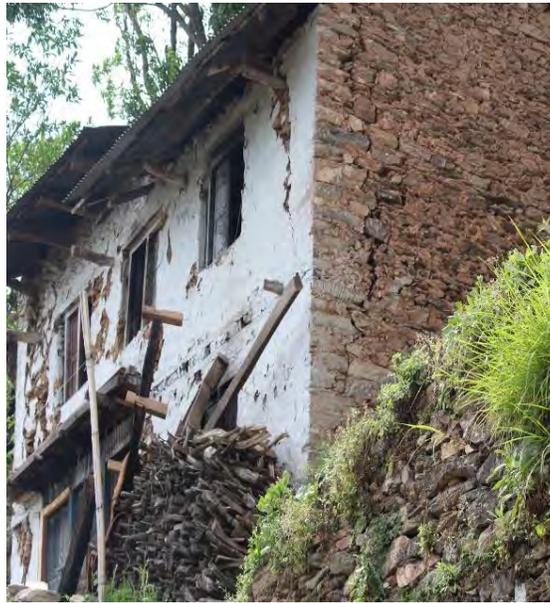
Figure 6.16: Vertical cracks in a building without timber bands (Photo: S. Brzev)

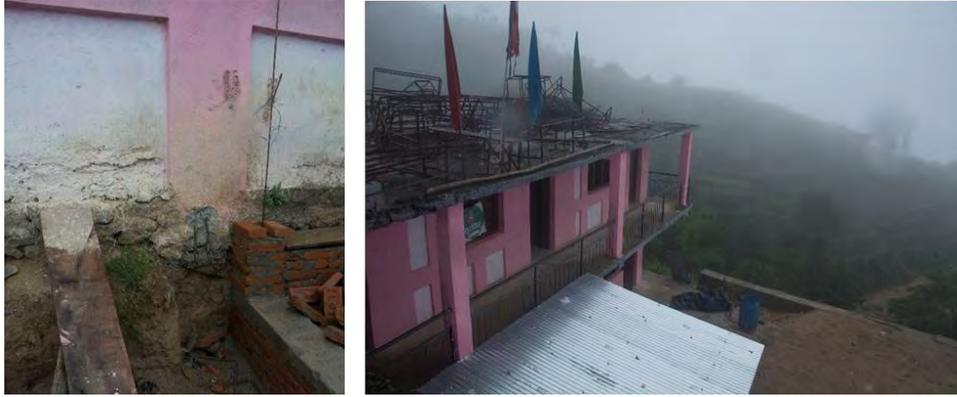
Figure 7.4: Several design and construction flaws observed in a recently upgraded school building in Kathmandu

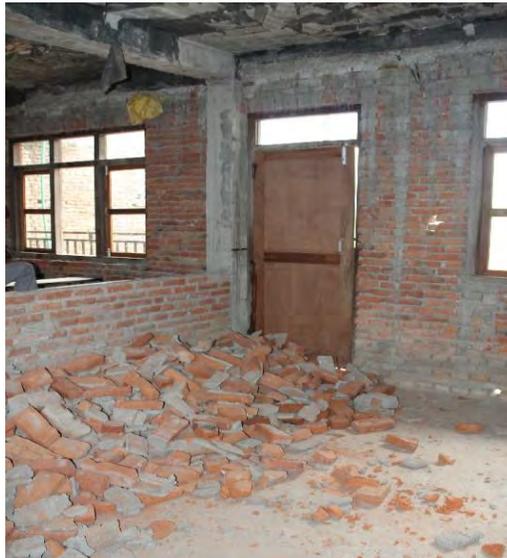
Figure 7.7: School building in Bhaktapur (Kathmandu Valley) experienced only moderate shaking, but it was deemed unsafe.

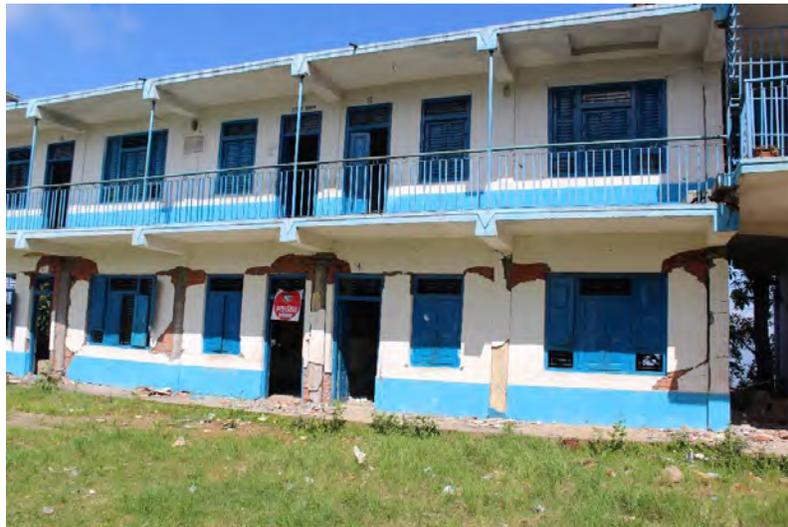
Figure 7.8: Heavy damage in Jana-Jagriti School, Sangachowk, Sindhupalchowk

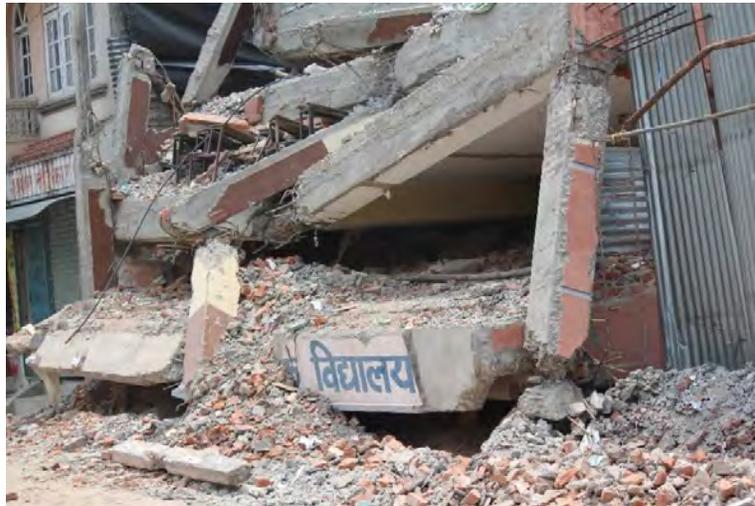
Figure 7.9: Pancake collapse of reinforced concrete building at DipJyoti Secondary School, Kathmandu

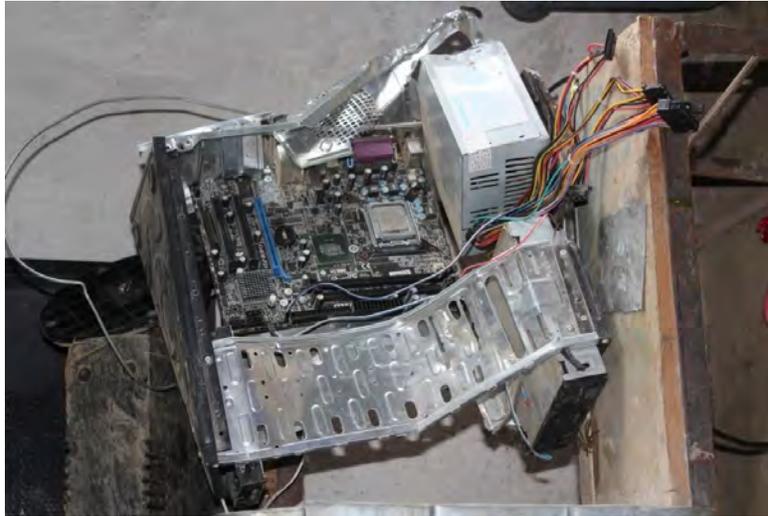
Figure 7.11: Damage to a computer in a science lab at SahidGhat School, Sundarijal, Kathmandu

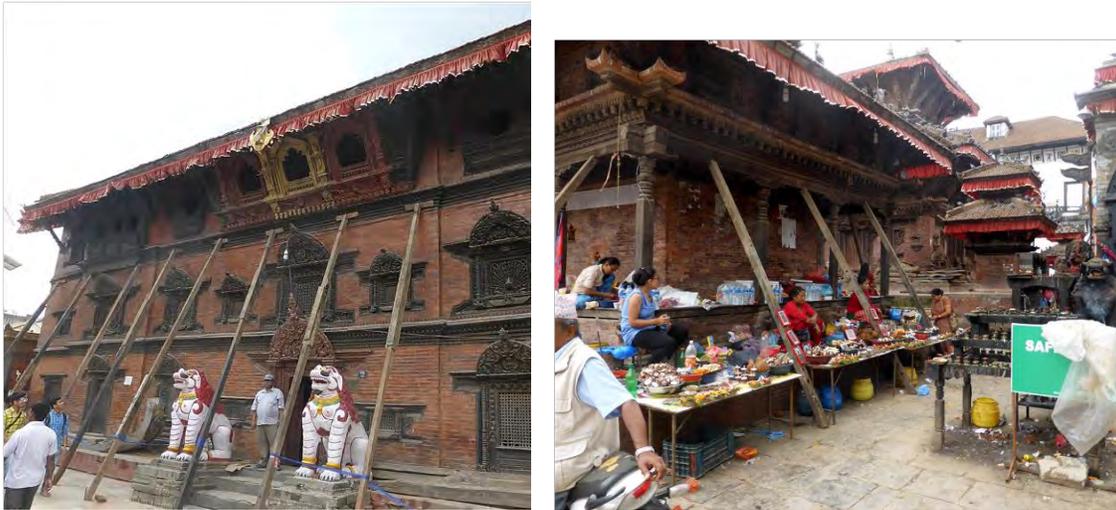
Figure 8.13: Damaged heritage structures at Kathmandu Durbar Square after the 2015 earthquake (S. Brzev)

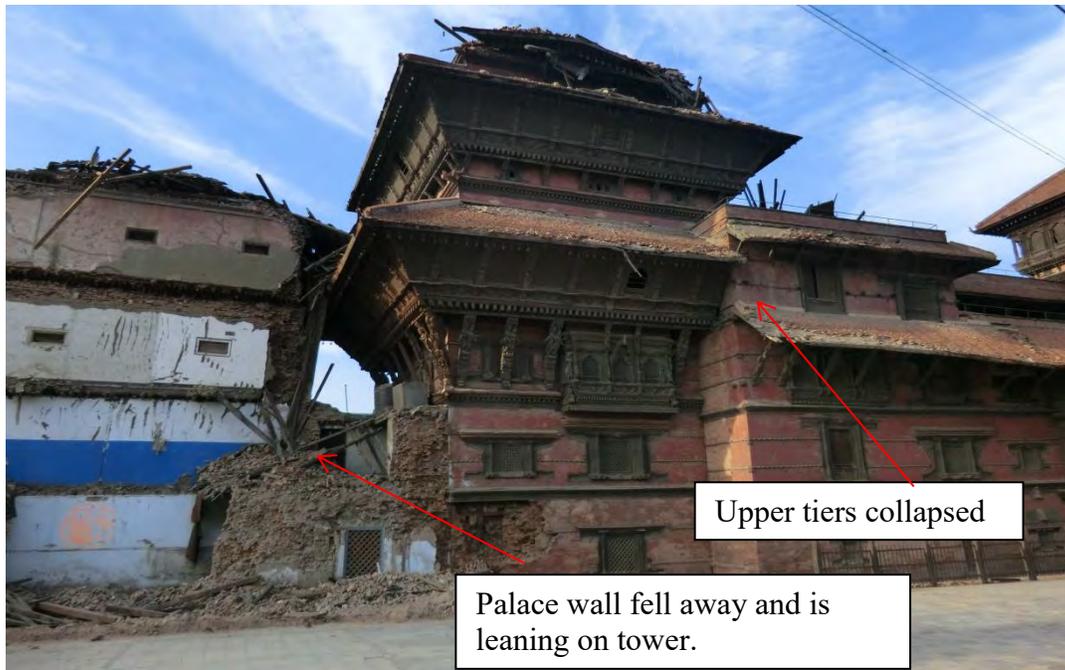
Figure 8.16: Severely damaged Basanpur Tower, Kathmandu Durbar Square (credit: David Biggs)

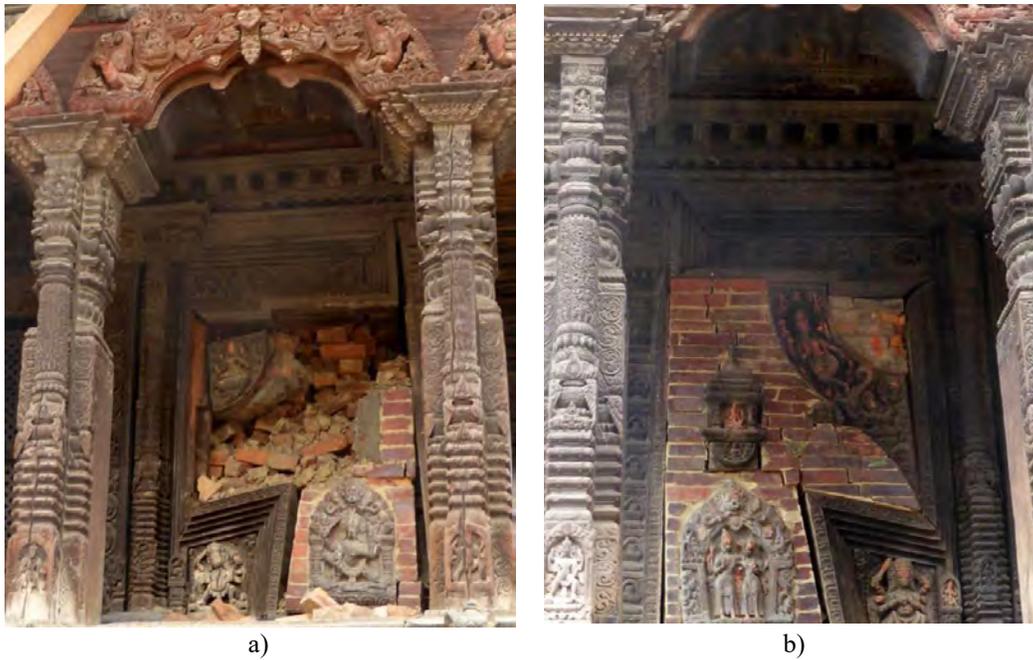
Figure 8.19: Damage of Vishwanath temple, Patan: a) a damaged panel showing dislocation and falling off of masonry and b) another panel that suffered minor damage—note timber bracing (S. Brzev).

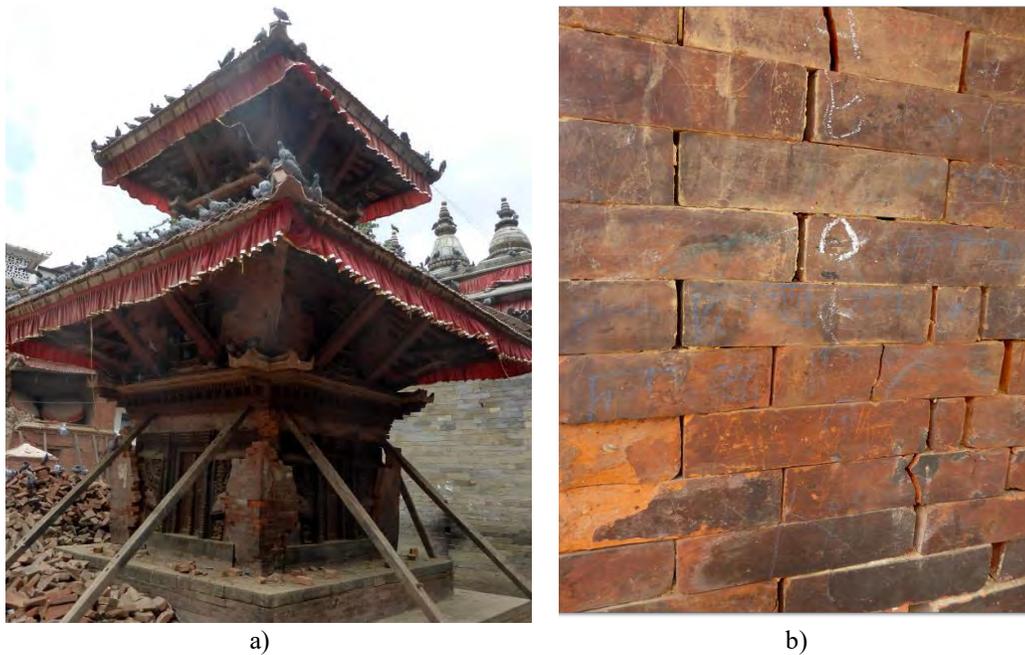
Figure 8.20: Damage to a two-tiered temple at Kathmandu Durbar Square: a) a view of the temple after the earthquake and b) an exterior brick masonry wall (S. Brzev)

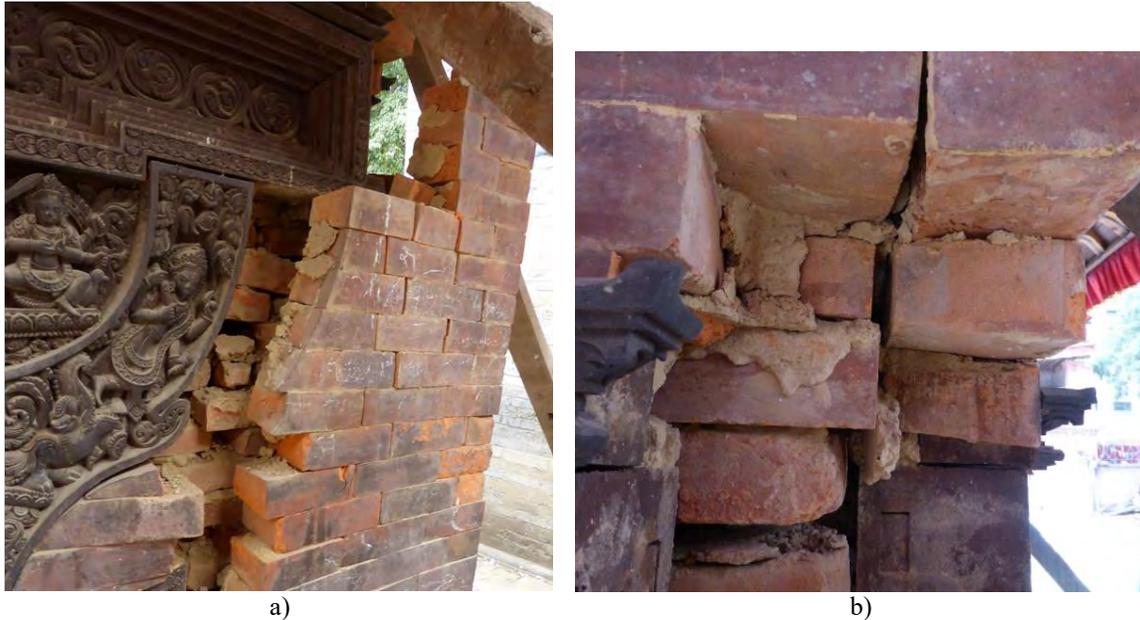
Figure 8.21: Damaged masonry wall in the temple shown in Figure 8.20: a) the separation of the exterior wall wythe and b) a detail showing an absence of the corner connection between interior wall wythes (S. Brzev)
