Shake Table Testing of a Full Scale Wood Frame Building Considering the Ground Motion Duration

Mehrtash Motamedi¹, Carlos E. Ventura², Graham Taylor³, Armin Bebamzadeh¹

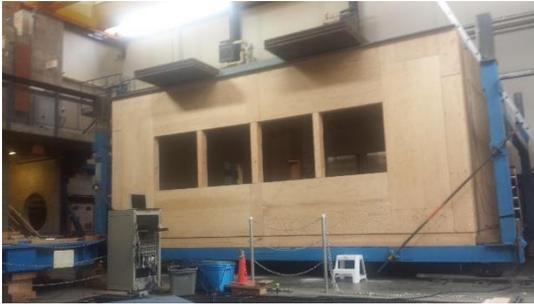
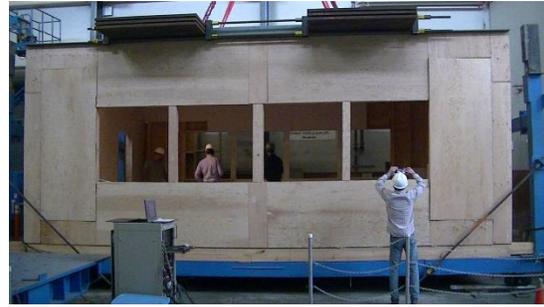
Figure 5 illustrates the general view of the Specimen Sp-1 (with Pattern “A”) before Test #1 and after Test #3. The deformed shear wall in south-west of the specimen and failure of the connections are shown in Figure 6(a). Figure 6(b) shows the internal damage after the third test run. The result of testing of Specimen Sp-1 confirmed that the shear wall panel reached a near-collapse state at least in 6% drift. The specimen sustained large inelastic deformation. However, it was still standing vertical and supporting the inertial loads. Typical damage in shear wall, nail pull through and separation of the plywood panels from studs are shown in Figure 7(a). Shear deformation and breaking of the nails are illustrated in Figure 7(b).

(a) (b)
Figure 5. Specimen Sp-1: a) Before test #1, b) After test #3.

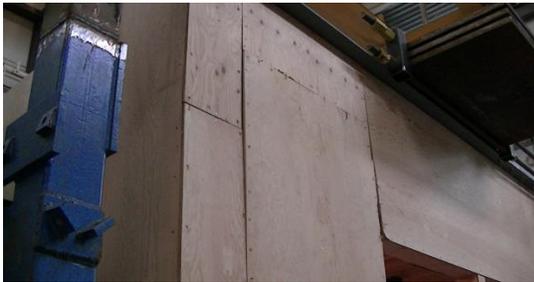
All specimens experienced damage in shear wall near 2% drift. Failure of the shear wall was localized along the edge panel connections. It was developed by nail pull through and cracking in the sheathings, followed by shear deformation of the nails and separation of the plywood panel from the studs. Also, rocking motion of the panels was observed when separated from the studs. For both configurations the failure mode was found to be similar and independent of the ground motion record. However, specimens with configuration Pattern “B” deformed less than the specimens with Pattern “A” when subjected to the same ground motion. The dominant failure of shear wall panels were nail pull through, where the nail remained attached to the stud but its head was pulled through the sheathing. This observation was found to be consistent with the findings in static cyclic tests performed on wood frame shear walls in SRG-2nd Edition. Nail pull through from stud connection was observed near 4% drift. The end walls in west and east side of the specimens remained with no damage in all tests.

(a) (b)
Figure 6. Damage in Specimen Sp-1 after test # 3: a) Southwest shear wall, b) Internal view of drywall.

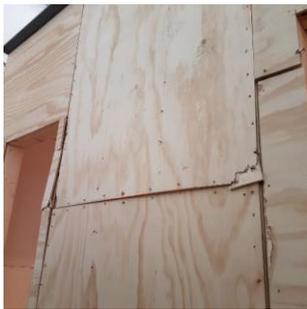
(a) (b)
Figure 7. Damage in Specimen Sp-4 after test #2, a) North-east shear wall, b) Shear off nails.

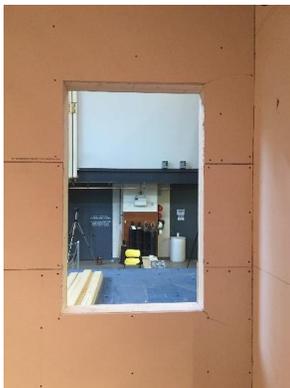
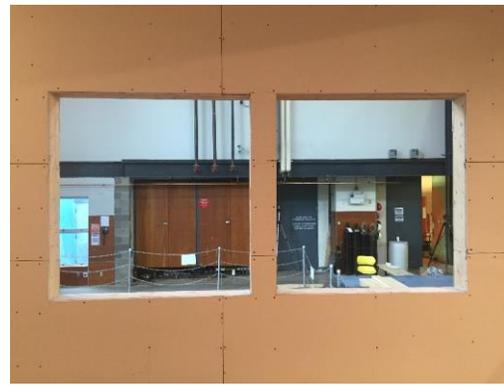
For internal gypsum wall board the failure mode was also found to be independent of the ground motion. The dominant failure mode was found to be tear-through as shown in Figure 8. It was observed to have occurred as the nail pushed laterally through the gypsum board resulting in a slotted hole around the nail and no resistance provided by the connection along the gap. Damage was observed to have occurred at both the top and bottom drywall panels. After testing, with only a small push by hand applied out of plane the plywood panels were easily detached from the wood frame.

(a) (b)
Figure 8. Specimen Sp-5: a) Before test #1, b) After test #2.
