## **Lessons learned from Nepal Earthquake from damages observed in buildings with low-strength masonry and non-ductile RC construction**

Bishnu Pandey<sup>1</sup>, Carlos E. Ventura<sup>2</sup>

### **ABSTRACT**

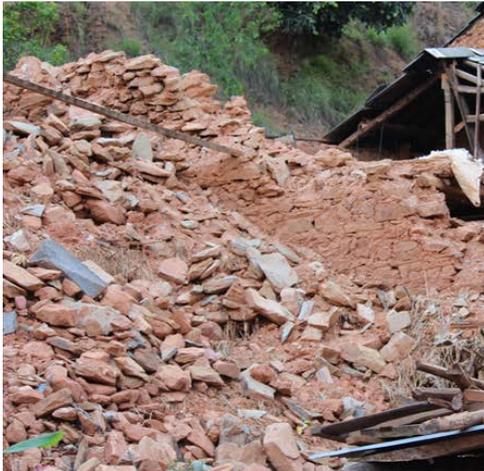
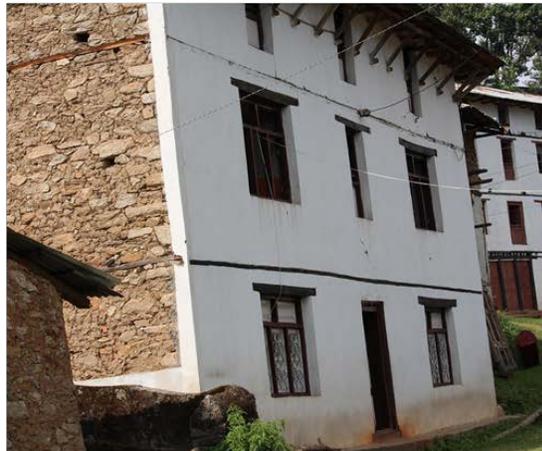
A typical damages observed in the stone masonry buildings were partial or complete out-of-plane collapse of walls, including gable walls; diagonal cracking in the piers between the openings; vertical cracks at the wall corners and collapse of upper storeys in the two- or three-storey houses. It was observed that some stone masonry buildings that have wooden bands provided at the lintel level survived the earthquake. Figure 2 shows two examples cases of stone masonry from earthquake hard-hit area. The first house (Figure 2a), which did not have band or any sort of anchoring of roof or floor to walls, collapsed completely. The other one (Figure 2b) had continuous timber band at floor levels and roof system was anchored with front walls. Despite being close to epicenter of the major aftershock of 12th May, 2015, it was undamaged.

Figure 2. Damage to stone masonry houses: (a) complete collapse in typical house, (b) no major damage in the house with horizontal timber bands

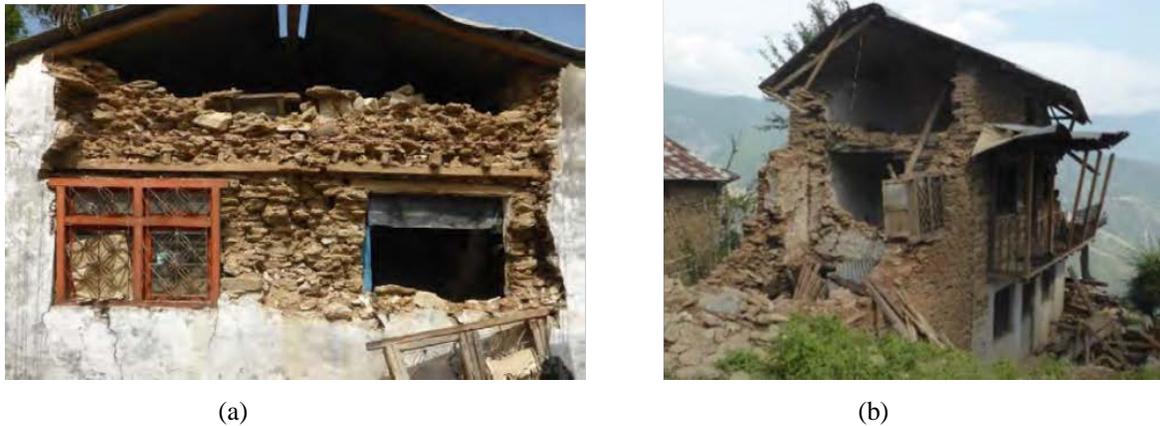
Delamination was widely observed in thick multi-wythe stone masonry walls where small stones were used in walling with no thru stones. These damages were seen in case of typical partial out-of-plane failure of gable or side walls. Complete out-of-plane-failure that led to collapse of houses were widespread throughout the earthquake hit area. These damages were prevalent when lintel or floor bands were absent and floor joists were not tied to supporting walls. Figure 3 shows delamination of wall in a partially collapsed wall and complete out-of-plane failure of a side walls in another house. Observed poor performance of these side walls is due to the fact that the timber floor and roof system that consist of joists are typically supported on, and sometime anchored with, longitudinal walls but side walls have limited connection only through planks with small bearings. In some buildings, only gable walls got collapsed in out-of-plane. These gable walls were made with same heavy stone material and were freely standing with no anchorage with roof and floor.

Figure 3. Out-of-plane failure of walls in stone masonry houses: (a) delamination, (b) complete failure of walls

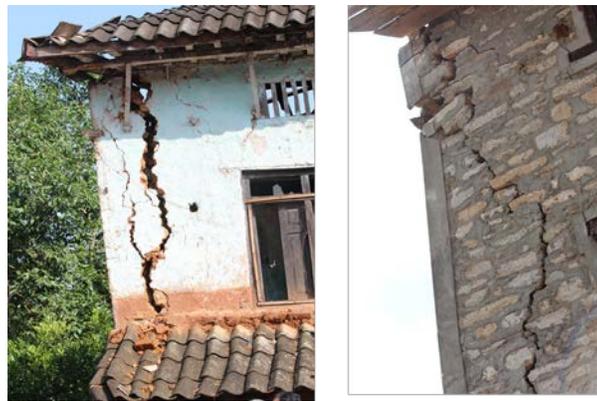
Separation of orthogonal walls in the corner region was also widely observed in partially damaged buildings. Figure 4 shows close-up looks of wall separations taken from two separate damaged houses. In buildings with lintel or floor bands, it was evident that those bands intercepted those separation cracks and minimized the damages.

Figure 4. Separation of walls in corners where horizontal bands were absent

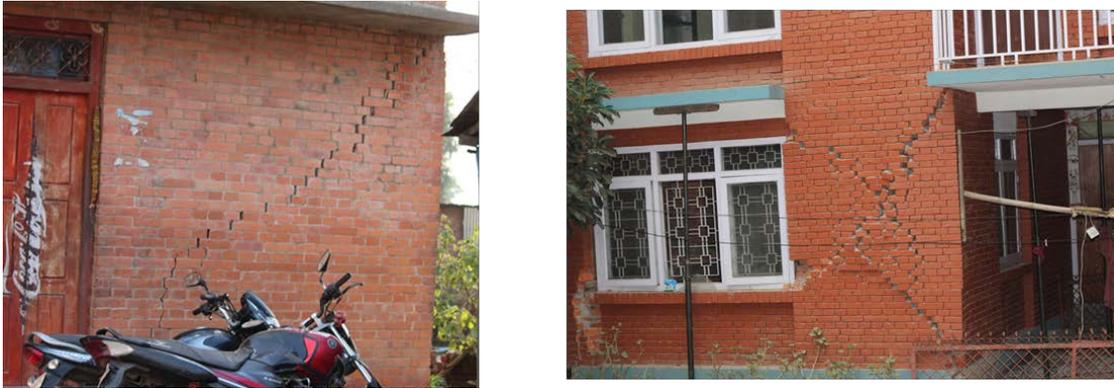
The building stock of masonry buildings with brick units was small in the earthquake hit area compared to stone masonry houses. Extensive damage was limited to brick masonry with mud mortar. For cases where the walls have two wythes of brick—outer wythe made up of burned brick and inner wythe from sun-dried bricks—delamination occurred. Other damage patterns were similar to stone masonry. The cause factors for the damage were also similar. However, diagonal cracks in walls were more prevalent in brick masonry houses (Figure 5).

Figure 5. Diagonal in-plane shear cracks in brick masonry walls

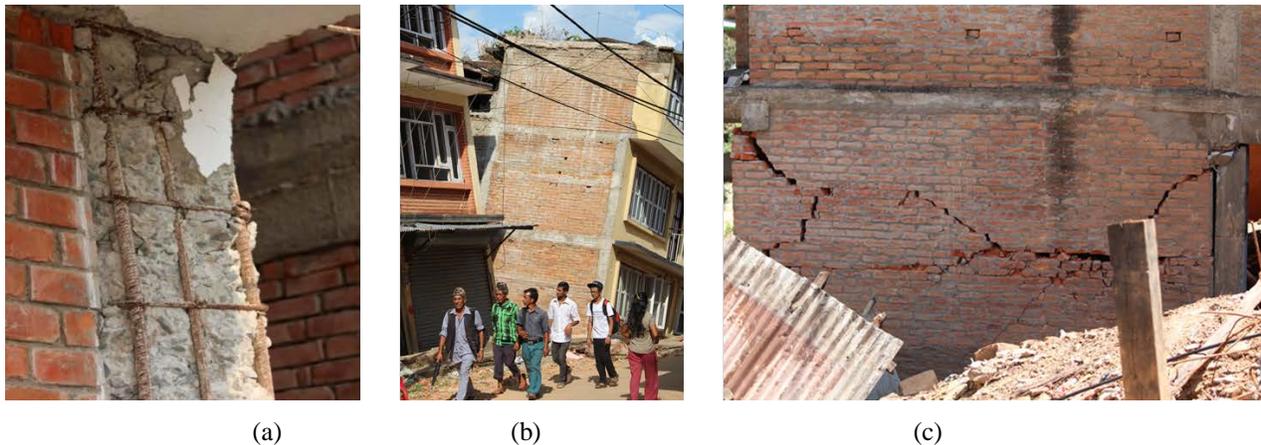
The earthquake-induced structural damage in low-rise RC construction is mainly attributed to inadequate detailing of RC structural components and poor construction quality, increased seismic demand due to structural irregularities, and shear or flexural failure of RC frames with infills [7]. Figures 6a, 6b and 6c show typical damages observed in RC buildings when they have one or more those deficiencies. In figure 6a, column tie reinforcements with 7mm diameter bar were spaced at 250mm and have with 90° hooks. The concrete in column might not get the confinement needed for the required resistance. The size of columns is 300mm x 300mm, but the beams are larger with 300mm width and almost 6000 depth resulting into stronger beams than columns. Figure 6b represents typical ground storey failure due to soft story generated from large openings or open front retail stores or restaurants. The problem was severe in major shopping streets passing through town-centres as buildings have more open first stories. In hill towns, the problem was aggravated as they have buildings in shopping districts in hill ridge requiring unequal columns to offset the ground level difference. Damage was also observed in infill walls in RC buildings. Figure 6c shows an example how the RC frame buildings with infill acts dominantly in shear mode due the presence of infill. Although RC frame construction were supposed to respond in flexure ideally, these building resisted the ground shaking with significant participation from the walls. Once shear demands exceed the capacity of the masonry walls severe damage occurred to these buildings, sometimes leading to collapse.

Figure 6. Damage in reinforced concrete buildings with brick infill walls: (a) poor detailing of rebars in concrete column, (b) soft-storey collapse of buildings due to open first floor , (c) damage to infill walls and concrete column due to shear
