## Performance of structures during the September 19 2017 Puebla Morelos Earthquake in Mexico

A magnitude 7.1 earthquake occurred in central Mexico on September 19, 2017 in the states of Morelos and Puebla, including parts of Mexico City. The Canadian Association for Earthquake Engineering sent a team of geotechnical and structural engineers to the earthquake-stricken region to investigate the effects of the earthquake from Canadian seismic design perspectives. Structural damage was primarily observed in non-ductile reinforced concrete frames with and without masonry infills, confined masonry buildings, and traditional non-engineered unreinforced load bearing masonry and adobe buildings. The building inventory consisted of pre-1985 poorly designed reinforced concrete frames and post-1985 well-designed buildings with seismic force resisting systems consisting of reinforced concrete frames or frame-shear wall interactive systems. A great majority of buildings performed well. Unlike the interplate earthquake of 1985, which occurred off the coast along the Middle America Trench, 350 km west of Mexico city and caused widespread damage to long period structures in the central part of th

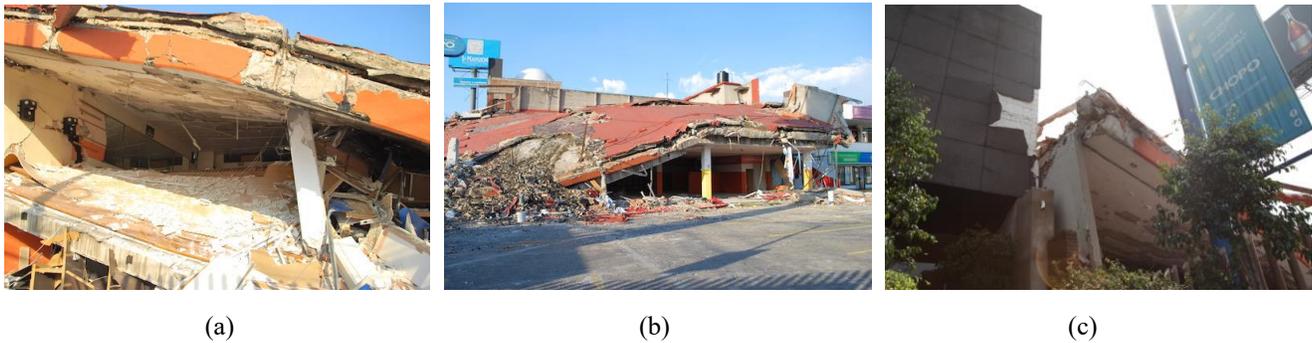
One of the common features of reinforced concrete frame buildings, often with masonry infill walls, was lack of ductile detailing in reinforced concrete columns and use of strong beams and weak columns. Figure 3 illustrates a 3-storey reinforced concrete frame building with exterior masonry infill walls. It was being used as a sports facility prior to the earthquake with open interior space. The building suffered from hinging of columns, top and bottom, when the strong and rigid floor system transferred seismic forces to the supporting columns. The failure was in the form of collapse of second and third floor columns.

The building was designed and built during the pre-1985 era with poor seismic design practices. Another potential factor for the collapse was the rear support of the building, which consisted of a slender confined masonry wall with small size columns and confined brick masonry.

Figure 3. Lack of sufficient bracing and use of strong beams - weak columns

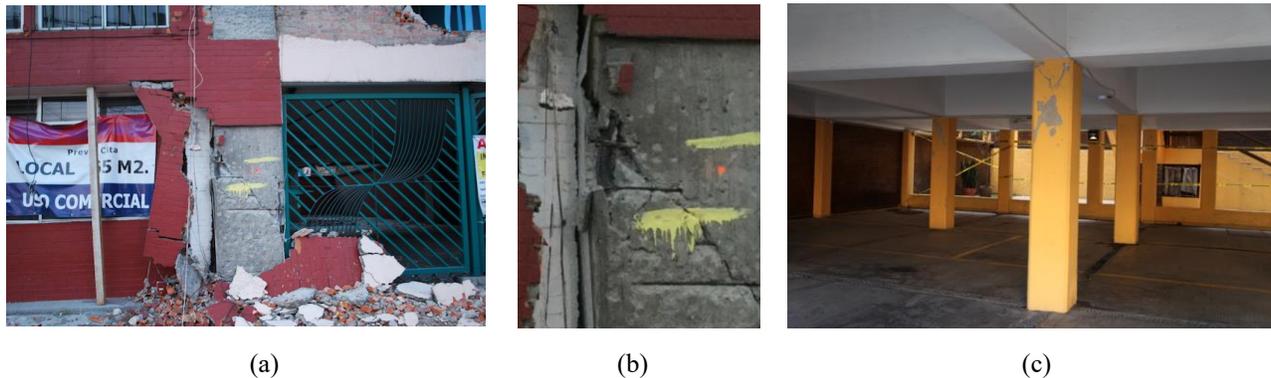
Lack of column transverse reinforcement was evident in older pre-1985 buildings. Figures 4(a) and 4(b) illustrate wide diagonal tension cracks in one of the first storey columns of a multi-storey reinforced concrete frame building with masonry infill walls, located in the Piedad Narvarte district of Mexico City. The figure also illustrates buckling of column longitudinal reinforcement in the vicinity of the previously opened wide diagonal cracks. Similar diagonal tension cracks were observed in other older residential buildings as shown in Figs. 4(c) because of increased seismic force demands associated with soft stories.

Figure 4. Diagonal tension cracking of first-storey columns due to insufficient transverse shear reinforcement

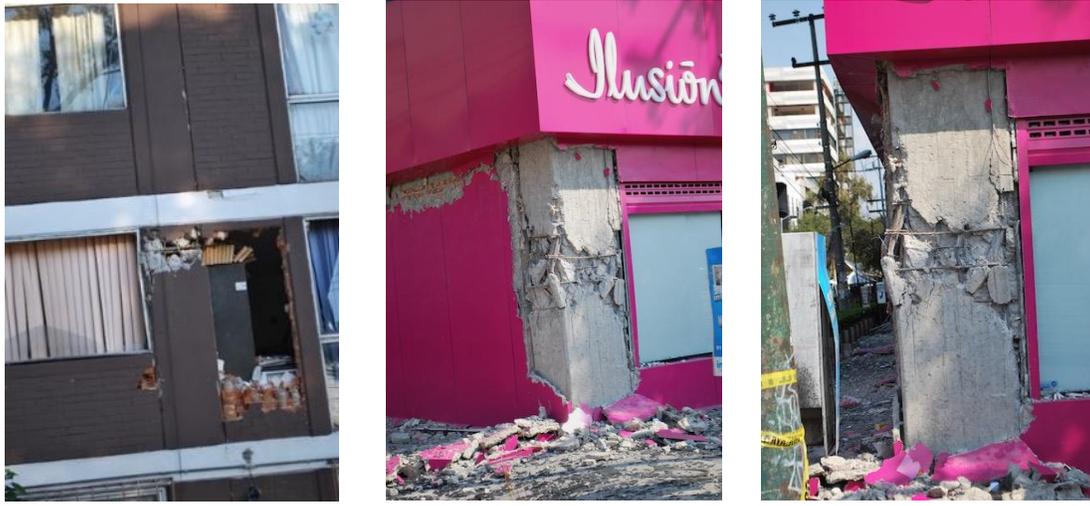
Some of the columns also suffered from lack of concrete confinement and buckling restraining ties. Figure 5(a) shows hinging of a concrete column in a residential building. Buckling of longitudinal reinforcement with insufficient column ties of a government office building near San Antonio Abad Subway Station in Mexico City is illustrated in Figs. 5(b) and 5(c). The figure demonstrates that widely spaced small size perimeter and interior ties were not able to prevent buckling of disproportionately larger longitudinal bars in compression. These buildings were designed and built prior to the revisions of the seismic detailing requirements of the code of practice after the 1985 Mexico City Earthquake. However, some of the newer 5-storey reinforced concrete buildings designed and built recently also suffered column damage though these buildings in general performed well. This is illustrated in Fig. 6. The factors contributing to the column damage in this building was widely spaced column ties and increased seismic force demands due to the short column effect.

Figure 5. Lack of concrete confinement and buckling restraining ties in pre-1985 buildings

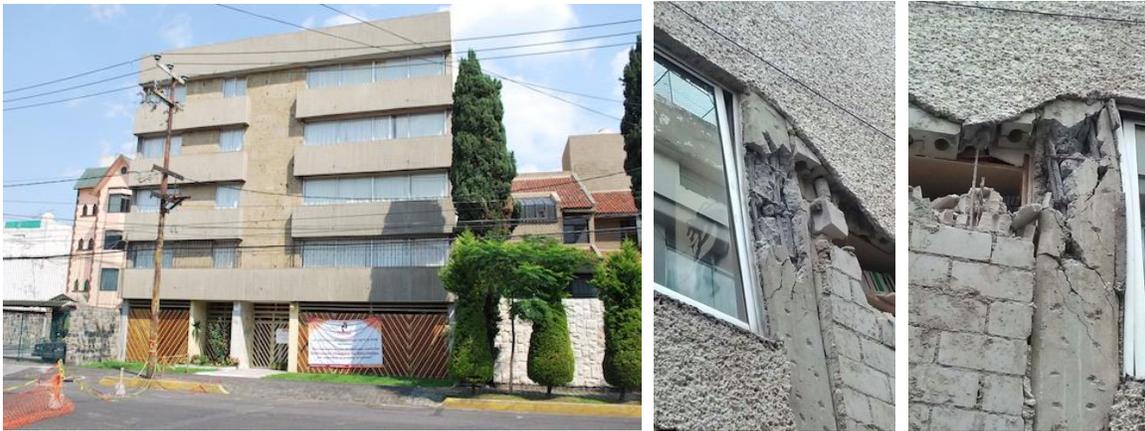
Figure 6. Lack of column transverse reinforcement and short column effect in a post-1985 reinforced concrete frame building with concrete block masonry infill walls

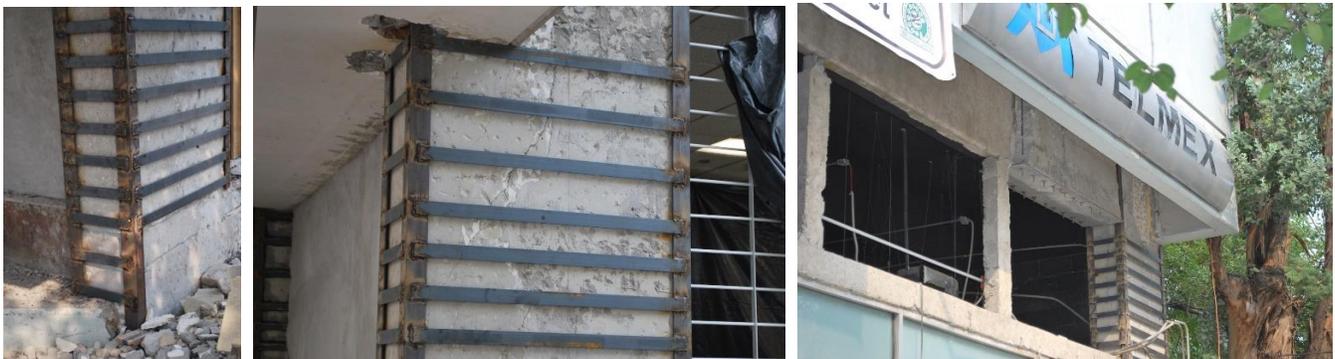
A number of reinforced concrete frame buildings were retrofitted after the 1985 Mexico City Earthquake. The retrofit techniques included column strengthening and frame bracing with diagonal steel elements. Figure 7 illustrates a typical column strengthening technique commonly used in Mexico City. The figure illustrates the retrofit of Telmex Mexican Telecommunication Company building after the earthquake with columns that had already suffered some shear cracking. The technique consists of steel angles placed longitudinally at each column corner with steel strips welded to each angle in two transverse directions. It is interesting to note that this building had a concrete shear wall in the short direction and the column shear cracks were associated with shear force reversals in the long direction. The same technique was used in an 8-storey reinforced concrete government building located near the San Antonio Abad subway station. The columns of the building were strengthened as shown in Fig. 8. However, this did not prevent the failure of columns and the collapse of the 4<sup>th</sup> floor in the corner, while many other columns in the building suffered varying degrees of damage. The same column retrofit strategy was also implemented in one of the residential reinforced concrete frame buildings in the Calle Sonora Esquina Parque district of

Figure 7. Column retrofit technique commonly used in Mexico City

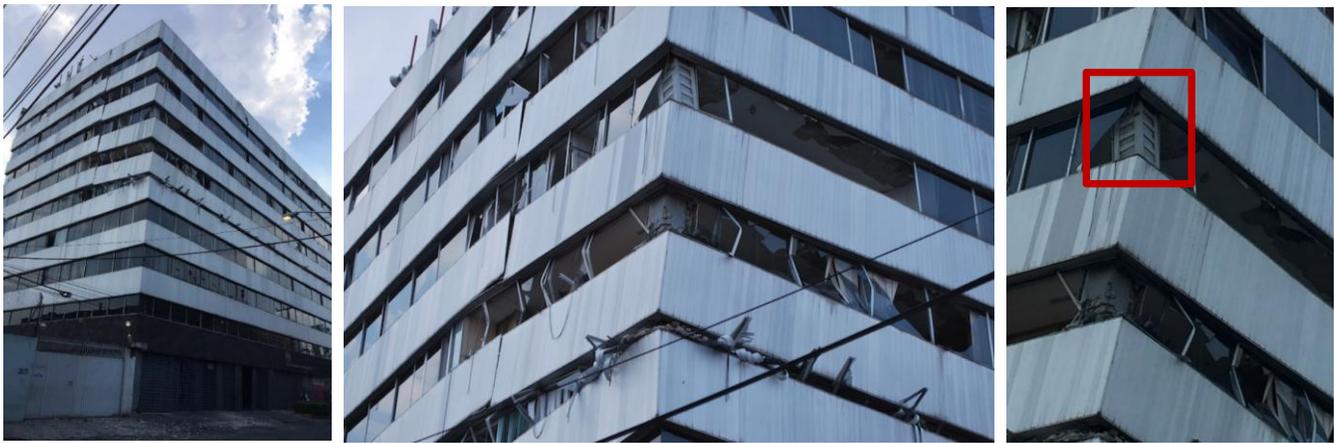
Figure 8. Eight-storey government office building with retrofitted columns following the technique illustrated in Fig. 7 suffered collapse of the 4<sup>th</sup> storey columns

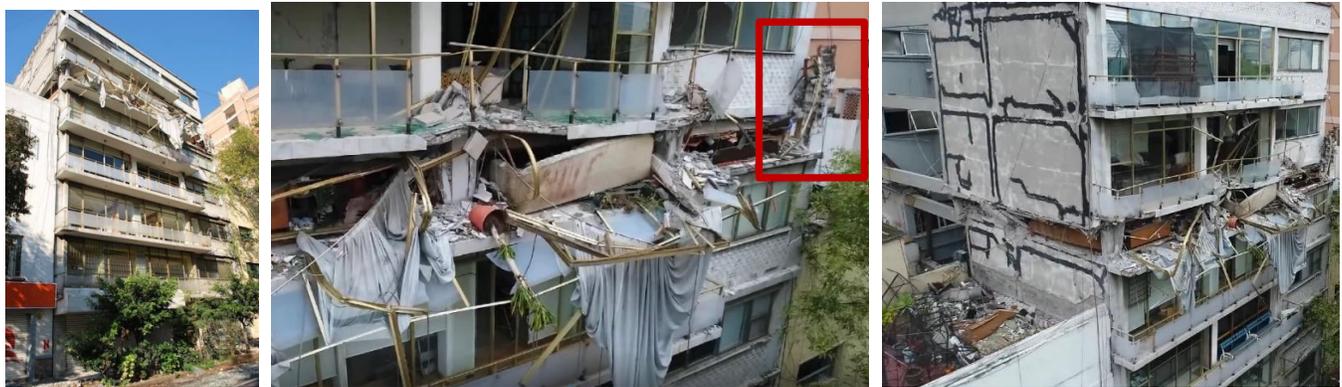
Mexico City. This eight-storey reinforced concrete frame building, shown in Fig. 9, had been retrofitted before the earthquake, possibly in anticipation of increased seismic shear demands at the level below where it was supported laterally by the adjacent building. The building suffered from pounding against the adjacent building and the 6<sup>th</sup> floor collapsed after shear rupturing of columns.

Figure 9. Residential building with column retrofit technique shown in Fig. 7 suffered from pounding of the building against a shorter adjacent building, suffering from shear rupturing of the retrofitted columns

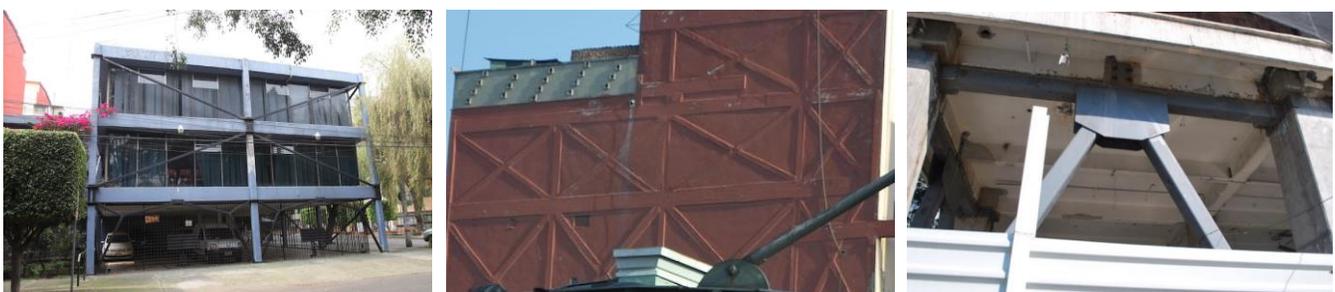
Another seismic retrofit method observed was bracing of frame buildings with structural steel. Two buildings that had been retrofitted with cross bracings before the earthquake survived the quake without any sign of damage. These buildings are shown in Figs. 10. Another reinforced concrete building was in the process of being retrofitted with structural steel braces during the visit as also illustrated in Fig. 10. It appears that, when seismic force and deformation demands are high in soft stories or places of discontinuity, global interference, such as lateral bracing is a better choice than individual column retrofitting.

Figure 10. Seismic retrofit of frame buildings with steel braces

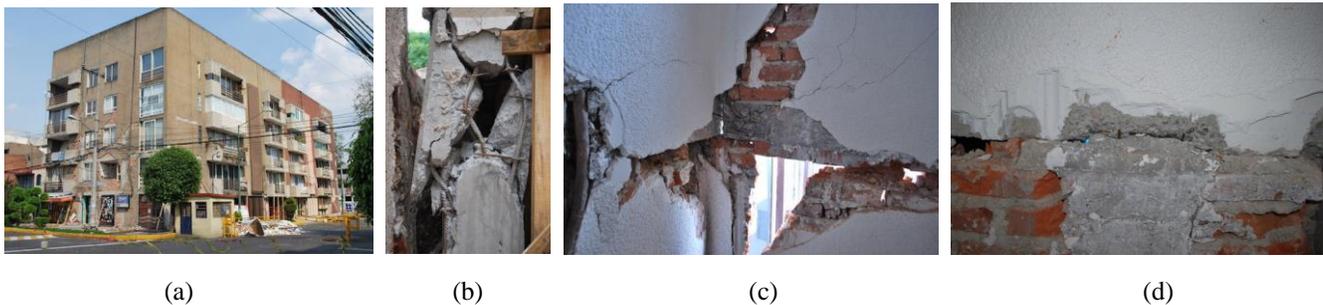
In some multistorey residential buildings the combined use of reinforced concrete frames around the perimeter of the buildings with confined masonry construction elsewhere was noted. Some of the older confined masonry buildings constructed prior to 1985 suffered damage due to lack of proper detailing. A number of apartment buildings visited by the team in the borough of Tlalpan, south of Mexico City showed poor detailing of load bearing walls, tie columns and bond beams. Figure 11(a) shows three attached condominium buildings of similar structural configuration. Fig. 11(b) illustrates lack of sufficient column ties and Figs. 11(c) and (d) show lack of continuity of reinforcement between tie columns and bond beams. The interior and exterior masonry walls suffered significant damage in the form of diagonal shear crack. This is illustrated in Fig. 12. However, reasonably good size columns and beams used around the perimeter of the buildings helped maintain the gravity load carrying capacity even after the loss of some of the load bearing masonry walls.

Figure 11. Behaviour of confined masonry residential buildings

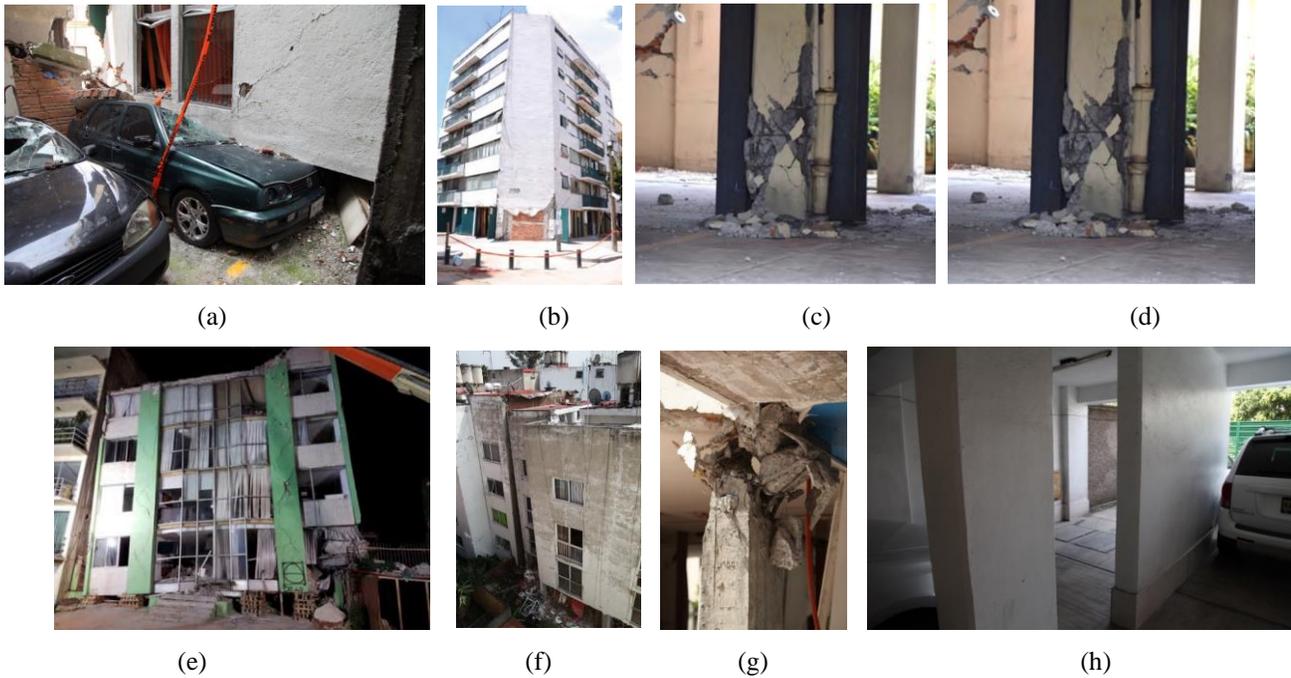
The use of open space at the first-storey level of residential buildings is common in Mexico City. This space is often used for parking, creating soft stories and associated vertical stiffness and strength irregularities. Soft stories usually have reinforced concrete frames with small size columns having limited shear capacities, as well as limited inelastic deformability. Upper floors either have load bearing masonry walls or reinforced concrete frames with masonry infills. The use of soft stories is forbidden in the 2004 Mexico City Seismic Code [5]. However, many were built prior to 2004. Figures 12(a) through (g) show reinforced

concrete frame buildings with soft stories. The columns of the building suffered damage due to increased force and deformation demands and lack of sufficient transverse reinforcement to meet these demands. Figure 14(h) shows a soft-storey building with narrow shear walls providing sufficient resistance to increased demands without any sign of damage.

Figure 12. Reinforced concrete buildings with soft stories

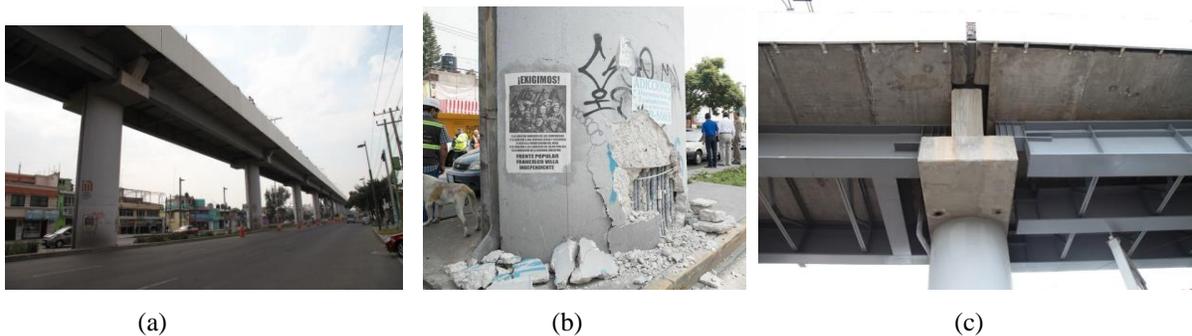
Most of Mexico's bridges were designed and constructed before 1970, without consideration of seismic design. More recent bridge designs have adopted the American Association of State Highway and Transportation Officials (AASHTO) Bridge Design Specifications [6], which include seismic design requirements. Despite the majority of bridges lacking seismic design, bridges generally performed well during the September 19, 2017 earthquake. Members of the reconnaissance team were able to visit four damaged bridge sites within the Mexico City area to gather information, as well as bridge performance observation data on lessons learned from the Mexico earthquake experiences. The types of bridge damage observed include plastic hinge formation at a bridge pier column, foundation rocking, torsional movement of bridge girders, damage to shear keys, large movement or deformation of bridge bearings, longitudinal movement of bridge girders and abutment failures. Figure 13 shows Mexico Metro Line viaduct, which consists of two steel girders at each span, simply supported on single 2.0 m diameter circular reinforced concrete column bents with heavy cap beams. The steel girders support a concrete deck of width sufficient to accommodate two parallel tracks for trains running in opposite directions. The viaduct suffered damage to one of its 2.0 m diameter columns at the intersection of Av. Tlahuac and Calle Gitana between the metro stations Alvois and Nopalera of Line 12. Figure 13 (b) illustrates the formation of a plastic hinge at the base, which was subsequently repaired by providing a reinforced concrete jacket.

Figure 13. (a) Mexico Metro Line viaduct, (b) plastic hinge forming at the base of a bridge column, (c) longitudinal displacement at deck level and lateral displacement

At a distance 1.2 km south-east of the column damage site, at the intersection of Av. Tlahuac and Av. Guillermo Prieto, the Metro Line 12 viaduct has the alignment layout of an S-shaped double curve. At this location, damage was observed at the shear keys of a span with three steel girders. This was attributed to excessive movement of the girders in the longitudinal direction, resulting in complete spalling of the concrete restraint at the shear keys. Significant rocking of the column piers, possibly exacerbated by torsional response of the curved viaduct, was observed. Figure 13(c) shows significant shift of the girders along the longitudinal direction of the viaduct.

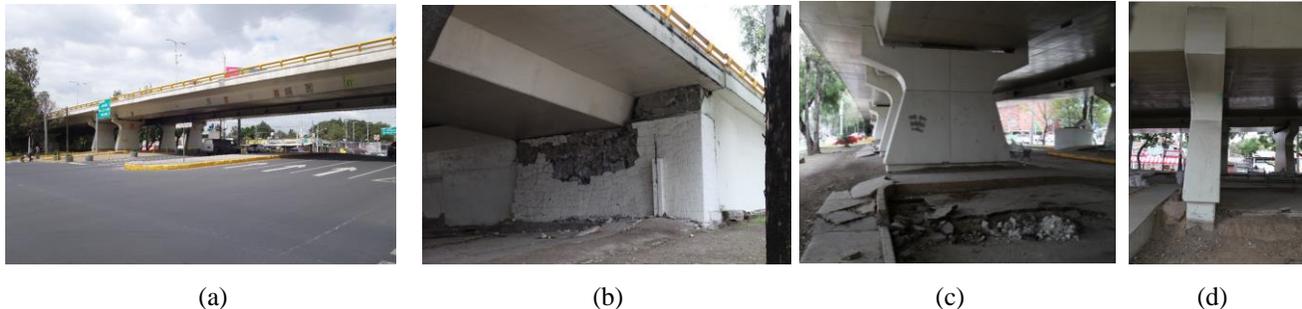
Another bridge damage site visited by the reconnaissance team was a highway bridge located at Circuito Interior Avenida Rio Churubusco photos in Mexico City. The bridge structure is shown in Fig. 14(a). It consists of two parallel underpass bridges. The 5-span bridge has wall piers and unreinforced masonry (URM) abutments. The URM abutments were damaged during the earthquake as shown in Fig. 14(b). Some reinforcement was observed at the exposed upper part of the abutment; but the lower main part of the masonry abutment was unreinforced. Permanent tilting of some of the wall piers was clearly evident after the earthquake as shown in Fig. 14(c).

Figure 14. (a) Parallel 5-span underpass, (b) damaged URM abutments, (c) rocking of wall pier, (d) tilting of wall pier
