## Effectiveness of Surface Gravel Replacement for Liquefaction Damage Mitigation at Soma LNG Terminal during 2022 Fukushima Earthquake

### ABSTRACT

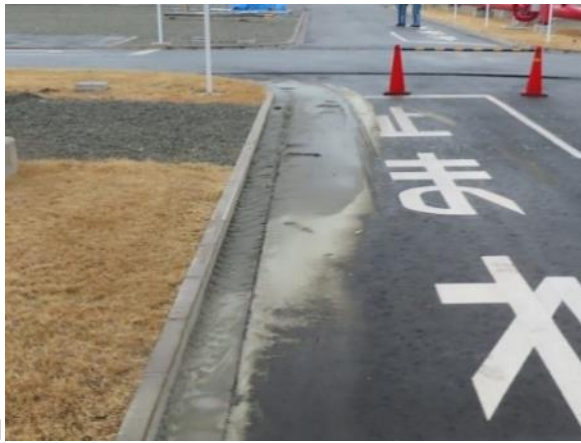
Looking at the on-site roads, sand boiling occurred at the gap between L-shaped gutters and asphalt pavement as shown in Picture 1(a), with sand in some places also extending onto the grassy area beyond the L-shaped gutter as in Picture 1(b).

(a) Sand boiling from interface between L-shaped gutters and asphalt pavement

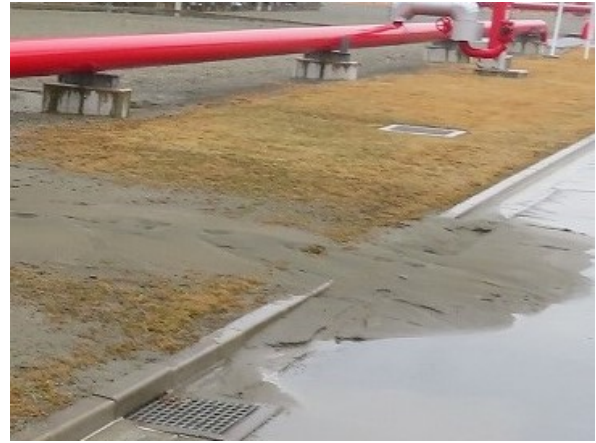
(b) Sand boiling from grass beyond L-shaped gutter

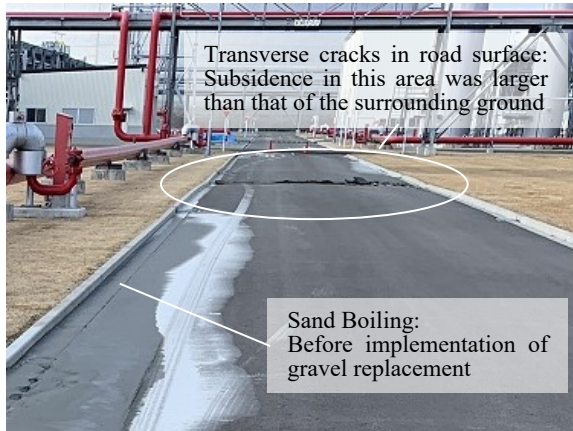
After the 2021 earthquake, cracks and unevenness were observed in the L-shaped gutters and the pavement surface, and there was evidence of sand boiling from the interface between the L-shaped gutters and the asphalt pavement. The white circled areas in Picture 2(a) indicate cracks caused by the strong seismic motion. Differences in motion amplitude between the liquefied and non-liquefied parts would influence the occurrence of cracks in the road. On the other hand, after the 2022 earthquake, no significant unevenness was observed in the L-shaped gutters nor did sand boil from the interface between the L-shaped gutters and the asphalt pavement. Note that the 2022 earthquake occurred before the asphalt pavement was restored, as shown in Picture 2(b).

(a) After 2021 earthquake

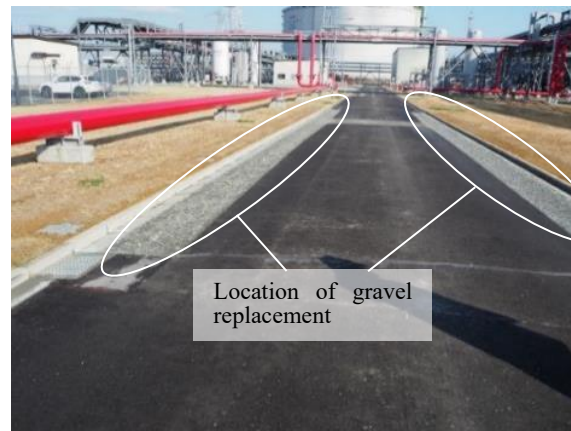
(b) After 2022 earthquake

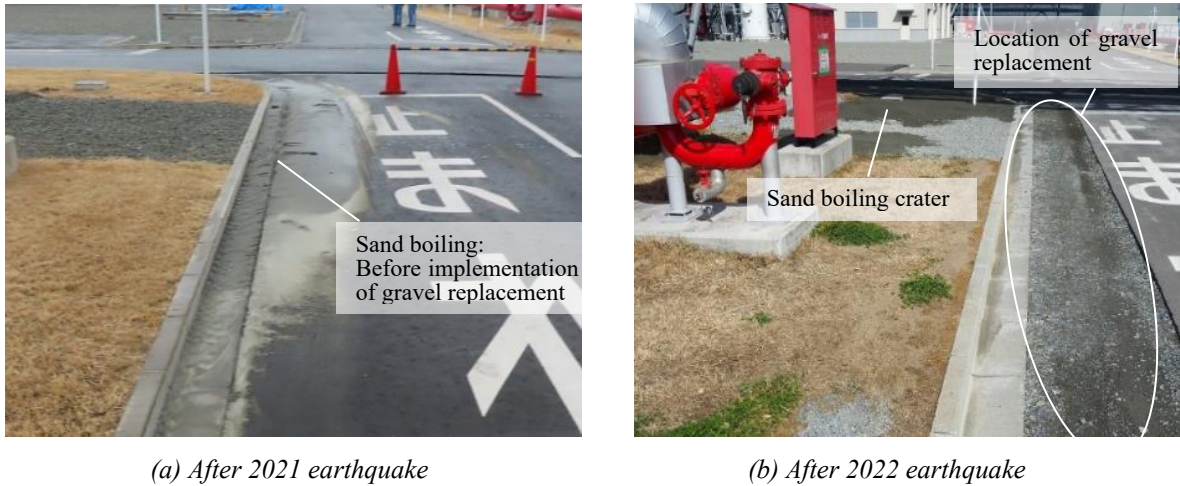
Picture 3. Intersection of Road B and Road 4 (Figure 7②): 'Under asphalt' type)

During the 2021 earthquake, sand boiling occurred at the interface between the L-shaped gutters and the asphalt pavement. In the 2022 earthquake, there was no sand boiling from the interface or damage to the L-shaped gutters. Sand boiling did

occur on an unprotected grassy area about 2-3m away from the road intersection. The 2021 earthquake did not cause this sand to boil, so no measure was taken in this area. It would have been caused by the stronger motion of the 2022 earthquake.

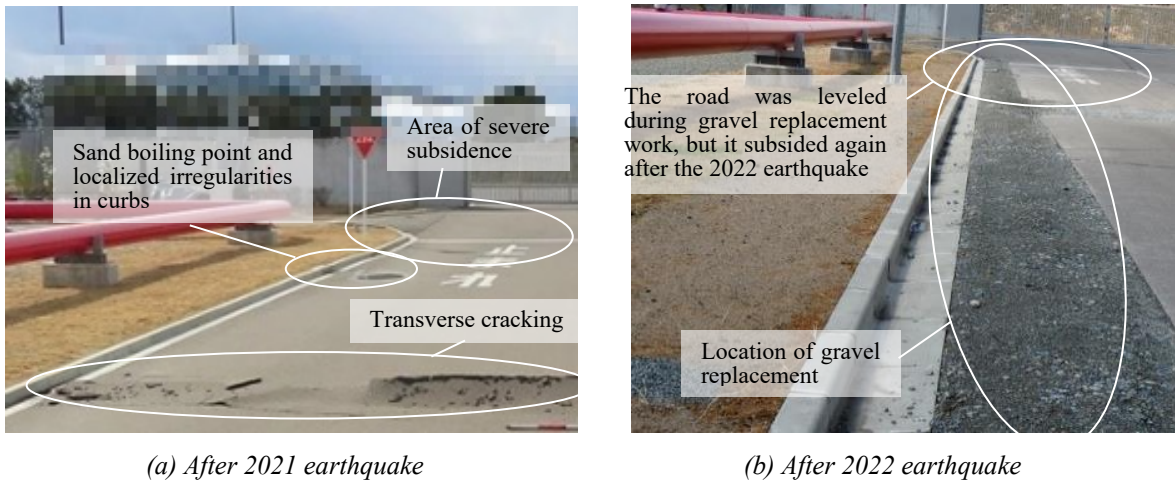
Picture 4. Road 2 (Figure 7③): 'Under both' type)

After the 2021 earthquake, there was evidence of cracks in the asphalt pavement, a sand boiling crater and depressions in the asphalt pavement, and irregularities in the L-shaped gutters. The area in the background of the picture (shaded yellow in Figure 7) suffered severe overall subsidence while the L-shaped gutters and road surface also subsided slightly in response. Although the L-shaped gutters were made level during the replacement work, overall mild subsidence happened again in the 2022 earthquake. This type of mild settlement would be caused by relatively heavy liquefaction in this area. The severity of liquefaction depends on exact location, because the soil type and fine content of reclaimed land varies.

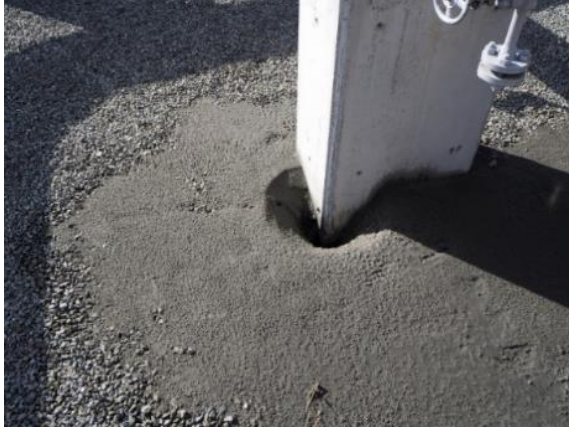
At position ④ in Figure 7, there is a group of foundation structures that support various pipework. Sand boiling occurred in this vicinity in the 2021 earthquake. Picture 5 shows one pipe foundation that tilted in the direction of the nearby sand boiling adjacent to the foundation.

(a) Sand boiling adjacent to foundation (b) Uneven settlement of foundation with adjacent sand boiling

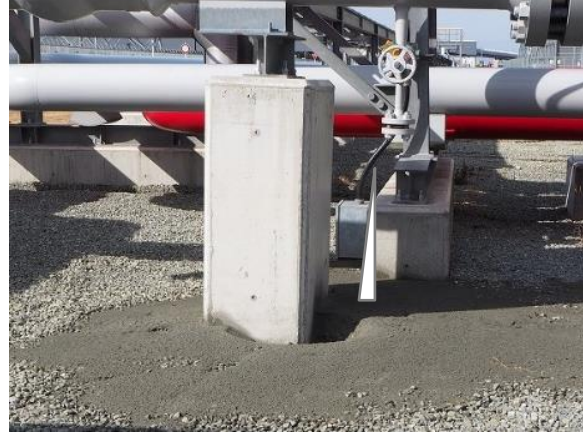
Figure 8(a) shows the mechanism by which sand boiling causes uneven foundation settlement. Gaps form around the foundation due to the difference in response between ground and foundation, allowing sand boiling to occur adjacent to the foundation. Uneven settlement leads to tilting of the foundation as the ground is progressively damaged. The tilting phenomenon progresses gradually as ground near the surface continues to liquefy. This gradual tilting occurs during liquefaction over a period of a few minutes to 10 minutes during and after shaking. Loosening of the soil under the edge of the foundation as a result of sand boiling increases the tilting of the foundation [1], [2]. This is what is thought to have occurred with these foundations. This understanding leads to the conclusion that liquefaction damage may be reduced by ensuring the ground remains strong by quickly draining only water and not sand from immediately below the foundation. Based on this conclusion, surface gravel replacement was implemented as shown in Figure 8(b) to achieve this. A 300mm-thick layer of No. 7 crushed stone was laid with a width of 300mm under the foundation and 500mm outside both sides of the foundation. Groundwater is drained to the surface through  $\phi 300$  pipes filled with No. 7 crushed stone.

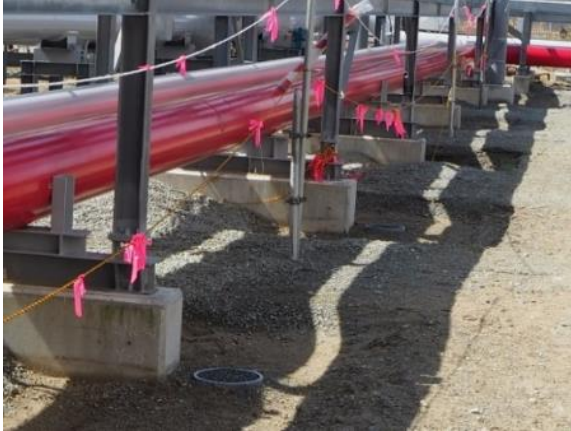
At the time of the 2022 earthquake, gravel replacement work had already been implemented for some of the foundations. The blue colored areas in Figure 8(b) are the locations where the work had been completed. Picture 6 shows the situation around the foundations after the 2022 earthquake. The sand boiling that occurred around the foundations in the 2021

earthquake was not seen in the 2022 earthquake. Although gravel replacement work was still in progress at the time, the measures were seen to have a certain effect in suppressing sand boiling around the foundations. Further, in contrast with the 2021 earthquake, there was no noticeable sinking of the foundations or uneven settlement. After the earthquake, No. 7 crushed stone from within the drainage pipes was found spilled over the ground surface. This was observed at almost all the drainage pipes. Because the 2022 earthquake occurred at night and was not directly observed, the flow of groundwater to the ground surface, driven by the excess porewater pressure, is assumed to have flushed some of the crushed stone out of the pipes. This phenomenon can be taken as evidence that the crushed stone layers have fulfilled their function and the installed gravel drain reduced liquefaction damage by dissipating excess porewater pressure promptly.

(a) Group of pipework foundations

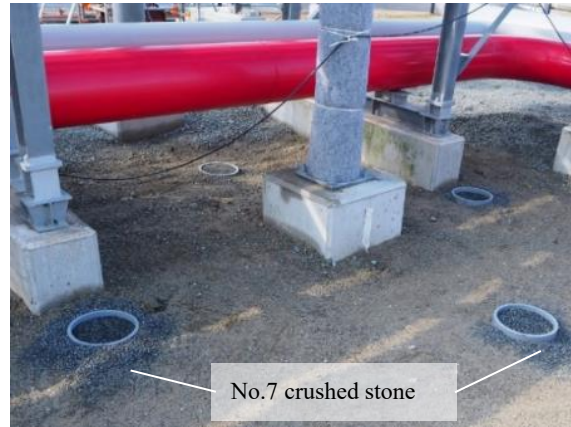
(b) Crushed stone ejected from  $\phi$  300mm drainage pipe
