INTENSIFIED ONGOING GROUND CRACKING DURING EARTHQUAKES IN MEXICO CITY

Robert C. Lo^{1*}

¹Klohn Crippen Berger *lorobertc@gmail.com

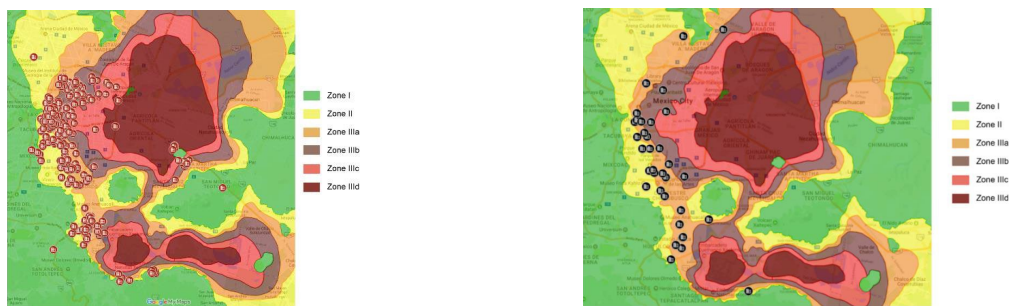
(a) Map showing buildings deemed unsafe for occupation (b) Map showing collapsed buildings

Figure 1 Maps showing seismic zonation for Mexico City and building damages on September 19, 2017 EQ <https://www.sismosmexico.org/mapas>

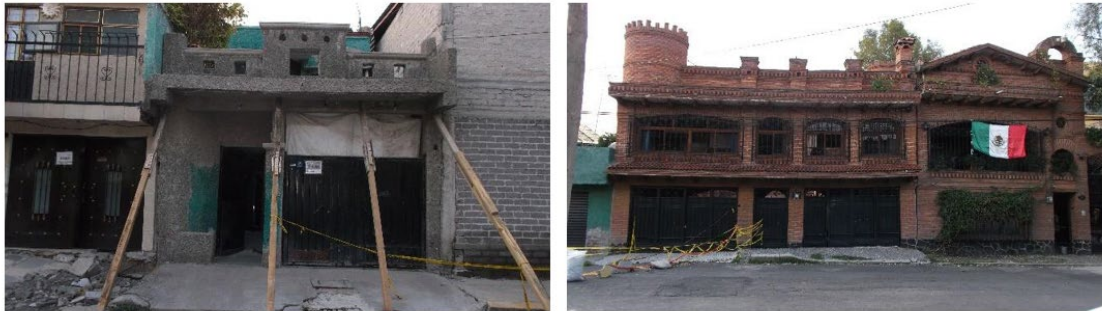
The problem of ongoing ground cracking and its intensification during seismic events, such as the September 19, 2017 event, has only recently been studied systematically since 2005 [7]. Figure 3, taken after the 2017 earthquake, shows how the buildings in the affected area were stressed, requiring shore up. Factors contributing to this phenomenon include: (1) hydraulic fracturing in flooded areas; (2) regional subsidence in areas with abrupt transition; (3) stratigraphic anomalies; (4) evapo-transpiration; and (5) buried geologic structures.

Figure 3 Buildings damaged by intensified ground settlement and crack during September 19, 2017 Puebla-Morelos Earthquake

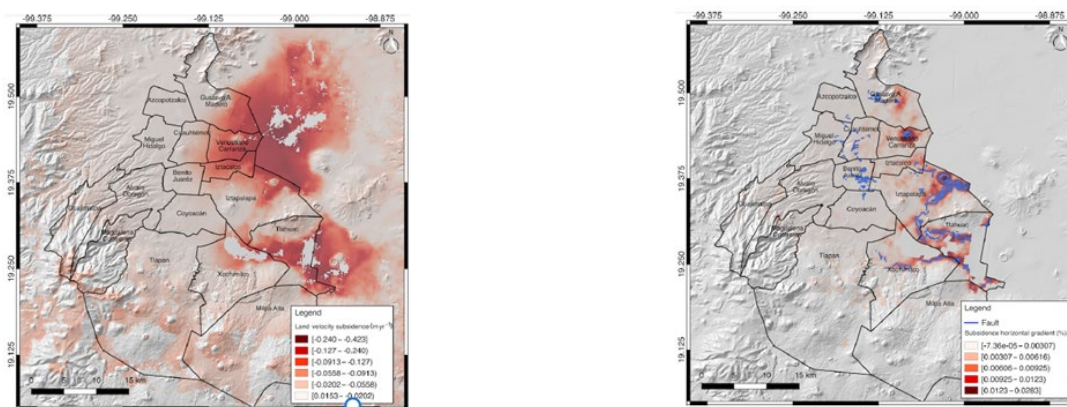
Solano-Rojas et al. (2020a) described the multiscale approach using multi-platform InSAR products to study ground cracking in Aguascalientes Valley and Mexico City [8]. Solano-Rojas et al. (2020b) employed InSAR and GPS satellite geodetic techniques using satellite-acquired SAR data between November 2014 and November 2017 from the Sentinel-1 satellites provided by the European Space Agency (ESA) to study the intensified ground cracking during the September 19, 2017 earthquake [9]. Figure 4(a) shows a map of the subsidence rate for Mexico City, while Figure 4(b), derived from Figure 4(a), shows a map of the horizontal gradient of subsidence for the city. Figure 4(b) indicates strong horizontal gradients of subsidence occur where fractures of the ground surface are common in areas such as former Texcoco and Chalco-Xochimilco Lakes and lower slopes of the Sierra de Santa Catarina.

Figure 4 Subsidence rate and horizontal subsidence-gradient maps for Mexico City (from Solano-Rojas et al. 2020b[9]).

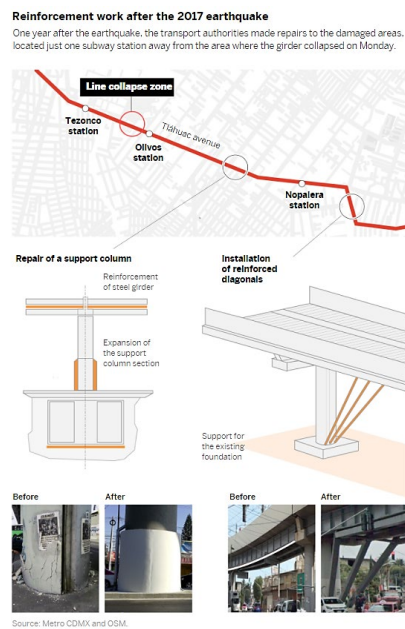
In the 2017 Puebla-Morelos earthquake, water and sewer lines were damaged, especially in the Colonia Del Mar area, where shallow faulting and ground surface cracking occurred [10]. Many of these damages occurred earlier in the 1985 Michoacan quake [3]. Two segments of the elevated viaduct of Metro Line 12, about 1.2 km apart, suffered structural damage in 2017: one involved a column failure near its base with spalled concrete and exposed re-bars, and the other involved failure of concrete restraint at the shear keys of steel girders. The rocking motion of the column pier appeared to be the cause at both locations (see Figure 5). The repairs were ongoing during our October 2017 visit [9]. On May 3, 2021, Metro Line 12 collapsed with a death toll of at least 25 and dozens injured [11]. The cause of this collapse has been investigated [12]. These infrastructures suffered from additional stress and strain associated with earthquake events. The phenomenon of intensified ground cracking during earthquakes most likely is at play as well. Thus, we anticipate that the new tool of InSAR Satellite Imageries can aid in the investigations of lifeline performance in certain areas of Mexico City.

Figure 5 Reinforcement work after the 2017 earthquake and Metro Line 12 collapse on May 3, 2021 (from El Pais 2021[11])
