Seismic Performance of Precast Prestressed Hollow-core Floors and Residual Capacity of Web-cracked Floor Units

Mohamed Mostafa^{1*}, Richard S. Henry² and Kenneth J. Elwood³

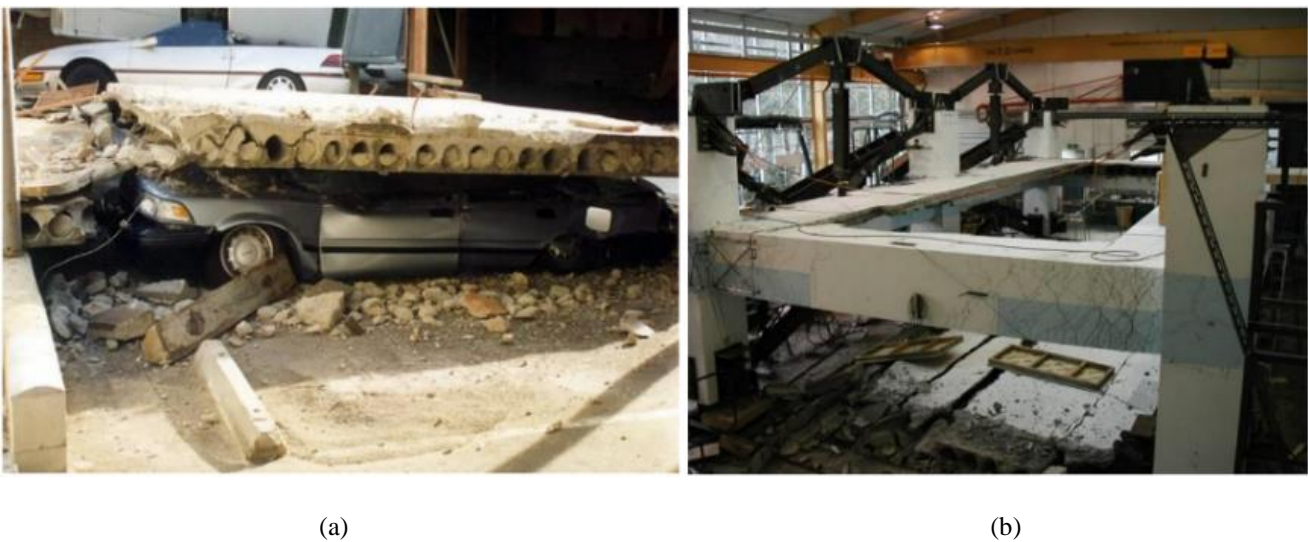
The collapse of HC floor units during the 1994 Northridge earthquake, as shown in Figure 3a, raised serious concerns in New Zealand about the expected seismic performance of these floors in future events where HC floors had been widely used in New Zealand since the late 1970s [19]. Subsequently, significant research investigating the seismic performance of HC floors has been undertaken over the past 25 years in New Zealand. A series of component tests were conducted to better understand the behavior of specific HC floor connections under seismic actions [4], [6–8], [20]. However, it was not until the early 2000s that critical failure mechanisms of these floors were exposed in a large-scale super-assembly test (Figure 3b) [10].

Figure 3. a) Hollow-core floor collapse during 1994 Northridge Earthquake [21] b) Hollow-core floor collapse in large-scale test [10]

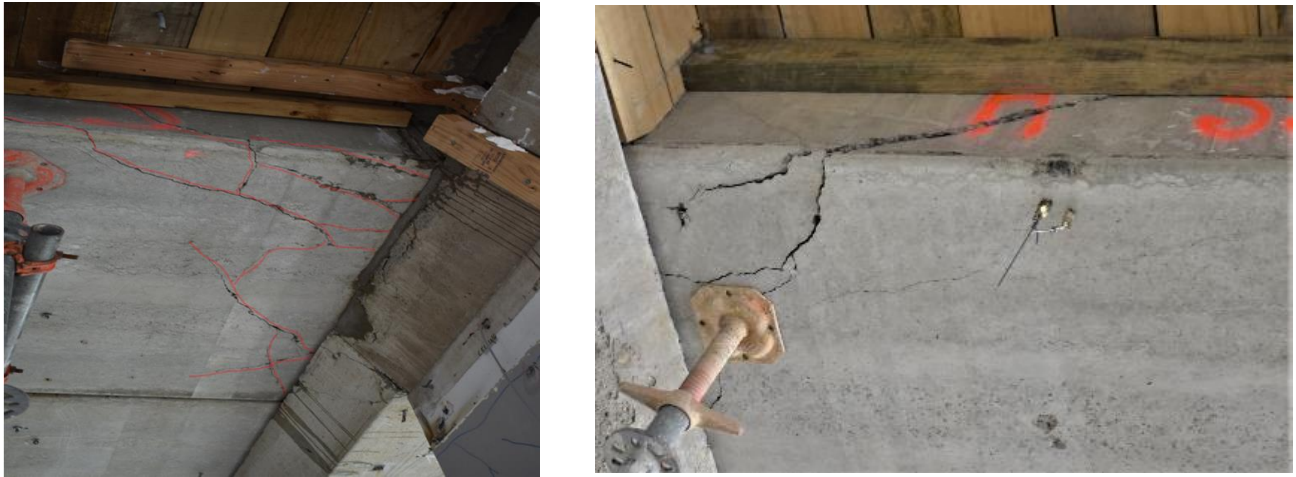
Damage observations from the building showed unexpectedly poor performance of HC floors that incorporated current seismic detailing requirements according to the New Zealand concrete structures design standard, NZS3101:2006 (Figure 5).

Figure 5. Examples of damage observed in HC floor units with current detailing seated within the plastic hinge region showing cracking of the unreinforced webs of the floor units

HC floor units seated within the plastic hinge region can be subjected to significant bending and twisting demands due to the deformations of the supporting structure. Moreover, HC floor units seated within the plastic hinge region were found to receive critical damage, where cracking of the unreinforced webs of these floor units was observed. Cracking the unreinforced webs impairs the gravity load-carrying capacity during and after an earthquake (Figure 5).

The susceptibility of HC floor units to sustain a higher degree of damage when seated at or adjacent to an intermediate column (within the plastic hinge regions of the supporting beams), even when incorporating current seismic detailing requirements, was highlighted. The observed damage suggests that although the current New Zealand concrete design standards may include provisions that require consideration for deformation compatibility between precast flooring systems and the supporting structural system, HC flooring systems incorporating current seismic design and detailing requirements may not satisfy the targeted performance of international concrete design provisions requirements to consider deformation compatibility if the units were seated within a plastic hinge region.

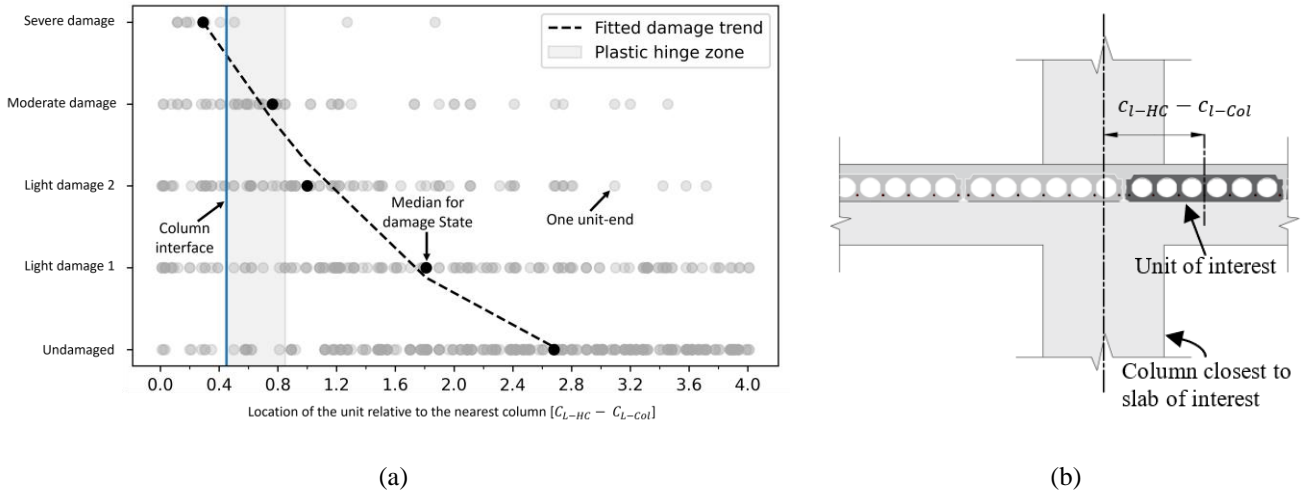
To quantify the extent of damage sustained in the floors, a qualitative damage assessment criterion was developed to classify different observed damage states in the case study building. Each HC unit-end was assigned a damage state from light-severe based on how likely the gravity load path was compromised. A light damage state represented negligible or cosmetic damage, and severe damage indicated that the unit gravity load-carrying capacity had been significantly compromised. The damage severity for each HC unit-end was plotted against each unit location relative to the nearest column for 684 unit-ends (i.e. 342 HC units), as shown in Figure 6. It was noted that there was a trend for the damage severity, where the closer the unit support was to a column (i.e. supported in beam plastic hinge region), the higher the degree of damage. [22]

Figure 6. a) Damage trend of HC units relative to the floor unit location (centerline of HC unit relative to centerline of nearest column). The plastic hinge length was taken as half of the supporting beam depth (effective plastic hinge length ~ 0.5 beam depth) b) illustrative schematic of the HC unit location used

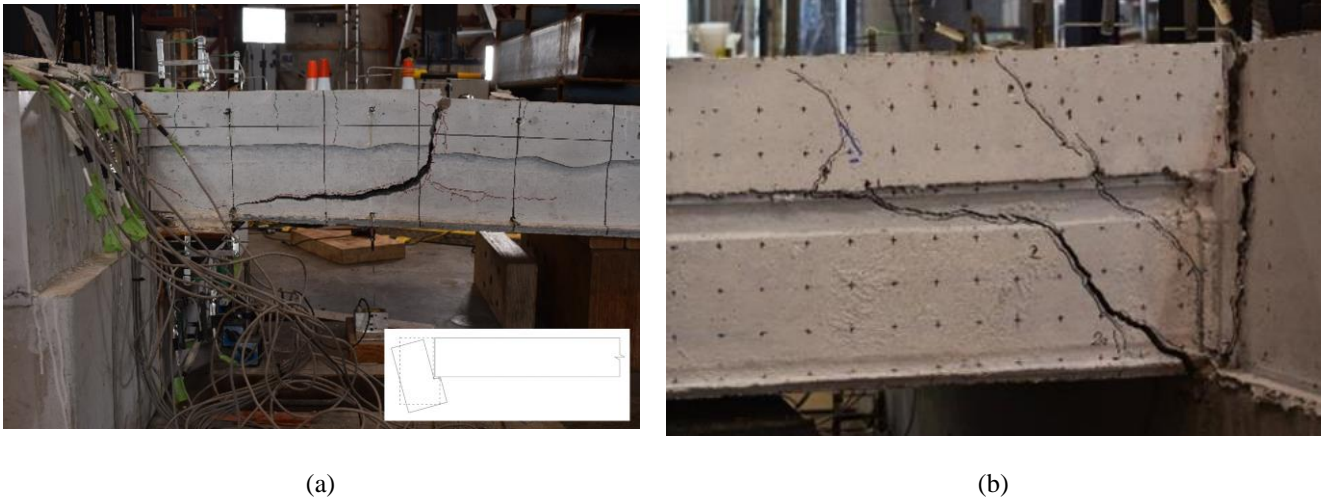
The design of HC floor units to resist gravity loads in shear assumes an uncracked section. However, HC floor units were observed to sustain web cracking and other critical damage when subjected to earthquake-induced deformations in laboratory experiments (Figure 7) and post-earthquake field observations (Figure 5).

Figure 7. Propagation of cracking into the unreinforced webs of the HC floor unit under simulated earthquake demands. a) negative moment failure [23] b) Positive moment failure [24]

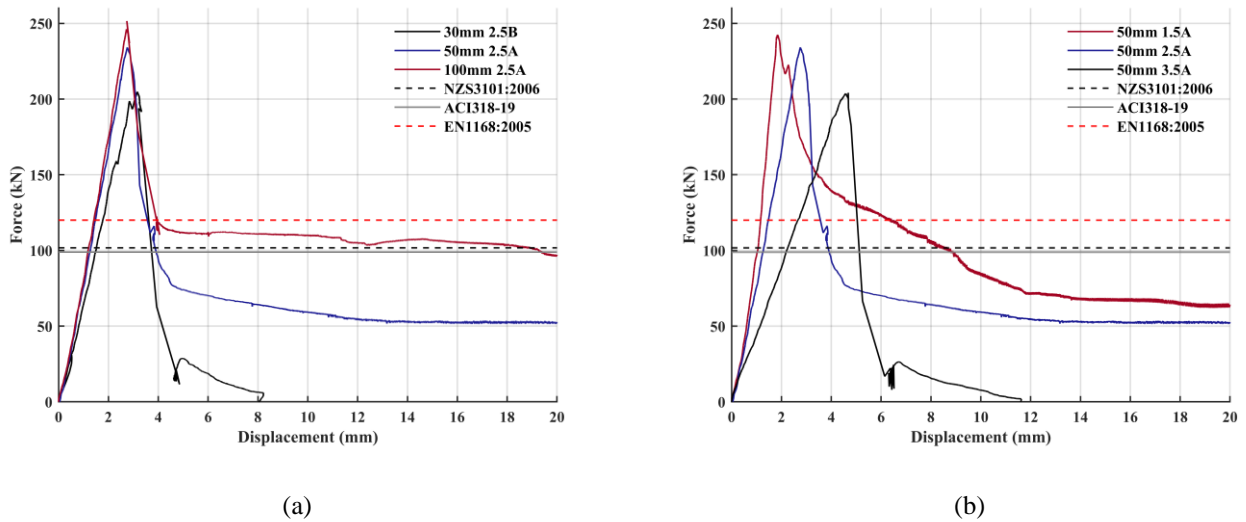
Across the tests, a relatively similar post-peak behavior was observed in the shear-displacement response, where a significant drop in load-carrying capacity upon diagonal cracking of the unreinforced webs of the HC units, as presented in Figure 9. Generally, after the drop applied force, due to the cracking of the unreinforced webs, the applied shear force remained at an almost constant residual value with increasing applied displacement.

The shear span was fixed for the first test set, and the support seating length was varied between 30, 50, and 100 mm. Tests with a 100 mm (~4in) support seating length could maintain almost the full estimated section shear capacity of the HC unit according to design standards (NZS3101:2006, ACI318-19, EN1168:2005). Whereas tests that had 50 mm (~2in) support seating length maintained about 50% of the estimated capacity of these floor units. Finally, tests that used a 30 mm (~1.2in) support seating length could not maintain the applied force with increasing displacement upon cracking. Figure 9a shows the shear strength versus deflection curve for some of the tested units with different support seating lengths.

For the second test set, as 50 mm is a commonly specified seating length for existing HC flooring systems in New Zealand [25], the support seating length was fixed to 50 mm (~2in), and the shear span was varied between 1.5d, 2.5d, and 3.5d. Tests with 1.5d and 2.5d generally maintained a residual load of around 50% of the estimated section capacity. However, tests with 3.5d did not maintain any significant residual capacity. Figure 9b shows the shear strength versus deflection curve for some tested units with different shear spans.

Figure 9. Some of the recorded responses from the testing campaign showing a) effect of support seating length on post-peak response b) effect of shear span on post-peak response

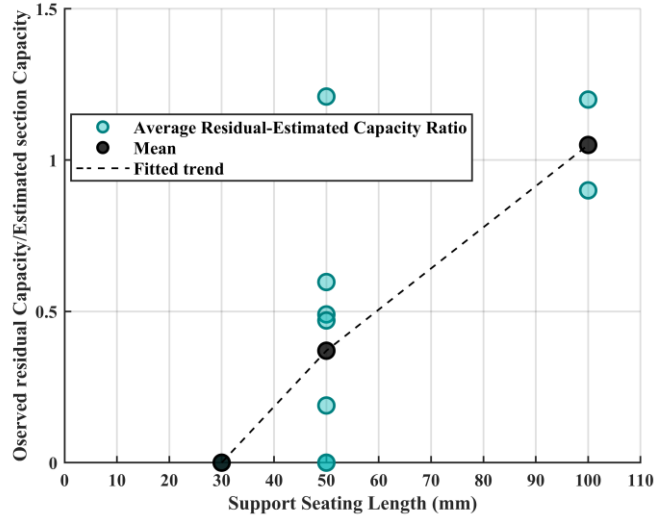
The observed residual load was compared to the estimated section capacity according to the New Zealand concrete design standards (NZS3101:2006), American concrete design standards (ACI318-19), and European design standards (EN1168:2005), and a relationship between the support seating length and the expected residual shear strength as a ratio from the estimated section shear capacity of the HC floor units was plotted as shown in Figure 10.

From Figure 10, a significant loss in residual gravity load-carrying capacity is expected for HC floor units upon cracking of their unreinforced webs if the support seating length is less than 50 mm. This finding can be critical for post-earthquake structural assessment. It should be noted that although HC units with 100 mm support could maintain a residual load almost equivalent to the calculated section capacity, there are very few buildings (in New Zealand) incorporating HC flooring systems with 100 mm support seating length.

Figure 10. Observed residual-estimated capacity ratio according to concrete design standards relative to tested support seating lengths
