Seismic Retrofit and Structural Assessment of a Modern Timber Building Re-Commissioned for Exterior Conditions as a Giant Gazebo

Francis Vandal^{1*}, Félix Bouffard² and Jean-François Martel³

ABSTRACT

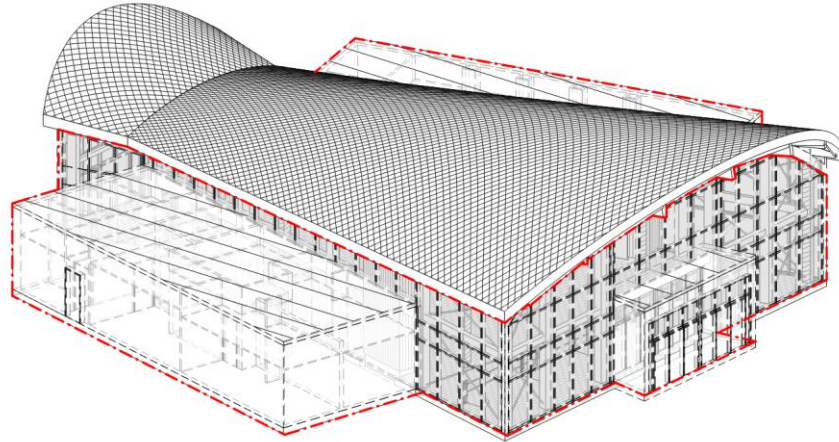
Figure 1. Existing glulam building before deconstruction.

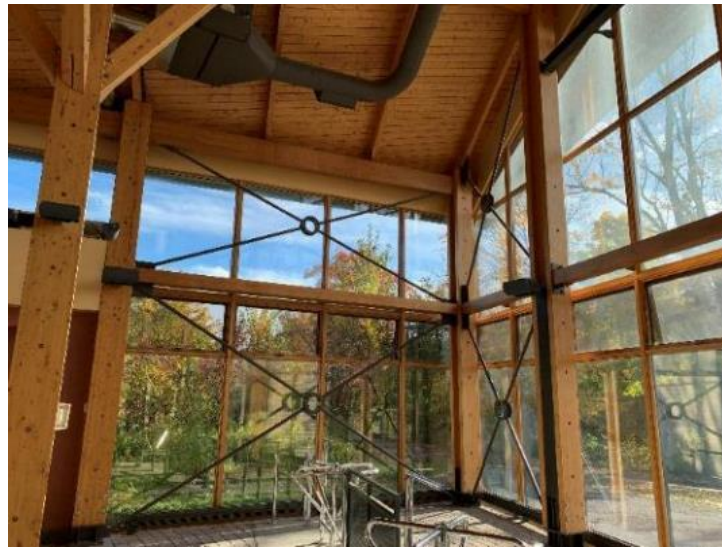
The existing seismic force resisting system (SFRS) is composed of tension-only steel braces oriented in both directions and located at one end of the building, as shown in Figure 2. After studying the existing structural drawings and the shop drawing details, it became evident that the light-frame wood walls connected to the glulam columns provided lateral resistance and stability to the structure. Therefore, the removal of the wings and envelope, for re-commissioning the building as a giant exterior gazebo, modified the diaphragm supports conditions, rendering it to a cantilever. This transformation made the gazebo very likely to perform poorly under large seismic demand, unless a retrofit was performed. In addition, the roof's diaphragm composition appeared to have limited capacity in regard with the shear forces coming from the seismic demand, as per the National Building Code of Canada (NBCC) [1]. Drawings and site survey revealed a design that did not allow for redirection of lateral forces to the foundation, which is critical in the case of a large seismic event.

Figure 2. Existing steel bracing system.

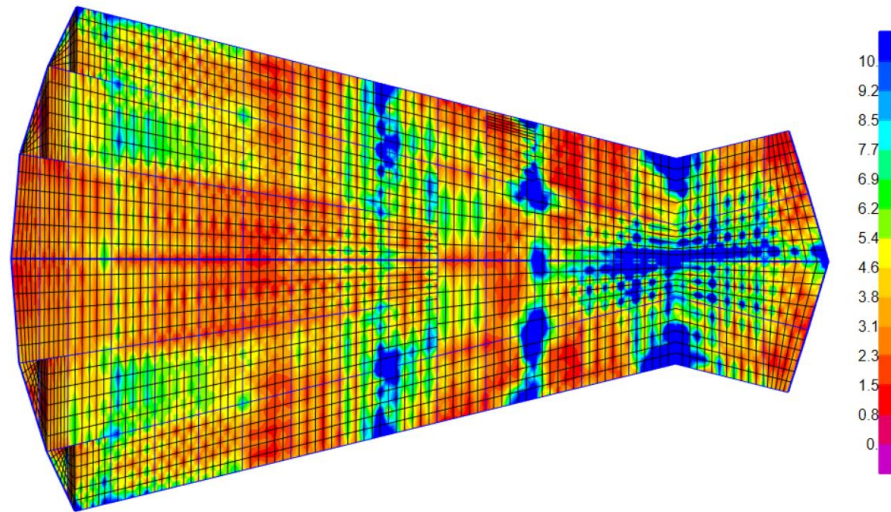
The analyses were achieved by generating a response-spectrum analysis (RSA) measuring the contribution from each natural mode of vibration to indicate the likely maximum shear stresses in the diaphragm as shown in Figure 4. Based on the results from the RSA and available existing drawings, multiple deficiencies were identified that required numerous retrofit solutions. An axial load, and shear flow analysis through designated collector beams was also performed.

Figure 4. Maximum stress in the diaphragm.

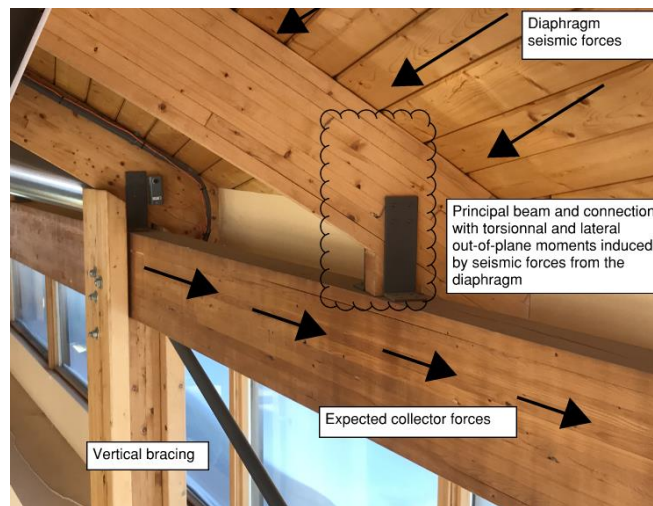
One of the most important deficiencies identified was the lack of a rigid connection between the diaphragm and the longitudinal collector beams of the vertical bracings. The analyses showed that torsional and lateral out-of-plane moments were induced in the principal beams, see Figure 5.

Figure 5. Existing diaphragm deficiency

- Depending on the selected retrofit solutions studied, strategic collector beams were identified and designated to transfer the lateral loads from the diaphragm to the vertical bracing system.
- To retrofit the identified deficiency concerning the lack of a rigid connection between the diaphragm and the longitudinal collector beams, three solutions were studied:
 - Adding customized C shape connections between the collector beam and the wood deck.
 - Adding light-frame wood shear walls between the collector beam and the roof the wood deck.
 - Adding stiffeners and plates to the existing steel connections.

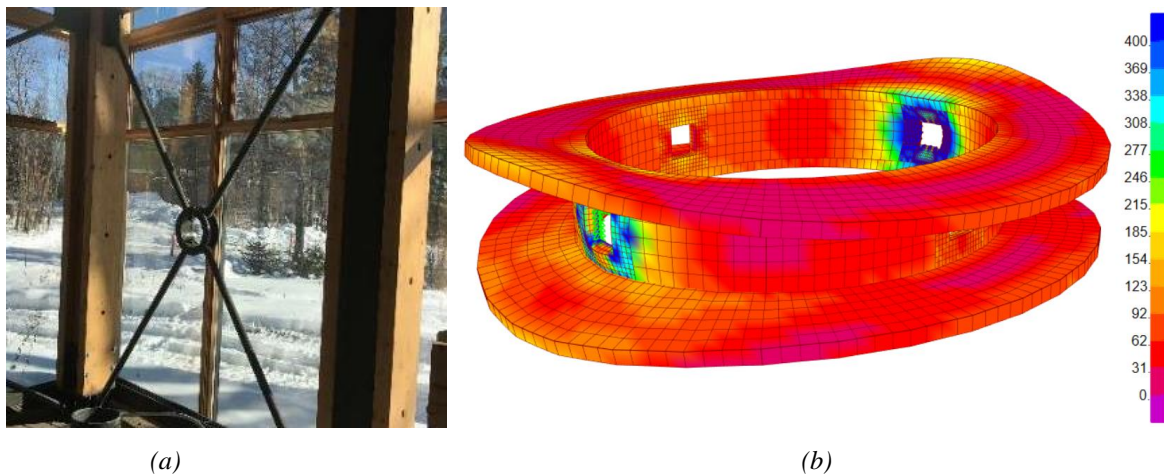
The major requirement for the bracing system was to obtain proper seismic behaviour while keeping the existing custom design. The middle connection of the X braces is formed with steel rings welded to a circular bent plate, shown in Figure 6. This connection ensures that the tension force is transferred from one tension element to another. Through all the methods taken to study this special component, the most efficient analysis method used was solid modeling and detailed finite element analysis (FEA). Using the CSI SAP2000 software and seismic forces in the bracing rings resulting from a capacity design approach, Von Mises stresses [8] were analyzed in the steel element. No major deficiencies were revealed by this study. The existing rings were therefore deemed adequate to sustain their design loads. These design loads were found to induce stresses reaching approximately 80% to 90% of the yield capacity of the material. FEA analysis led to the conclusion that tension-only steel rods are the energy dissipating component in this system.

Figure 6. Bracings connector ring: (a) existing steel rings, (b) FEA model and results.

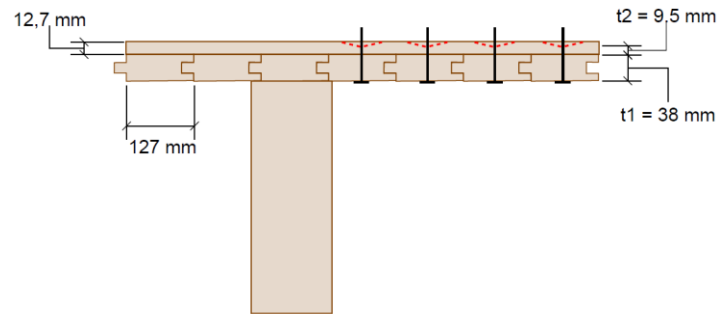
Figure 7. New nailing pattern performed from underneath of the roof structure.

- To sustain shear forces, it was studied to upgrade the composite action between the plywood and the wood deck through a new nailing pattern performed from the underneath, see Figure 7. This is the opposite of a normal plywood diaphragm as it is normally nailed from the top of the plywood. As this case is not specifically covered by CSA O86-19 standard [3], many numerical tests were performed, many discussions were held, and specialized professional's opinions were obtained. The results of these can be summarized with the following recommendations:

- Ideally the tip of the nail should exceed from the plywood.
 - It is important to respect minimal thicknesses in respect with nail diameter as illustrated with figure 12.17 of CSA O86-19. For a 12.7 mm thickness plywood, the maximum nail diameter is 2.54 mm.

- In the equations of clause 12.9.3.2 of CSA O86-19 standard [3], use the value of f_2 in place of f_3 . f_3 allows for some membrane effects in the equations d, e, and g. This membrane effect is more significant when the nail is nailed directly into the plywood as it is a thin element.
- There is a risk that the tip of the nail chip the plywood a little bit when it will come out of the plywood surface, which will reduce its contact length (value of t_2). As a precaution, it would be recommended to subtract the thickness of a ply in the calculation of t_2 . In the case of 12.7 mm (4 ply) plywood, this represented an approximate value of $t_2 = 9.5$ mm.

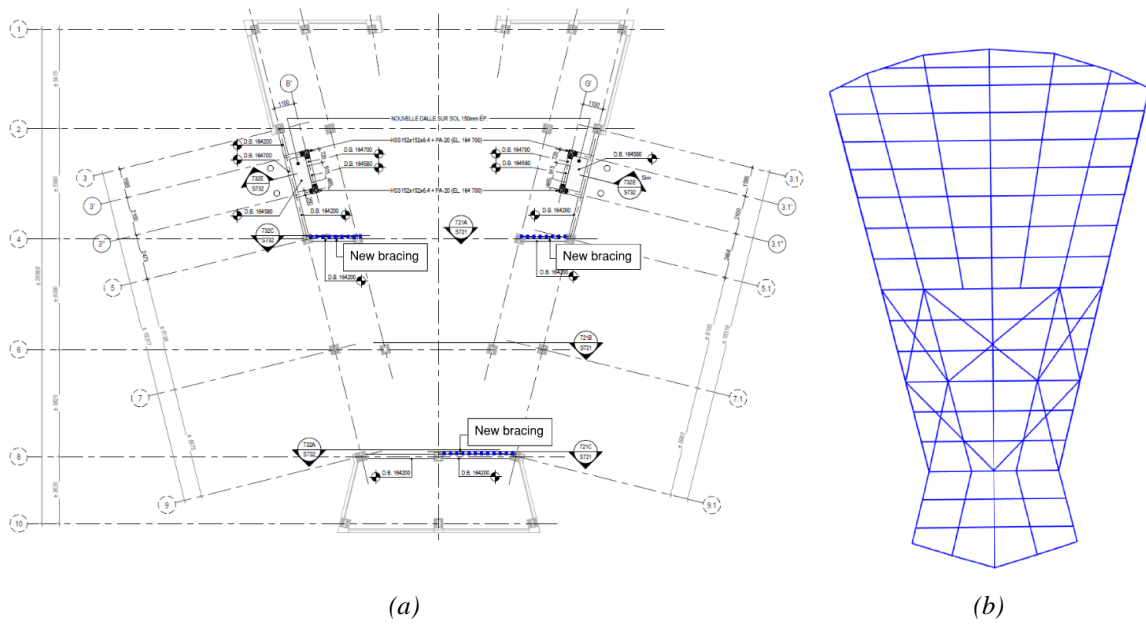
Figure 8. Implemented seismic retrofit: (a) New vertical tension-only X bracings, (b) New horizontal tension-only bracings layout under the roof.

- The add of three new vertical tension-only X bracings bays, see Figure 8.
- Customized C shape connections between the longitudinal collector beams and the wood deck to provide a rigid link.

- New foundation walls and footings under the new vertical tension-only X bracings to provide stability and shear capacity.
- New horizontal tension-only bracings under the roof, see Figure 8. For these elements, it was especially important to assess the thermal stresses, as temperature in Quebec City features annual variations between -30°C and 30°C . These stresses were added to specified initial tension in the braces, to be added during the construction process, to ensure their proper activation during an earthquake event. The simultaneity of the initial tension and thermal stresses with seismic stresses was also studied.

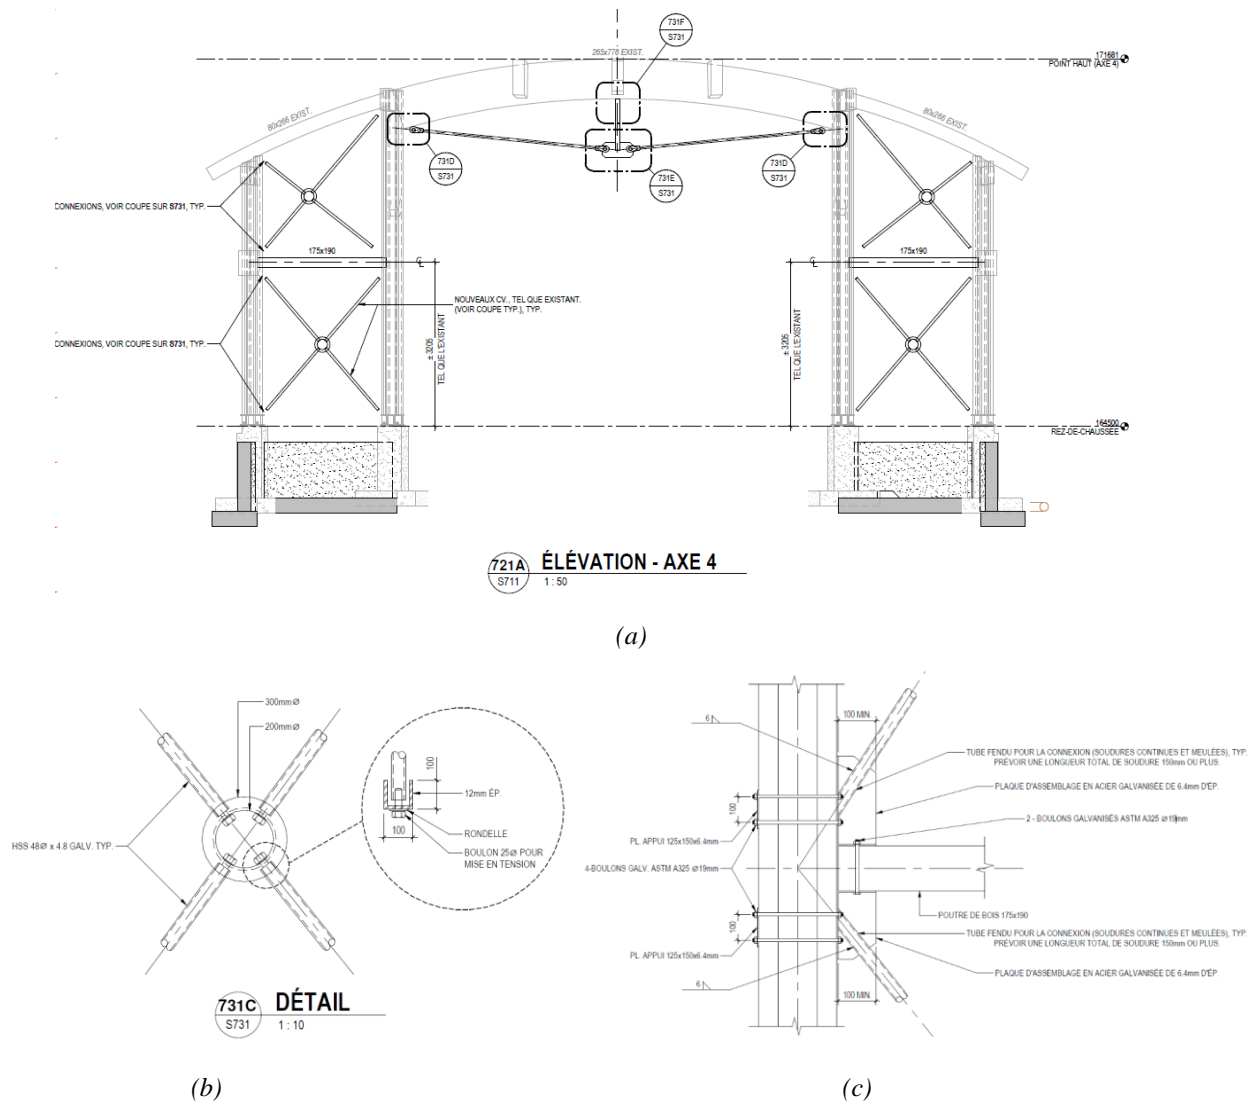
Figure 9. Detailed design and modelling of the connections (a) New vertical tension-only X bracings layout, (b) Steel rings, (c) New vertical tension-only X bracings center beam and column connection.

The construction schedule would not allow for contractor's designed connections, as it would usually be the case in steel and glulam projects. Because of that, and because the existing timber frame had many specificities to consider, the structural engineer designed and modeled all the needed types of connections for this retrofit, see Figure 9.
