## Seismic Performance Evaluation of Previously Retrofitted Oak Street Bridge

### ABSTRACT

The Oak Street Bridge first opened to traffic in 1957 and carries BC Highway 99 between the Cities of Richmond and Vancouver across the North Arm of Fraser River. The bridge has previously undergone comprehensive seismic retrofits over five phases between 1993 and 2004. The seismic retrofit works were completed in concert with BC Ministry of Transportation's implementation of designated Disaster Response Routes (DRRs) and Economic Sustainability Route (ESRs), which prioritized the seismic upgrade of regional routes and bridges that are vital to emergency response and post-disaster recovery. In these previous seismic retrofits, the focus was to minimize the risk of structural collapse and to minimize injuries and loss of life. As such, the earlier seismic retrofit criteria were based on a target performance of life safety/collapse prevention level for a 1 in 475-year design earthquake.

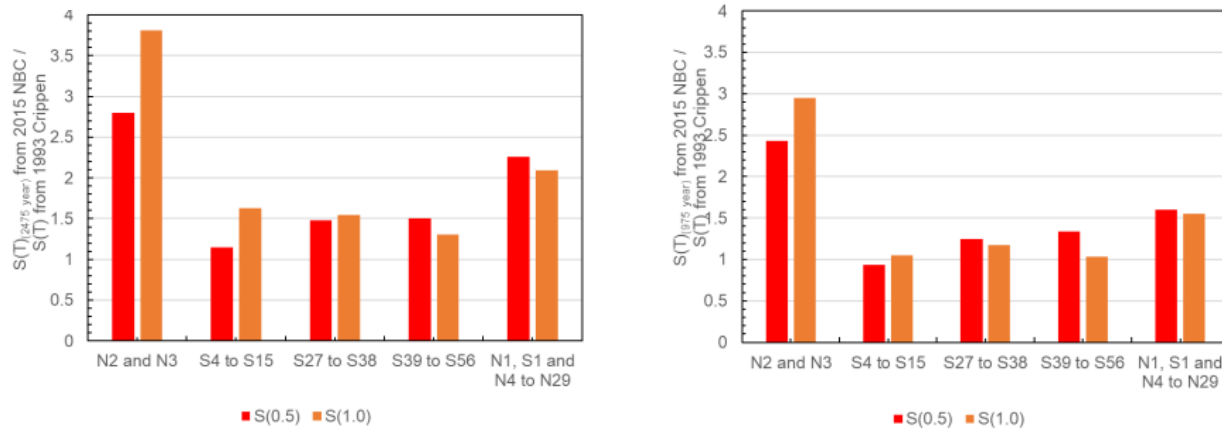
Figure 8. Comparison between design spectral accelerations used in previous retrofitting versus those recommended in the current study based on 2015 NBC

To limit the discussion, Figure 8 shows only the increase in seismic demand for the 1 in 2475 and 975-year events [3] at periods of 0.5 and 1 second. In general, for the 2475-year event [3], the increase in seismic demand is generally expected to be about

1.5 to 2 times compared to the Crippen International [9] values. However, this increase at Piers N2 and N3 is about 2.7 to 3.8 times depending on the period of the structure. This difference is attributed to the use of site-specific response spectra versus firm ground (“till spectra”) at these pier locations. For the 975-year event [3], the increase in seismic demand is generally expected to be about 1.0 to 1.5 times compared to the Crippen International [9] values, except at Bents N2 to N11 where the increase is 2.4 to 2.9 times depending on the period. Although not shown below, if 2020 NBC is adopted, the seismic demand is generally expected to increase by about 20 to 50 percent compared to the 2015 NBC [3] for 2475 and 975-year events.

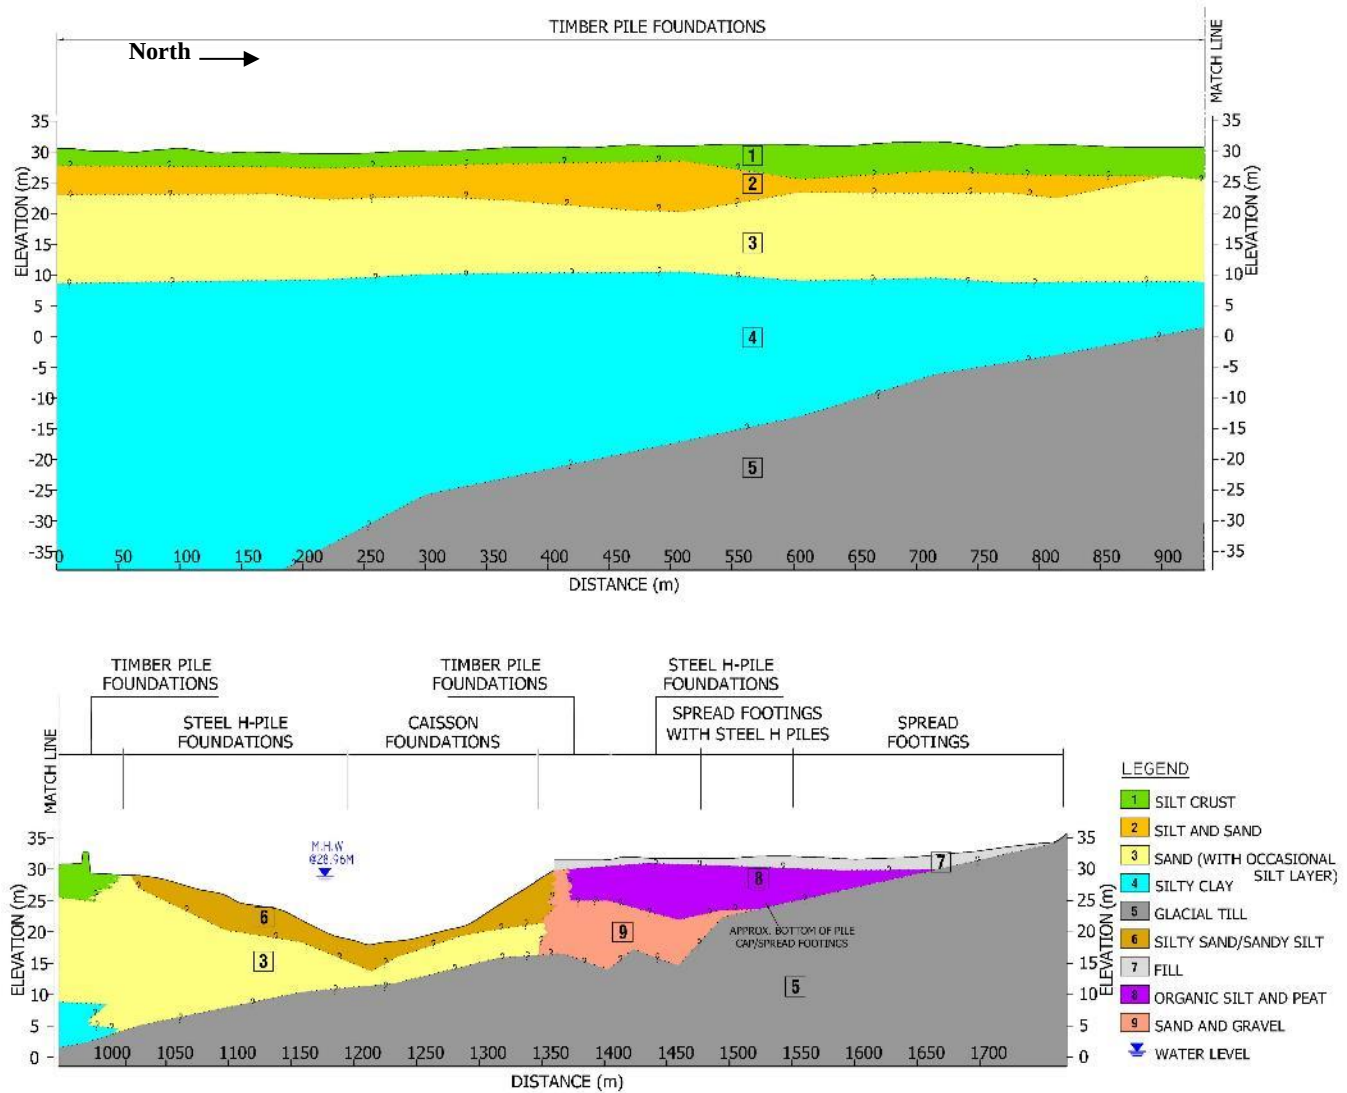
Figure 9. Interpreted soil profile along the alignment

The greatest challenge for the foundation evaluation was the variation in soil conditions, extent of liquefaction and its consequences and different types of foundations. To demonstrate the variation in soil stratigraphy along the alignment, a simplified soil stratigraphy is shown in Figure 1, and different soil units are described below:

- **South Approach (Piers S2 to S73):** The south side of Fraser River is underlain by a Silt Crust (Unit 1) of 2.4 m to 5.2 m thick. Firm to soft silt crust was overlain by sand fill at some locations. Above soil unit is underlain by Sand and Silt (Unit 2) with thickness up to 7.3 m. This is underlain by fine to medium Sand (Unit 3) with thicknesses ranging between 9 m and 13.7 m. This is followed by a firm to stiff Silty Clay (Unit 4) with seams of fine sand, where the thickness was interpreted to exceed more than 60 m at the southern end of the alignment. The interpreted peak undrained shear strengths ranged from about 40 kPa at the top of the soil unit, increasing at a rate of 1.5 kPa/m as the depth increases. This is underlain by a very dense Glacial Till (Unit 5).

- **River Channel (Piers N1 and S6):** The river channel was underlain by a loose to compact fine medium sand layer (Units 3 and 6) with a combined thickness ranging from 8 to 10 m, followed by Glacial Till (Unit 5)

- **North Approach (Piers N44 to N2):** The north side is underlain by Fill (Unit 7) that ranges from 0 to 2.1 m, underlain by Peat and Organic Silt (Unit 8), that extends from Pier N25 towards the river. The thickness of this unit increases towards

the river where the maximum thickness reached approximately 9.6 m between Pier N6 and N7. This is underlain by a dense to very dense Sand and Gravel (Unit 9) with a maximum thickness of 15 m near the riverbank, followed by Glacial Till (Unit 5).

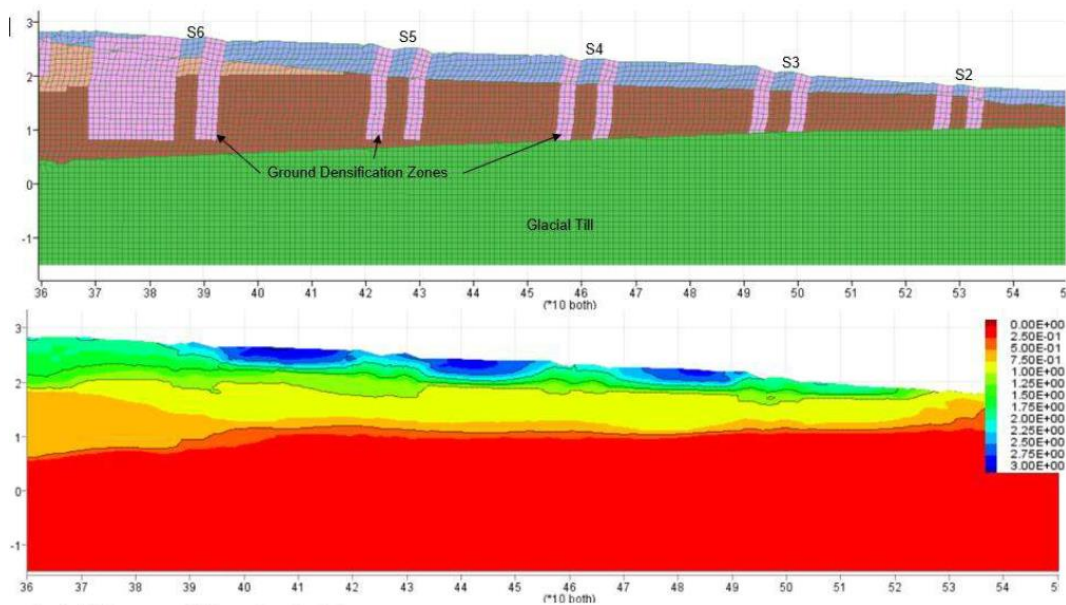
Figure 10: Horizontal ground displacements near S6 to S2 predicted for the 1 in 975 year seismic event (2015 NBC). Displacements are in meters.

Similar to Bent S2, Bents S3 to S6 were constructed by excavating the alluvial soils to a depth of 9 m to 12 m below ground surface and installing HP10x42 steel H-piles. Each pier was supported on 60 H-piles. Despite the ground densification carried out during previous retrofitting works, relatively large ground displacements have been predicted for the 975-year and 2475-year seismic events in FLAC analysis. For example, Figure 10 shows the ground displacements estimated for an inslab earthquake that represent the 975-year event. The estimated ground displacements extend below the pile cap level and impact the H-piles. According to LPILE analysis, the flexural capacity is exceeded under kinematic and inertial loading combinations. The likelihood of damage is low for the 1 in 475-year event where the magnitude of ground displacement is smaller and depth is shallower. This is consistent with the intentions of the original ground densification undertaken at this site that targeted a similar seismic return period.

| Bents | Foundation Type | Seismic Deficiency |
|---|---|---|
| S3 to S6 | H piles. | Potential deficiencies related to kinematic loading, which may cause flexural failure of H piles. Seismic inertial load demand is likely to exceed the H pile flexural capacity. |

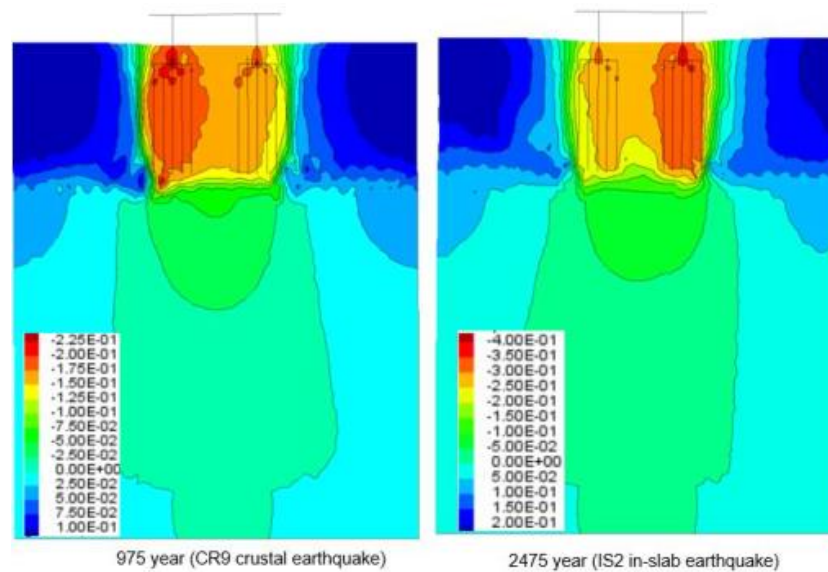
Figure 11: Post-seismic settlements estimated at end of shaking for 1 in 975 and 2475 year events in Bents supported on timber pile groups (2015 NBC)

Bents S7 to S73 are supported on untreated timber piles, and most of the pile groups consist of either 19 or 25 piles per group. Piles were installed with a very tight spacing of 0.9 m (~three pile diameters); such that liquefaction of soils within the pile group is unlikely to occur. For these bents, two failure modes are considered are likely: (a) the pile to pile cap connection failure similar to the Bents N2 and N3 at the north approach and/or (b) excessive settlement of the bent due to liquefaction and settlement of soils below the timber piles. Latter was considered a difficult task to quantify due to lack of current guidelines to estimate pile group settlement when liquefaction occurs below the pile group. A separate FLAC model was developed in the transverse direction to estimate the settlement of the pile group (Figure 11). The shear demands provided by the structural team for Bent S28 indicate a shear force of about 91 kN/pile for the 1 in 2475-year event which is significantly higher than the capacity predicted by Shama et al. [13] for a pile with a pile cap embedment of 0.5 times  $d_p$ . In addition, the post-seismic settlements caused by soil liquefaction below the pile cap can also increase the risk of separation.

| Bents | Foundation Type | Seismic Deficiency |
|---|---|---|
| S7 to S73 | Timber piles | Deficiencies related to both inertial and kinematic loading: (i) weak pile-pile cap connection that is vulnerable against seismic shear loading, uplift, differential settlement of pile group and pile-cap, and kinematic loading; and (ii) differential settlement of the pile group. |
