Taiwan-Thailand Seismic Retrofitting Collaborative Project of School Buildings in Thailand

ABSTRACT

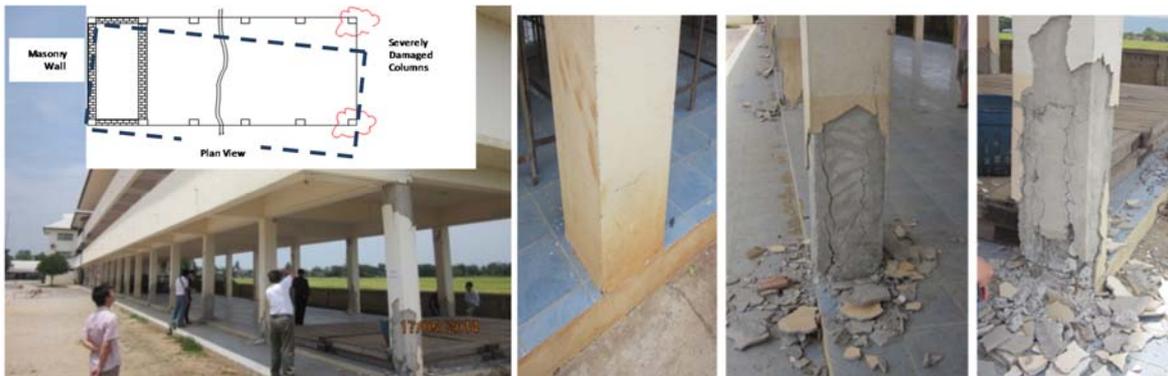
Several other factors also contributed to the vulnerability of these school buildings. The school buildings are generally designed in such a way that they have wide open spaces in the first story for assembly and school activities with a minimal amount of

infill walls. Compared to the upper stories where classrooms are located and infill walls are used to separate the rooms, the first story is generally much weaker. Under an earthquake, the deformation tends to concentrate in the first story where the story shear is generally the largest. In addition, because of the wide open spaces, the beams tend to be generally stronger than the columns exacerbating the soft story problem. The result is that the columns will be damaged while the beams remain almost intact. Figure 2 shows one particular school and its damage pattern. This school building is a 3-story frame structure located in Phan around 20 kilometers south of the epicenter. On one side of the building, masonry infill walls were provided around the staircase. The rest of the ground floor was fully open. The columns were severely damaged as seen in the figure. The damage pattern indicated that the building moved in a twisting manner in addition to the characteristic soft-story deformation. There was no observable damage to the beams indicating the building responded as a “strong beam-weak column” frame. This pattern was undesirable as it could lead to excessive sideways, potentially leading to collapse.

Figure 2. School Building Damaged by Soft Story and Torsional Irregularity.

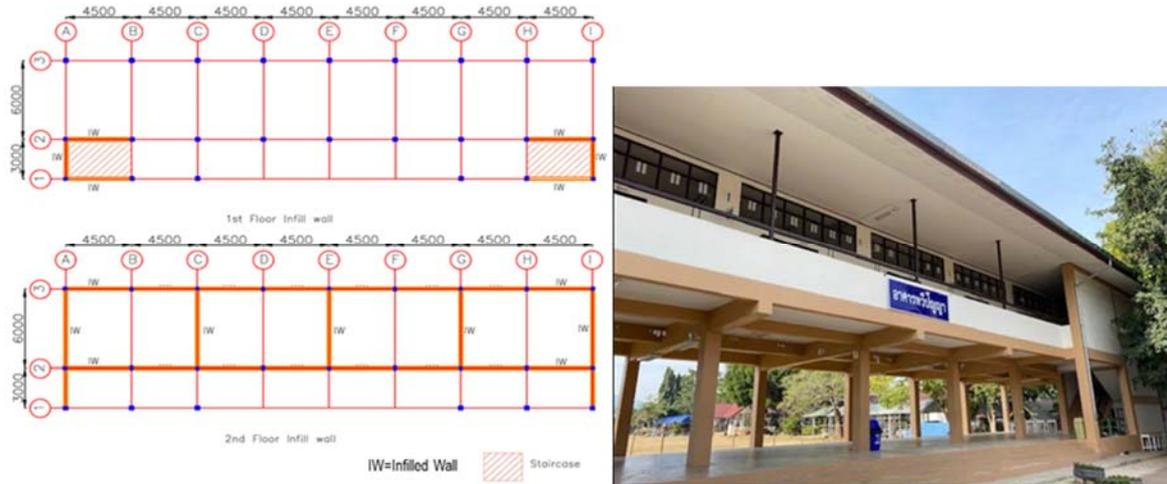
Three school buildings were selected for retrofitting in a pilot project to evaluate suitable retrofitting technology for Thai school buildings. Based on the observed weakness described previously, it was decided that the soft-story was the most important aspect to eliminate. The overview of one of the buildings and the key plans are shown in Figure 7.

Figure 7. The overview of the study building before retrofitting.

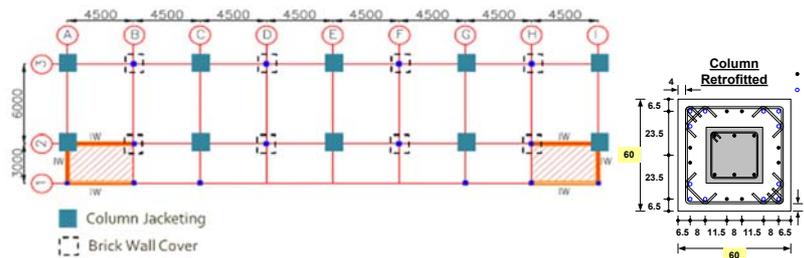
Figure 8. Building Plan and Location of Column Jacketing.

In this project, selective columns were jacketed. The final design consisted of jacketing alternate columns as shown in Figure 8. The rest of the columns were covered with brick walls to have the same size as the jacketed column for architectural reasons. Figures 9 and 10 show the details of the retrofitting plan. As expected, the specimen with dowel bars showed larger strength. However, the strength increase was approximately 10 percent only. More importantly, there was no discernable change in the ductility between the two specimens. For this reason, the design without the dowel bars was eventually adopted. Construction began in 2021. Figure 10 shows the jacketed columns during construction. As can be seen, the jacketing was also done for the columns below the ground level with the new rebars fully embedded into the foundation. The three buildings after the retrofitting are shown in Figure 11.

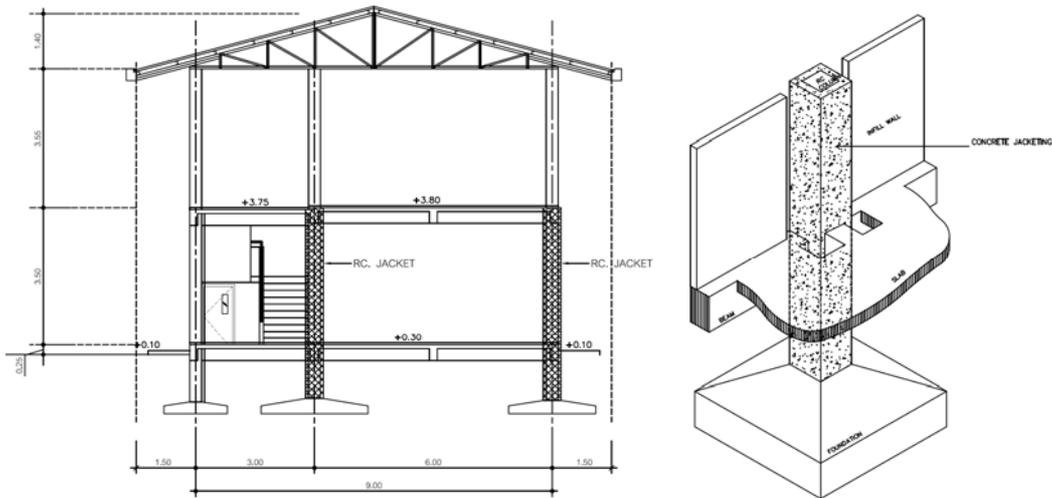
Figure 9. RC Jacketing Detail

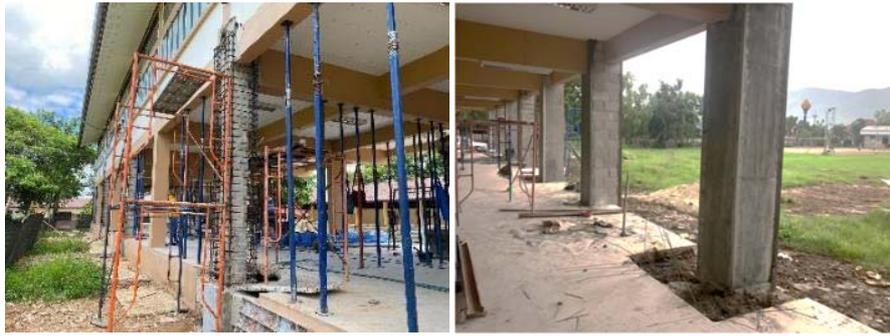
Figure 10. Column Jacketing during construction.

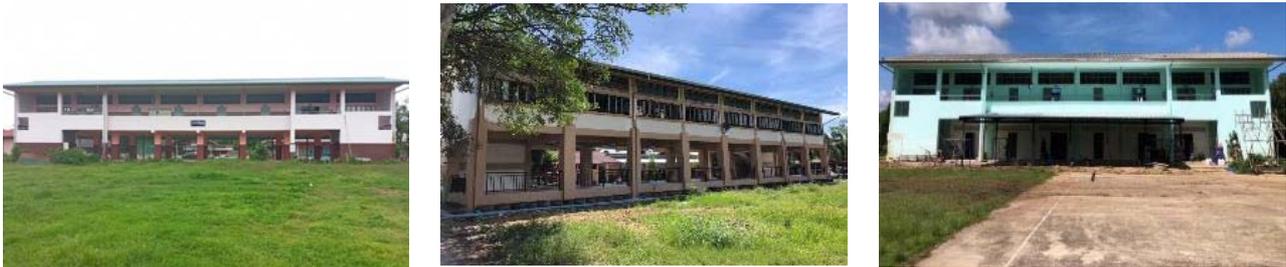
Figure 11. Three selected schools after retrofitting.
