## Performance review of 1st bridge retrofitted in BC

Queensborough was the first bridge ever retrofitted in BC. 01553 Queensborough Bridge (the Bridge) is constructed in 1960 and contains multiple segments. The Main Span segment (01553B) consists of three continuous spans of haunched steel plate girders with a total length of 205 m. The South Approach segment (01553A) consists of twenty-five concrete girder spans, built as a series of 3 span continuous, with a total length of 384 m. The North Approach segment (01553C) consists of nine concrete girder spans with a total span length of 183 m. In 1984, the six cast-in-place approach spans south of Bent S23 were replaced with pre-stressed concrete I-girder, reducing the number of spans by two while adding a curved alignment and a new south abutment.

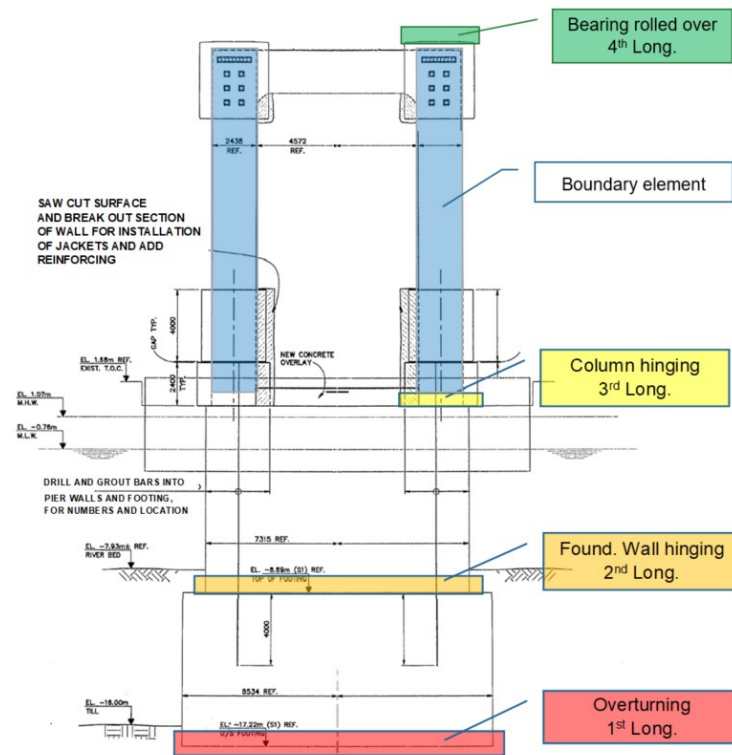
Figure 4: S1 modes of failure location

The S2 and N2 bents attract minimal earthquake loads attributing to the low stiffness of the rubber bearing installed during the 1993 retrofit. The transverse direction strength of the Main Span bent S1 was anticipated to be noticeably higher than the longitudinal direction due to the in-plane shear walls acting transversely. The longitudinal direction of the S1 bent shows adequate strength under the 1:2475 AEP event. The structure stays essentially elastic, except for the lead rubber bearings, whose nonlinear behavior is intended by design and was accounted for. A number of possible failure mechanisms which has been checked for the bent is listed in Figure 4 on the overall geometry of the bent numbered with the order of occurrence. It is shown that the overturning of the bent at the tremie foundation is the first mechanism and can be considered as a rocking mechanism. However, this mechanism needs to be investigated further in subsequent studies to make sure that the displacement is controlled by the adjacent spans.

It is recommended to investigate the longitudinal performance of the Main Span in more detail during the detailed assessment of the Bridge to quantify the rocking action in the longitudinal direction. Additionally, the smaller N2 and S2 bents should be further assessed to verify their performance.

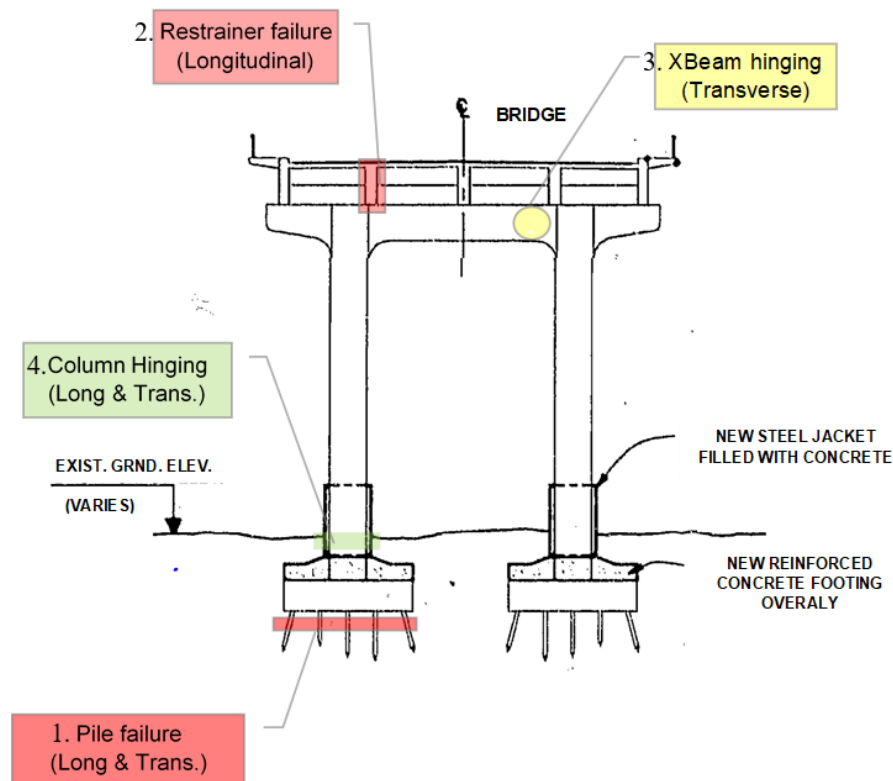
Figure 5: Three first modes of failure for S4 bent in both lateral direction

The cross-beam damage level does not meet the (Supplement to CHBDC S16-14, 2016) acceptance criteria, except for the S21 under 1:475 AEP event. Increasing the cross-beam capacity will impose further demands at the top of the bent columns. Alternatively, the retrofitted superstructure diaphragms that help to transfer the structure dead load directly to the bent columns could be further strengthened to carry the full-service load of the Bridge. As the cross-beam failure should not be allowed to occur, strictly speaking, the retrofit would not meet the (Supplement to CHBDC S16-14, 2016) acceptance criteria.

Bent columns on Bents S4 and S21 meet the performance objective of Minimal Damage for the 1:475 AEP level; however, they fail to meet the performance objectives of Repairable Damage for the 1:2475 AEP event. The performance and vulnerabilities of each bent elements are laid out in details.

It should also be noted that more precise modelling of the foundation and soil structure interaction will better estimate the overall seismic behavior of the South Approach and may improve the cross-beam and columns performance. Additionally, the spectrum used at this stage is the enveloped worst case for all bents which is conservative. Utilizing a more precise spectrum under specific bents may reduce the demands. All modes of failure for bent S4 are summarized schematically in Figure 5.

In addition to potential ground improvement, further structural retrofit is required to meet the performance objectives of the structure. To meet the Minimal Damage criteria under 1:475 AEP the cap beams should be post-tensioned. Although, for taller columns between S3-S8, the diaphragms are post tensioned as an alternative load path after cross-beam hinging, these diaphragms were retrofitted to life safety level and restricted service. Meeting the Lifeline bridge performance objective under 1:2475 AEP event is not possible as the columns have already been jacketed and further capacity improvement is not likely for them. However, further studies are highly recommended to consider the multi span effects. Adding dampers may also moderate the demand on the structure.
