Ninth Canadian Conference on Earthquake Engineering Ottawa, Ontario, Canada 26-29 June 2007

SEISMIC SAFETY OF A HISTORICAL ROW HOUSE COMPLEX BUILT DURING OTTOMAN PERIOD

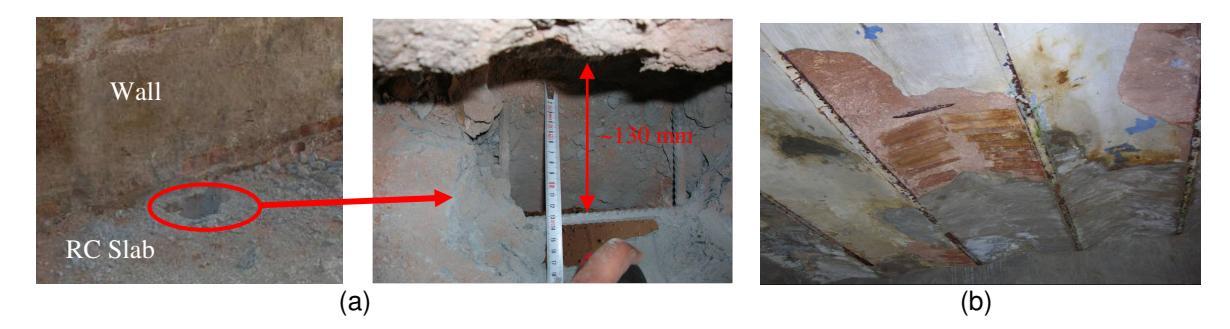
The buildings have experienced a severe earthquake in 1894, which effected many different parts of Istanbul. According to available information and observations on-site, the Block B of Akaretler Row Houses did not experience a considerable seismic damage after 1894 Istanbul Earthquake. Although not formed because of seismic events, several minor cracks in structural walls are observed. According to the authors, these cracks were formed due to singular loads concentrated on walls, mostly because of inadequate lintel lengths and/or local minor alterations in structural plan. Since the damages are almost negligible, it is concluded that these damages are not needed to be taken into account while assessing the seismic safety of the buildings. It should be noted that, although not directly related with seismic safety, some of the newly constructed reinforced concrete flat slabs have some damages, mostly because of insufficient flexural capacity due to improper placement of reinforcing bars, careless formation of supports and low concrete strength. Although the reinforced concrete slabs are not perfectly connected with structural walls, according to the authors, the friction forces between the structural walls and the reinforced concrete plates would be sufficient for providing the diaphragm effect. No doubt, the replacement of vaulted brick floors with reinforced concrete flat slabs improves the diaphragm effect, since the original vaulted slabs, which are still present in Block E and F had been poorly constructed. The connection of existing walls and reinforced concrete slabs of Block B, and original vaulted slabs in Block E are shown in Fig. 4.

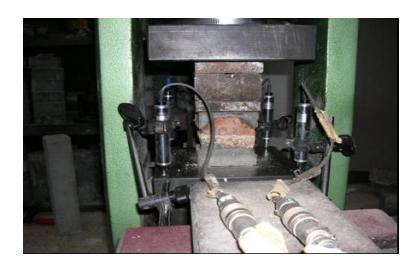
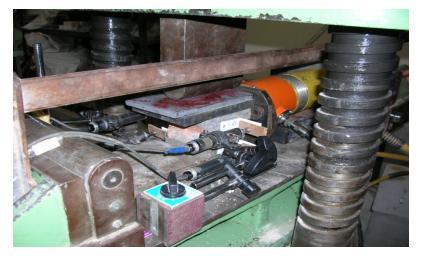
Figure 5. Laboratory tests.

The compressive strength tests are conducted on core samples taken from different floors of the structure, Fig. 5a. While evaluating the results of these tests, specimens exhibiting large variations were taken out of evaluation according to Chauvenet Criteria (Akman 1978). The compressive strengths and elasticity moduli are presented in Table 3. As seen in this table, both compressive strength and elasticity moduli of the specimens taken from the second floor are significantly lower than the specimens taken from the entrance and first floors. The buildings have not been maintained for almost more than 10 years. Therefore, this difference in compressive strength and elasticity modulus may be attributed to reduction of their capacities due to wetting and drying cycles, and humidity conditions, caused by insufficient maintenance of the roofing system. The relationships of axial stress and average axial strain are given in Fig. 6. Average compressive strength is 2.96 MPa and minimum compressive strength is 1.99 MPa. It should be noted that the allowable compressive stress for ordinary structural bricks produced in the field kilns is given as 0.8 MPa by the Turkish Seismic Design Code (2006).

Shear strength of core specimens is experimentally found for three different vertical stress levels, which are 0, 0.15 and 0.3 MPa, Fig. 5b. These values are chosen to represent vertical stresses in different floors, namely no axial stress case represents the situation in the second floor, while the axial stress levels of 0.15 and 0.3 MPa is assumed to represent the first and entrance floors, respectively. The location of the specimens in the buildings, vertical stress, axial load and shear strength are shown in Table 4. The relationships of shear stress and average horizontal displacement are given in Fig. 7. Average shear strengths are calculated for each axial stress level and shown in Table 4. As seen in this table, shear strength of cores under varying axial stress conditions are around 0.35- 0.40 MPa. According to Turkish Seismic Code; the shear strength of walls constructed with ordinary solid bricks considered is given as 0.2 MPa, when experimental data is not available. Since the applied axial stresses on the bricks are not high, the shear strengths are found to be close to each other for different levels of axial stresses. It should be noted that many factors may also affect the shear strengths obtained, such as the quality of jointing mortar, environmental conditions, the processes during taking out the cores from walls and preparation process of cores for experiments. Therefore it is believed that the obtained shear strengths just give general information about material qualities.

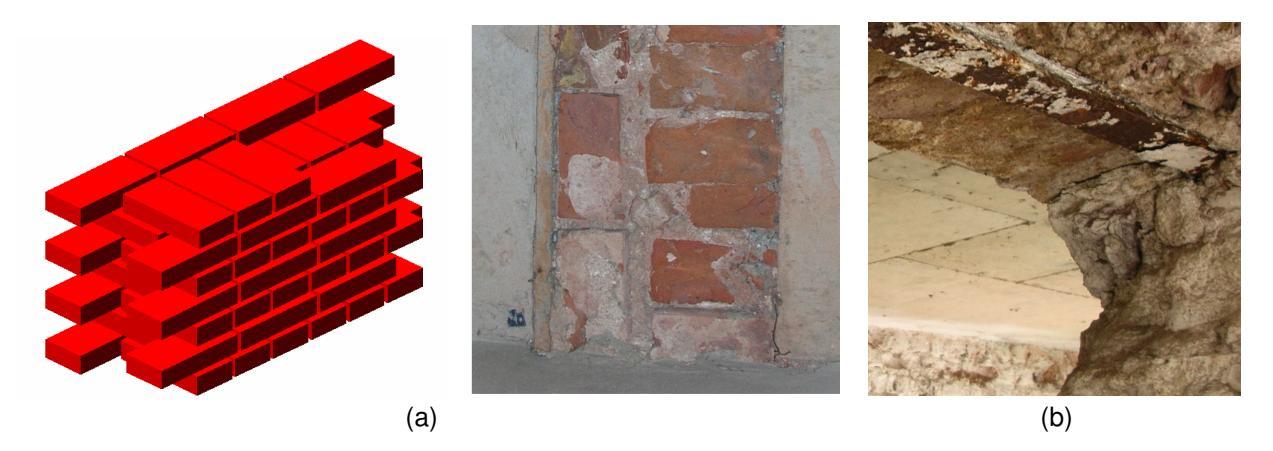
Composite structure of the walls is composed of bricks, mortar and steel ties, Fig. 8. Deteriorated by the environmental conditions and damaged by several interventions during the last century, steel ties, which were originally aimed to compensate the lack of diaphragms constraining the main walls, are evaluated to be out of service. Five different types of brick, having average dimensions of 60x110x240 mm³ have been used in the construction. Almost all masonry walls have cross bond (also known as English bond) brick arrangements with approximately 20 mm thick horizontal and 10 mm thick vertical mortar joints, Fig. 8.

Figure 8. a) Brick arrangement of the masonry walls, b) the steel tie.

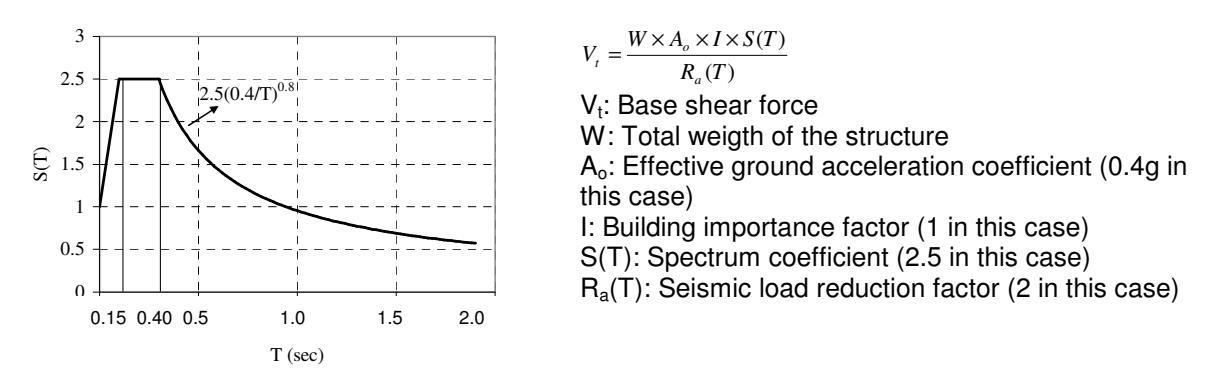
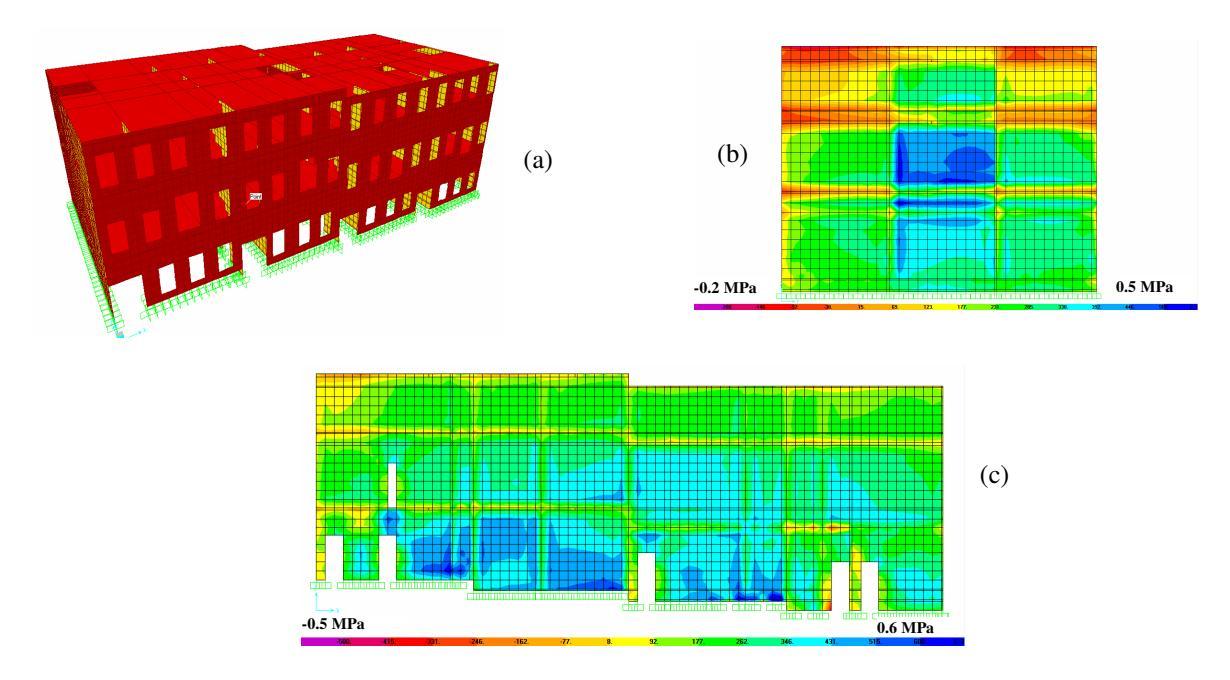
In order to investigate the seismic safety of the building, a macro-level linear elastic finite element analysis has been carried out. Though having limitations, linear elastic analysis constitutes a useful tool for understanding the general seismic behavior of masonry structures. Walls and reinforced concrete slabs of the three dimensional analytical model has been constructed by using four node shell elements and SAP 2000 structural analysis program. Since the structure has a form of repeating blocks in plan, aiming to decrease the run time, only 4 of the repeating blocks out of 8 has been taken into consideration during the modeling phase. The analysis has been performed for vertical and horizontal loads. Vertical loads includes the dead weight of the structure (unit weights: 18 kN/m³ for masonry and 25 kN/m³ for reinforced concrete) and the live load acting on the slabs (2 kN/m^2 as defined in TS 498/T1 (Turkish Standards Institution, 1997)), while the horizontal loads are derived through Turkish Seismic Design Code (Ministry of Public Works and Settlement, 1998). The equivalent static earthquake forces are acted in both longitudinal and transverse directions of the building. The structure is located in European part of Istanbul on a highly seismic zone, which is defined as second degree seismic zone. However, considering the uniqueness of the structure and the demand of the owner, the design horizontal acceleration required for the calculation of the base shear force is taken as 0.4g as given for the first degree seismic zones in the Turkish Seismic Design Code (Ministry of Public Works and Settlement, 1998), Fig 9. As also stated in the same code; building importance factor and spectrum coefficient are taken as 1 and 2.5, respectively. For masonry buildings, the seismic load reduction factor based on the ductility of the structural system is given as 2.5 by the Turkish Seismic Design Code 1998, while it was reduced to 2.0 in Turkish Seismic Design Code 2006. Therefore, although 1998 code is still valid, to be on the safer side, the seismic load reduction factor is taken into account as 2.0. Consequently, base shear coefficients are determined as 0.5 for longitudinal and transverse directions. Utilizing the average compressive strength value obtained from laboratory tests on brick masonry cores, the elasticity modulus is obtained approximately as 600 MPa (200 times the wall compressive strength) as formulated in the Turkish Seismic Design Code (Ministry of Public Works and Settlement, 2006). Natural vibration periods of first two modes are 0.28 and 0.27 seconds for longitudinal and transverse directions, respectively. A general view of the three dimensional mechanical model and shear stress contours of typical axes for longitudinal and transverse directions are shown in Fig. 10. In order to verify the results obtained from the three dimensional linear elastic analysis, a hand calculation has also been done. Average shear stresses obtained by dividing the earthquake induced shear forces by the net wall areas of each story results as 0.37, 0.30, 0.17 MPa for the entrance, first and second stories of the longitudinal direction; 0.24, 0.33, 0.20 MPa for the entrance, first and second floors of the transverse direction, respectively. These average shear stress values are in good agreement with the results of finite element analysis. Comparing the experimental shear strength values with these results it can be concluded that the structure has sufficient capacity for a design earthquake foreseen in the Turkish Seismic Design Code (Ministry of Public Works and Settlement, 1998 and 2006). According to the results of the analysis, the average compressive stresses are around 0.5 MPa, which is below the 2.96 MPa compressive strength value obtained from laboratory tests.

Figure 10. a) Three dimensional mechanical model b) Shear stress contours in transverse direction c) Shear stress contours in longitudinal direction.
