## SEISMIC VULNERABILITY INDICATORS FOR TIMBER ROOF STRUCTURES

M.A. Parisi<sup>1</sup>, C. Chesi<sup>2</sup> and C. Tardini<sup>3</sup>

### ABSTRACT

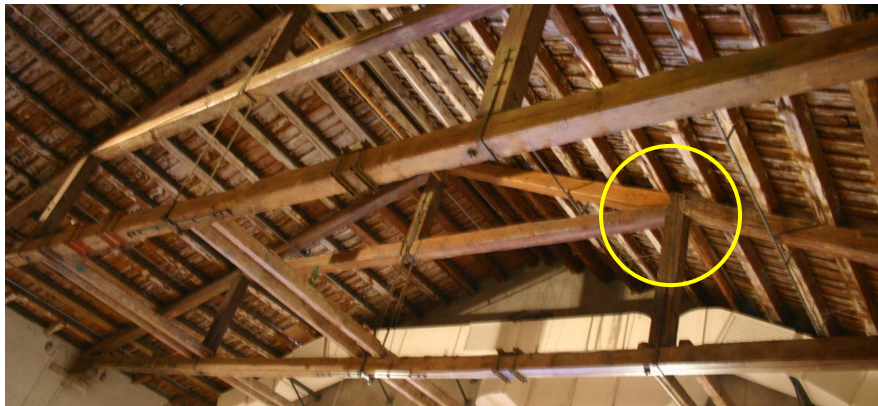
Figure 2. The rafter is not continuous in the node.

Occasionally, structural configurations are found that are unfit for any horizontal loading or even for non symmetric vertical loading. Truss nodes often modeled as hinges in truss analysis, are actually semirigid and generally permit equilibrium. Yet, safety margins may be low in normal working conditions and would not be acceptable for the seismic case. In these cases, the vulnerability is high and the situation should be remediated promptly. Figure 2 shows a truss that would not be equilibrated should the nodes be considered hinged.

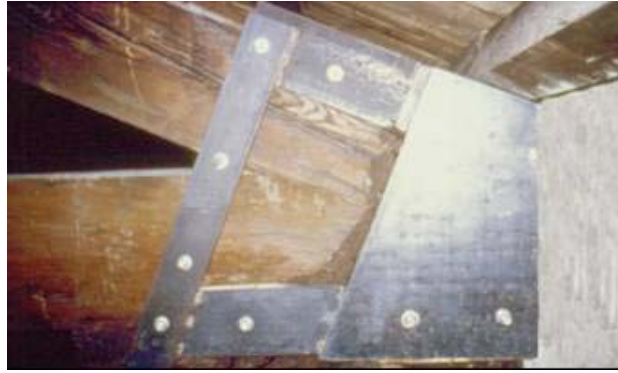
Figure 3. Intervention producing overstrengthening on the rafter to tie-beam node.

carried out in a recent past, typically in the second half of the 20th century, as in the example of figure 3 are at the high vulnerability side of the scale.

Eliminating the possibility of relative rotation between the connected elements modifies the original conceptual design of the node that should be conserved for service conditions unless particular problems arose, and may trigger brittle failure in extreme conditions, as in the case of earthquakes.

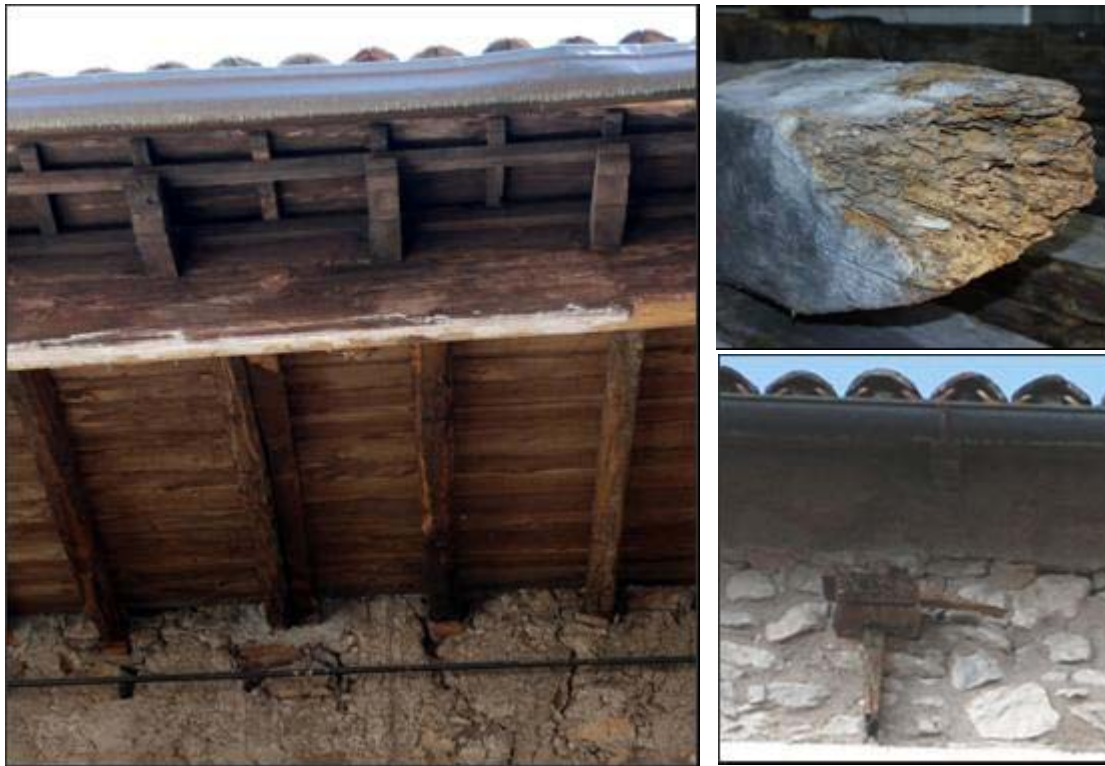
Figure 5. Different support conditions; built-in elements (left); decayed built-in beam end (top right); an old-time external restraint maintained support of the timber truss in the L'Aquila earthquake (bottom right).

For displacements parallel to the axis, that would tend to drop the truss from the support, examples of good construction techniques may be found where the tie beam is anchored with steel or even timber elements protruding from the wall and blocked on it. Figure 5 shows an example of timber restraints that gave good results in the L'Aquila, April 6, 2009 earthquake.

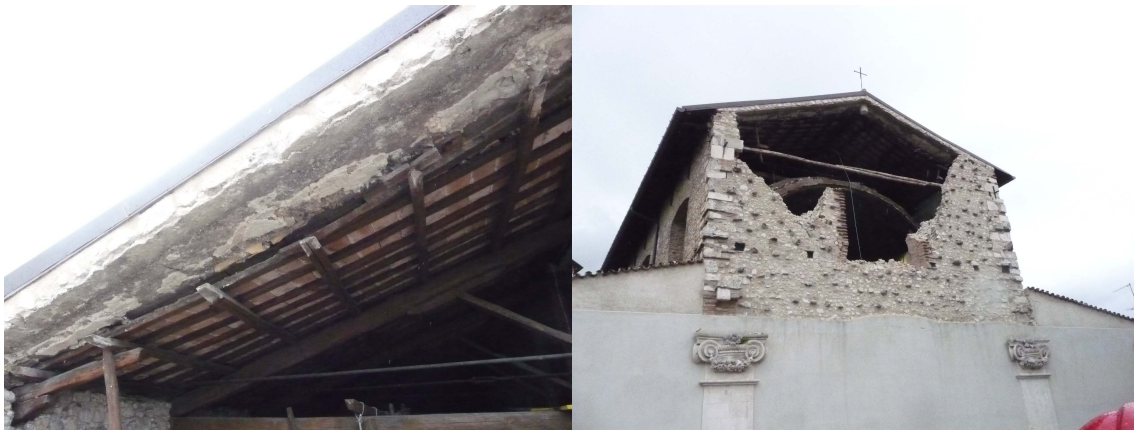
Figure 7. Increased dead load on roof structure (left), church of S. Biagio Amiterno, L'Aquila.

A significant cause of vulnerability may be found in changes to the original structural concept produced during the life of the structure. Interventions carried out to eliminate initial conceptual errors, not rare in constructions mostly based on traditional practice without reference to codified design principles, are frequently seen. Yet, modifications that actually induce vulnerability are equally frequent. This is the case of increased masses in strengthening interventions carried out according to criteria adopted in the last part of the 20th century. An example may be seen in Fig. 7 showing the roof of the church of S. Biagio Amiterno, damaged during the L'Aquila, Italy, earthquake of April 6, 2009. A heavy concrete slab had been laid with the aim at collaborating with the original roof structure and at constituting a stiff link between walls.
