FULL-SCALED SHAKING TABLE TEST OF A HOSPITAL MADE OF A BASE-ISOLATED FOUR-STORY CONCRETE STRUCTURE

ABSTRACT

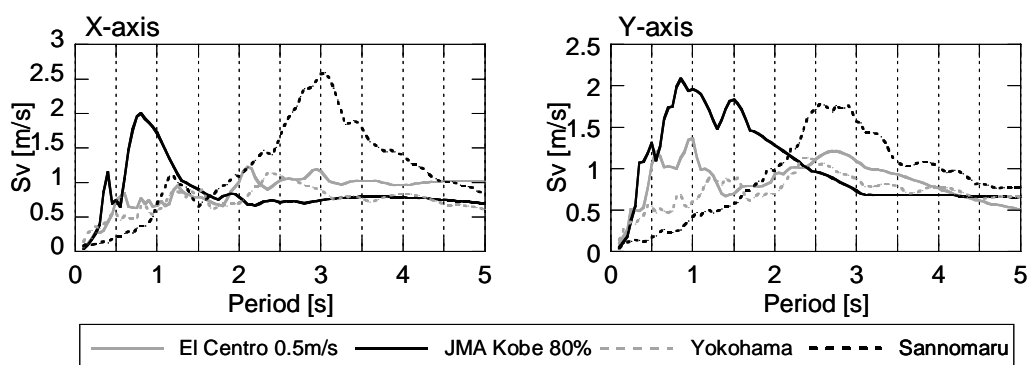
Figure 3 Response spectra of input motions

Four ground motions were used for the test. Three of them were classified as near-fault ground motion, whose dominant frequencies were less than 1.5 second. One was El Centro (Imperial Valley Earthquake, 1940) with PGV=0.5 m/s, which has been extensively used in Japanese design practice. One was JMA Kobe (Hyogoken-Nanbu Earthquake, 1995) with 80% in scaled magnitude, resulting in PGV= 0.60 m/s and 0.64 m/s for NS and EW directions. This

scaling was adopted to avoid excessive structural damage so that the test specimen could be used for many times of shaking. Only in JMA Kobe 80% a vertical component was added in the shaking. The other was a synthesized ground motion, Yokohama, yielded by the simulation of a hypothetical Kanto earthquake which was expected to hit our capital, Tokyo. A synthesized long-period and long-duration ground motion named Sannomaru was also adopted, which has a high possibility to resonate with base-isolated system. Figure 3 shows the pseudo velocity spectra of the four input motions. The direction of input ground motions are oriented so that the NS component corresponds to the longitudinal direction Y, and the EW component to the transverse direction X, as shown in Figure 1(a).

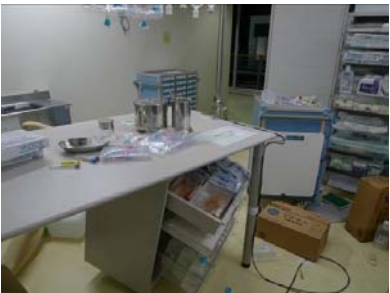
(a-1) Scattered contents
(Staff station, 2F)

Because the acceleration responses became relatively large up to 20.2 m/s^2 , almost all free-standing furniture and medical appliances including locked casters slid around 0.2 to 0.7 m on the average. Even heavy medical appliances slid up to about 0.5 m. In addition, contents on tables or inside shelves, for example, a monitor on a suspended rack at ICU, fell down. A mannequin on the

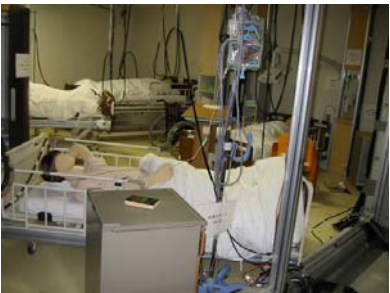
(b-1) Slid beds
(Patient room, 4F)

Acceleration responses were not large, avoiding all free-standing furniture from motion except for lock-free casters. Large amplitudes of floor movement induced by resonance between the base-isolation system and input ground motion caused the large amplitudes of sliding of casters, resulting in the maximum residual displacement of 3.5 m. During the shaking, casters gained high speed so that some hit on and broke the virus-proof wall in the operation room (Figure 6(b-2)), and some others crashed into other appliances, resulting in toppling. The performance of the operation room filled with lock-free casters was exceptionally unacceptable. A hanging-sliding door

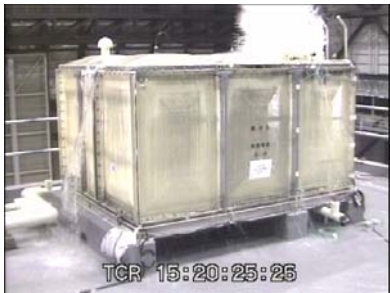
(b-3) Splashing water
(Roof)

repeatedly collided with its end stoppers with a speed high enough to break the stoppers. This type of door in hospitals is commonly designed so light that inertia force enables it to open and close very easily. Sloshing water of the rooftop tanks broke the lid and splashed from the roof, as shown Figure 6(b-3). This is because the period of sloshing and base-isolation system was relatively close: 1.67 s to 2.22 s for the sloshing period and 2.41 s and 2.56 s for NRB+U and HDRB.
