SEISMIC PERFORMANCE OF ARCH BRIDGES OBSERVED IN TANGSHAN EARTHQUAKE AND WENCHUAN EARTHQUAKE

ABSTRACT

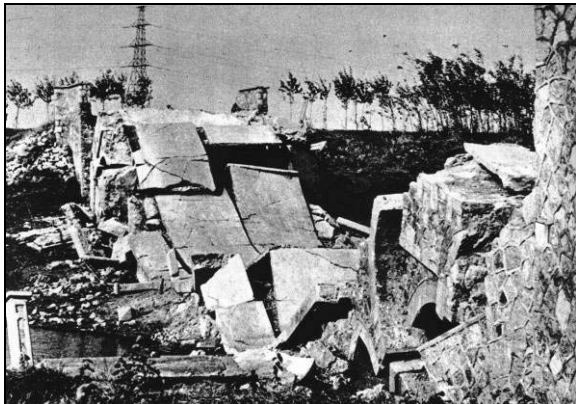
Figure 5. Ye Li Hong Qi Bridge collapsed

Figure 5 and Figure 6 (Wang 2007) were single-span double curved arch bridges, which were built on the unfavorable foundation soil and the span length was 37 m and 40 m, respectively. They collapsed as the earthquake occurred. However, the earthquake damage of those bridges that located on the well soil was slight or no damage occurred, such as Zhao Ge Zhuang Bridge, Si Zhuang Zi Bridge and several small bridges.

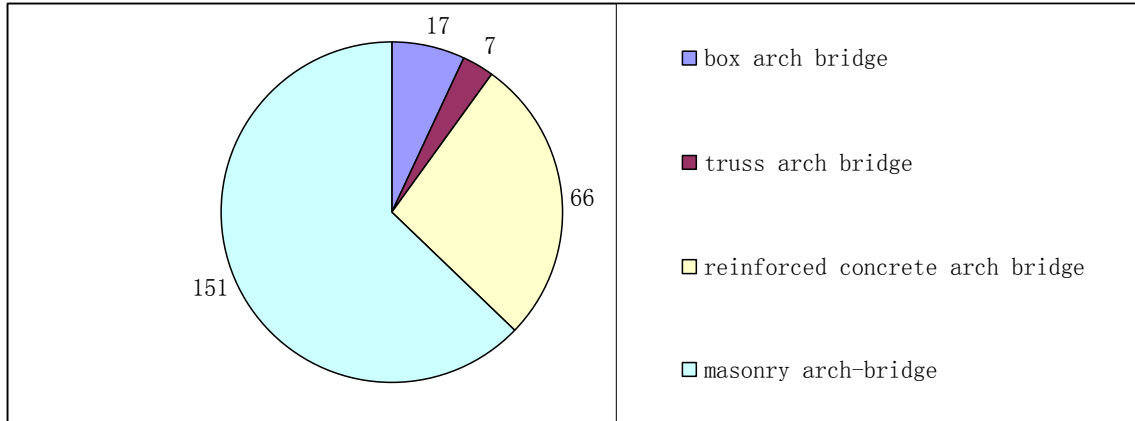
Figure 8. Type of arch bridge investigated

The authors have attended in several field investigation teams after shock. In the itinerary, the arch bridge accounted 241 in total. It included box arch bridge, truss arch bridge, reinforced concrete arch bridge and masonry arch bridge (See Figure 8).

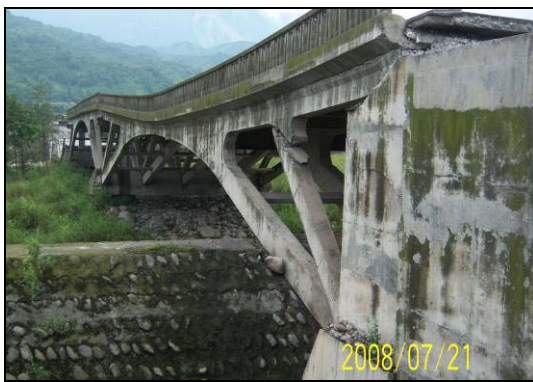
Figure 9. Xiao Yu Dong Bridge collapsed

After Wenchuan Great Earthquake happened, the strong motion of earthquake caused arch bridge to collapse, buckling of arch rib, shear failure, as well as crack on the soffit, which are showed in Figure 9 and Figure 10 (Wang 2008; Chen 2009). But many arch bridges located in the meizoseismal area survived and kept the traffic capacity (see Figure 11, 12 and 13). The lengths of bridges were not greater than 30 m, which means most of the arch bridges were small bridges. And most of the masonry arch bridges and double curved arch bridge were built in 1970s and 1980s.

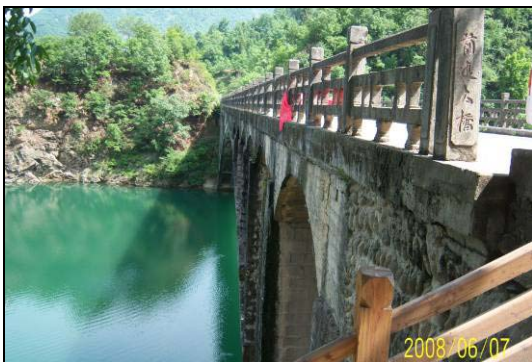
Figure 11. Qian Jin Bridge, a double curved arch bridge with a span length of 75m, was intact

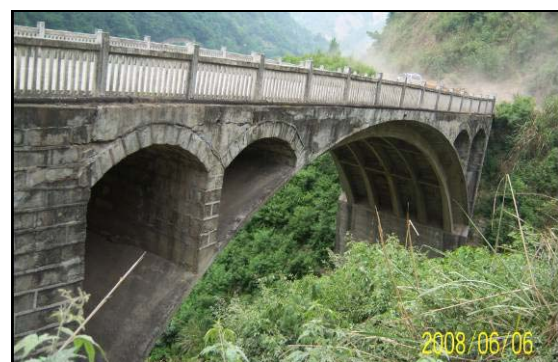
Figure 12. Tong Zi Liang Bridge, a rib bridge with a span length of 30 m, no damage occurred

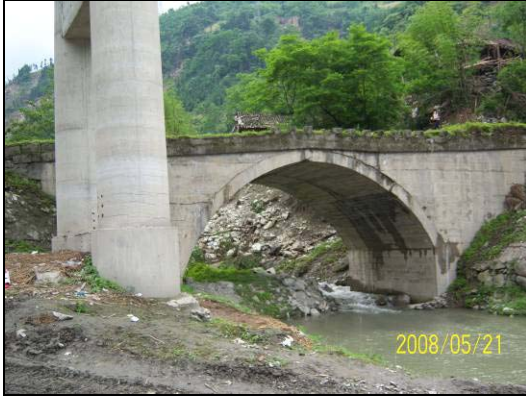
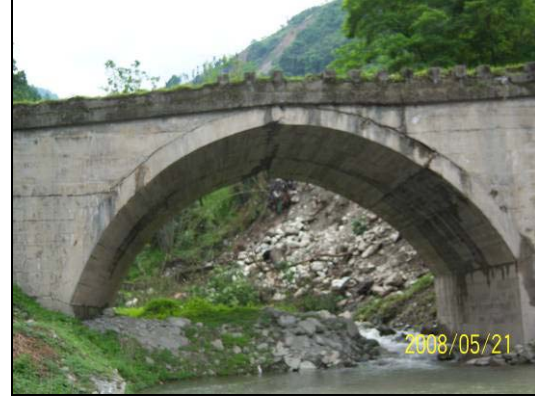
Figure 13. A small stone arch bridge beside the Bai Hua Bridge survived while Ba Hua Bridge collapsed in earthquake
