REPORT ON LABORATORY TESTING OF ANCHOR BOLTS CONNECTING WOOD SILL PLATES TO CONCRETE WITH MINIMUM EDGE DISTANCE

ABSTRACT

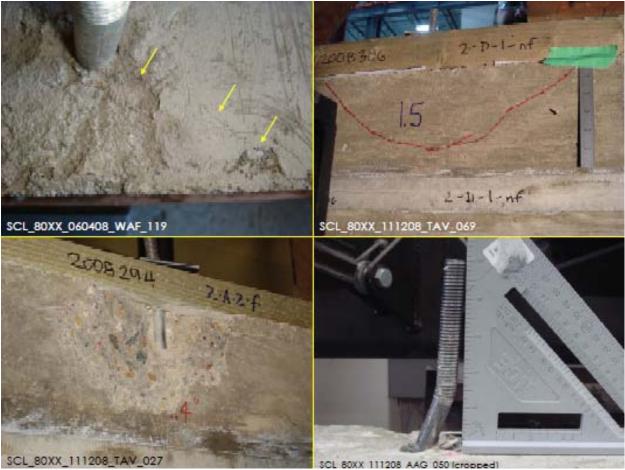
Figure 2 – concrete side break-out development

- initial take-up and displacement (connection assembly gets "seated")
- elastic bolt bending combined with wood crushing (dowel bearing)
- plastic bolt bending combined with wood crushing and some bolt elongation (as the bolt deflects and goes into tension; a clamping force also develops)
- plastic bolt bending combined with wood crushing and shallow concrete delamination (clamping forces continue to develop at as the bolt resists increasing tension forces). See Figure 2.

- plastic bolt bending combined with wood crushing and shallow spalling of concrete adjacent to anchor bolt. Again, see Figure 2.
- sill plate splitting (if developed during testing; occurs during the last 2 phases described above).

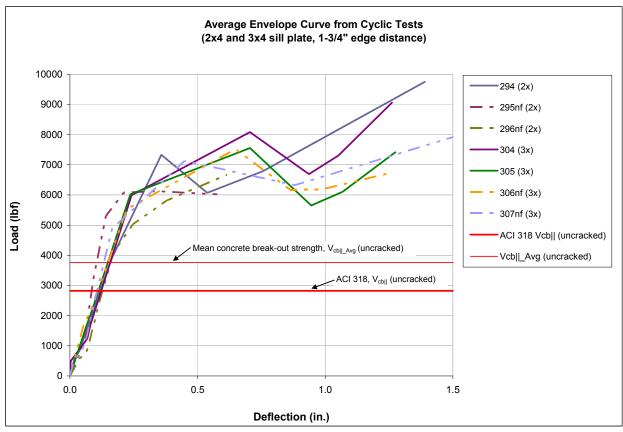
Figure 3 – Envelope curve (Chart 9 in full report)

The connection behavior is clearly ductile as shown in Figure 3 1 below. For additional discussion, refer to the SEAOC Seismology Committee's Blue Book article on anchor bolt and wood sill plate connections.
