SEISMIC RESTORATION OF HISTORICAL ISLAMIC MONUMENTS

A. Osman¹

This paper outlines the different methodologies and techniques followed for seismically restoring many of the Islamic monuments in Egypt during the past decade. Initially, it describes the different structural modes of failure exhibited by these monuments during earthquakes. Then, it discusses the methodology that should be followed to decide whether intervention is needed or not. Finally, it lists the restoration techniques utilized for repairing and strengthening these seismically endangered monuments.

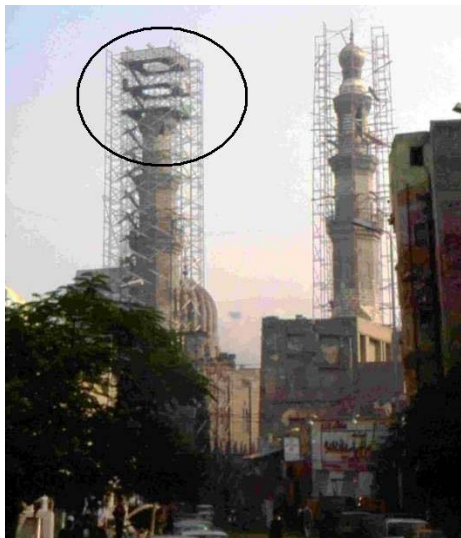
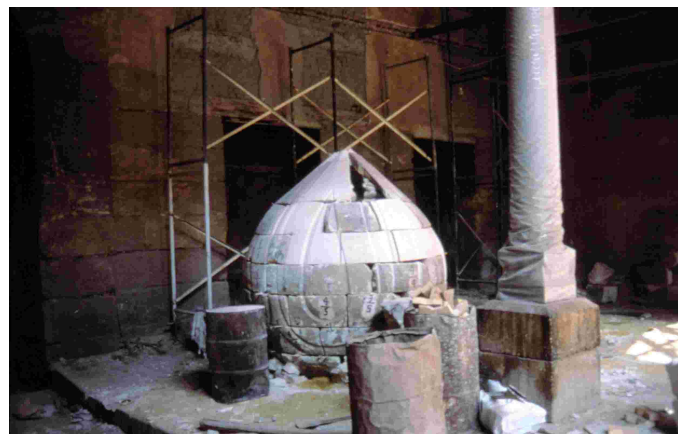
Figure 2. Damage to the top part of North Shaykho Minaret (Bassala) during 1992 Cairo earthquake, with this part reassembled again on the ground during the repair process.

Reviewing the observed damage reported during past moderate earthquakes indicated that they included; 1) Collapse to top part of the minarets as shown on Figs.2 and 3, especially the minarets belonging to Mamluk era. These minarets are characterized by having irregular mass and stiffness distribution along their heights which made them structurally vulnerable to damage during earthquakes compared to other minaret styles such as Ottoman ones which have uniform cylindrical shafts; 2) deep through cracks as shown on Fig.4 due to wall out-of-plan movement; 3) Bulging of the external leaves of the multi-leaf walls due to loss of contact between wall layers as shown on Fig.5; 4) cracking to large diameter domes similar to that shown on Fig.6; 5) deep corner cracks between perpendicular thick walls not physically connected as shown on Fig.7 due to their relative movement; and 6) Collapse of wooden roofs due to movement of supporting walls.

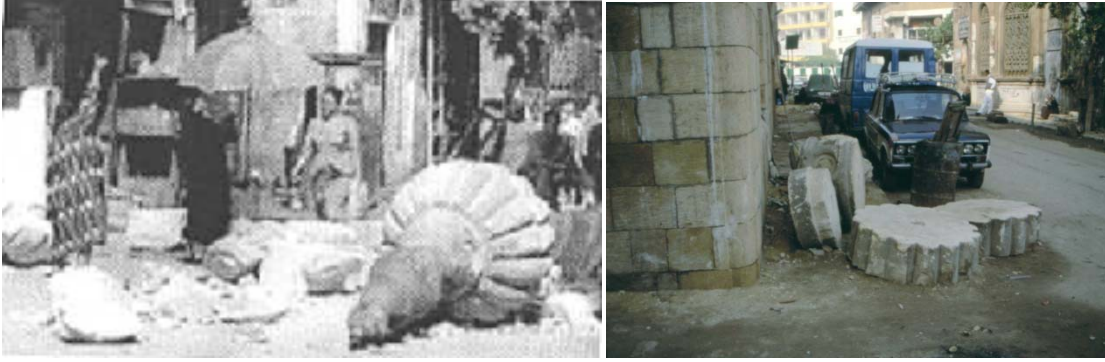
Figure 3. Falling of Al-Ssuity Mosque Bassala During Cairo 1992 earthquake

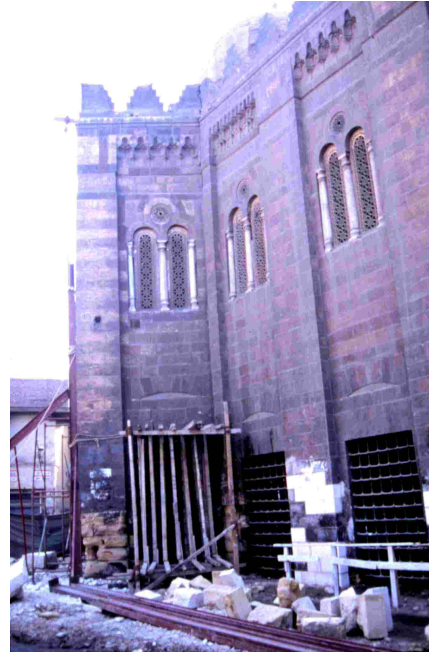
Figure 5. Bulging of external layer of mosque walls Shaykho

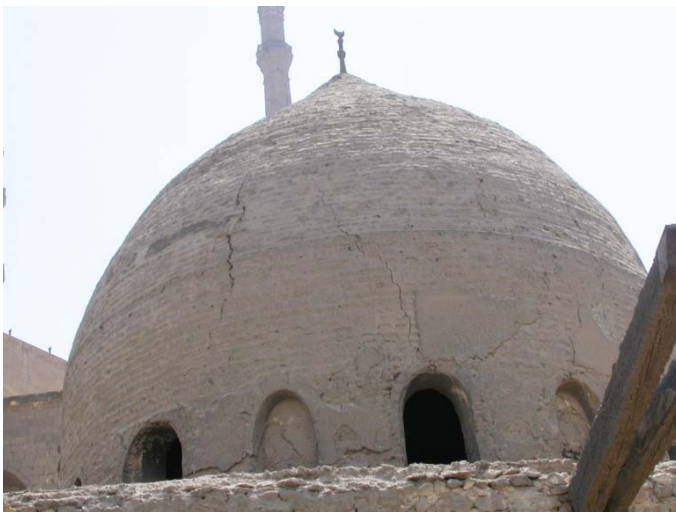
Figure 6. Cracking to domes of Bab El Azab

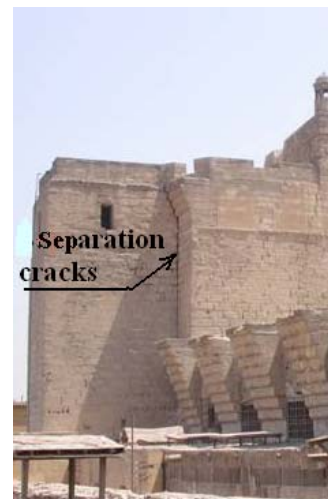
Figure 7. Deep separation cracks

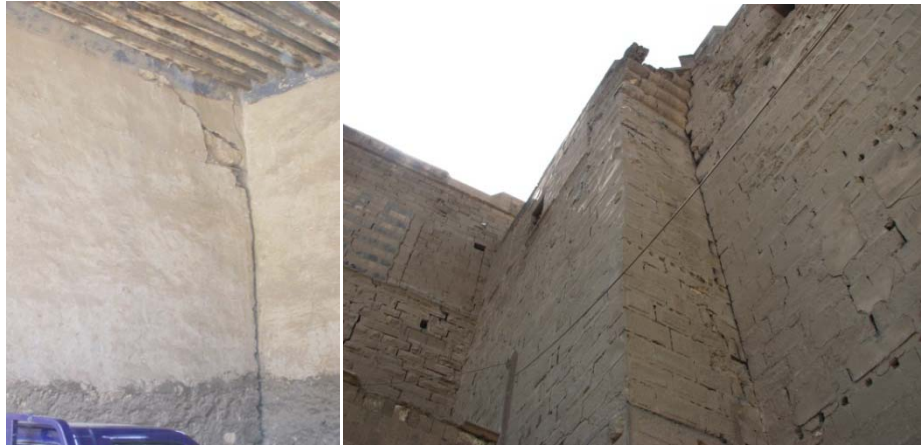
Figure 8. Deep through cracks at corner connection between perpendicular walls (Bab El Azab)

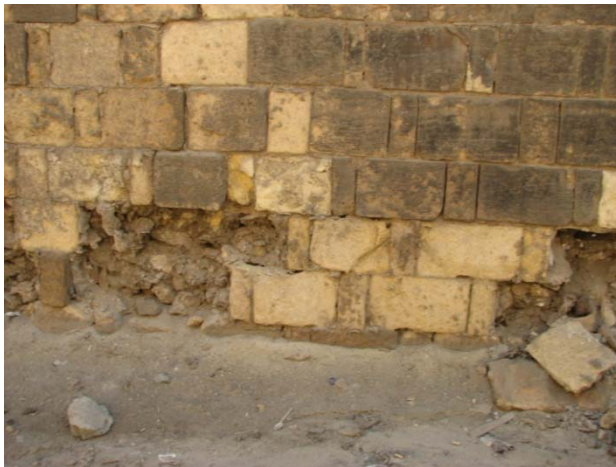
Figure 9. Decay to stones constituting the wall

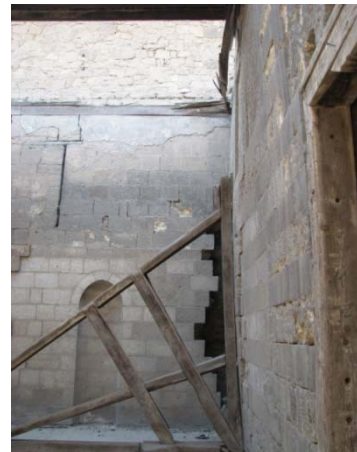
Figure 10. Bulging to wall

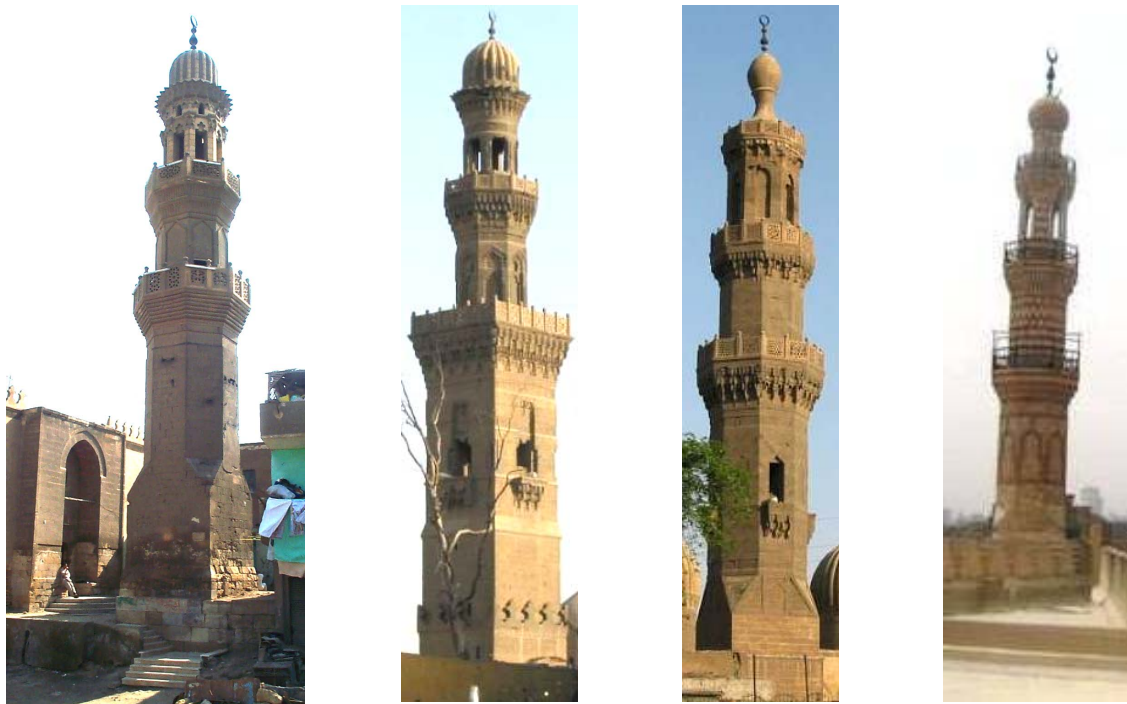
Figure 11. Studied minarets, from left to right, Manjaq Al Yusufi, Qusun, Al-sultaniya and Shaykha

context of three scientific research projects (El Attar, et al. 2001, El Attar and Osman, 2004 and Zaki, et al. 2008), full scale ambient vibration tests were conducted on five minarets, and the northern wall of Cairo city. The studied minarets are Manjaq Al Yusufi, Qusun, Al-sultaniya and north and south Shaykha minarets. Views to these minarets are shown on Fig. 11. As can be noted all these minarets belonging to Mamluk era. The conducted tests provided data on the natural periods of the minarets, mode shapes and damping values. Figure 12 shows, as a sample, the arrangement of the accelerometers along shaykha minaret height, the utilized data acquisition system and the spectrum of the signals. Similarly, ambient vibration test was conducted to measure the dynamic characteristics of northern Cairo wall as shown on Fig.13. Again, mode shapes, damping and associated frequencies were collected to be used later in verifying the finite element models. Ambient vibration tests showed that the frequencies for the first bending two modes for these cantilever Mamluk minarets are ranging from 1.1Hz up to 2.0 Hz as listed in Table 1.

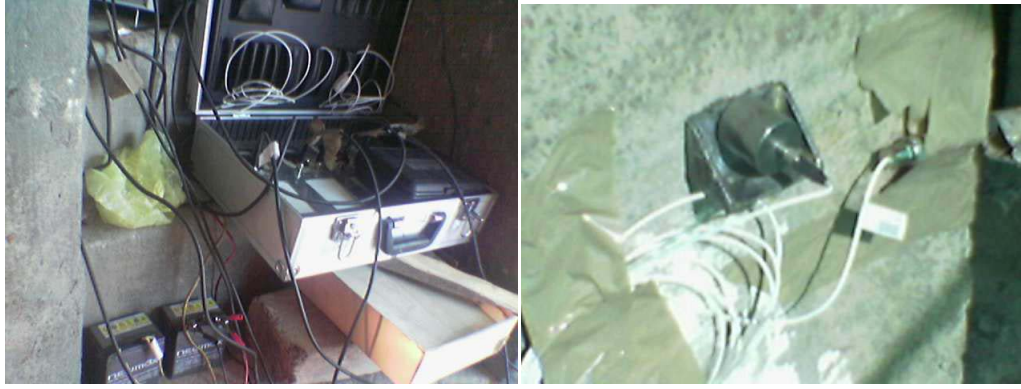
(Data acquisition system)

(Accelerometer with fixing devices)

Locations of the accelerometers

Sample Spectrum of the signals

Figure 12. Sample ambient vibration test to shaykho minaret

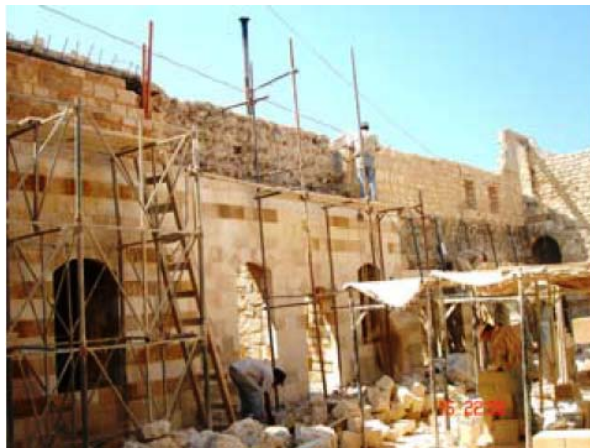
Figure 16. Rebuilding severely damaged walls

Different strengthening techniques are utilized for seismic strengthening of monuments. It started by strengthening the monument walls. If the wall is bulged from one side, this indicates separation of wall leaves due to loss or decay of mortar binding the wall leaves together. In this case the bulged layer is taken out and rebuilt straight with injection to remaining part of the wall with compatible mortar (lime mortar), where the use of cement mortar is not acceptable. If the whole wall is tilted or bulged out-of-plane, it has to be taken out and rebuilt as shown on Fig.16. If any wide cracks observed through the wall, it stitched using either wood or stainless rods (no black steel should be used) or the wide crack injected. Then, the walls are checked for slenderness. Usually for such buildings, L/t should be limited to 20, where L is the wall height or the distance between perpendicular walls, which is shorter, and t is the wall thickness. In case these limits exceeded, it is preferable to provide a diaphragm in the form of open wooden truss at required levels parallel to roof, or buttresses perpendicular to walls. After that, connections among perpendicular walls are checked for the existence of physical bond. If this bond is missing, stainless ties or wood corners are used to connect these walls to ensure that they will work together as box under the action of lateral loads (Fig.17). Then, the roof, which is usually a wooden one, is repaired and strongly connected to walls to ensure that the roof will work as rigid diaphragm with the walls. If foundation needs to be strengthen due to soil problems, either shallow foundation system similar to that shown on Fig.18 can be adapted to relief the exerted bearing stress on the soil by widening the foundation, or micro-piles is utilized as shown on Fig.19. For retrofitting domes and minarets, existing cracks can be stitched or injected and FRP can be used to enhance the tension capacity of these elements as shown on Figs.20 and 21.

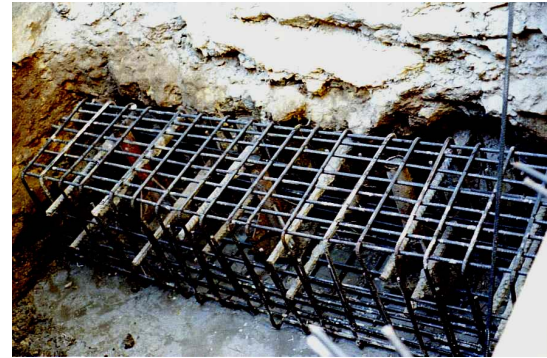
Figure 19. The use of Micro-piles

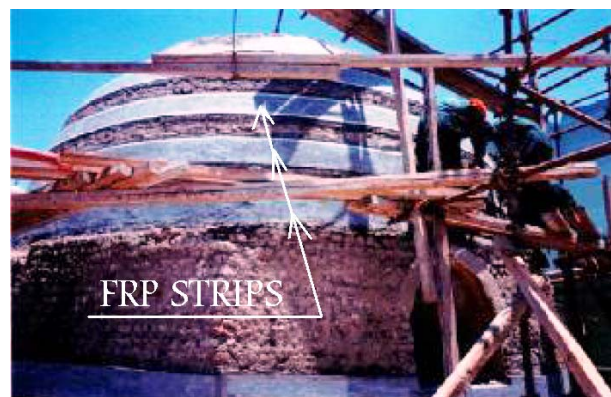
Figure 21. Repair of Al-Aini Dome with FRP
