EXPERIMENTAL STUDY OF TOMORROW'S STEEL BRACED FRAMES IN BUILDING STRUCTURES

Jiun-Wei Lai¹ and Stephen. A. Mahin²

ABSTRACT

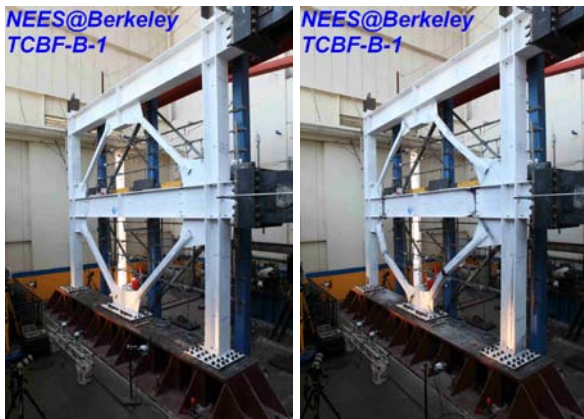
specimen are shown in Table 1. Figs. 3 and 4 show the photo of specimen TCBF-B-1 and TCBF-B-2 before testing. It should be noted that the roof beam, two columns and base plates are re-used after the testing of TCBF-B-1 specimen.

Figure 3. Specimen TCBF-B-1, before test (left), after test (right)

The displacement of the roof beam is monitored and controlled during the entire test process. The upper level actuator is displacement controlled and the lower level actuator is force controlled with one-half of the force feedback from the load cell in the upper level actuator used as the command signal. This makes the lateral force pattern an inverted triangular distribution through out the entire experiment. The test protocol is modified from the Appendix T of AISC Seismic Provisions (AISC, 2005) in order to compare with the results of future BRBF testing in the research project. Additional eight cycles corresponding to one half of the elastic design drift ($6@0.5D_{be}$) and one elastic design drift ($2@D_{be}$) are added to the test protocol. Fig. 7 shows the cyclic loading protocol for the first three specimens. During the entire test process, the loading is paused when major observations are found and the loading is terminated following the cycle where both braces at a particular story (typically the first story) completely fracture. Each specimen is instrumented with displacement transducers, sticks, slip gages and wire pots to measure the inter-story drifts, relative displacements and local deformation of members or connections. Linear type strain gages and rosettes are also glued on the specimen to recover the internal force distributions during the tests. The whole specimens are painted with whitewash to observe the yield pattern (Figs. 3 and 4).

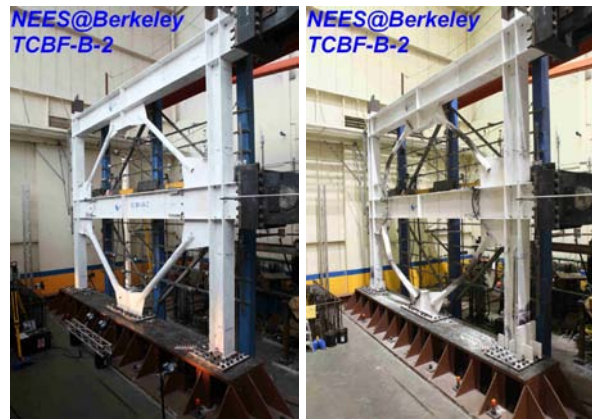
Figure 4. Specimen TCBF-B-2, before test (left), after test (right)

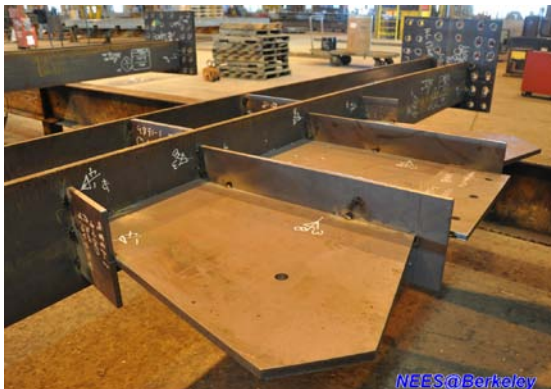
Figure 5. The one-piece gusset plate

The gusset plates which connect braces from both stories in each specimen are 3/4" thick, one-piece gusset plates with two finger plates welded on them and spliced to the W24 x 68 lower beam (Fig. 5). The 2t brace-to-gusset plate recommended separation for out-of-plane buckling of the bracing system is used in each specimen to represent the typical detail in the design practice. Reinforcing plates at the net section of the braces are provided to prevent premature failure of bracing components (Fig. 6). More detail descriptions of test specimens are presented in the companion test report (Lai, 2009).

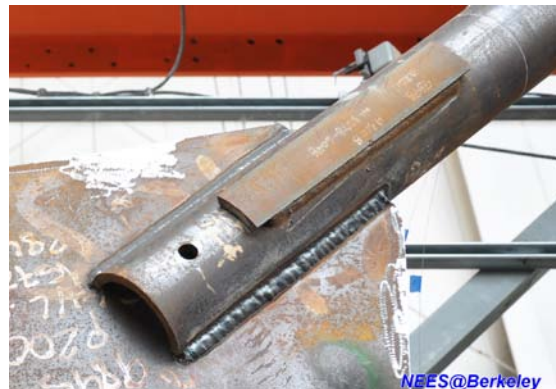
Figure 6. Detail view of reinforcing plate

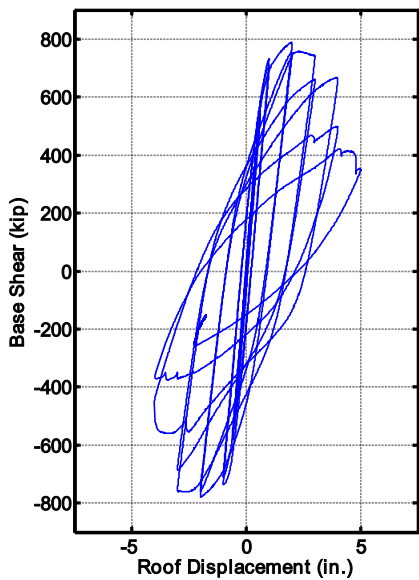
The base shear vs. controlled roof displacement of the specimen is shown in Fig. 8. The relationship between story shear and inter-story drift for specimen TCBF-B-1 is shown in Fig. 9. Table 2 illustrates and lists the major observations on the testing protocol with brief descriptions.

Figure 8. Base shear vs. roof displacement relationship for TCBF-B-1

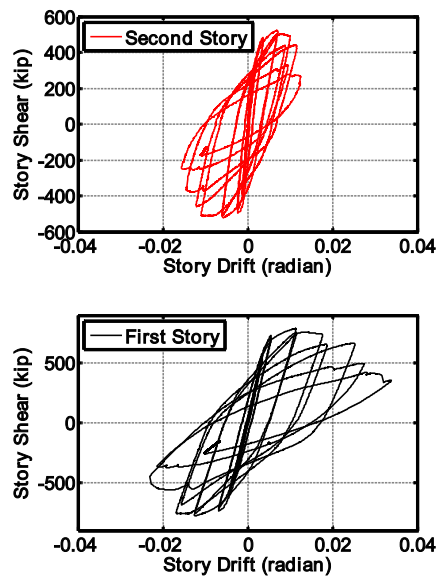
Figure 9. Story shear vs. inter-story drift relationship for TCBF-B-1

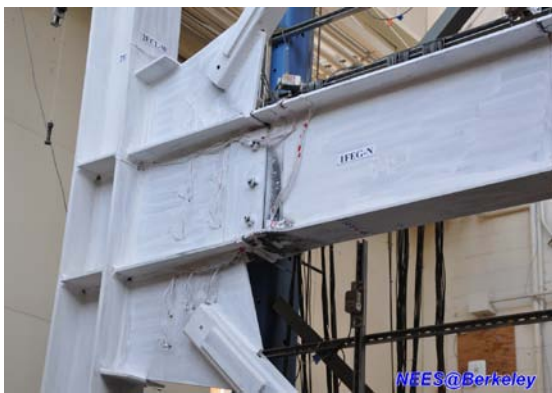
1	The braces at both stories start global buckling. (all out-of-plane to the north side)
2	The braces start local buckling at the middle portion of the brace. The top flange and web of lower beam at western side start local buckling. The bottom flange and web of lower beam at eastern side start local buckling (Fig. 10).
3	Cracks initiated in the outside corner of HSS brace at first story for both braces.
4	The cracks in the first story western brace propagated from outside corners to the center of the HSS brace section during the first cycle of the load step (Fig.11).
5	The western brace at ground story completely fractured during the first half cycle of loading to a roof displacement of 3.8 inch to the west. Crack initiated at the outside corner of HSS brace section at second story for both braces.
6	The bottom flange at eastern side of lower beam fractured at the CJP weld line during the second cycle of $2.0 D_{bm}$ load step at roof displacement about 3.8 inch to the west (Fig. 12).

Figure 10. The beam-to-gusset plate splice at east side of lower beam

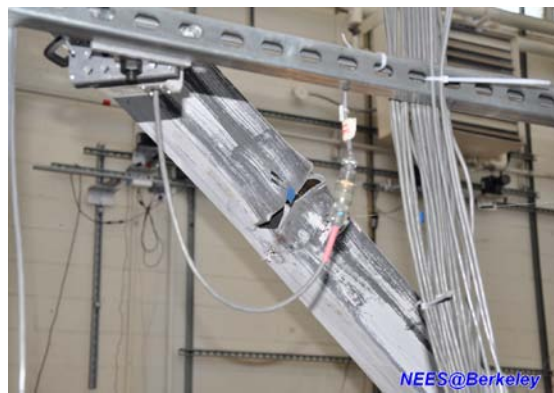
Figure 11. The brace at first story (West)

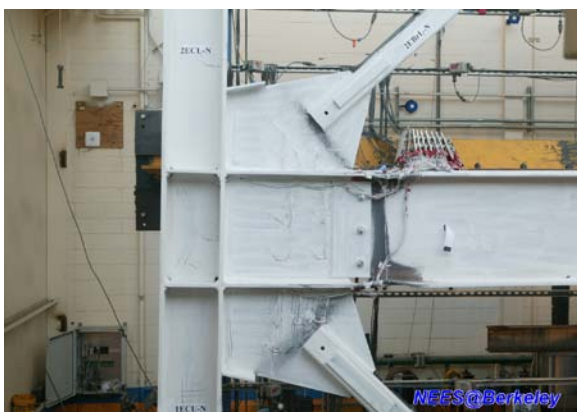
Figure 12. The beam to one-piece gusset plate connection at east side

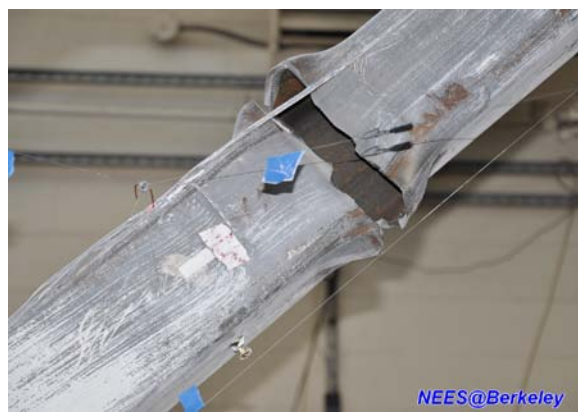
7	The eastern brace at first story completely fractured during the first cycle of $2.5 D_{bm}$ load step at roof displacement corresponded to 4.7 inch to the east (Fig. 13).
8	The cracks in the second story eastern brace propagated from outside corners to the center of the HSS brace section during the first cycle of $2.5 D_{bm}$ load step. Test stopped at about 2.2 inch of roof displacement to the west.

Figure 13. The brace at first story (East)

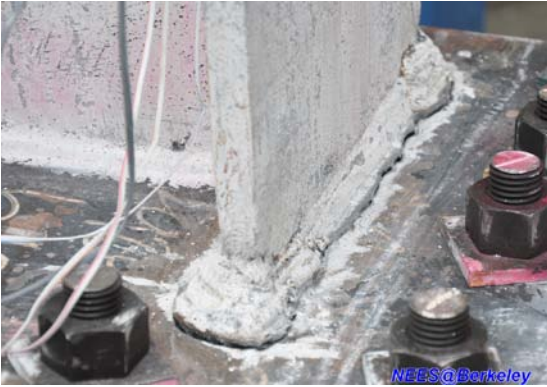
This specimen re-uses the roof beam, the columns and base plates from the previous test. Before the first trial, some welding repairs are conducted at the column bases. During the first trial at about 2-in. roof displacement (the second cycle of 1.5 D_{bm} load step), the west side column base fractures (Fig. 14) and then the test pauses to repair the column base (Fig. 15) to continue the subsequent loading. The base shear vs. controlled roof displacement of the specimen is shown in Fig. 16. The relationship between story shear and inter-story drift for specimen TCBF-B-2 is shown in Fig. 17. Table 3 illustrates and lists the major observations on the testing protocol with brief descriptions.

Figure 14. Fracture of the column base flange welding at west side

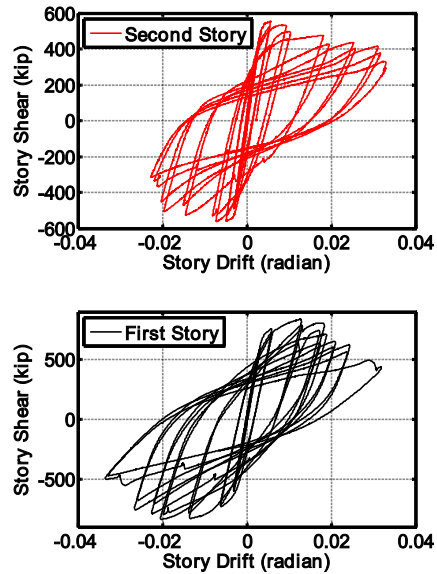
Figure 17. Story shear vs. inter-story drift relationship for TCBF-B-2

From the results shown above, we can see that under similar base shear capacity, the framed specimen with round HSS braces exhibits better ductility capacity than the one with square HSS braces. The peak base shear degrades slower and the local buckling of the braces occurred later in TCBF-B-2 specimen under the same test sequence. Besides, the story drift at each story of TCBF-B-2 specimen tends to be more uniform than TCBF-B-1 specimen. The story shear vs. story drift relationship at each story for both specimens is not symmetric once the brace fractured in certain floor level. The brace and gusset plate configuration of the specimen tends to amplify the rotation demand at both ends of lower beam-to-gusset splices similar to an EBF link beam. From the observation during the tests, once the plastic hinges formed at both ends of the lower beam, even if top or bottom flanges partially (or completely) fracture, the frame specimen redistribute the internal force to resist larger roof lateral displacement which implies that a pinned beam-to-gusset details might be used to avoid local damage (flanges or web buckling and fracture) at this region. In specimen TCBF-B-2, the net section failure mode (Fig. 19) happened in the finger plate of one-piece-gusset which indicates a modified finger plate to gusset plate details should be used to avoid this failure mode. Yield patterns (photos not show here) on the column flanges also indicate that significant torsion and biaxial bending occurred in the column under large deformation which can cause unexpected local damage such as column base failure. Frame action also observed in the tests but not sure how much it affects the results, further research is needed.

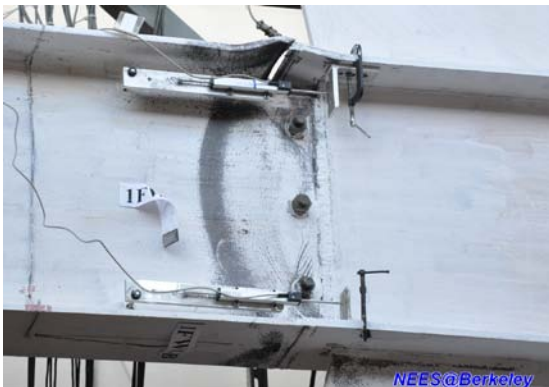
Figure 18. The beam splice at west side

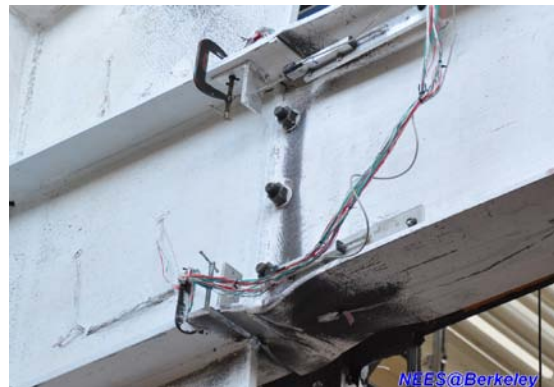
Figure 19. The beam splice at east side

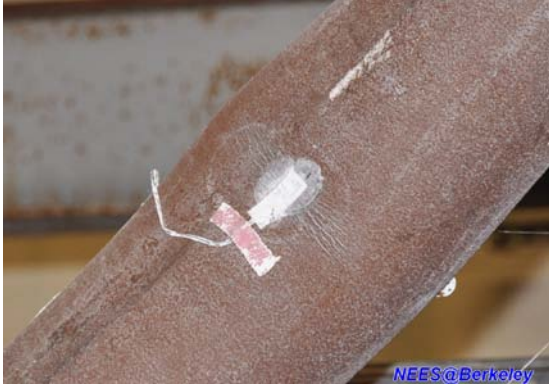
Figure 20. The cracks in the middle of western side of round HSS brace

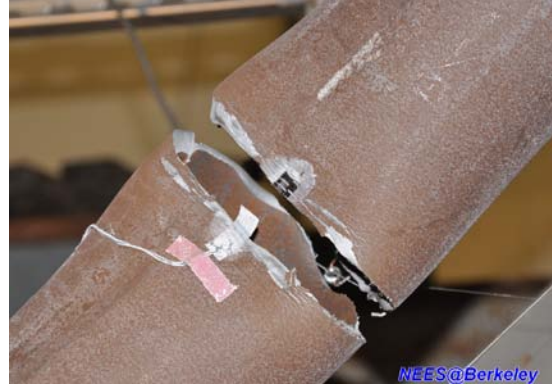
Figure 21. Completely fracture of the brace at first story (West)
