SHEAR STRENGTH AND DRIFT CAPACITY OF HIGH-PERFORMANCE FIBER REINFORCED CONCRETE LOW-RISE WALLS SUBJECTED TO DISPLACEMENT REVERSALS

By Adamantia Athanasopoulou¹ and Gustavo Parra-Montesinos²

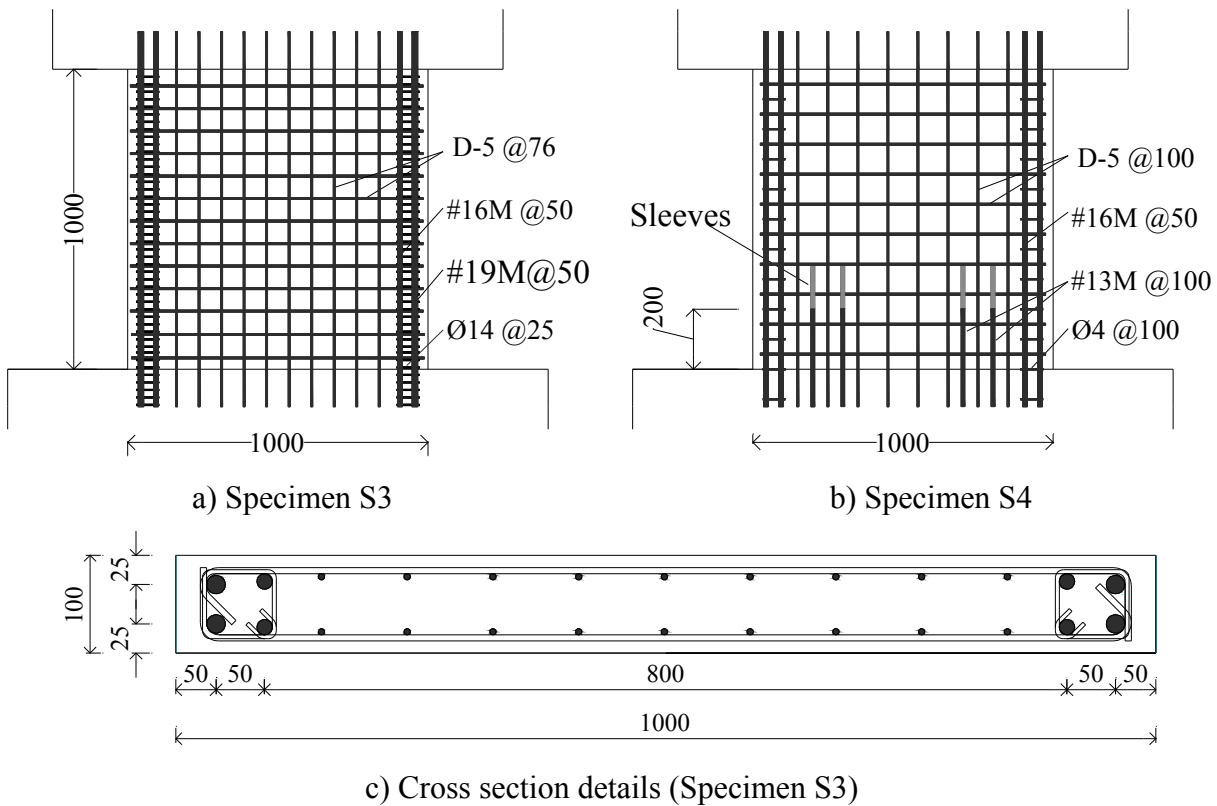
Figure 2. Wall reinforcing details of selected specimens

be attained. Because large inelastic deflections were expected to be imposed on the test walls, special boundary elements were provided in all the RC specimens as required by the ACI Building Code. This provision led to single hoops at the tight spacing of 25 mm at the wall edges. As an example, the reinforcement layout in RC Specimen S3 is shown in Fig. 2a (elevation) and 2c (cross section).

The boundary regions in Specimens S4 and S9, designed for a higher shear stress, were confined with hoops at a 100 mm spacing, which corresponded only to one-fourth of the confinement reinforcement provided in the companion RC Specimens S3 and S8, respectively. Fig. 2b presents the reinforcing detailing for Specimen S4.

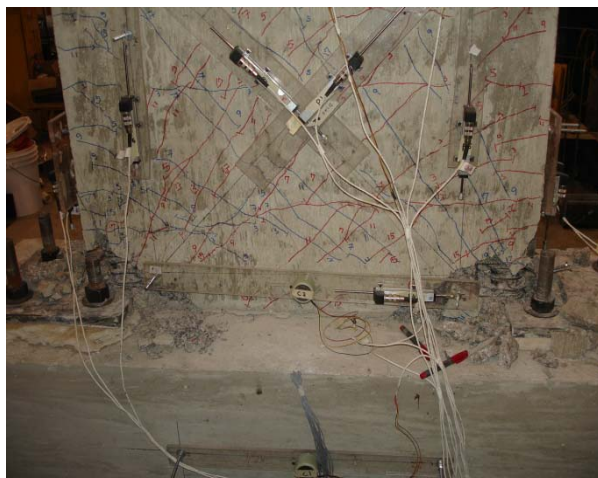
a) Specimen S8 at 2.1% drift

Figure 4. Damage in RC specimens

of the increased shear stress demand, Specimen S8 was subjected to a peak shear stress of $0.78\sqrt{f'_c}$ (MPa) at a drift of 0.9%, with substantial loss of strength for larger drifts. At 1.8% drift, severe concrete spalling in the boundary elements was evident and the test was terminated at 2.1% drift when the wall had lost more than 40% of its strength. Fig. 4a shows the state of damage in Specimen S8 at the end of the test. Similar cracking pattern and damage localization was observed in Specimens S1 and S5.

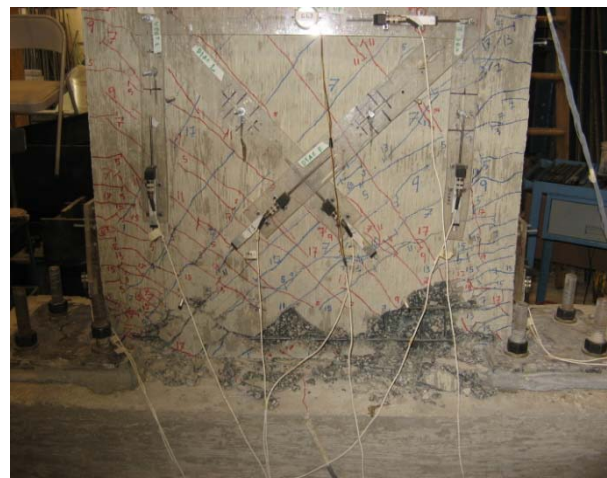
b) Specimen S3 at 1.9% drift

As opposed to the other RC specimens, Specimen S3 experienced significant shear-related damage at drifts larger than 1.3% (peak shear stress of $0.67\sqrt{f'_c}$ (MPa)). Damage was characterized by web concrete crushing in the lower part of the wall, followed by a rapid strength loss. The wall had lost about 30% of its strength at a drift of 1.7% (Fig. 3c) and the measured shear distortions in the lower part of the wall exceeded 0.01 rad. Fig. 4b shows the damage in Specimen S3 near the end of the test.

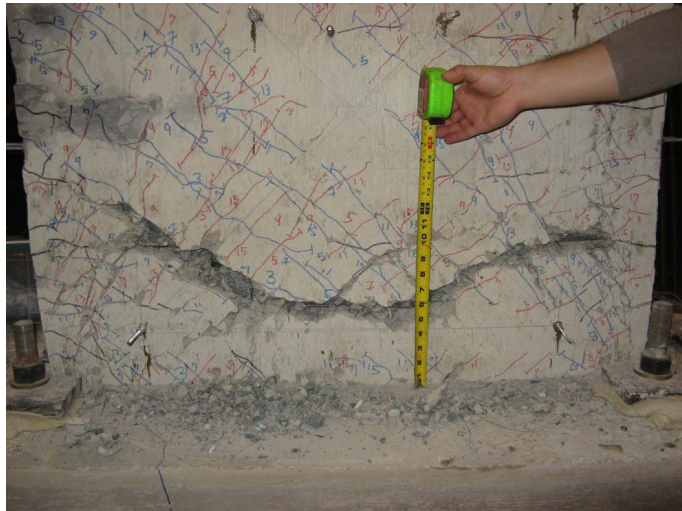
a) Specimen S9 at 2.1% drift

Figure 5. Damage in HPFRC specimens with dowel bars

The addition of dowel bars in HPFRC Specimens S4 and S9 resulted in damage concentration in a horizontal crack at the section where the bonded region of the dowel bars ended. These two specimens sustained a peak shear stress of $0.54\sqrt{f'_c}$ (MPa) and $0.71\sqrt{f'_c}$ (MPa), respectively. Fig. 3d shows the load versus drift response for Specimen S9. Specimen S4 exhibited some minor concrete spalling at the wall web at 1.7% drift and failed at approximately 2% drift due to substantial rotations concentrated at the horizontal crack where the dowels terminated. On the other hand, damage concentration was evident in Specimen S9 only for drifts larger than 1.9%. The specimen could sustain more than 90% of the peak load at a drift of 2.4%. No indication of instability was observed in the wall boundary regions despite the significant relaxation in the confinement reinforcement (Fig. 5a). Compared to RC Specimens S3 and S8, the use of HPFRC led to a much denser array of cracks with smaller widths, improving the damage tolerance of the walls.
