SEISMIC UPGRADING OF DEFICIENT REINFORCED CONCRETE FRAMES WITH INTERNAL STEEL FRAME

ABSTRACT

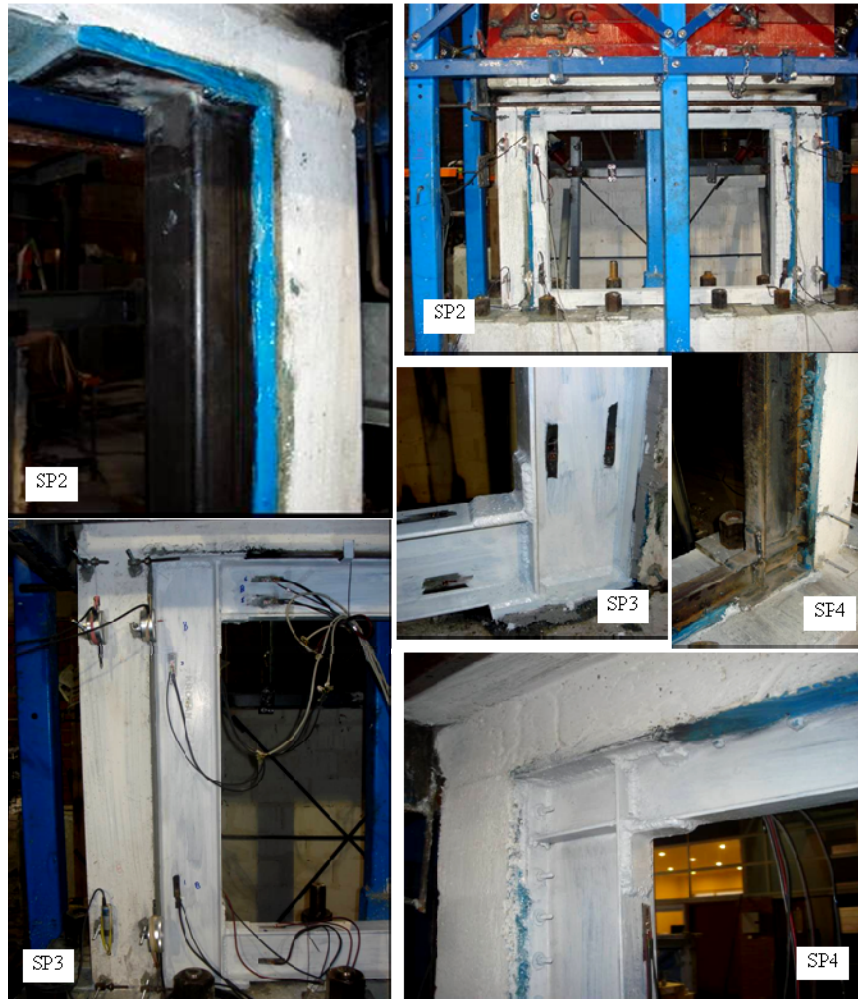
Figure 3. Pictures of test specimens during the construction used in specimen SP2; I-sections were used in specimens SP3 and SP4). The second parameter was the ISF installation method (method I was used in SP2 and 3; method II was used in SP4).

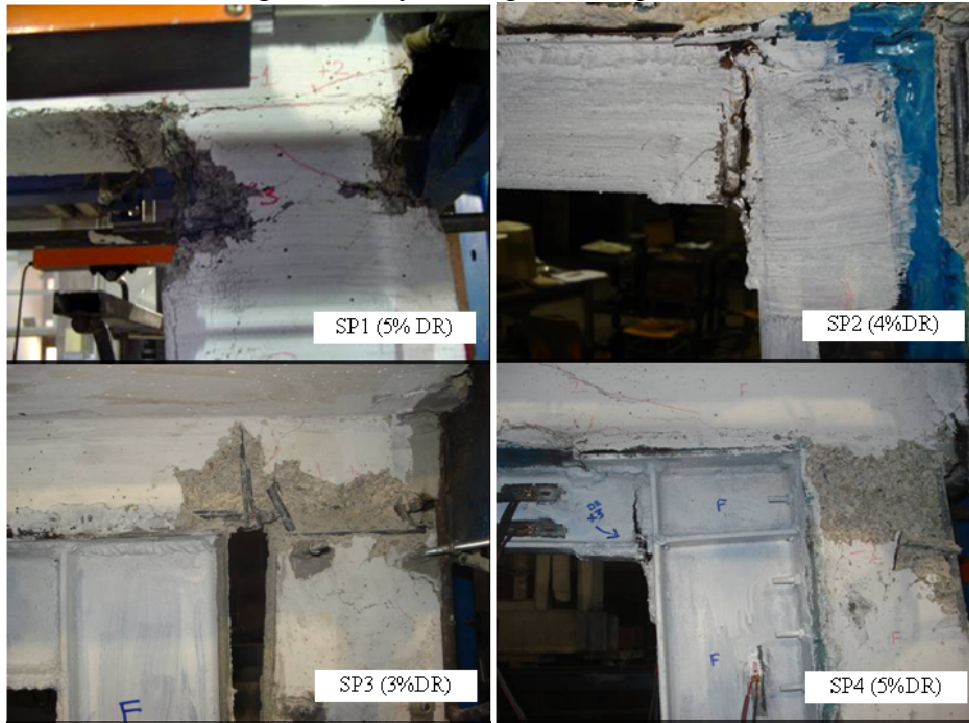
Figure 5. Pictures of the test specimens during the tests

Hysteretic response of the test specimens is presented in Fig. 4. This figure also shows important events such as plastic hinge formation in the RC columns (determined from curvature measurements), fracture initiation of ISF elements and joint failure of RC frame. Deformation levels corresponding to hinge formation from the measurements at the columns ends were marked on the cyclic response, Fig 4. Pictures of test specimens during the test are presented in Fig. 5. Summary of test results are presented in Table 2.

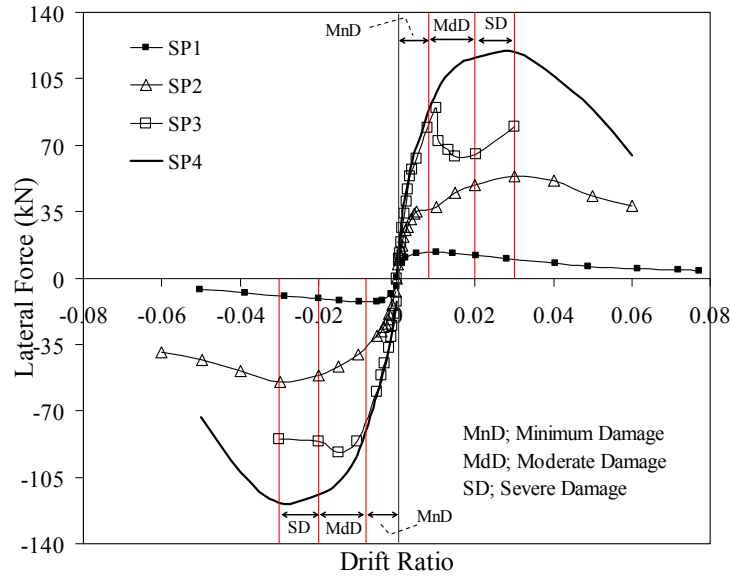
Figure 6. Envelope response of the test specimens

Fig. 6 compares the envelope of lateral strength versus deformation response obtained from all specimens. Fig. 7 indicates the cumulative energy dissipated at the completion of each DR up to the end of ± 4 % DR cycles, except for specimens SP3, in which beam-column joint failure occurred after completion ± 3 % DR cycles. Proposed upgrade schemes resulted in strength increases of 4 to about 9 times the strength of the reference RC frame. On the other hand, energy dissipation capacity increased by amount of 4.9 to 11.8 due to less pinching, stiffness and strength degradation. As a result, if the seismic energy induced by the ground motion is desired to be dissipated by the structure, the reference frame specimen SP1 had poor seismic energy absorption and dissipation capacity with a rapid strength degradation requiring upgrades. Upon upgrading, there was less pinching, stiffness degradation and larger energy dissipation capacity in frames strengthened with ISF. It can be observed that highest energy dissipation and strength enhancement was observed for specimen SP4 with fully composite section.

Based on the observations from the experiments, damage levels at the following drift ratios can be examined, Fig. 6; a) Minimum Damage is defined as the onset of steel beam yielding or first column hinging at the RC frame. In this performance limit, no significant damage except minor concrete cracking was observed.

0.8 % DR as minimum damage level can be accepted for strengthened frames with ISFs. b) Moderate Damage is defined at the occurrence of significant damage (i.e. plastic hinge formation in the column) on the RC frame. Significant yielding may occur at the steel beam. This performance limit was selected at 2 % DR. c) Severe Damage defined as the fracture initiation of ISF. 3 % DR is a safe limit for this damage level. The proposed values in this study are similar to
