9th US National and 10th Canadian Conference on Earthquake
Engineering: *Reaching Beyond Borders*
toronto july 25-29, 2010
9ième Conférence Nationale Américaine et 10ième Conférence
Canadienne de Génie Parasismique: *Au delà des Frontières*

USE OF STEEL BELTED AUTOMOBILE TIRES AS TRANSVERSE COLUMN REINFORCEMENT FOR IMPROVED SEISMIC PERFORMANCE

Adel Bugaldian¹ and Murat Saatcioglu²

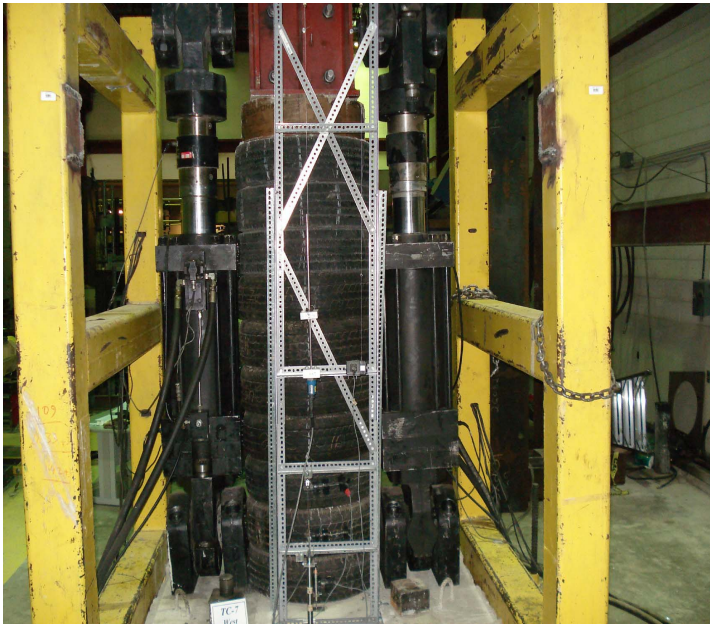
a) Column at 2% lateral drift

Fig. 5 Performance of Column TC-7 at selected stages of loading

Column T-7 with a high aspect ratio was designed to perform predominantly in the flexure mode. The longitudinal reinforcement consisted of twelve continuous No. 25 (25.2 mm diameter) deformed bars, without splices. There was no conventional transverse reinforcement in the column. The test started with the application of full axial load, followed by lateral load reversals in the displacement control mode. No damage was observed during the first three cycles at 0.5% lateral drift ratio at 12.5 mm displacement and corresponding lateral load of 177 kN. There was no yielding of reinforcement recorded. When the deformation was increased to 1% drift ratio, the strain readings on the longitudinal reinforcement indicated yielding during the third cycle. The strain reading at 175 mm above the footing indicated 0.21% on the west side. Subsequent deformation cycles resulted in increased reinforcement strains, without any visible damage until the end of 5% drift cycles. The strains in the rim of the third tire from the base reached 0.32% during 3% drift cycles. The strains in longitudinal reinforcement at 175 mm below the footing reached 0.47% and 0.55% at the end of 5% drift cycles. The maximum lateral load at 5% lateral drift was 403 kN. At the beginning of 6% drift cycles, high strains were recorded on the treads of the first tire on the west side, and the second tire on the east side. Subsequently, the first and second tires from the bottom started to separate from each other on the east side. There was an increase in the volume of concrete within these tires due to internal damage to concrete. The strains in the rims were increased to 0.48% at this load stage. There was a slight drop in lateral load resistance at the end of the second cycle of 6% drift. Loud sound was heard as the longitudinal reinforcement ruptured on the west side. Subsequently, the second tire ruptured on the East side. There was a significant drop in load resistance at 7% drift ratio. This was attributed to the rupturing of longitudinal reinforcement in tension and the rupturing of the second tire from the bottom. The buckling of longitudinal reinforcement was observed at this stage of loading. The column was able to develop 6.5% lateral drift prior to sustaining 20% decay in strength. At the end of the second cycle of 7% drift the lateral load dropped suddenly to 50% of peak resistance and the test was stopped due to a safety concern. There was extensive damage observed on the east side of the second tire, which was accompanied by the buckling of longitudinal bars. The duration of the test for this column was about two and a half hours.

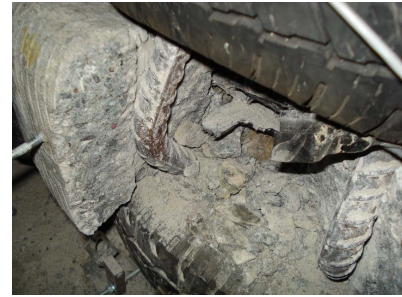
c) Bar buckling at the end of test

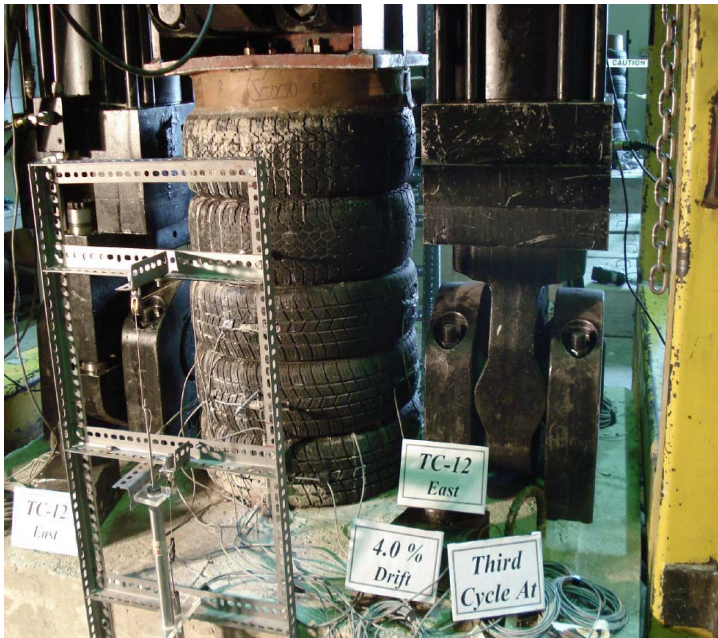
a) Column at 4% lateral drift

Fig. 6 Performance of Column TC-12 at selected stages of loading

Column TC-12 was a shear critical circular column with reduced shear span of 1200 mm. The longitudinal reinforcement consisted of twelve continuous No. 20 (19.5 mm diameter) deformed steel bars without any splicing. There was no conventional transverse reinforcement. The test procedure was identical to that employed for the previous column. No damage was observed during the three cycles at 0.5% drift ratio with maximum lateral load resistance of 235 kN. At the end of 1% drift cycle, the strains in extreme longitudinal bars reached 0.62%, 0.75%, and 0.56% at the column-footing interface on the east and west sides, and at 135 mm above the footing, respectively. The strains continued increasing with increased lateral drift and reached
