SEISMIC PERFORMANCE OF CONCRETE ENCASED STEEL BUILDINGS WITH RIVETED JOINTS

M. Naderi , J.W .Butterworth , G.C. Clifton

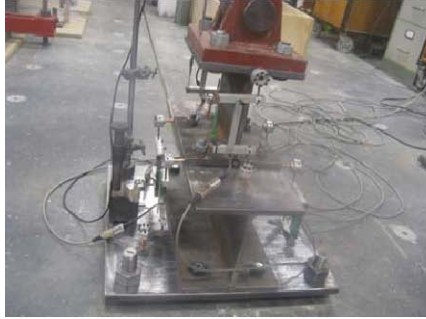
Fig 7. Tee stub experimental test

To validate the ABAQUS model, two experimental tee stub tension tests were undertaken. The test setup is shown in Figure 7. The tee stub representing the attachment to the beam flange is shown oriented vertically. The aim of the test was to measure the separation between the stem of the loaded tee stub and the base column to which it is bolted. The tension load is applied vertically upwards and the bottom section represents the typical column section to which the tee stub is attached. There was a good compatibility between the results of the experimental tests and the ABAQUS model, as shown in Figure 8 except initial stiffness of numerical results is higher than experimental test resulting from high clamping force applied to both end of bolts in Abaqus environment.

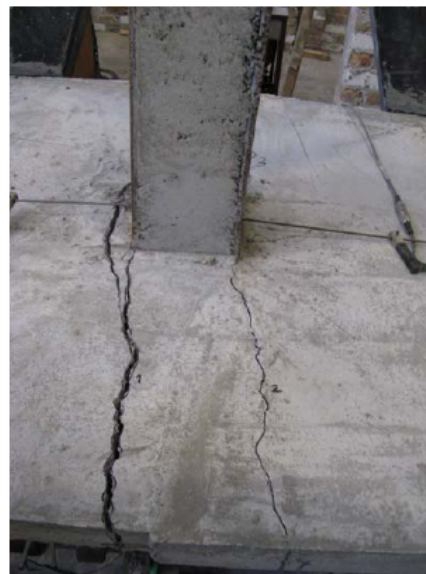
column flange connection, where the two connecting bolts soon failed. The slab provided greater tension capacity at top flange level, developing the cracks shown in Fig. 13, but with no fracture of reinforcing bars. Compressive capacity by bearing of the beam flanges against the column flanges together with the tensile capacity available through the slab reinforcement generated the moment capacity at larger rotations.

Fig 12 . The Location of weakest point of connection Fig 13. Crack Pattern across the slab

Visible inelastic action in the joint first developed in the bolts holding the beams onto the bearing seats, with these bolts yielding in shear, then fracturing in shear with increased column rotation. From a rotation of approx 0.01 radians and beyond, the rotating column pushed the two beams apart, putting the reinforcement running past the column into the slab on each side into yield in tension. This reinforcement which comprised plan bars was able to slip in the concrete and so accommodate the increasing opening of the gap by tension yielding over an increasing length of bar without suffering necking and fracture close to the rotating column. There was no fracture of the reinforcement even at a column rotation of over 0.06 radians.

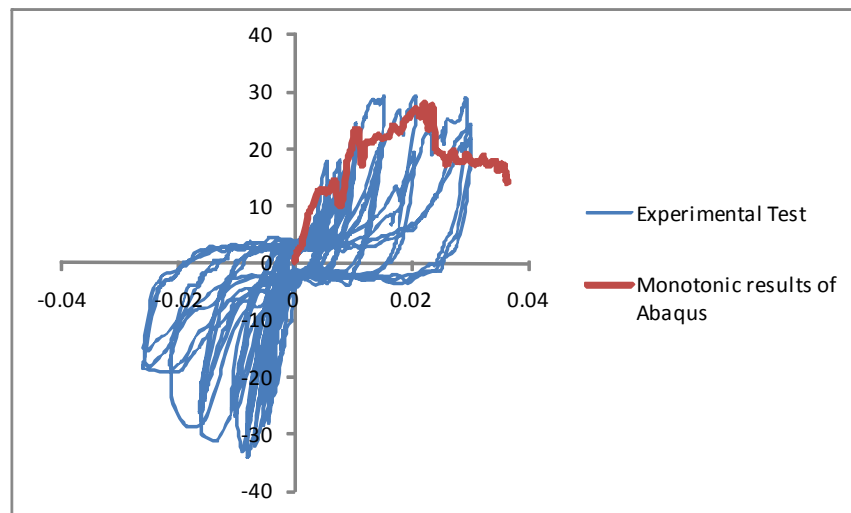
Fig 14. Moment-rotation curves for half-scale model (KN-m)

Fig 14 shows the experimental moment-rotation plot with the preliminary Abaqus monotonic result overlaid. It can be seen that there is good agreement between the two graphs although the Abaqus results still require correcting to the measured concrete compressive strength and stress-strain behavior of the concrete.

As expected from previous FE analyses of typical riveted joints, the connection behavior falls into the flexible category and had a maximum moment capacity of 30 kNm at a rotation of 0.015 radians. This means that for a full-scale connection the expected maximum moment capacity provided by as built joint would be about 120 kNm.

From fig 14 , it can be seen that cyclic loops for riveted joint are pinched and repeat of cycle

leads to considerably drop in stiffness. The results indicate that joint strength is limited by the strength of the tension load path through the slab in the as-built model. .

The first experimental test on the “as built” assemblage was completed in mid-November 2009, providing data for comparison with the FE study and confirming the overall behavior of the joint. As seen in Figure 14, the initial agreement is quite satisfactory however the model will be further modified to improve the prediction of experimental performance and pattern of inelastic action observed.

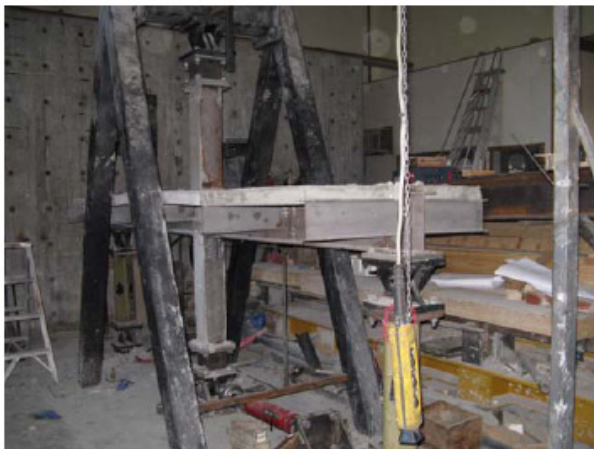
Fig 15. Test Setup

The experimental test of the half-scale model representing the “as-built” conditions was completed early November and the data is still being analyzed. Cyclic testing was in accordance with the SAC protocol with 3 cycles of joint rotation at interstorey drifts of 0.3%, 0.5%, .75% , 1% , 1.5% , 2% , 3% applied by rotating the column which was pinned at top and bottom and loaded by a horizontal actuator at the bottom pin. The column ends coincided with the mid-storey heights above and below the joint being tested. The beams were also pin-supported at their ends, with the pin locations corresponding to mid-span in the actual building.

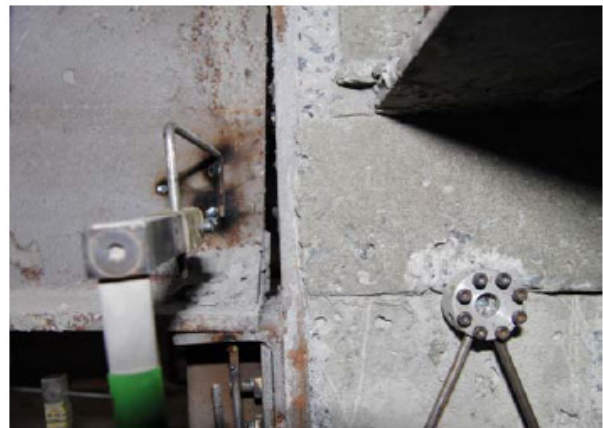
Fig 16. Fracture of bolts between beam and angle

Fig 16 taken during the final step (.03 rad) of cyclic loading and show governing failure mode, which is shear failure of rivets between seat angle as it was expected besides the separation of seat angle and beam can be seen as well. This in itself is an undesirable failure mode and this non-ductile behavior must be modified to develop higher strength and more ductile modes of failure enhanced with appropriate retrofitting measures.

The method being considered to achieve this is to greatly enhance the tension load path through the slab so that the rotating column cannot push the two halves of the slab apart, but instead will generate compression yielding of the beam flange in contact with the column flange.

Development of this enhanced tension load path through the use of carbon fibre wrap laid onto the top of the concrete slab and extending past the column is the first option being considered.
