EXPERIMENTAL STUDY ON THE PERFORMANCE OF BRICK MASONRY PIERS BEFORE AND AFTER RETROFITTING WITH REINFORCED PLASTER

Mohammad Ashraf¹, Qaisar Ali², Akhtar Naeem Khan², Bashir Alam¹, Amjad Naseer¹

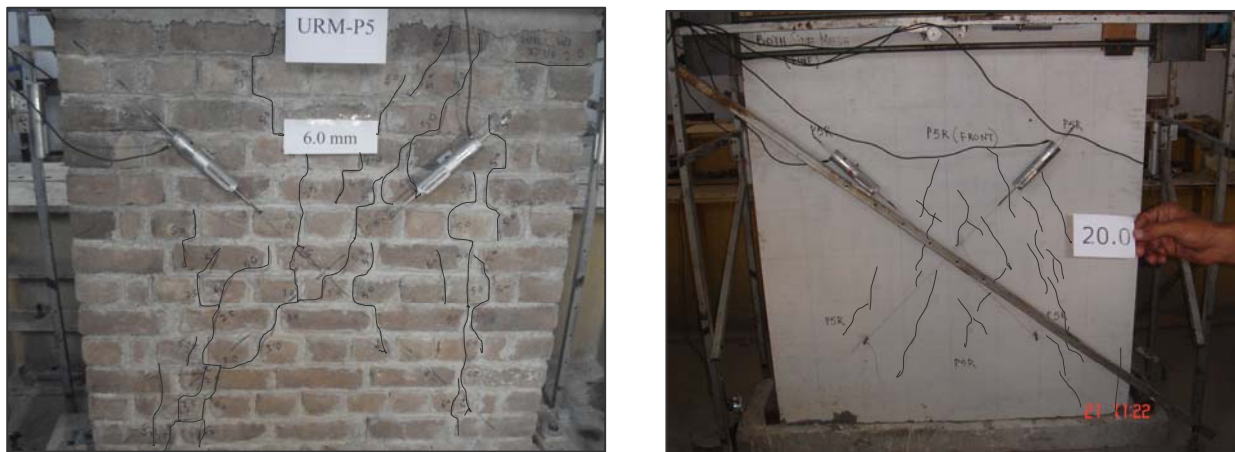
Figure 5. Final damage photograph of specimens P5 (left) and P5R (right)

represents a mixed rocking-shear mode. The application of reinforced plaster in combination with grout injection, thus, changed the behavior mode from shear to rocking-shear mode. Figure 5 shows the final damaged photograph of both specimens. The damages in specimen P5 were distributed in the whole specimen. First vertical compression cracks appeared and finally a diagonal crack was noticed at the peak strength. On the other hand in P5R the damages were mostly confined to the bed joint at the bottom. Initial cracking in the specimen P5 and P5R has been observed during 1.5 mm cycle. Increase in the shear strength of the pier was the reason to activate the rocking mode. The deformation capacity was limited by the out-of-plane sliding at the base of bear.

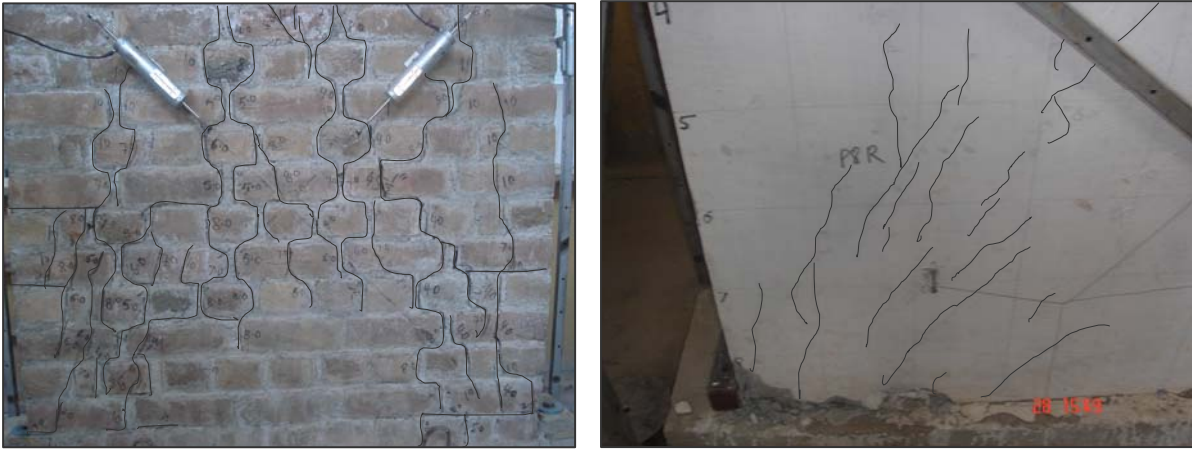
cracks in P8 were appeared in mortar joints and then converted to diagonal cracks passing through the bricks near the peak strength (Figure 7). The pier P8R continued to rock with bed joint crack opening and closing. In the last cycles (1.5% drift) some out-of-plane sliding and twisting have also been observed which limited the deformation capacity of the retrofitted pier.

Figure 7. Final damage photograph of specimens P8 (left) and P8R (right)

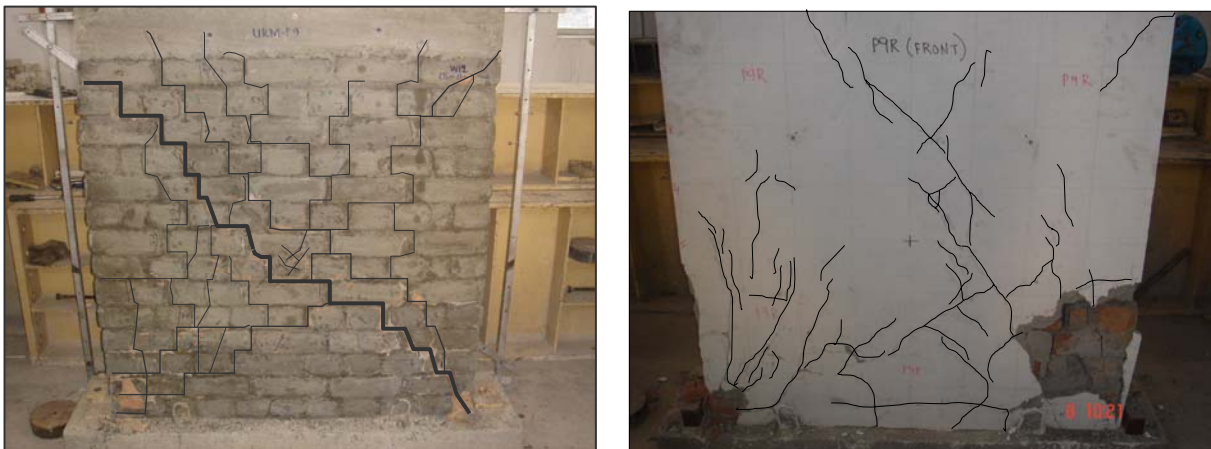
diagonal crack has been noticed (Figure 9). The ultimate condition appeared in the form of toe crushing.

Figure 9. Final damage photograph of specimens P9 (left) and P9R (right)

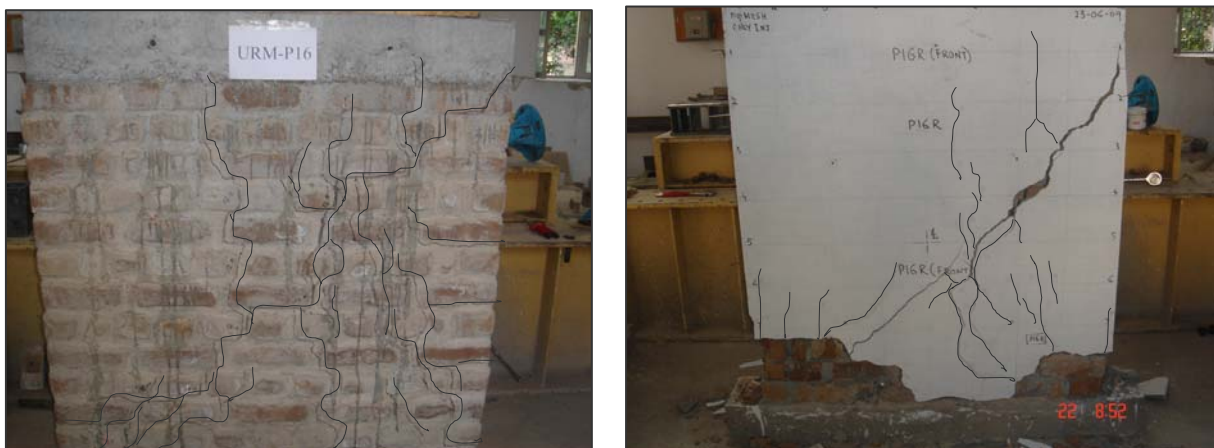
Figure 11. Final damage photograph of specimens P16 (left) and P16R (right)
