Experimental study on the seismic response of telecommunications equipment supported on access floor

C.M. Wong¹ and W.K. Tso²

ABSTRACT

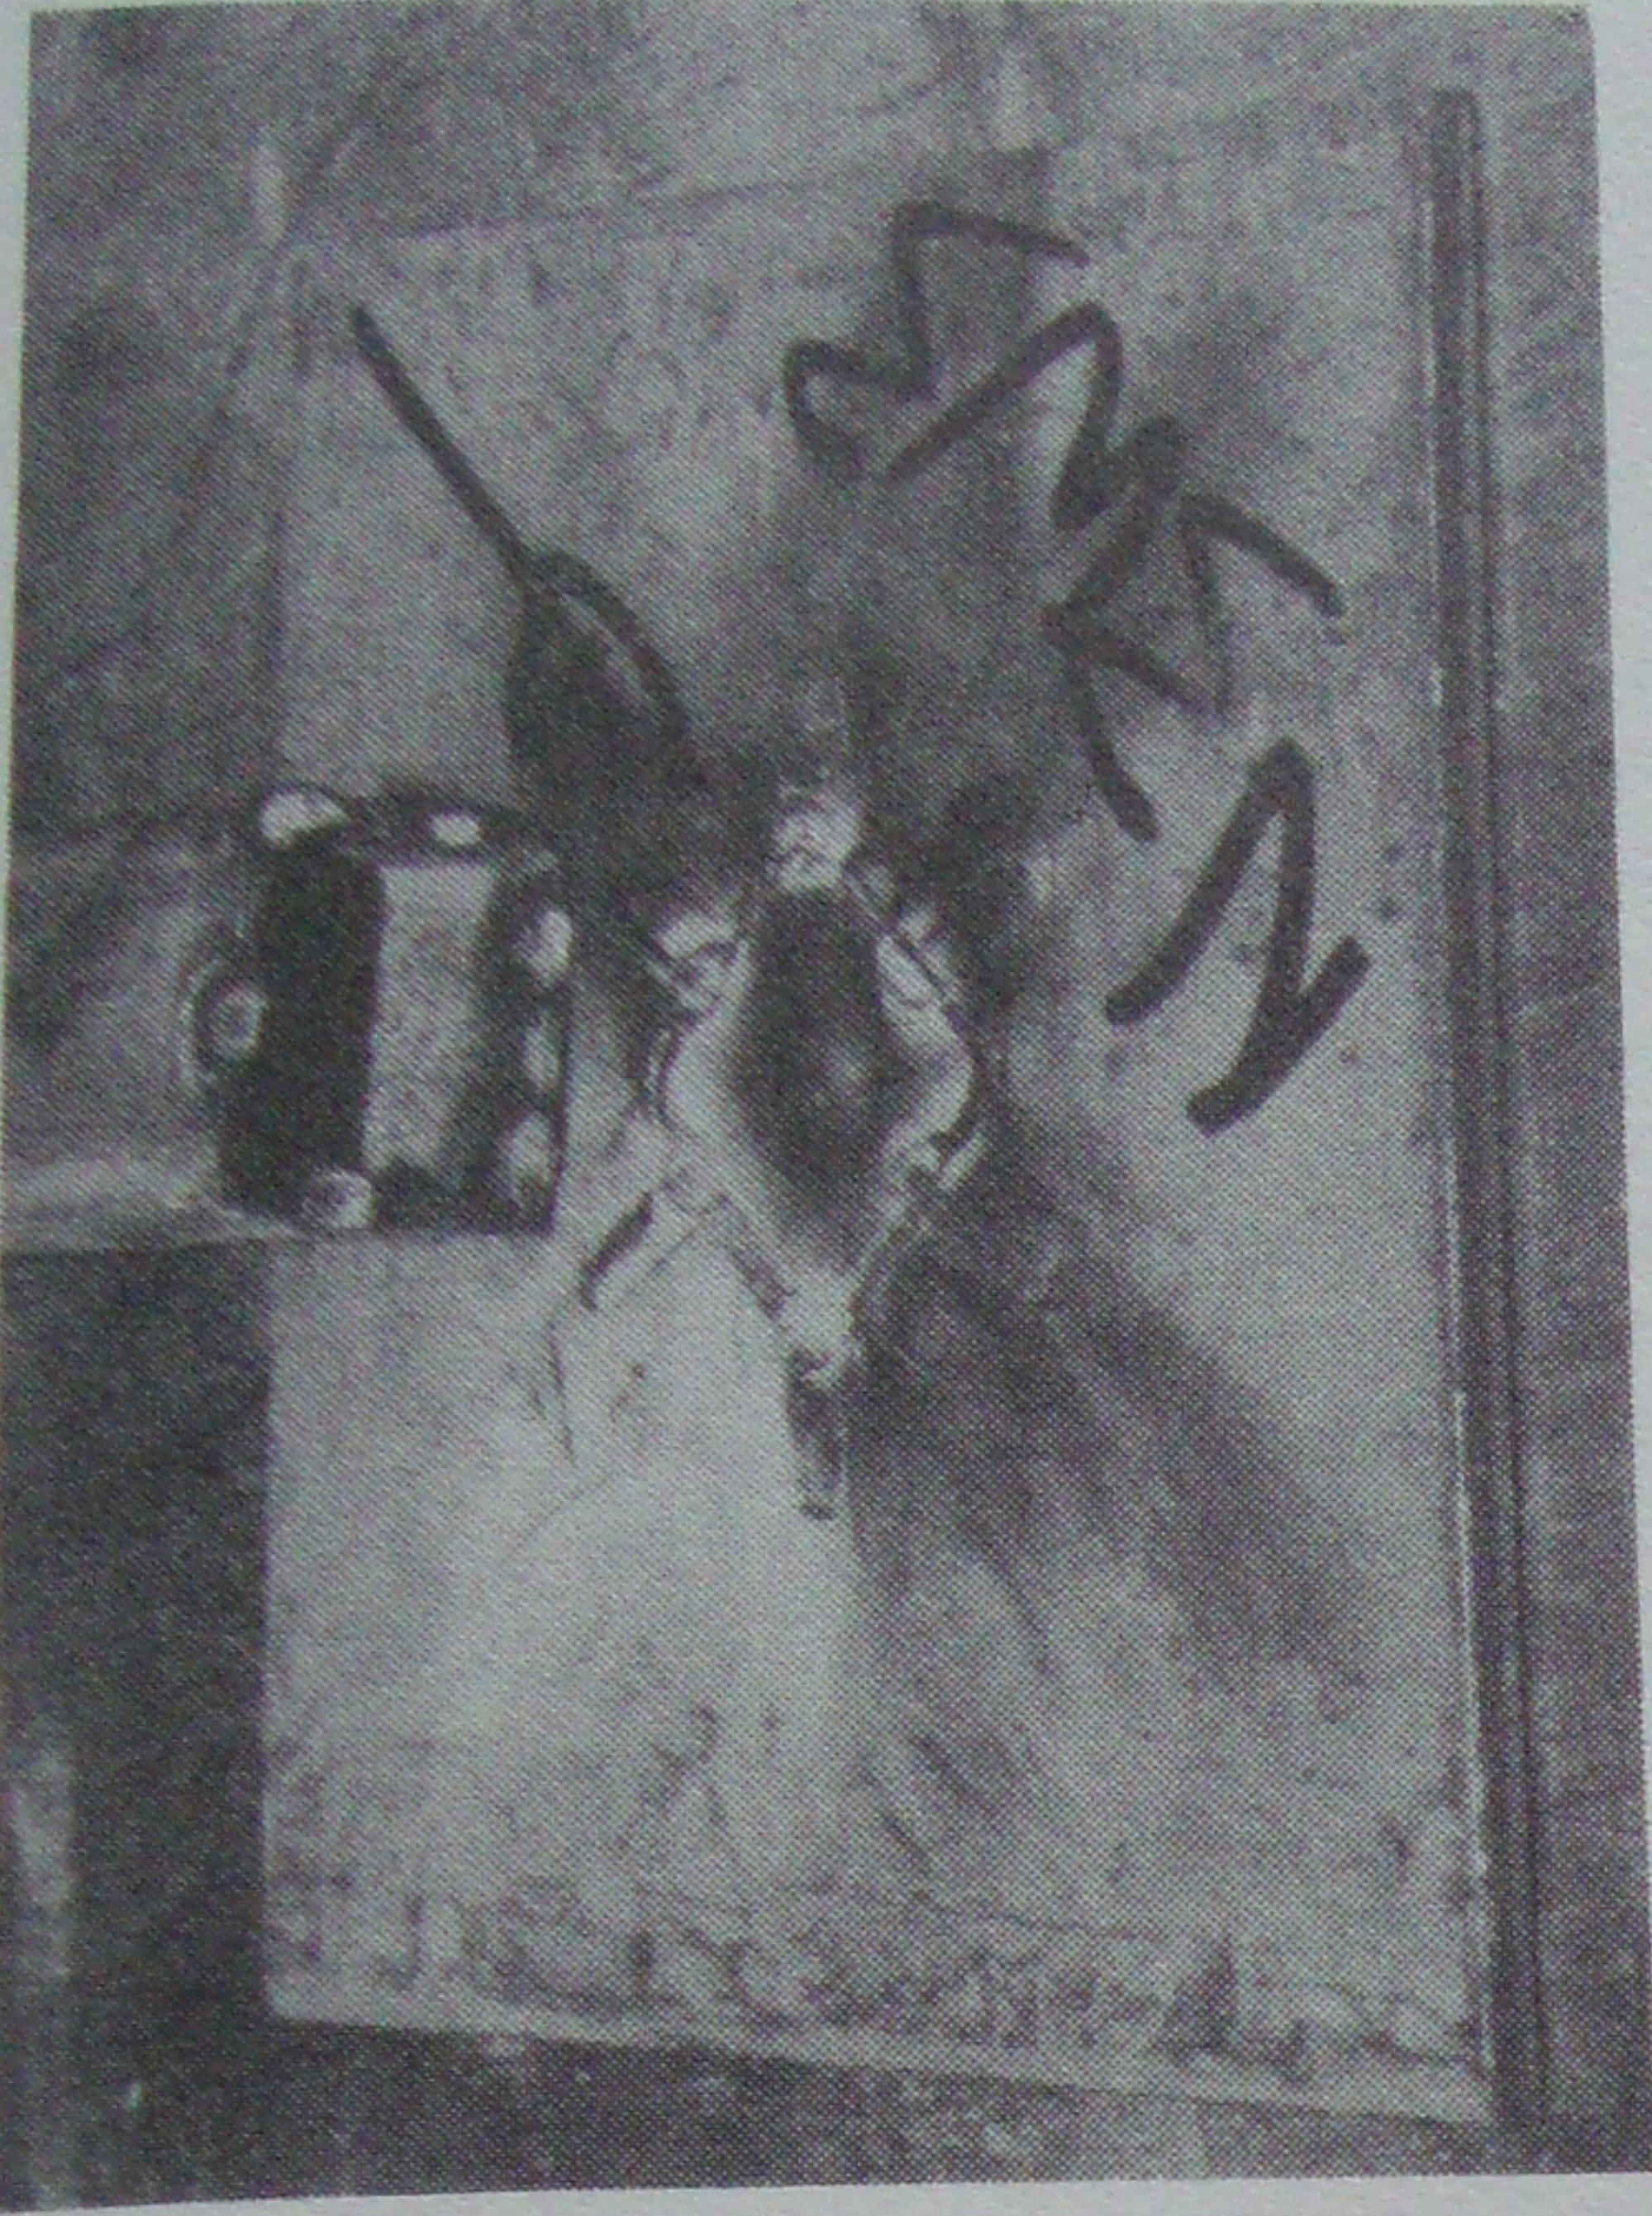
Fig. 7 Damaged pedestal of access floor 'B' after NEBS time history test

The equipment cabinet on the various access floors was tested until the access floors were damaged by gradually increasing the intensity of the NEBS shaking. None of the access floor systems could sustain more than a 50% intensity of NEBS shaking without damage while supporting the equipment cabinet. The access floors of suppliers A and B failed under the NEBS shaking in a similar manner as the failure depicted in the static tests. The failure was due to the tearing of the spot-welds at the base plate of the pedestals. A typical damaged pedestal is shown in Fig. 7. System A can sustain a slightly higher NEBS shaking than system B due to stronger spot-welded based plate connections. Although in some tests more than half the pedestal stems were completely severed from the base plates, no collapse of the access floor occurred because the stringers were holding all the pedestal stems together. Access floor system C failed under the NEBS shaking in a totally different way from the failure observed in the static tests. The failure was due to the shearing off of the pedestal heads as shown in Fig. 8. Since the pedestal heads were the only support for the floor panels, the shearing off of several pedestal heads directly underneath the equipment cabinet led to a collapse of the access floor under the weight of the equipment cabinet. The collapsed access floor can be seen in Fig. 9. Such catastrophic failure was primary due to the lack of a stringer system which stabilizes the pedestal and provides a more even distribution of the imposed seismic force to the pedestals. It was observed in the tests for one of the access floors with a stringer system that in spite of 90% of the pedestal stems were severed from their base plates no collapse occurred.

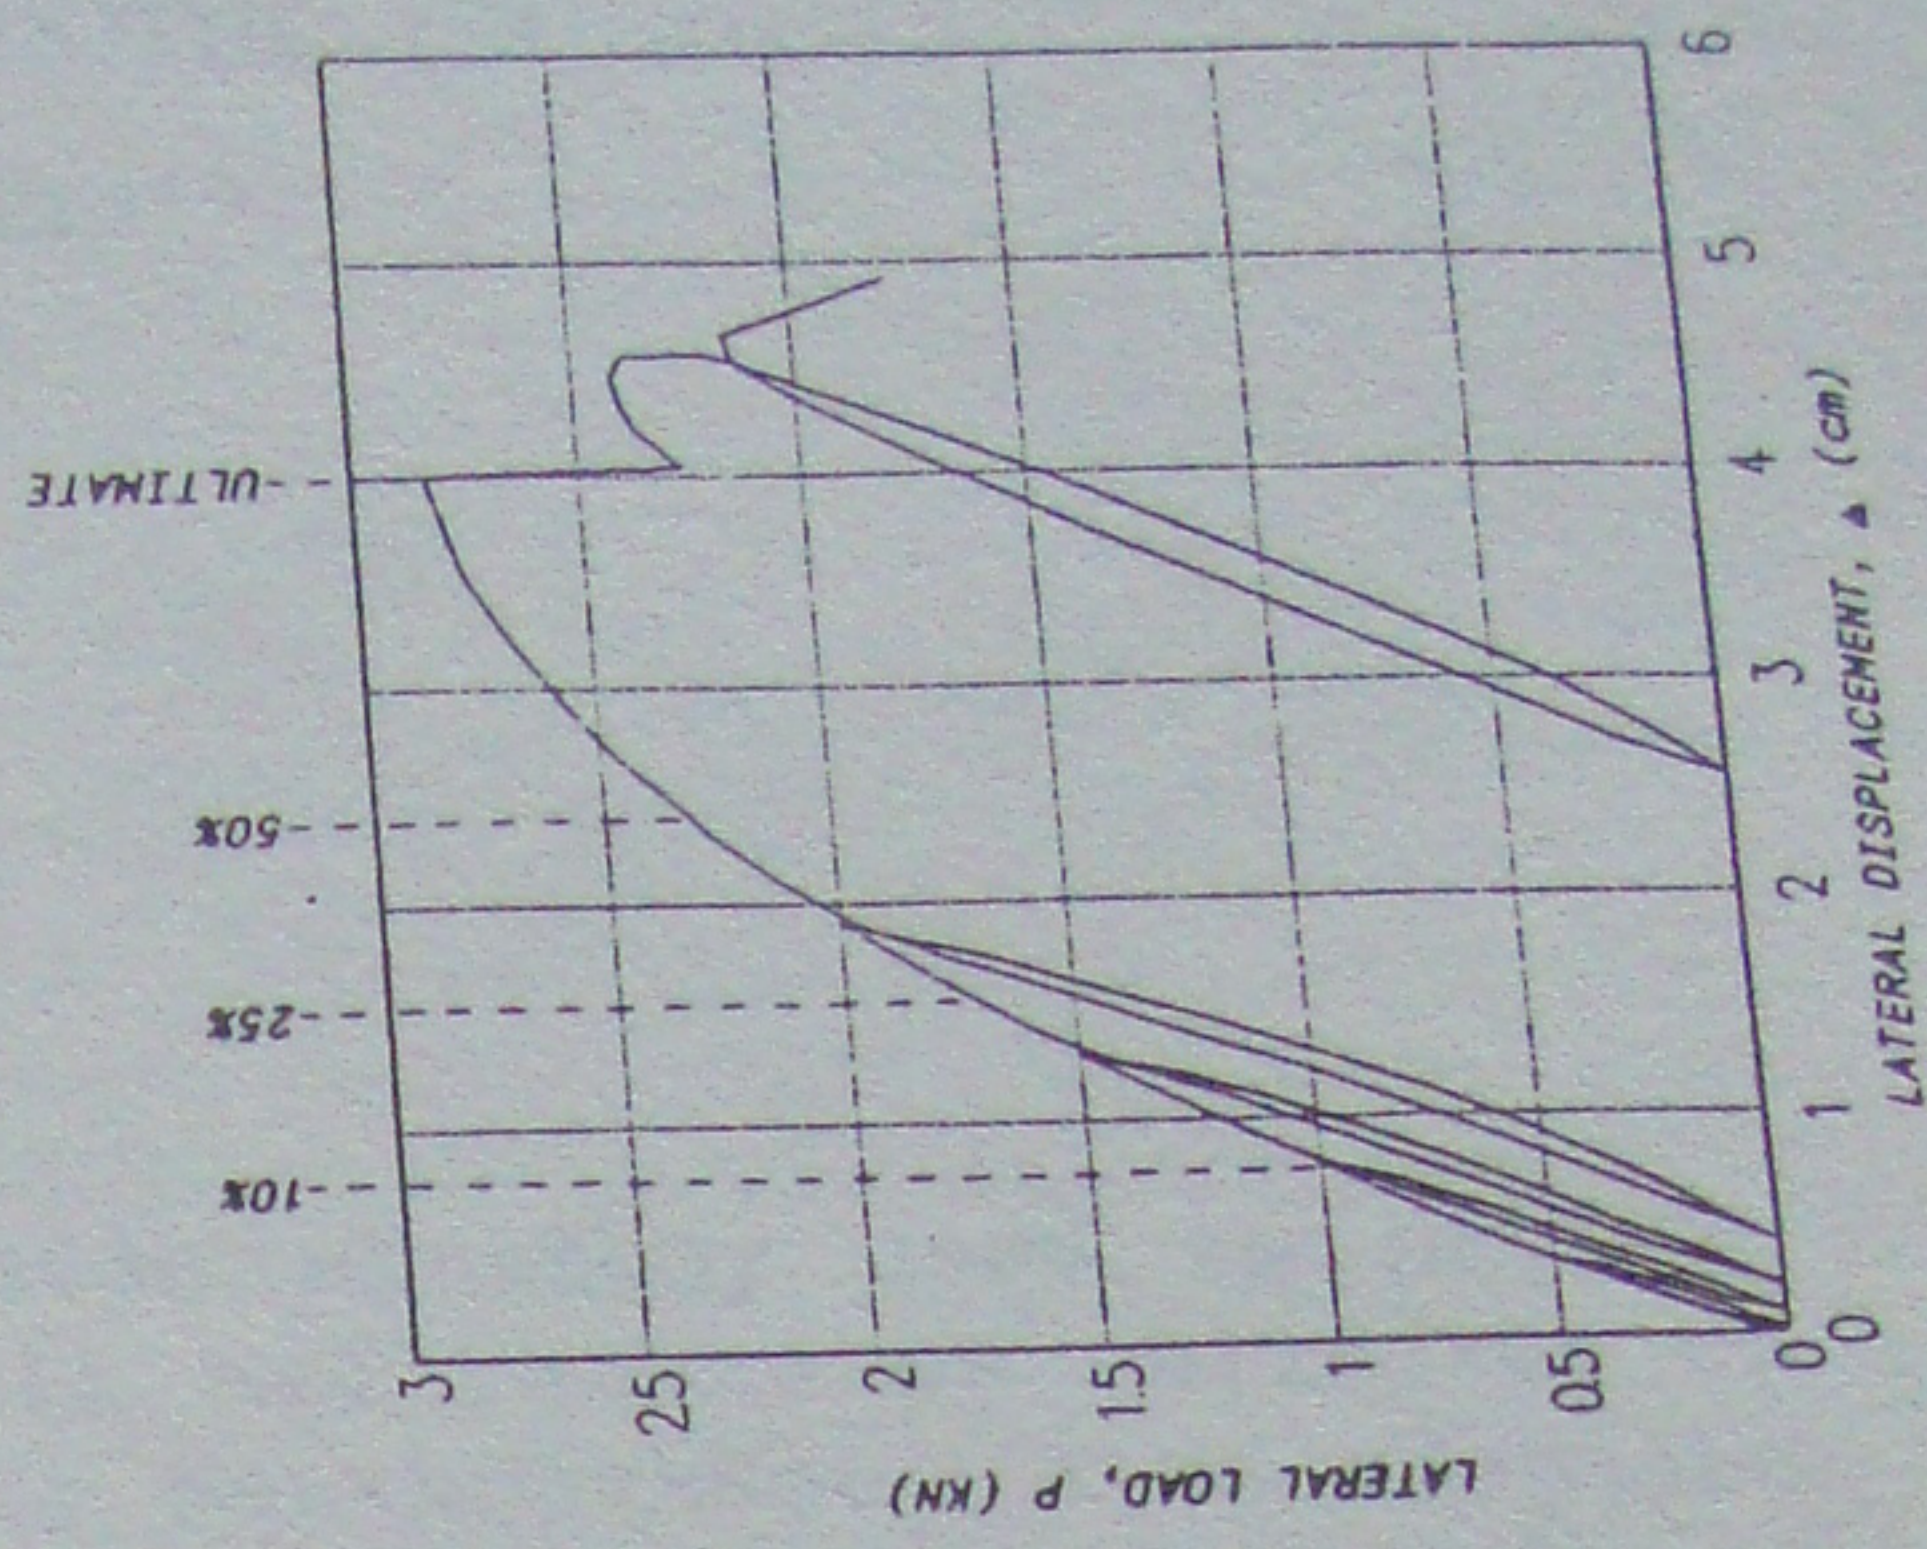
Fig. 10 Correlation of results between static test and dynamic test for access floor 'A'

In order to relate the results of the NEBS time history test to that of the static test, the maximum floor displacements under different level of NEBS shaking are indicated on the static lateral-load displacement curves. Fig. 10 shows the load-deflection curve for the access floor system A. The maximum floor displacement denoted in the figure were obtained from the NEBS test performed for the equipment cabinet in the back-to-front direction on the access floor system A. For the 50% NEBS excitation test where the access floor was damaged, the load induced by the maximum displacement was very close to the ultimate load. The correlation with the dynamic test results implies that it is viable to use the static test results of a simple one-panel access floor module to evaluate the seismic safety margin of an access floor system given that the upper-bound access floor displacement can be estimated with reasonable accuracy.
