# The seismic renovation and repair potential of ferrocement coatings applied to old brick masonry walls

H.H. Lee<sup>I</sup> and S.P. Prawel<sup>II</sup>

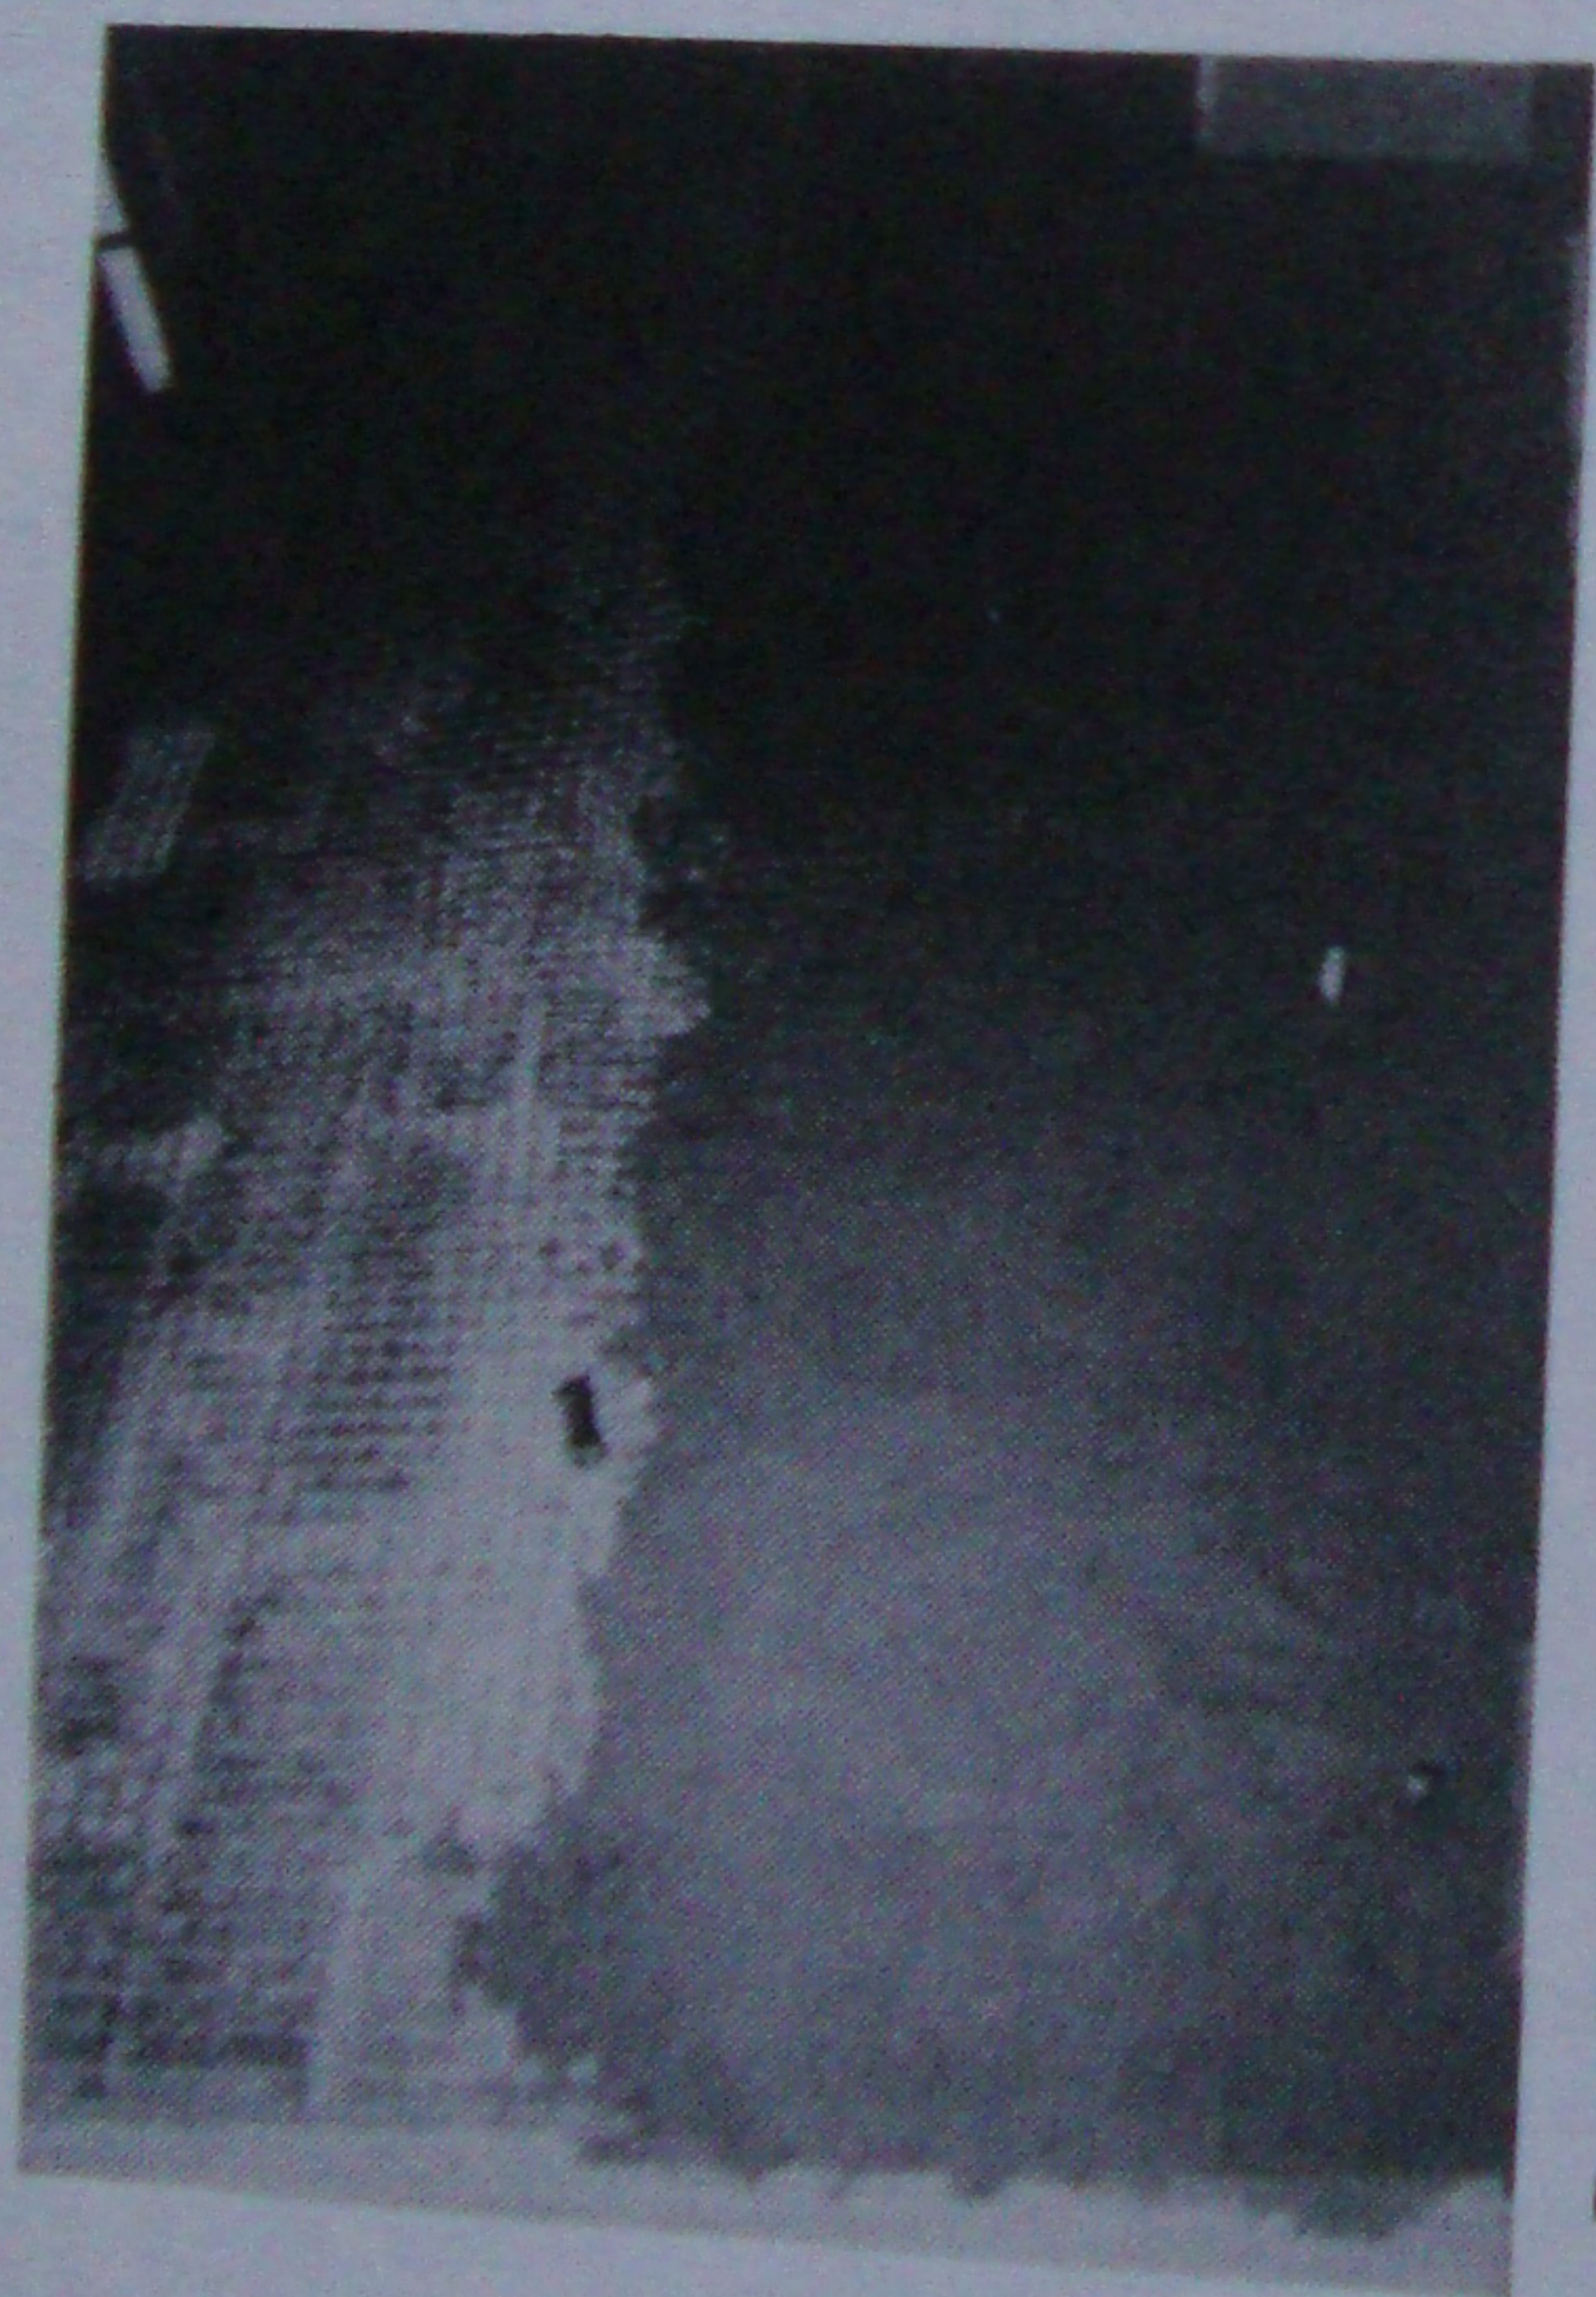
Fig. 1 The Ferrocement Overlay Attached to the Masonry Wall

The second part of this series of diagonal split tests were performed on four 42 in. x 8 in. wall specimens built from old reclaimed brick using ASTM type M mortar. Three of them were coated on both sides with the coated ferrocement overlay, each using a different size of mesh, as shown in Figure 1, while one bare wall was left as a control. All specimens were placed in a moist room to cure. Those to be coated were removed after 14 days and a 1/2 in. coating of ferrocement was applied. They were then put back into the moist room for an additional 28 days. After curing, each specimen was placed in a 300,000 lb. Universal testing machine, checked for alignment and loaded in diagonal split to destruction.

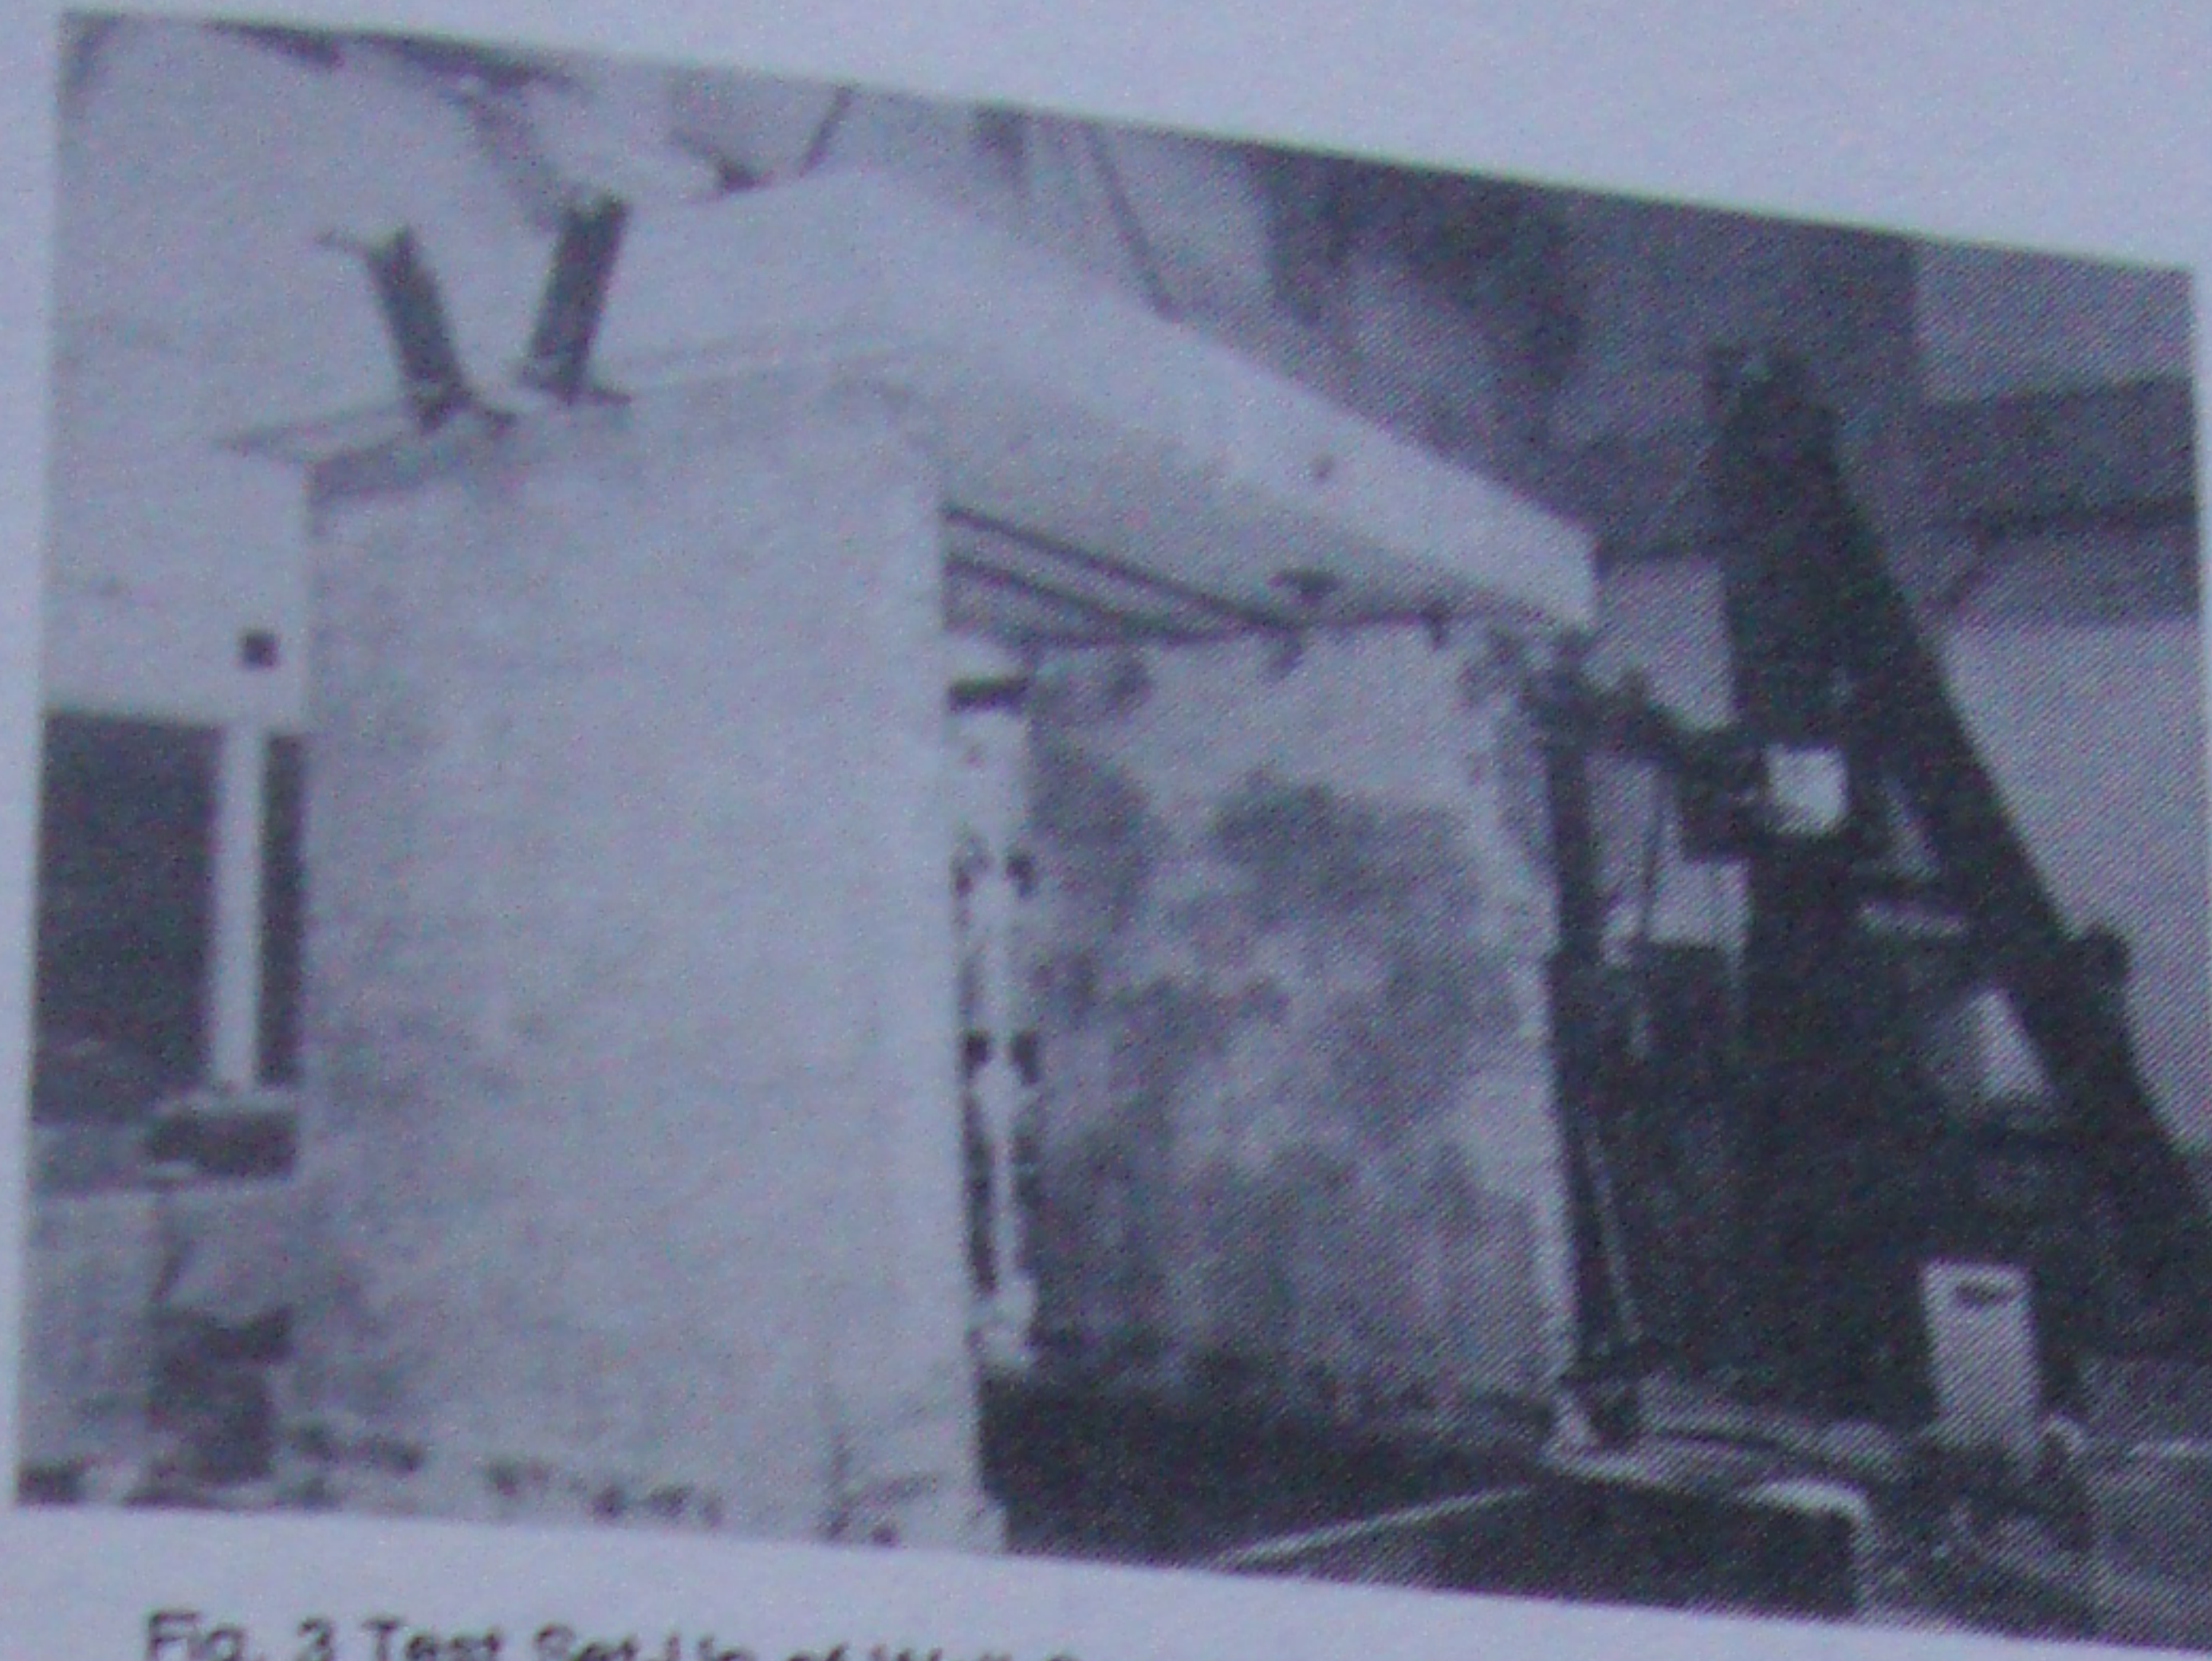
A typical test set-up for a pseudostatic cyclic loading test is shown in Fig. 3. As shown, two wall specimens were mounted on the test base which was

anchored to the strong test floor. A ten-ton concrete ballast block was used to represent the overburden loads at the first floor level of a typical two-story masonry building. The block was attached to simulate a pin at the top and a fixed base at the lower end of the wall. A servo hydraulic actuator having a capacity of 55-kip and a 24-inch stroke was horizontally mounted between the heavily braced reaction frame and the ballast block which also acted as a rigid diaphragm. To simulate the usual nonrigid connection between the top of the wall and diaphragm or roof of an old masonry building, the end of the wall was allowed to rotate freely when subjected to out-of-plane loadings.

Fig. 3 Test Set-Up of Wall Specimens in Cyclic Loading Test

Sonic displacement transducers, calibrated statically and conditioned within the MTS 406 controller previous to the test, were mounted on the surface of the wall specimen at even intervals from the base as can be seen in Fig. 3. Tests for the in-plane and the out-of-plane behavior of the wall specimens were both carried out, for both coated and uncoated specimens.

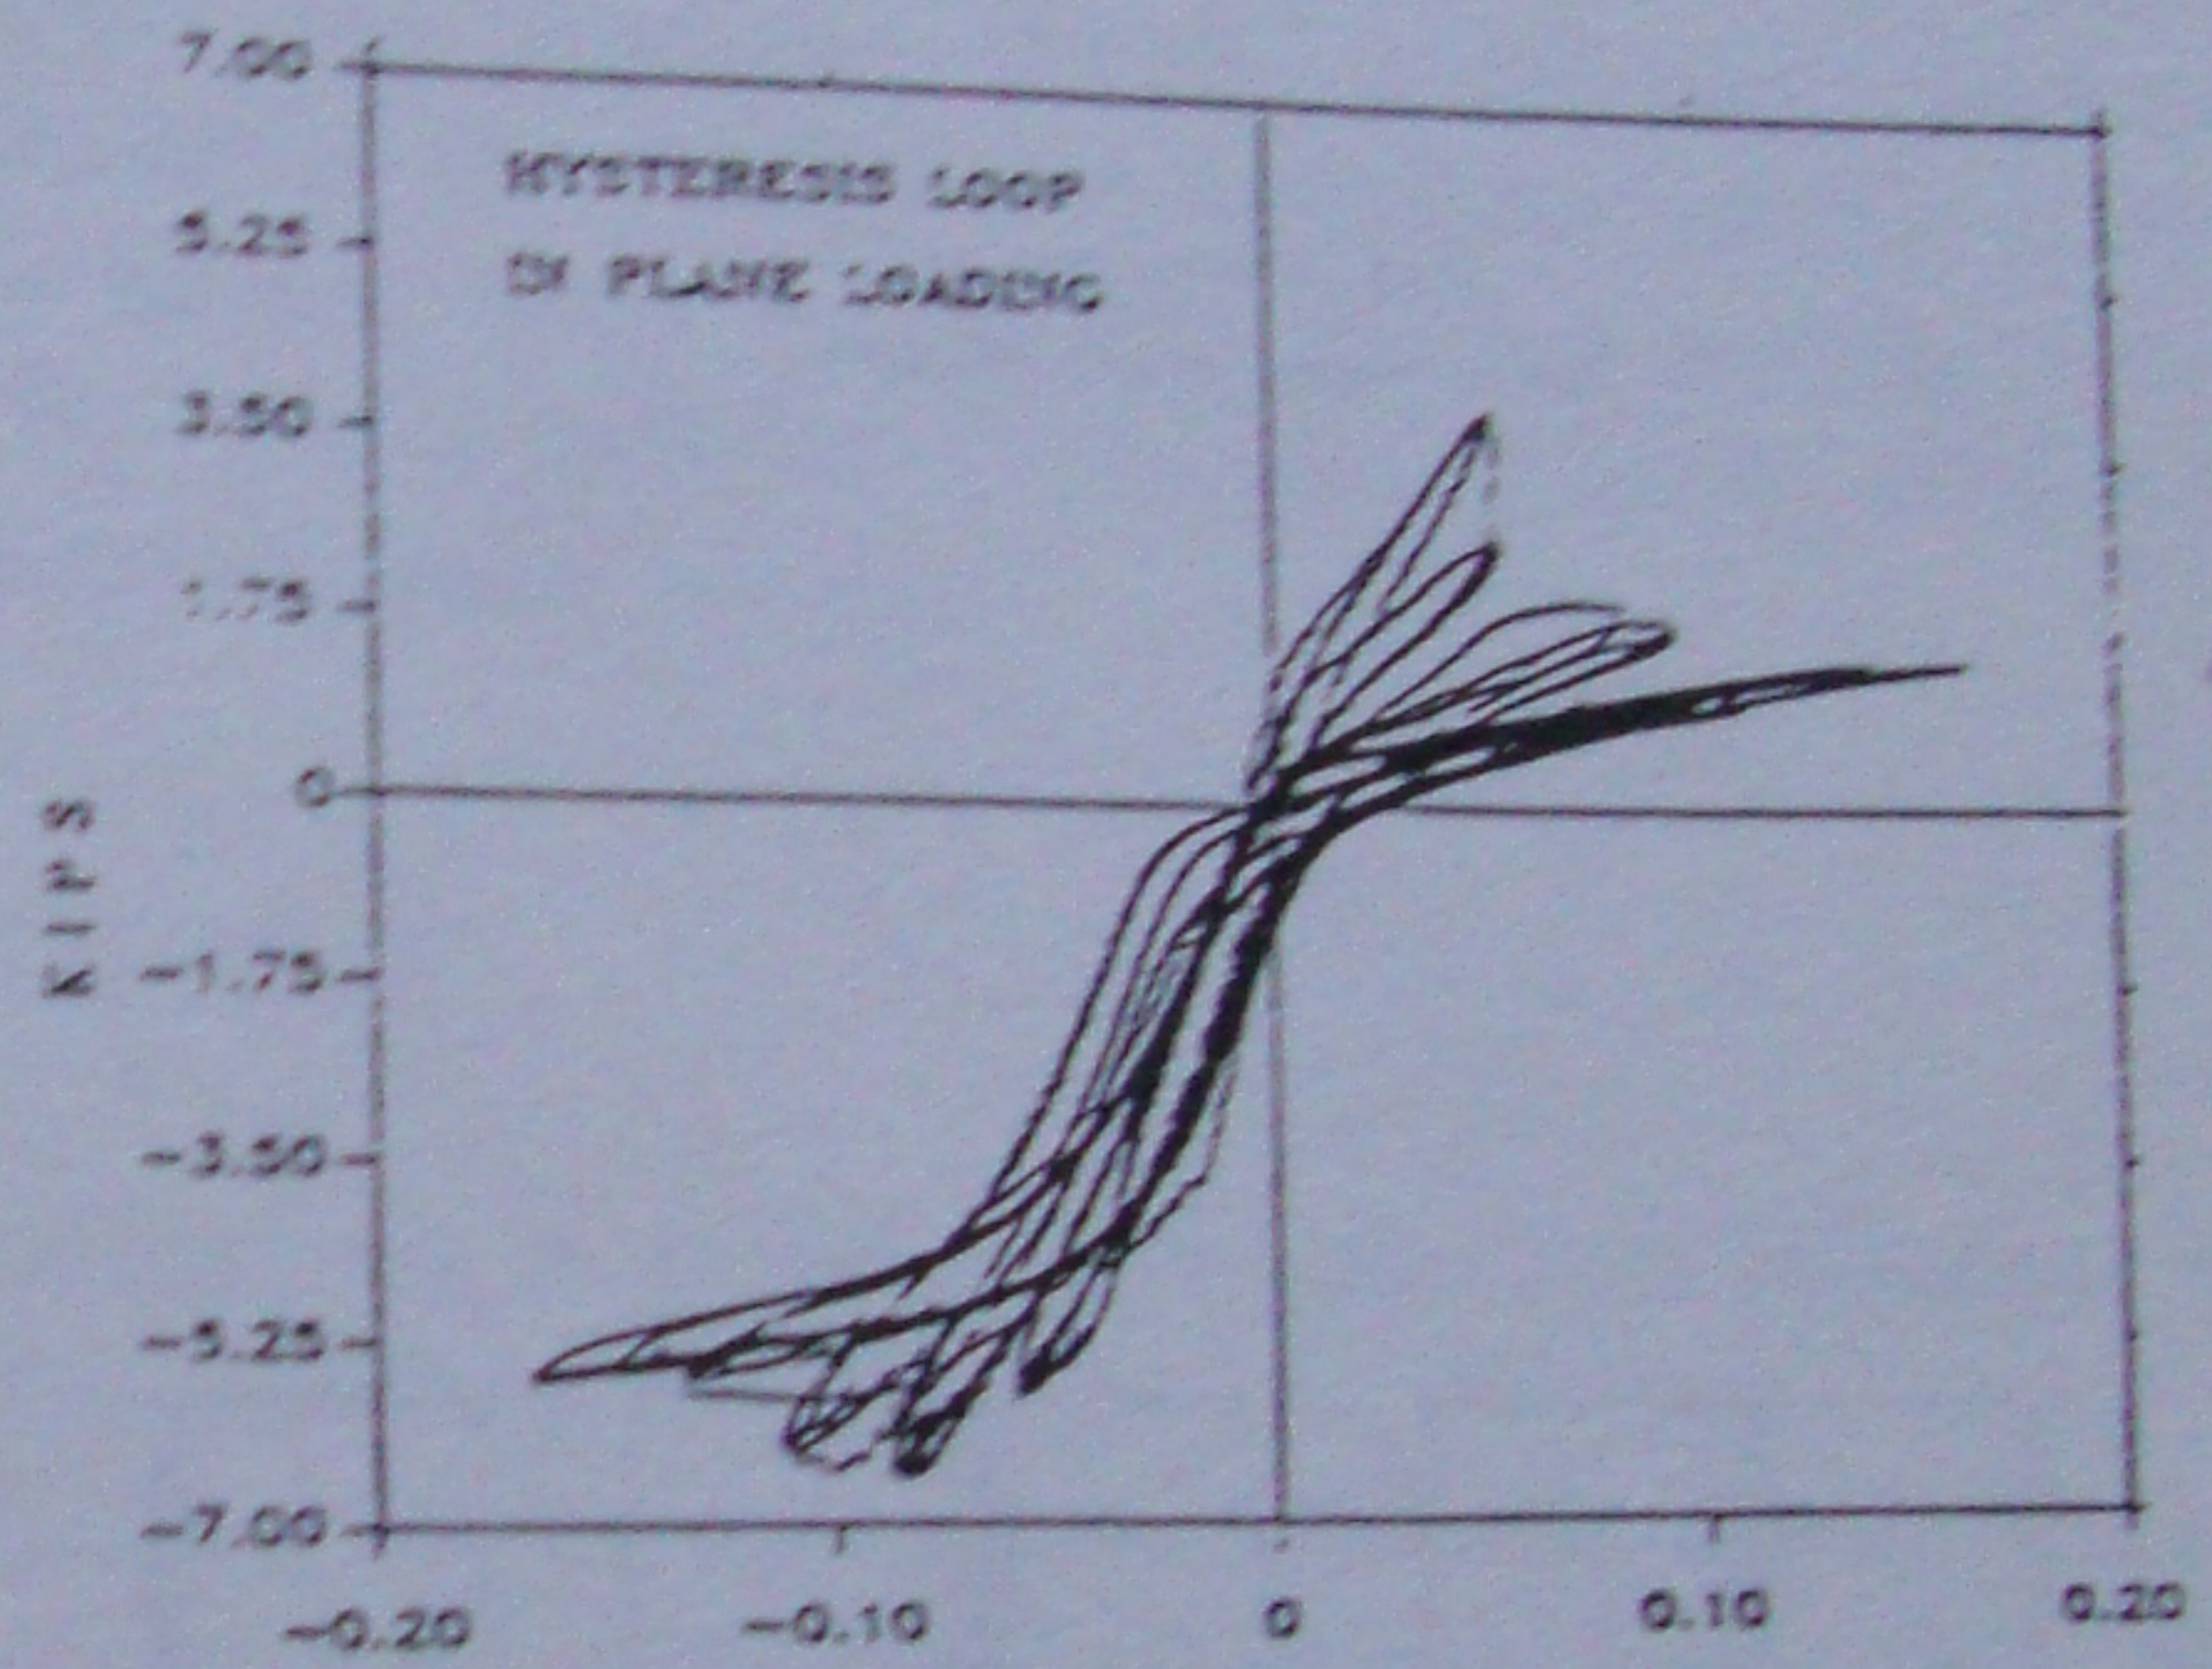
Shown in Fig. 4(a-d) are the hysteric loops corresponding to either uncoated or coated walls in the cyclic loading tests. As shown for the out-of-plane test, both the coated and uncoated walls behaved in a ductile way, except that the uncoated walls had a much lower loading capacity and a very poor energy dissipation capacity. For the uncoated walls subjected to the in-plane loadings, the strength for one end dropped immediately after the first loading cycle while the strength for the other end of the wall specimen showed an increase. This nonsymmetric pattern was produced in subsequent loading cycles and reflected in the hysteric loops because the loss of the resistance at one end of the wall, where sliding occurred when loading was applied. For the coated walls under in-plane loadings, elastic behavior was realized in the early loading stages. When the loading intensity was increased, the specimens started to yield at one end of the wall. Good energy dissipation was noted in the hysteric loops.

Fig. 4(a) Typical Hysteresis Loops for Plain Wall in Out-of-plane Test

Fig. 4(c) Typical Hysteresis Loops for Plain Wall in In-plane Test

Fig. 4(b) Typical Hysteresis Loops for Coated Wall in Out-of-plane Test

Fig. 4(d) Typical Hysteresis Loops for coated Wall in In-plane Test

The energy dissipation capacity is taken as the average area contained in the hysteresis loops for three cycles of repeated loading for each stage of test. It can be seen in the hysteretic loops that in general, in the early loading stages, the energy dissipated in both the plain and the coated walls is very small since the response was still in the elastic range. In the later loading stages, significant dissipation of energy was found in the coated wall specimens, particularly for the wall specimen in the out-of-plane test. The energy dissipation capacity of masonry brick wall improved 3-6 times by the ferrocement overlay.

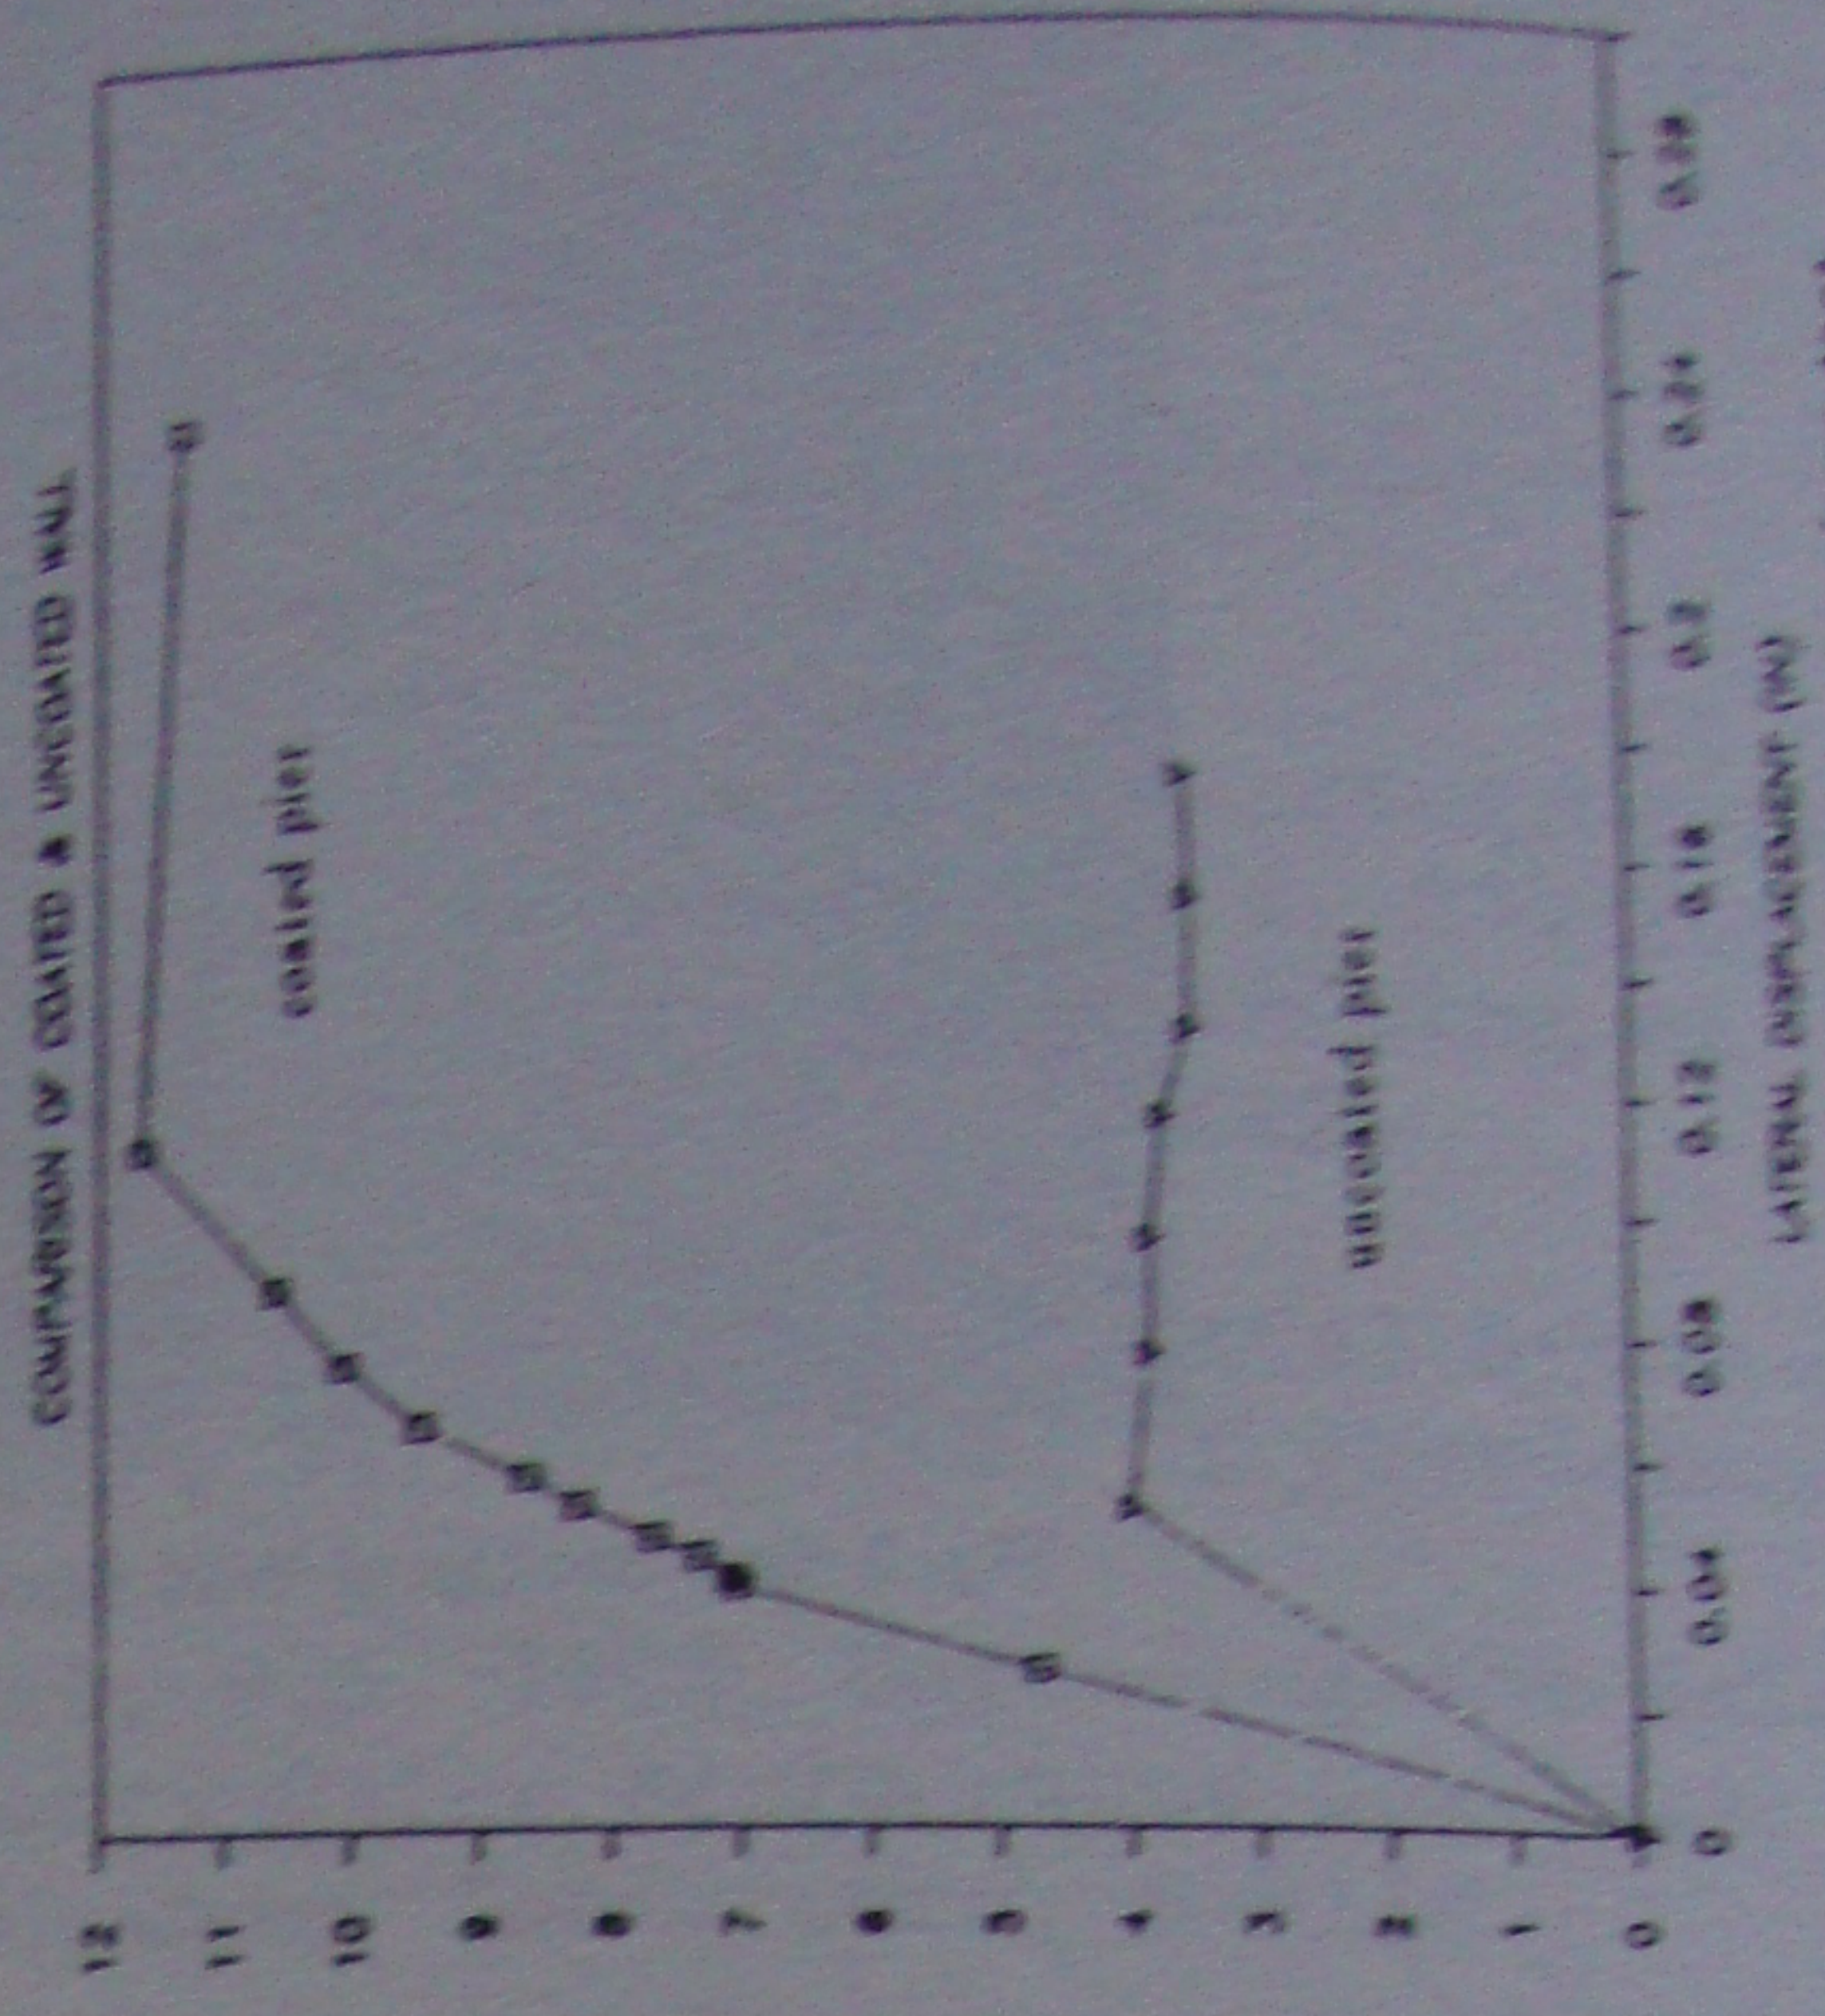
The in-plane strength is improved by about 3 times when the brick wall specimen is coated by the ferrocement overlay. Considerable improvement in the flexural strengths of the coated walls was also indicated in the results of the pseudostatic tests. Fig. 6 (a,b) shows the hysteretic envelopes taken from the cyclic loading test results for the plain and the coated walls when subjected to both in-plane and out-of-plane loadings. Each point shown in the hysteretic envelopes was obtained from the hysteresis loops by averaging the absolute extreme values of the six peaks of three cyclic loadings and the corresponding absolute values of the relative lateral displacement for each test stage. It can be seen that the ultimate strength of the masonry wall was upgraded by 3 to 4 times by the ferrocement overlay.

Fig. 6(a) Hysteresis Envelope for out-of plane test

Fig. 6(b) Hysteresis Envelope for in plane test

Ductility, an important indicator of earthquake resistant ability, was obtained from the hysteretic envelopes and defined as the ratio of the maximum displacement at the failure point to the extrapolated displacement corresponding to the same loading point, which was noted in the envelopes. According to this definition, the ductility for the walls in the out-of-plane test was found to be 6.70 and 9.50 for the plain and coated walls respectively, while in the in-plane test, it was 3.50 and 4.00. It is evident that the ductility of the masonry walls was improved by the application of ferrocement coatings.
