## Design of Seismic Retrofit for Oak Street Bridge Bent

In March of 1993, the British Columbia Ministry of Transportation and Highways (The Ministry) contracted Klohn-Crippen (formerly Crippen) to undertake the first phase of detailed seismic retrofit of the Oak Street Bridge. The bridge, originally designed and constructed in the mid 1950's, is a major link connecting Vancouver and Richmond.

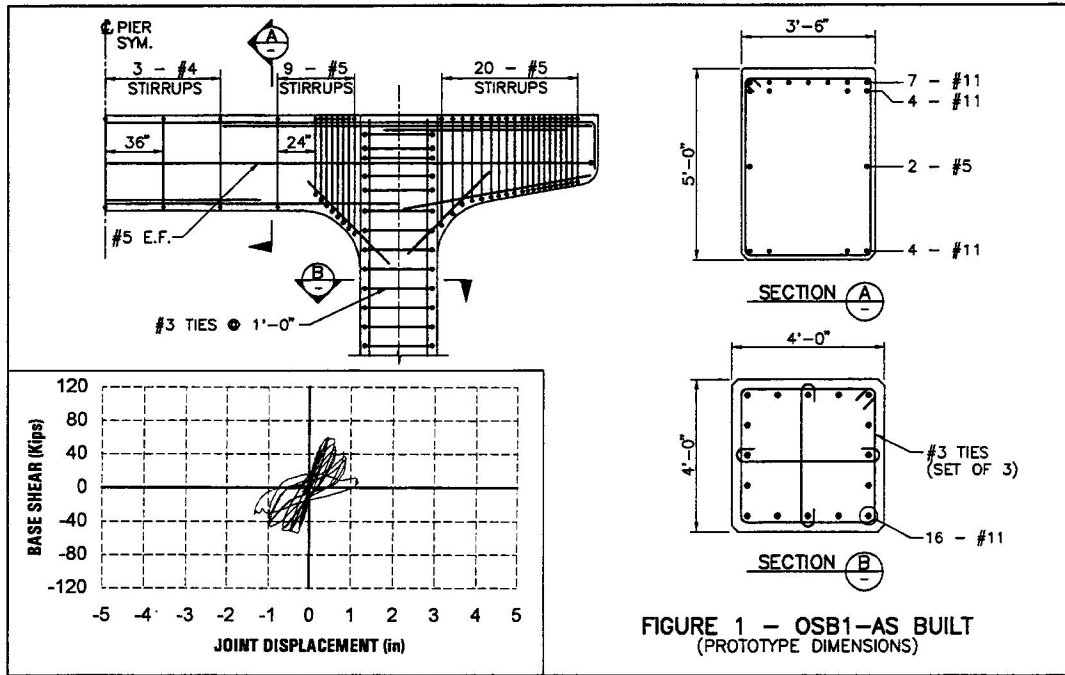
The as-built specimen OSB1, shown in Figure 1, is representative of the bridge piers as they now exist. The model hysteresis plot provided in Figure 1 graphically illustrates the extremely poor lateral load response expected from the existing bridge piers and confirms the severity of the identified deficiencies. Based on test observations and the hysteresis plots obtained, the failure of actual bridge piers during even a moderate earthquake is expected to be sudden, brittle, and potentially catastrophic.

The test model failed at a beam shear demand of 58 kips following the formation of a flexural shear crack adjacent to the haunch where the stirrup steel drops off dramatically (see Figure 1). The failure mode was brittle with no ductility capacity.

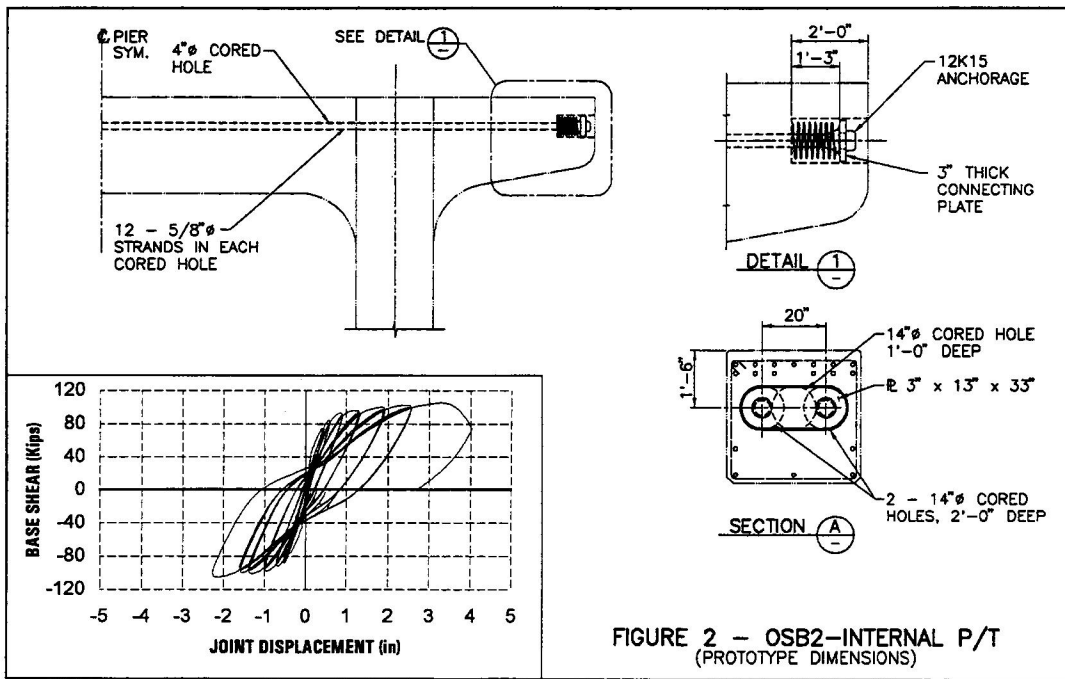
The design for cap beam strengthening on this specimen incorporated bonded internal post-tension strands inside two parallel longitudinally cored holes (see Figure 2). The post-tensioning was chosen to be internal for two reasons: it was thought more efficient to have the strands bonded and integral with the existing cap beam; and it does not affect the existing appearance of the structure. The strands were placed in the upper region of the kern of the cap beam cross section to optimize the negative moment capacity while ensuring no permanent tension was introduced on the soffit concrete fibres. The coring tolerances on the model specimen were easily achieved.

A significant beam shear crack developed in the same critical region of the cap beam that produced failure in OSB1, however the post-tensioning was sufficient to enable the beam to carry the shear demands while forcing plastic hinging into the columns. Shear failure eventually occurred in the tension column hinge zone at a global ductility of about six (see hysteresis loops in Figure 2), three times that

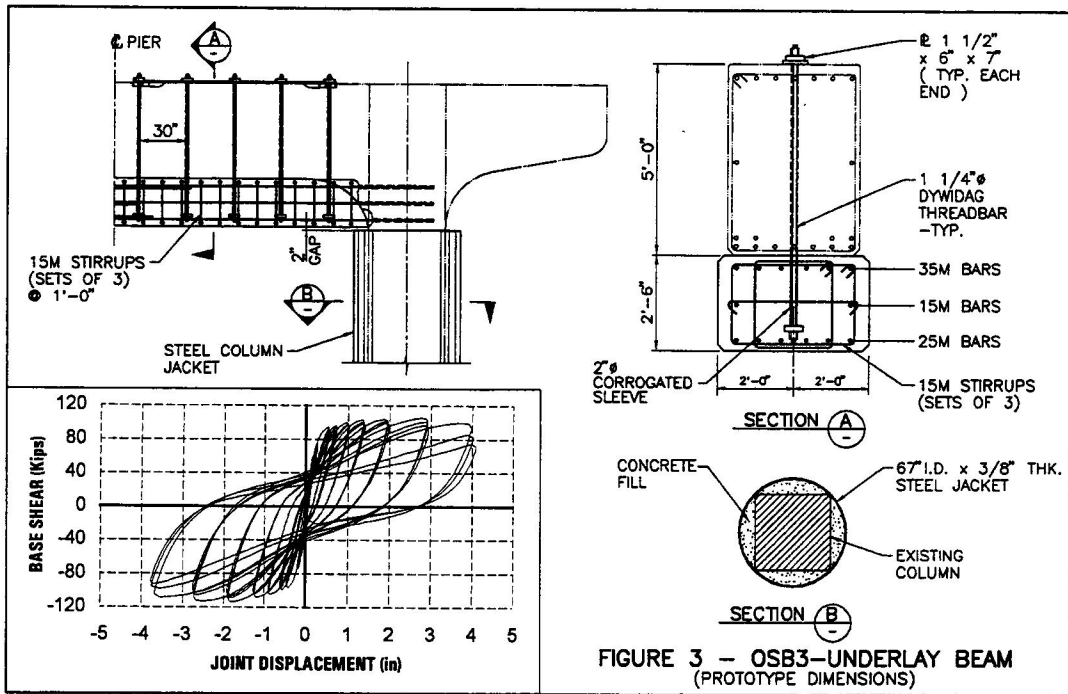
The retrofit of specimen OSB3, shown in Figure 3, combined a new reinforced concrete underlay beam clamped to the existing cap beam with vertical post-tension rods inside of cored holes. The width of the new beam was chosen (based on advice from the contractor) to match the existing column width, which is 6 inches wider than the cap beam on the prototype, so as to provide easier access for the concrete pour. The vertical post-tension bars were necessary for shear but also provided a clamping force which improved the bond conditions for the top layer of existing reinforcing. A steel plate was installed on top of the existing beam to increase the amount of negative moment reinforcement. Steel column jackets were provided on this specimen to prevent column shear failure.

Testing found the retrofit capbeam of OSB3 to be very robust with little cracking observed throughout the duration of the test. This was likely due to the fact that the observed column hinge overstrength of 1.15 was approximately 15 percent lower than the 1.35 used for retrofit design. The lower portion of the beam-column joint experienced much of the observed damage with concrete spalling leading to main column reinforcement buckling at a ductility of 9. At an ultimate global displacement ductility of 12, significant degradation of lateral load (see hysteresis loops in Figure 3) occurred during cycling as column bars fractured.

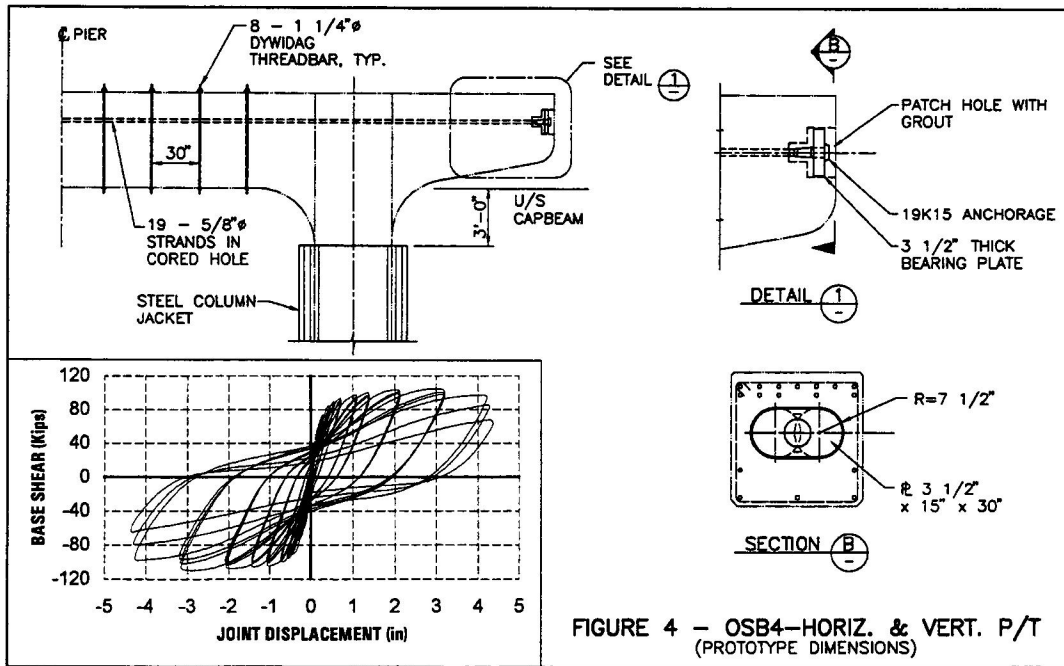
During construction of retrofit specimens OSB2 and OSB3, information was gained about problems to expect during construction. Also during this time it was discovered that the coring tolerances desired for the Oak Street Bridge piers, using the OSB2 configuration, may be difficult to achieve. Much of the experience gained here helped determine the requirements of the third retrofit scheme OSB4, shown in Figure 4.

The OSB4 retrofit specimen incorporated longitudinal post-tensioning through a single cored hole in the cap beam, two rows of vertical cap beam post-tensioning rods, and a round steel column jacket. A

OSB4 test results, shown in Figure 4, were similar to those of OSB3 (underlay scheme). While joint performance was improved in the region above the fillet, the ultimate performance of the region immediately above the steel jacket was virtually identical in the two tests. The gravity loads were reliably resisted through the extreme limits of the test, such that even at ductility demands of six times the design values, collapse would not be expected.
