Reducing The Risk From Non-Structural Building Components In Earthquakes

White, William A. S.¹

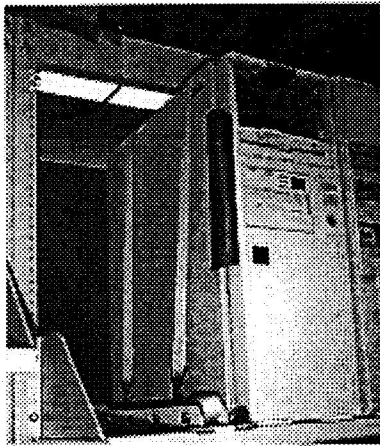
Figure 5 - attachments to CPU on LAN rack

Figure 4 shows the results after a test with input motion A2. Figure 5 shows restraint devices for a CPU on the LAN rack. It should be noted that the bars holding the straps had not been designed specifically to fit the width of the LAN rack. Hence the result at figure 6 which shows the CPU being barely held from falling. The input motion for this test was A8 and the LAN rack was bolted to the concrete floor. Figure 7 shows the Seismic Isolation Platform from Tekton Inc. with the LAN rack mounted on top.

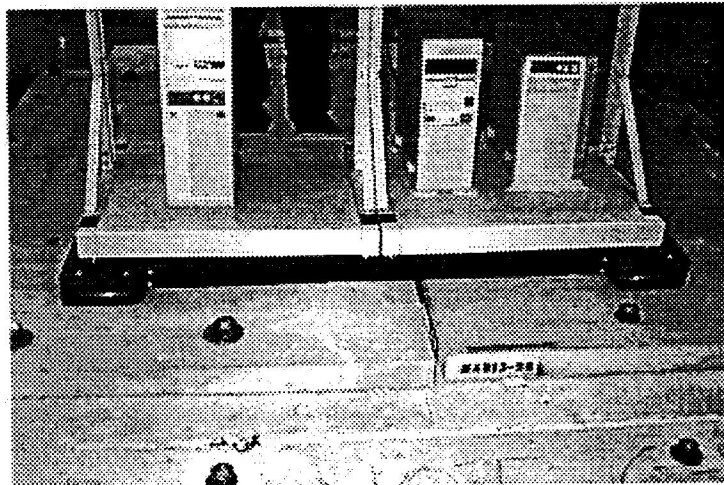
Figure 7 - LAN rack with base isolation
